Release Notification and Corrective Action

Name of Company BOPCO, L.P. <i>260737</i>	Contact Tony Savoie
Address 522 W. Mermod, Suite 704 Carlsbad, N.M. 88220	Telephone No. 432-556-8730
Facility Name Bass Federal 3 Well #4 "Release #2"	Facility Type E&P

BOPCO
 Bass 3 Fed #4 Spill #2
 Eddy County, New Mexico

**Bass 3 Federal #4 Site #2 (2RP-402)
Soil Chemistry Table**

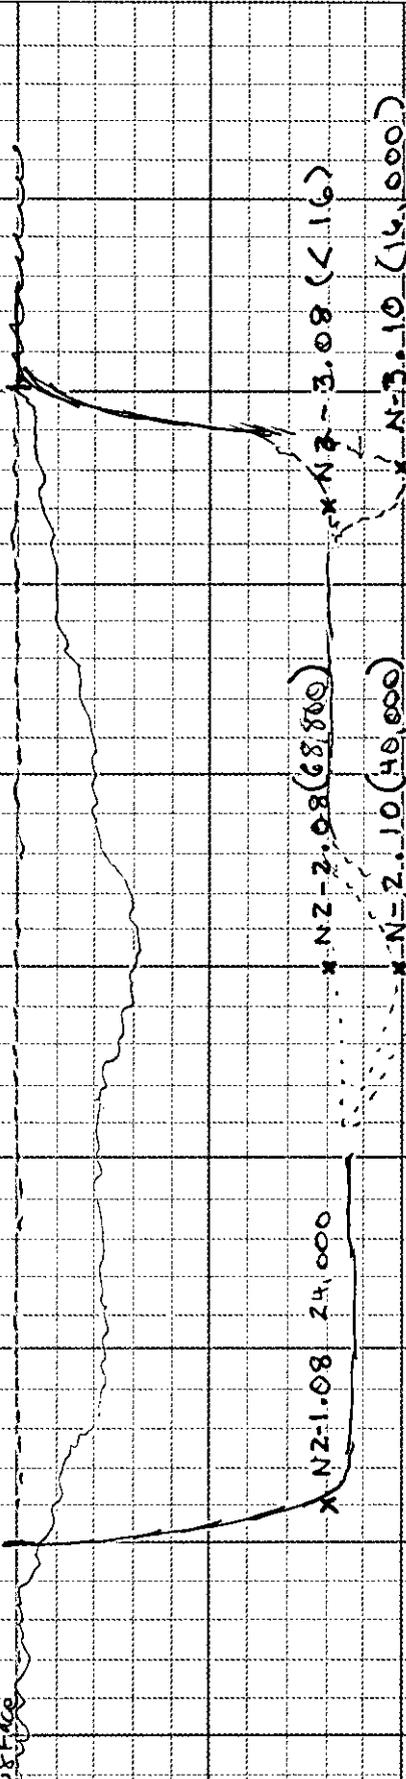
North Trench
3/30/10

X-NZ-1.08 24,000

X-NZ-2.08 (28,800)

X-NZ-3.08 (<16)

X-N=2.10 (40,000)

X-N=3.10 (14,000)

X-N=C.13 (19,200)

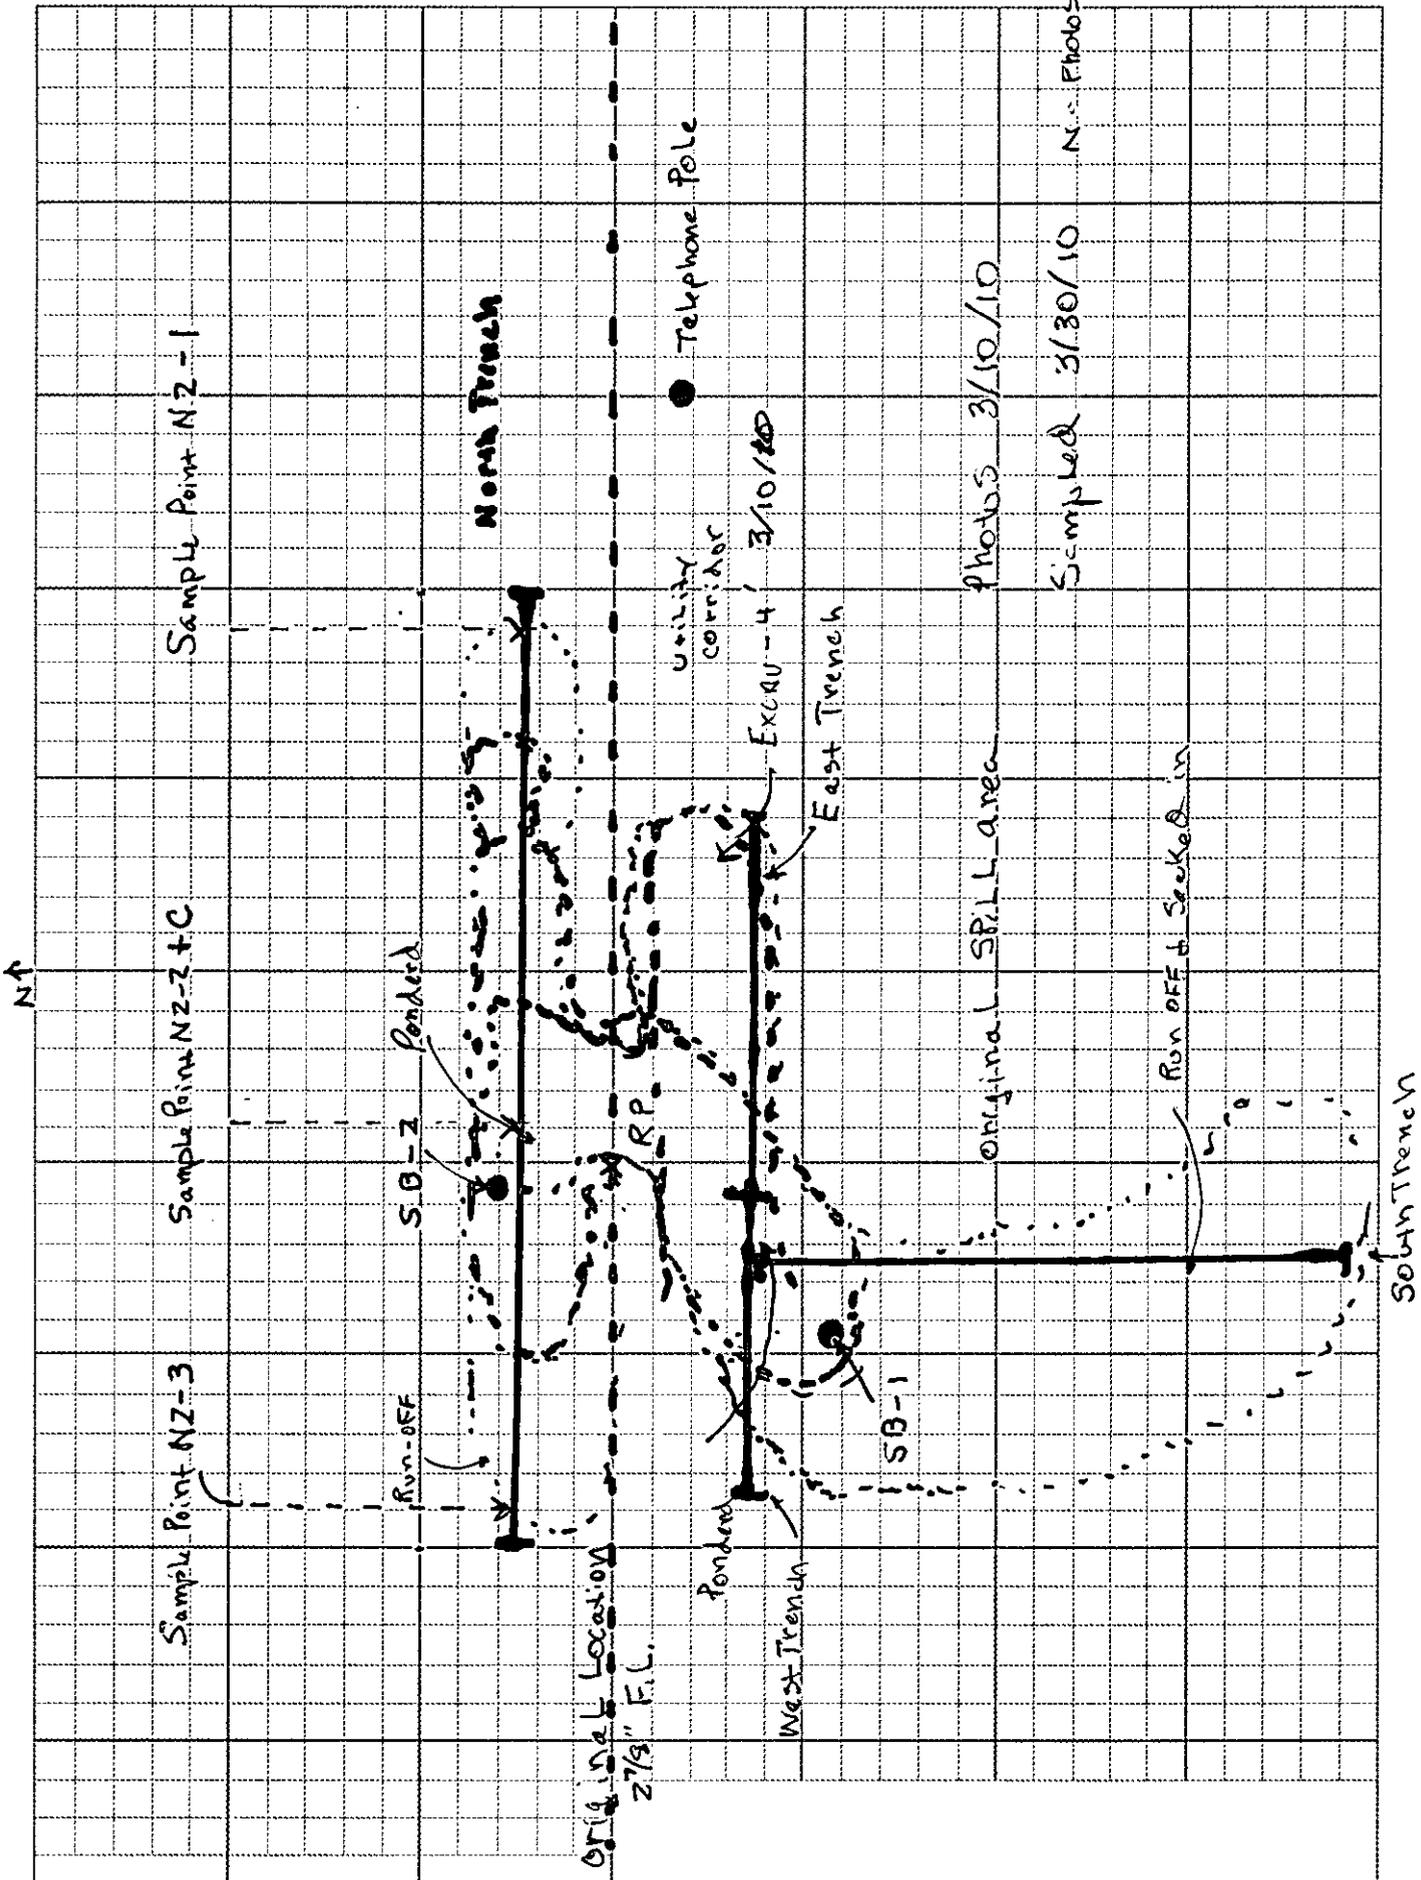
Sample Point NZ-1

Sample Point NZ-2+3

Sample Point NZ-3

SB-2 Ponded

North Trench

Original Location
2 7/8" F.I.L.

West Trench

SB-1

East Trench

Run OFF & Sealed in

South Trench

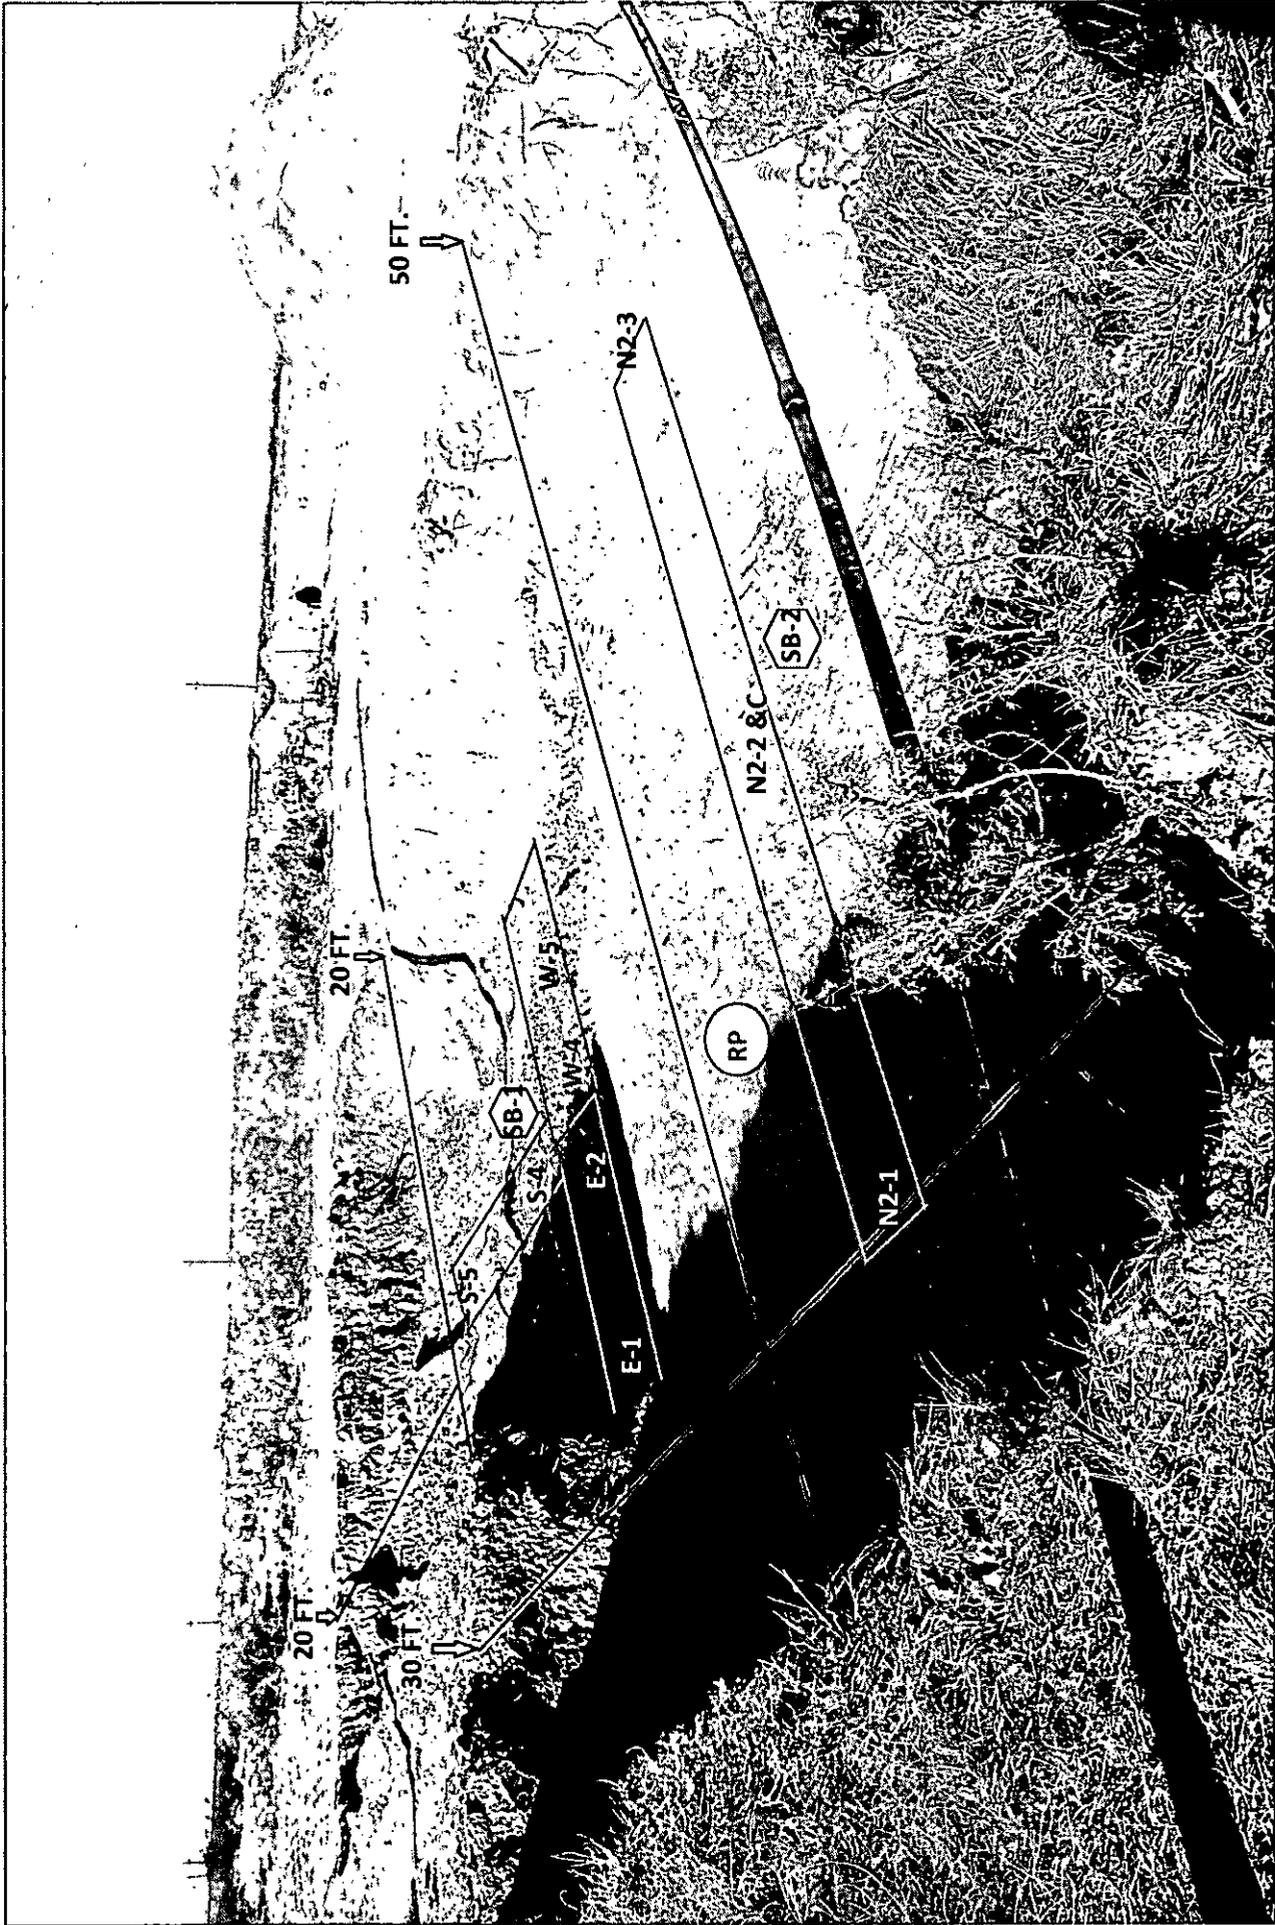
NE ↗
Corner

6/17/10
Photo 0880 Enhanced
Liner Installed 7/21 & 22/10
