**3R-1033**

**Enterprise  
Madsen Gas Com #1E**

**ENTERPRISE PRODUCTS  
MASDEN GAS COMM #1E  
PIPELINE RELEASE AND SUBSURFACE WATER INVESTIGATION WORK PLAN**

**GROUNDWATER INVESTIGATION REPORT  
MASDEN GAS COM #1E NATURAL GAS PIPELINE RELEASE**

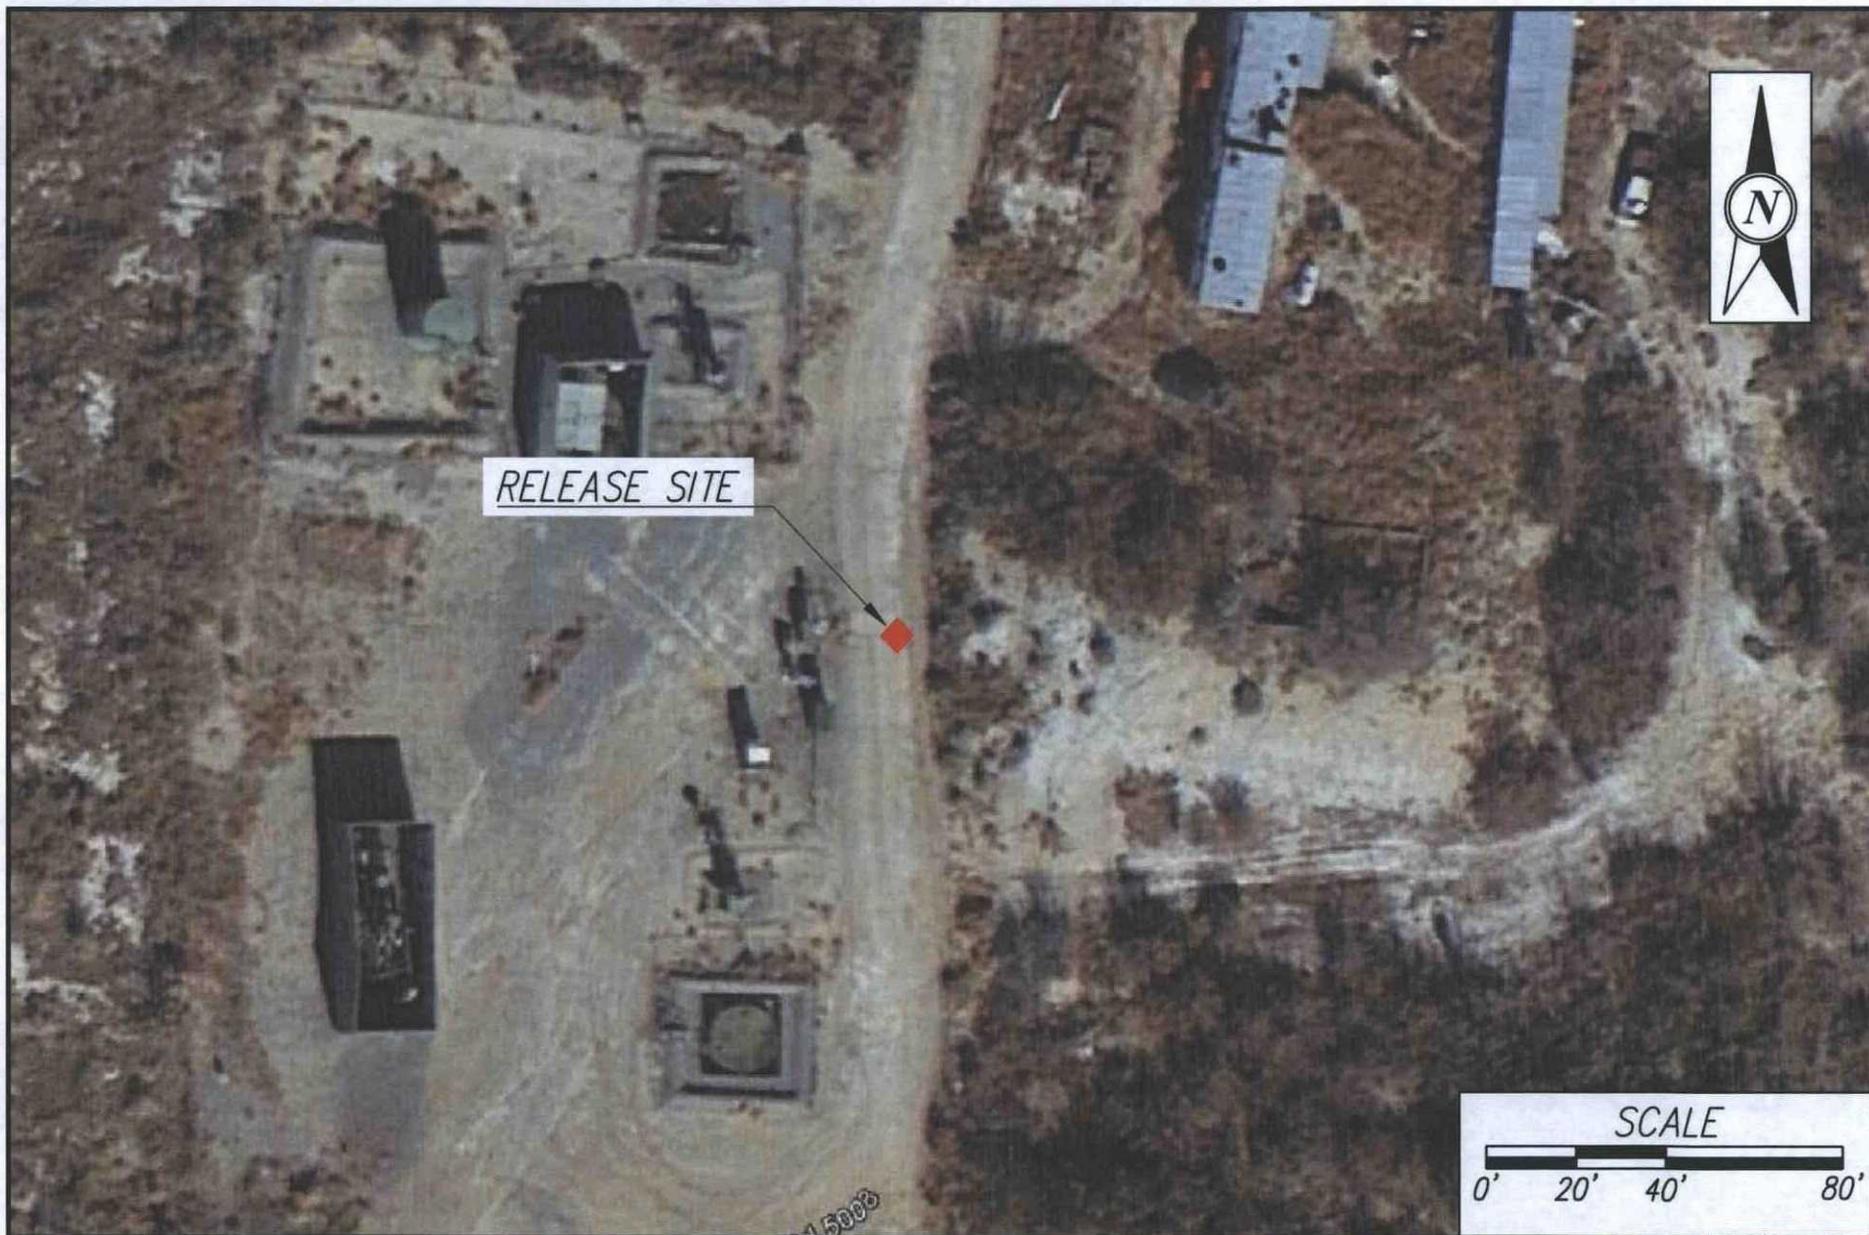
RELEASE SITE

On behalf of Enterprise Products Operating, LLC. (Enterprise), SMA has prepared this report that describes remediation of a hydrocarbon release associated with the Brookhaven A2 well tie pipeline release site. The site is located in the NW ¼ NW ¼ Section 28, T29N, R11W, San Juan County, 36.700959°, -108.001644°, San Juan County, New Mexico on privately owned land. Figure 1 illustrates the location of the site.

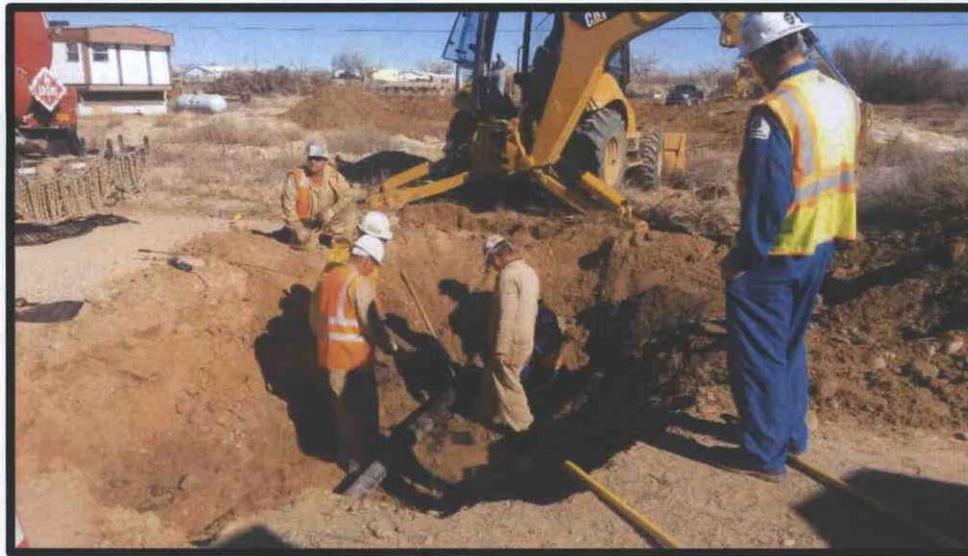
**Photo 1:** Excavation commenced on February 10, 2015, using a rubber tire backhoe operated by West States Energy Contractors

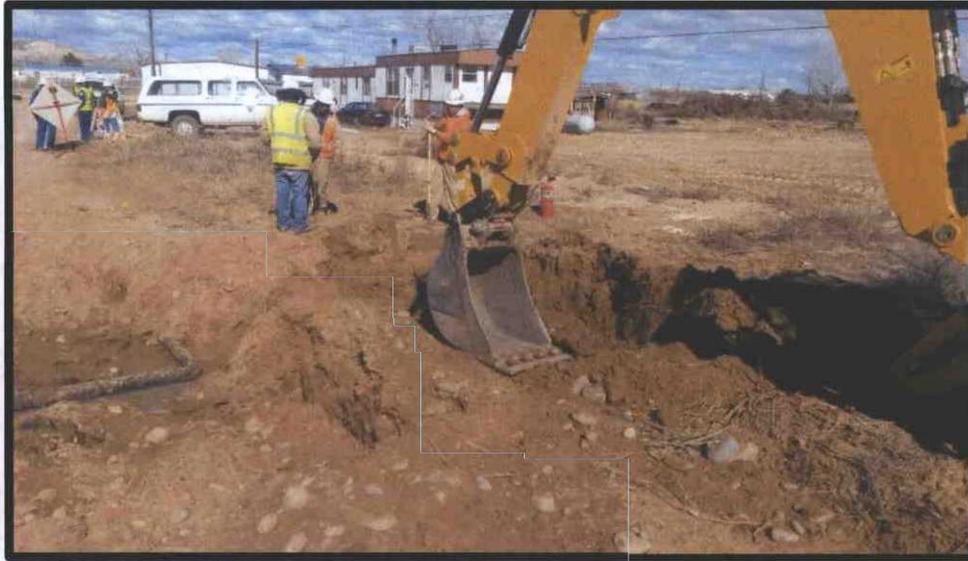
**Photo 5:** City of Bloomfield waterline, running north parallel to pipeline, marked with yellow flagging. Excavating on the east side of waterline to determine extent of contamination.

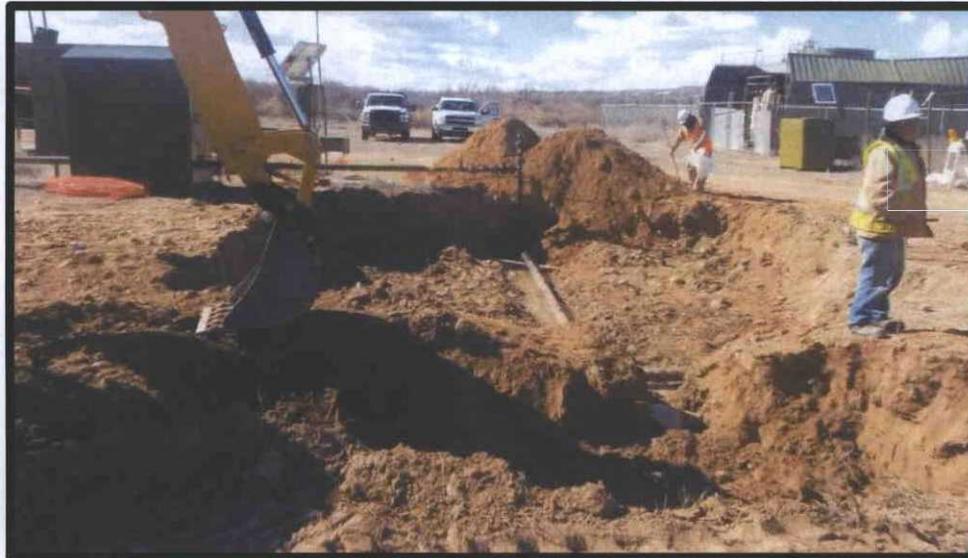
**Photo 6:** City of Bloomfield waterline remained buried during excavation activities.

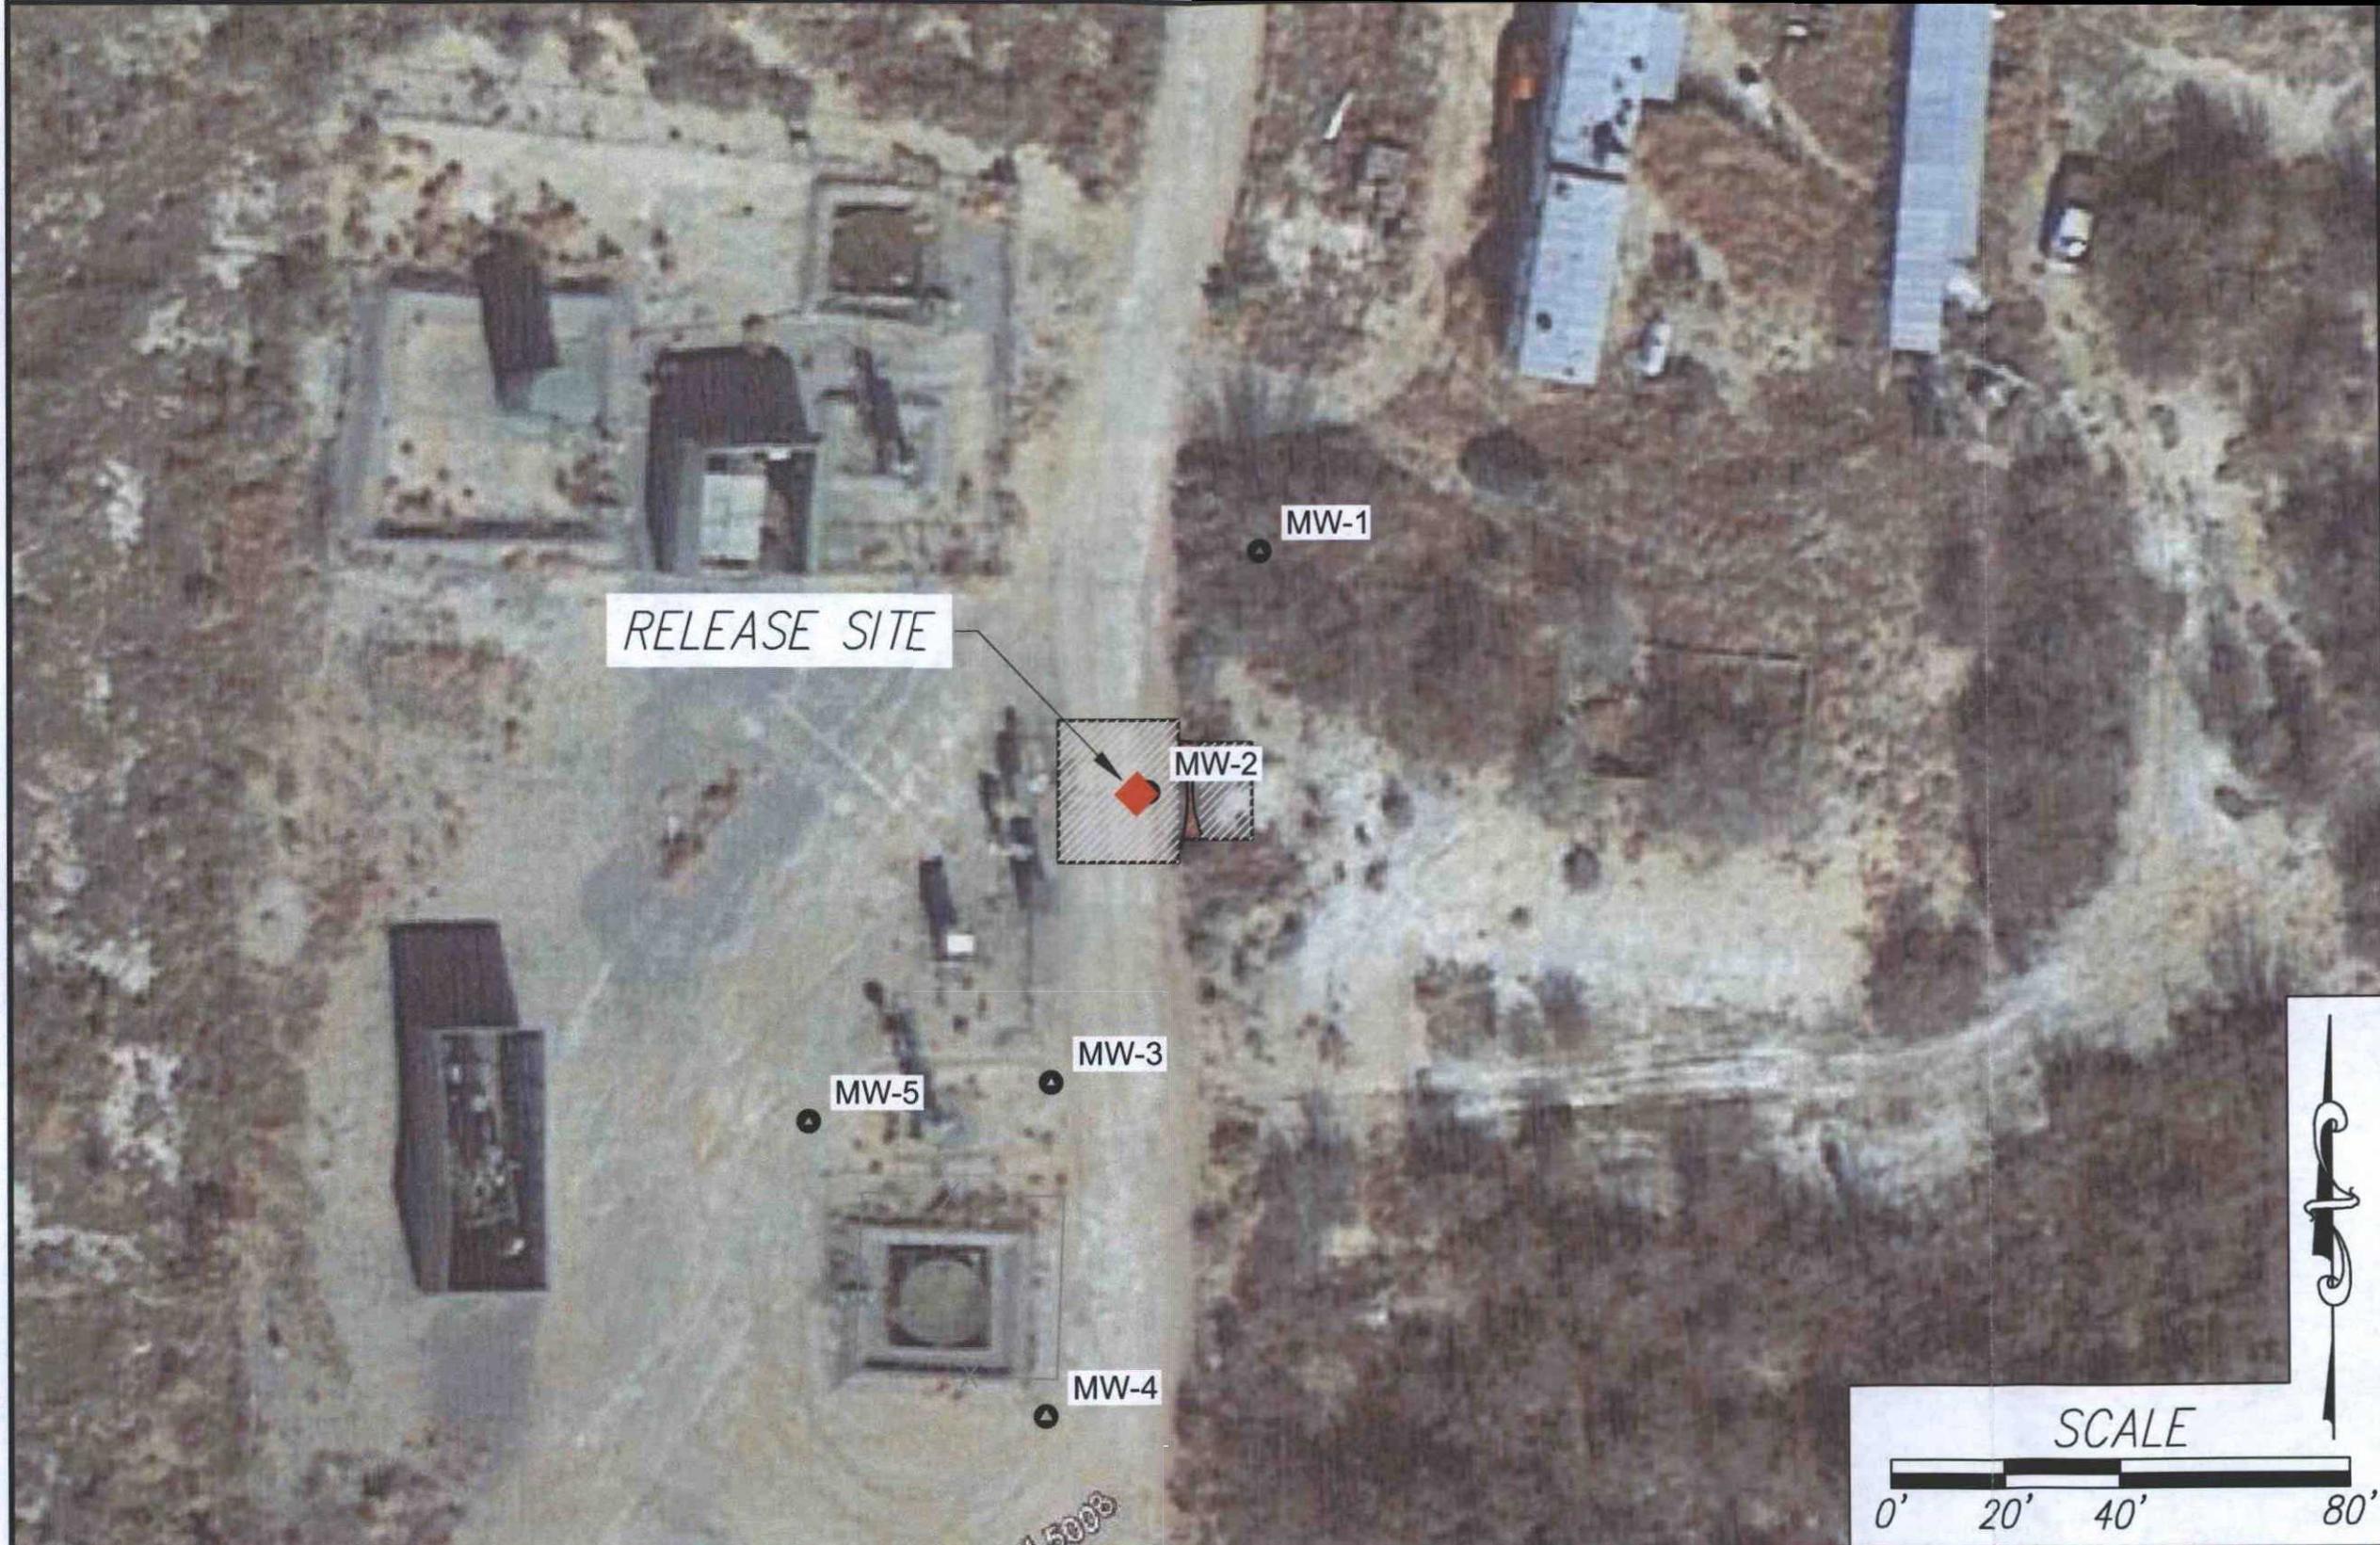
Designed SM	Drawn DJB	Checked RSA
Date: August 2015		
Scale: Horiz: 1"=40' Vert: N/A		
Project No: 5123699		
Figure 2

**Monitoring Well Locations:** SMA determined that the installation of five monitoring wells was necessary in order to establish a groundwater gradient and to better identify the extent of possible groundwater contamination at the Masden Gas Com #1E site. A hydro excavator was used to advance all 5 soil borings to 5 feet bgs to ensure clearance of all underground utilities and infrastructure. Hydro excavation of the 6" PVC waterline in the vicinity of the release was completed to remove the remaining contaminated soils in contact with the waterline. Soil and water removed during hydro excavation was recovered in the hydro excavation truck. The material was transported and disposed of at the Industrial Ecosystems Incorporated (IEI) landfarm on Crouch Mesa. A site map depicting the well locations is included as Figure 2.

The release site is located on privately owned land at an elevation of approximately 5,410 feet above sea level. During excavation activities subsurface water was encountered at approximately 3.5 feet below ground surface (bgs). Figure 1 depicts the site vicinity and Figure 2 depicts the site location.

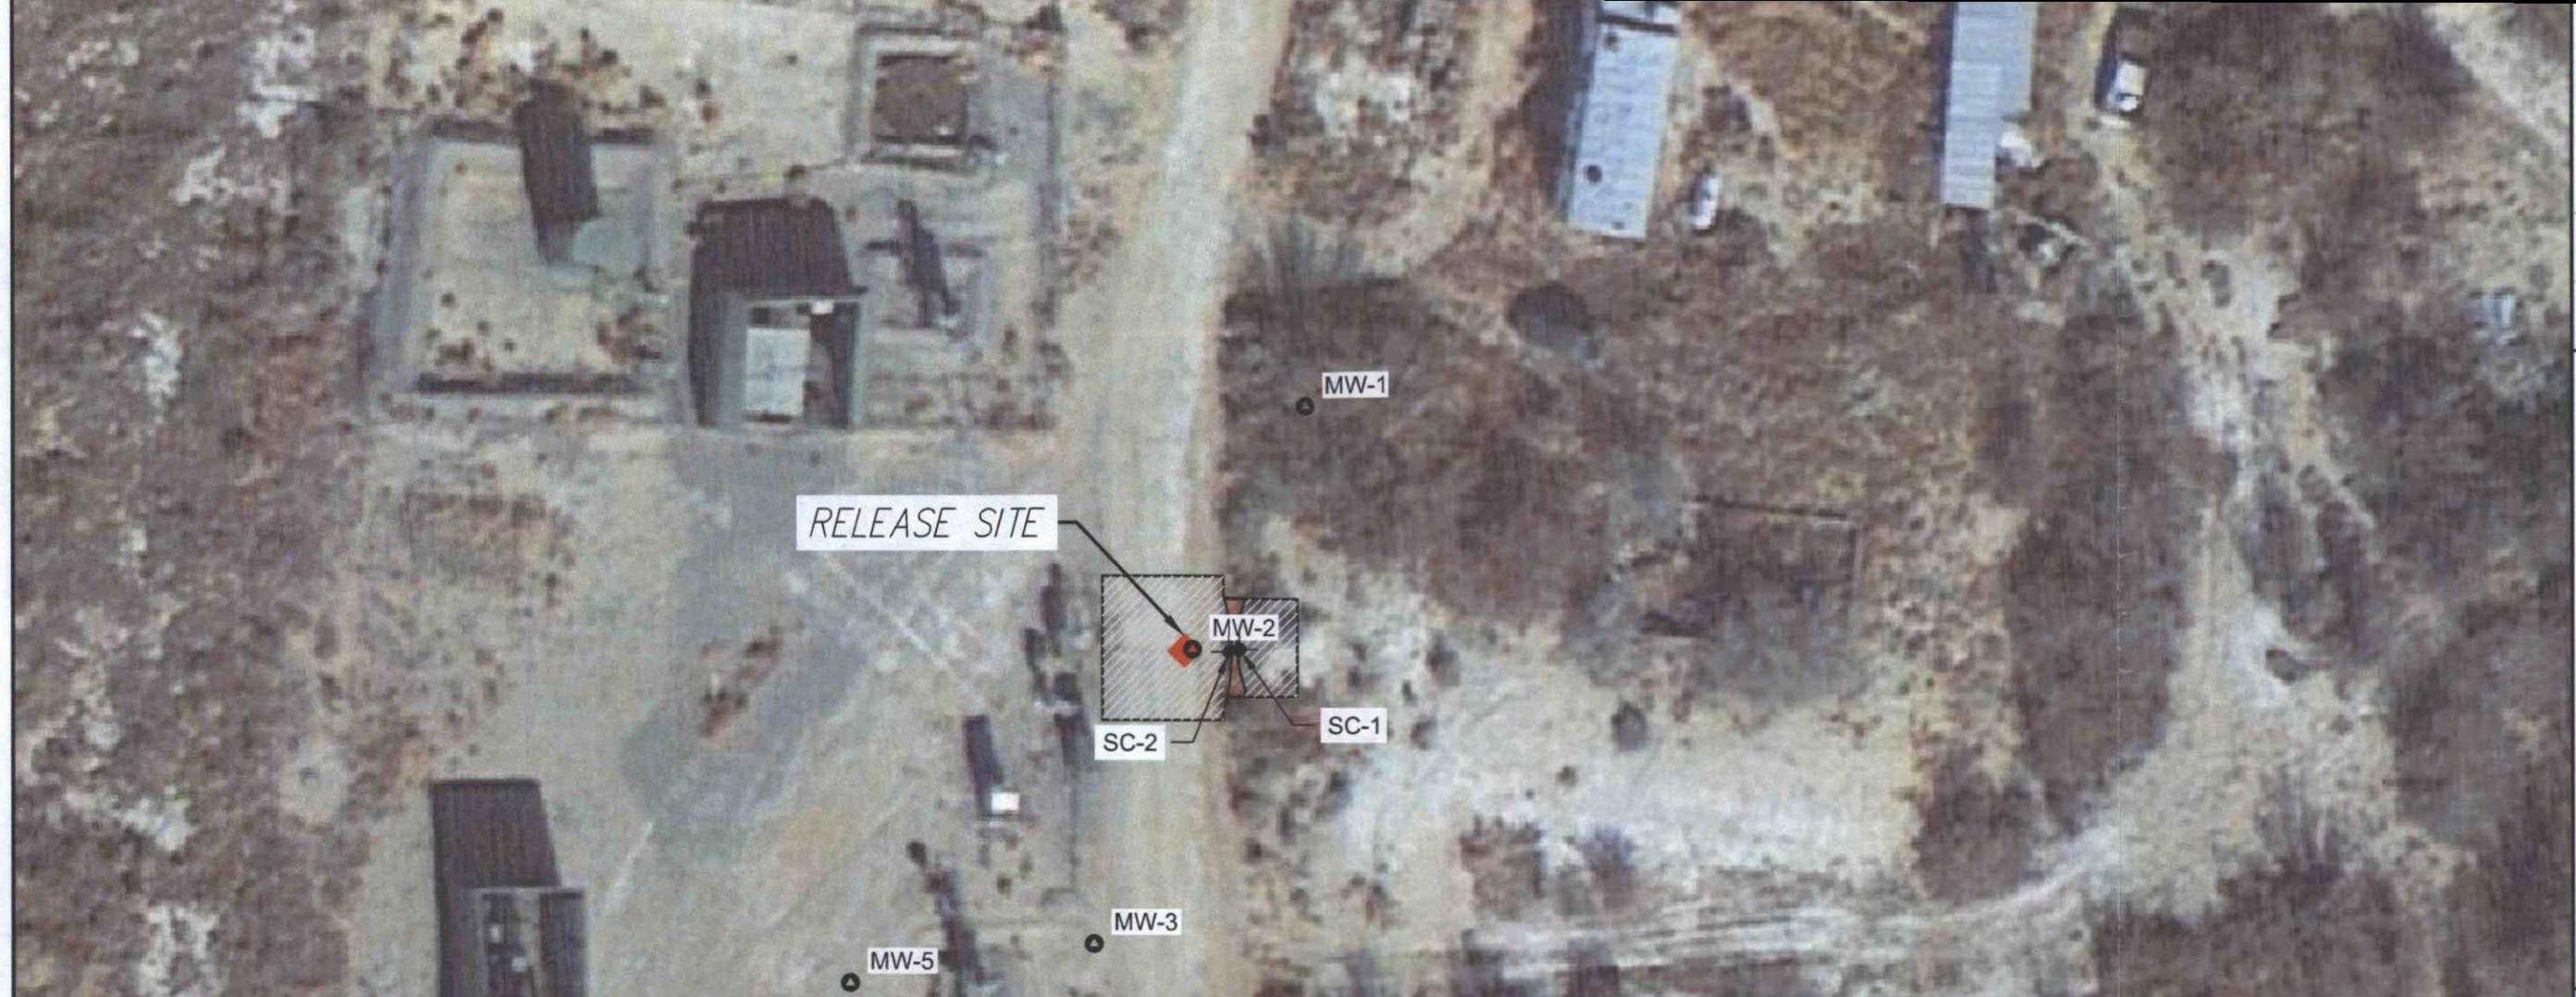
Date	Time	Sample ID	Sample Depth (Feet BGS)	Method 8015 GRO	Method 8015 DRO	Method 8021 Benzene	Method 8021 BTEX	Method 300.0 Chloride
NMOCD Guidelines				NMOCD Site Ranking: 40		100 ppm	10 ppm	50 ppm
7/6/2015	8:45	MW-1 @ 3'	3'	<5.0	<9.9	<0.050	<0.10	49
7/6/2015	12:45	MW-2 @ 3'	3'	<b>710</b>	<b>91</b>	1.5	83.2	190
7/6/2015	13:25	MW-3 @ 3'	3'	<4.9	<9.9	<0.049	<0.097	61
7/6/2015	13:30	MW-4 @ 3'	3'	<4.9	<10	<0.049	<0.097	44
7/6/2015	13:45	MW-5 @ 3'	3'	<5.0	<10	<0.050	<0.099	<30
7/6/2015	9:00	SC-1 Trench E Wall	0-3'	9.8	<10	<0.047	<0.095	34
7/6/2015	9:15	SC-2 Trench W Wall	0-3'	<b>630</b>	<b>20</b>	0.48	53.98	39

ENTERPRISE  
 FARMINGTON, NEW MEXICO  
 SOIL SAMPLE ANALYTICAL MAP  
 MASDEN GAS COM #1E  
 SECTION 28, T29N, R11W  
 SAN JUAN COUNTY, NEW MEXICO

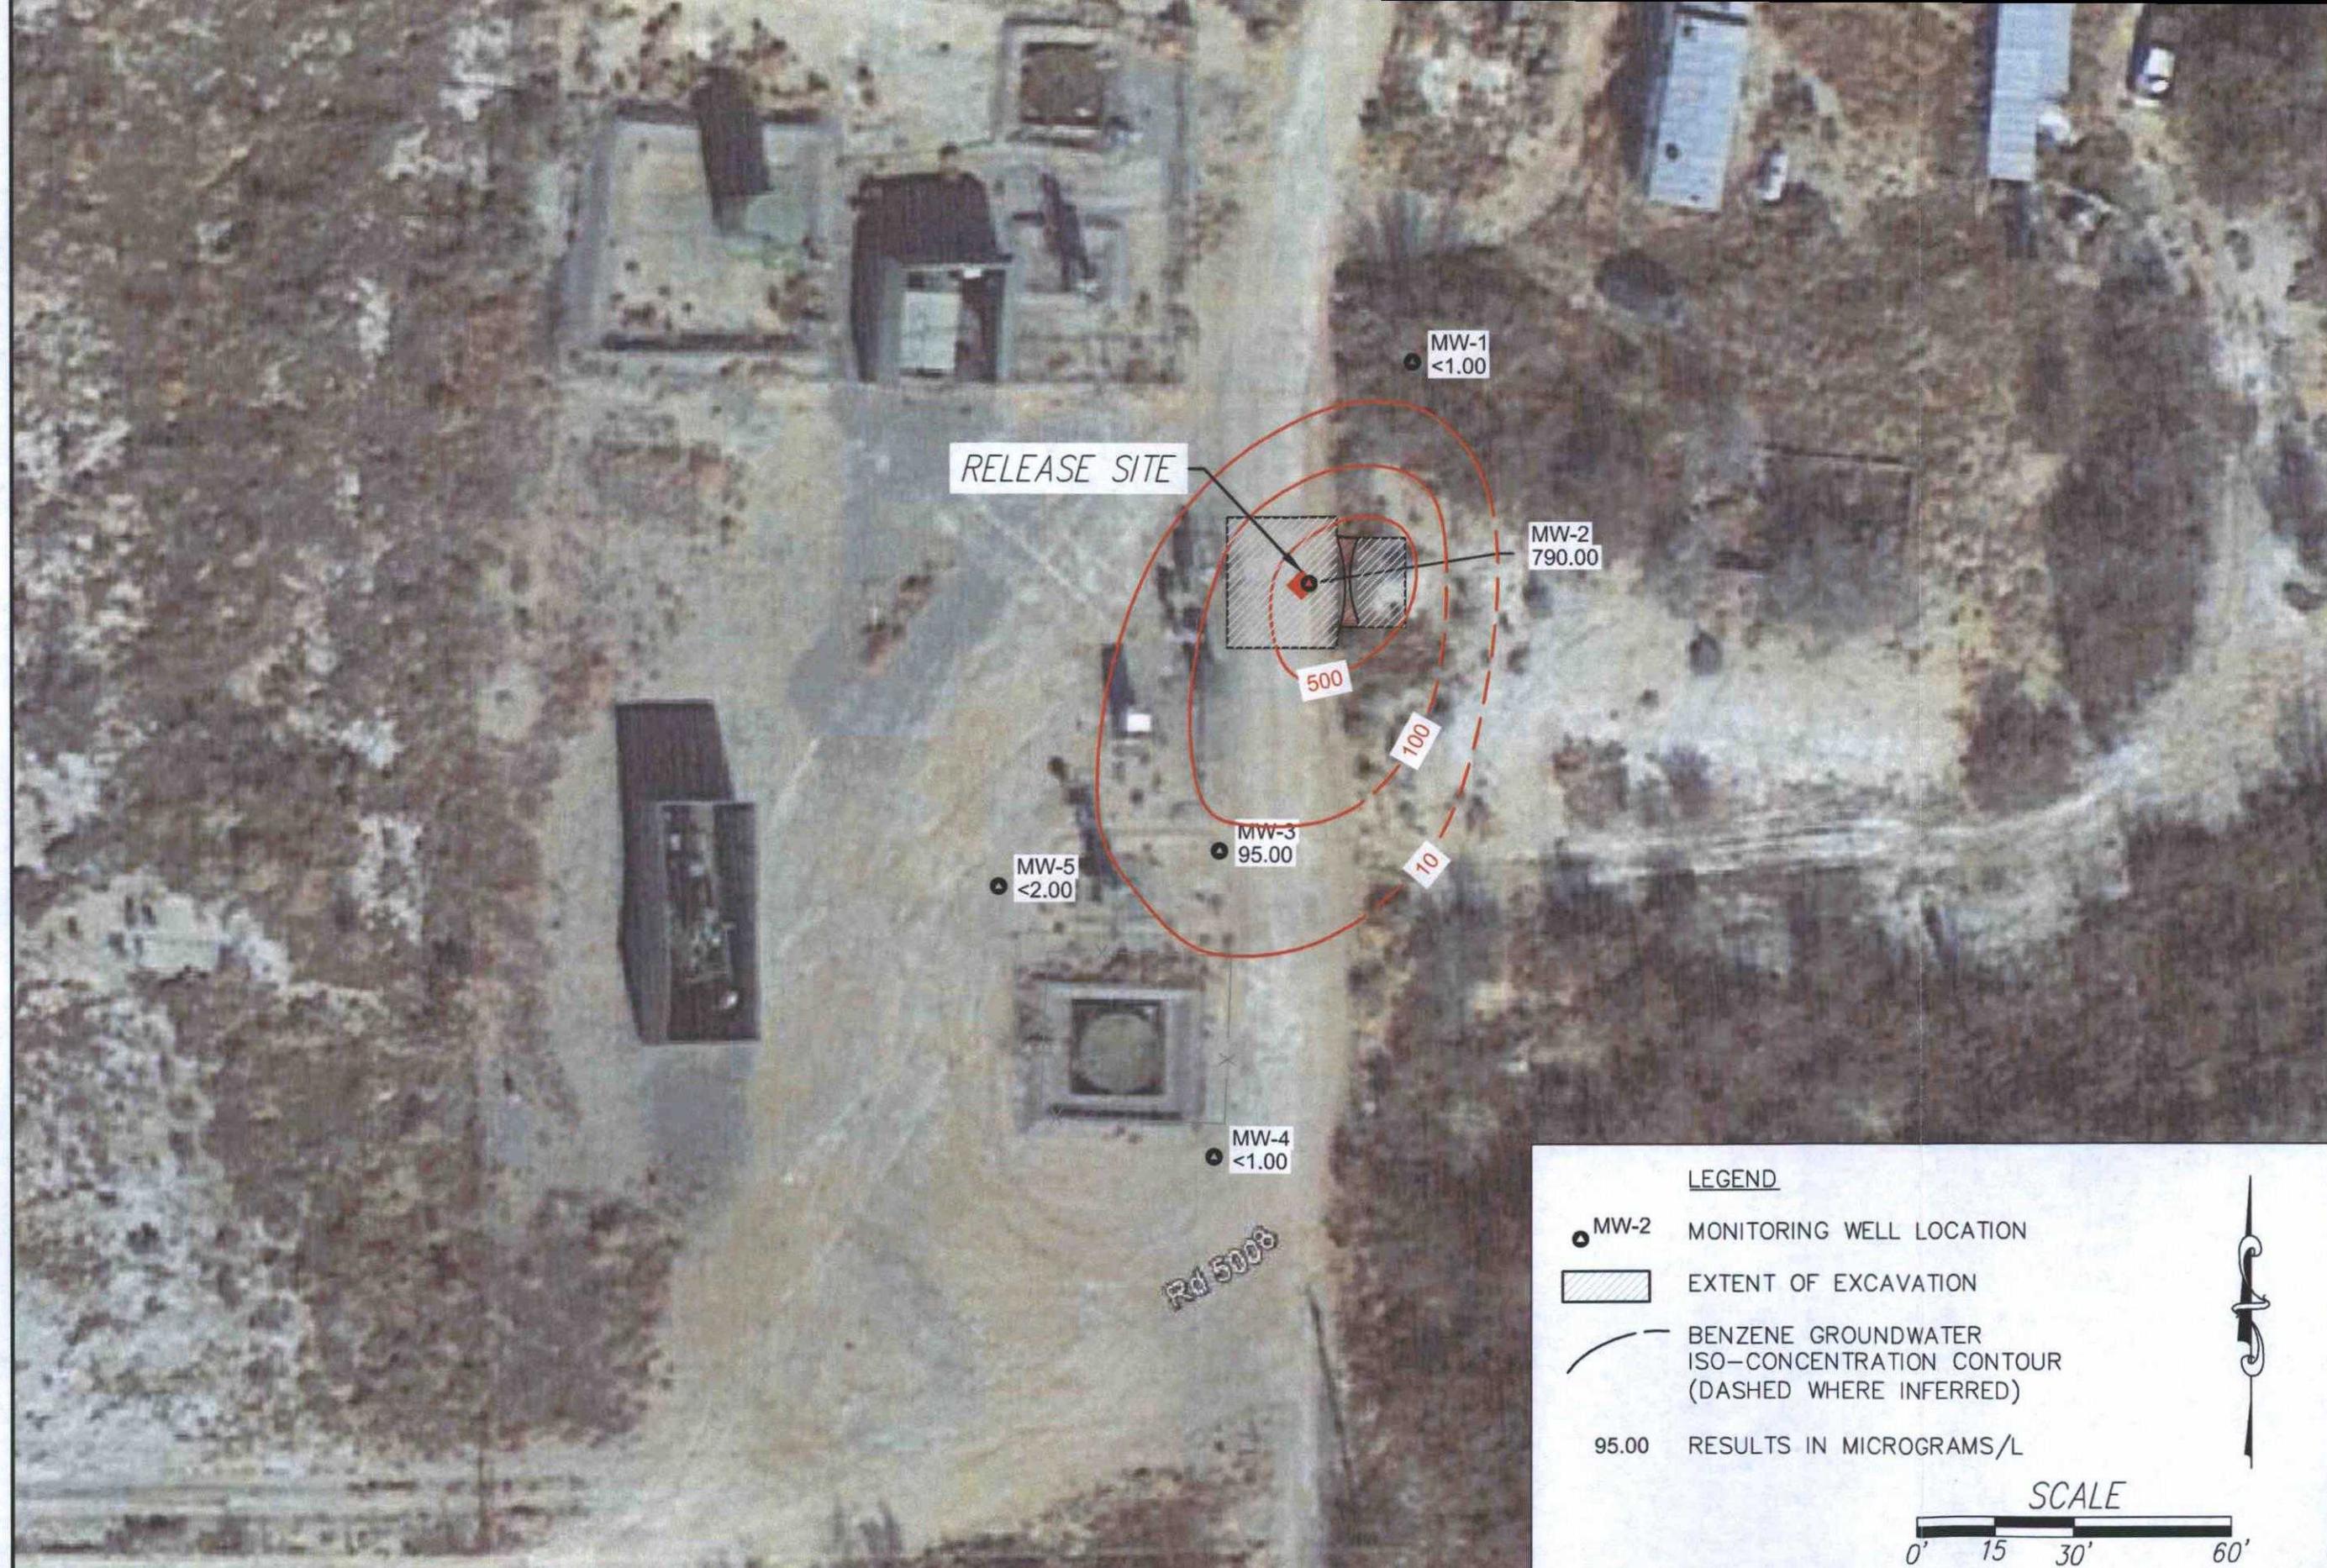
ENTERPRISE	FARMINGTON, NEW MEXICO	Rev #	Date	
<b>BENZENE ISO-CONCENTRATION MAP</b> <b>MASDEN GAS COM #1E</b> SECTION 28, T29N, R11W <small>SAN JUAN COUNTY, NEW MEXICO</small>				
<b>SMA</b> <small>Engineering Environmental Surveying</small>				
<b>Souder, Miller &amp; Associates</b> 401 West Broadway Avenue Farmington, NM 87401-5907 Phone (505) 325-7535 Toll-Free (800) 519-0098 Fax (505) 326-0045 <a href="http://www.soudermiller.com">www.soudermiller.com</a> Serving the Southwest & Rocky Mountains				
Designed JES	Drawn GJF	Checked RSA		
Date: August 2015				
Scale: Horiz: 1"=30' Vert: NA				
Project No: 5123699

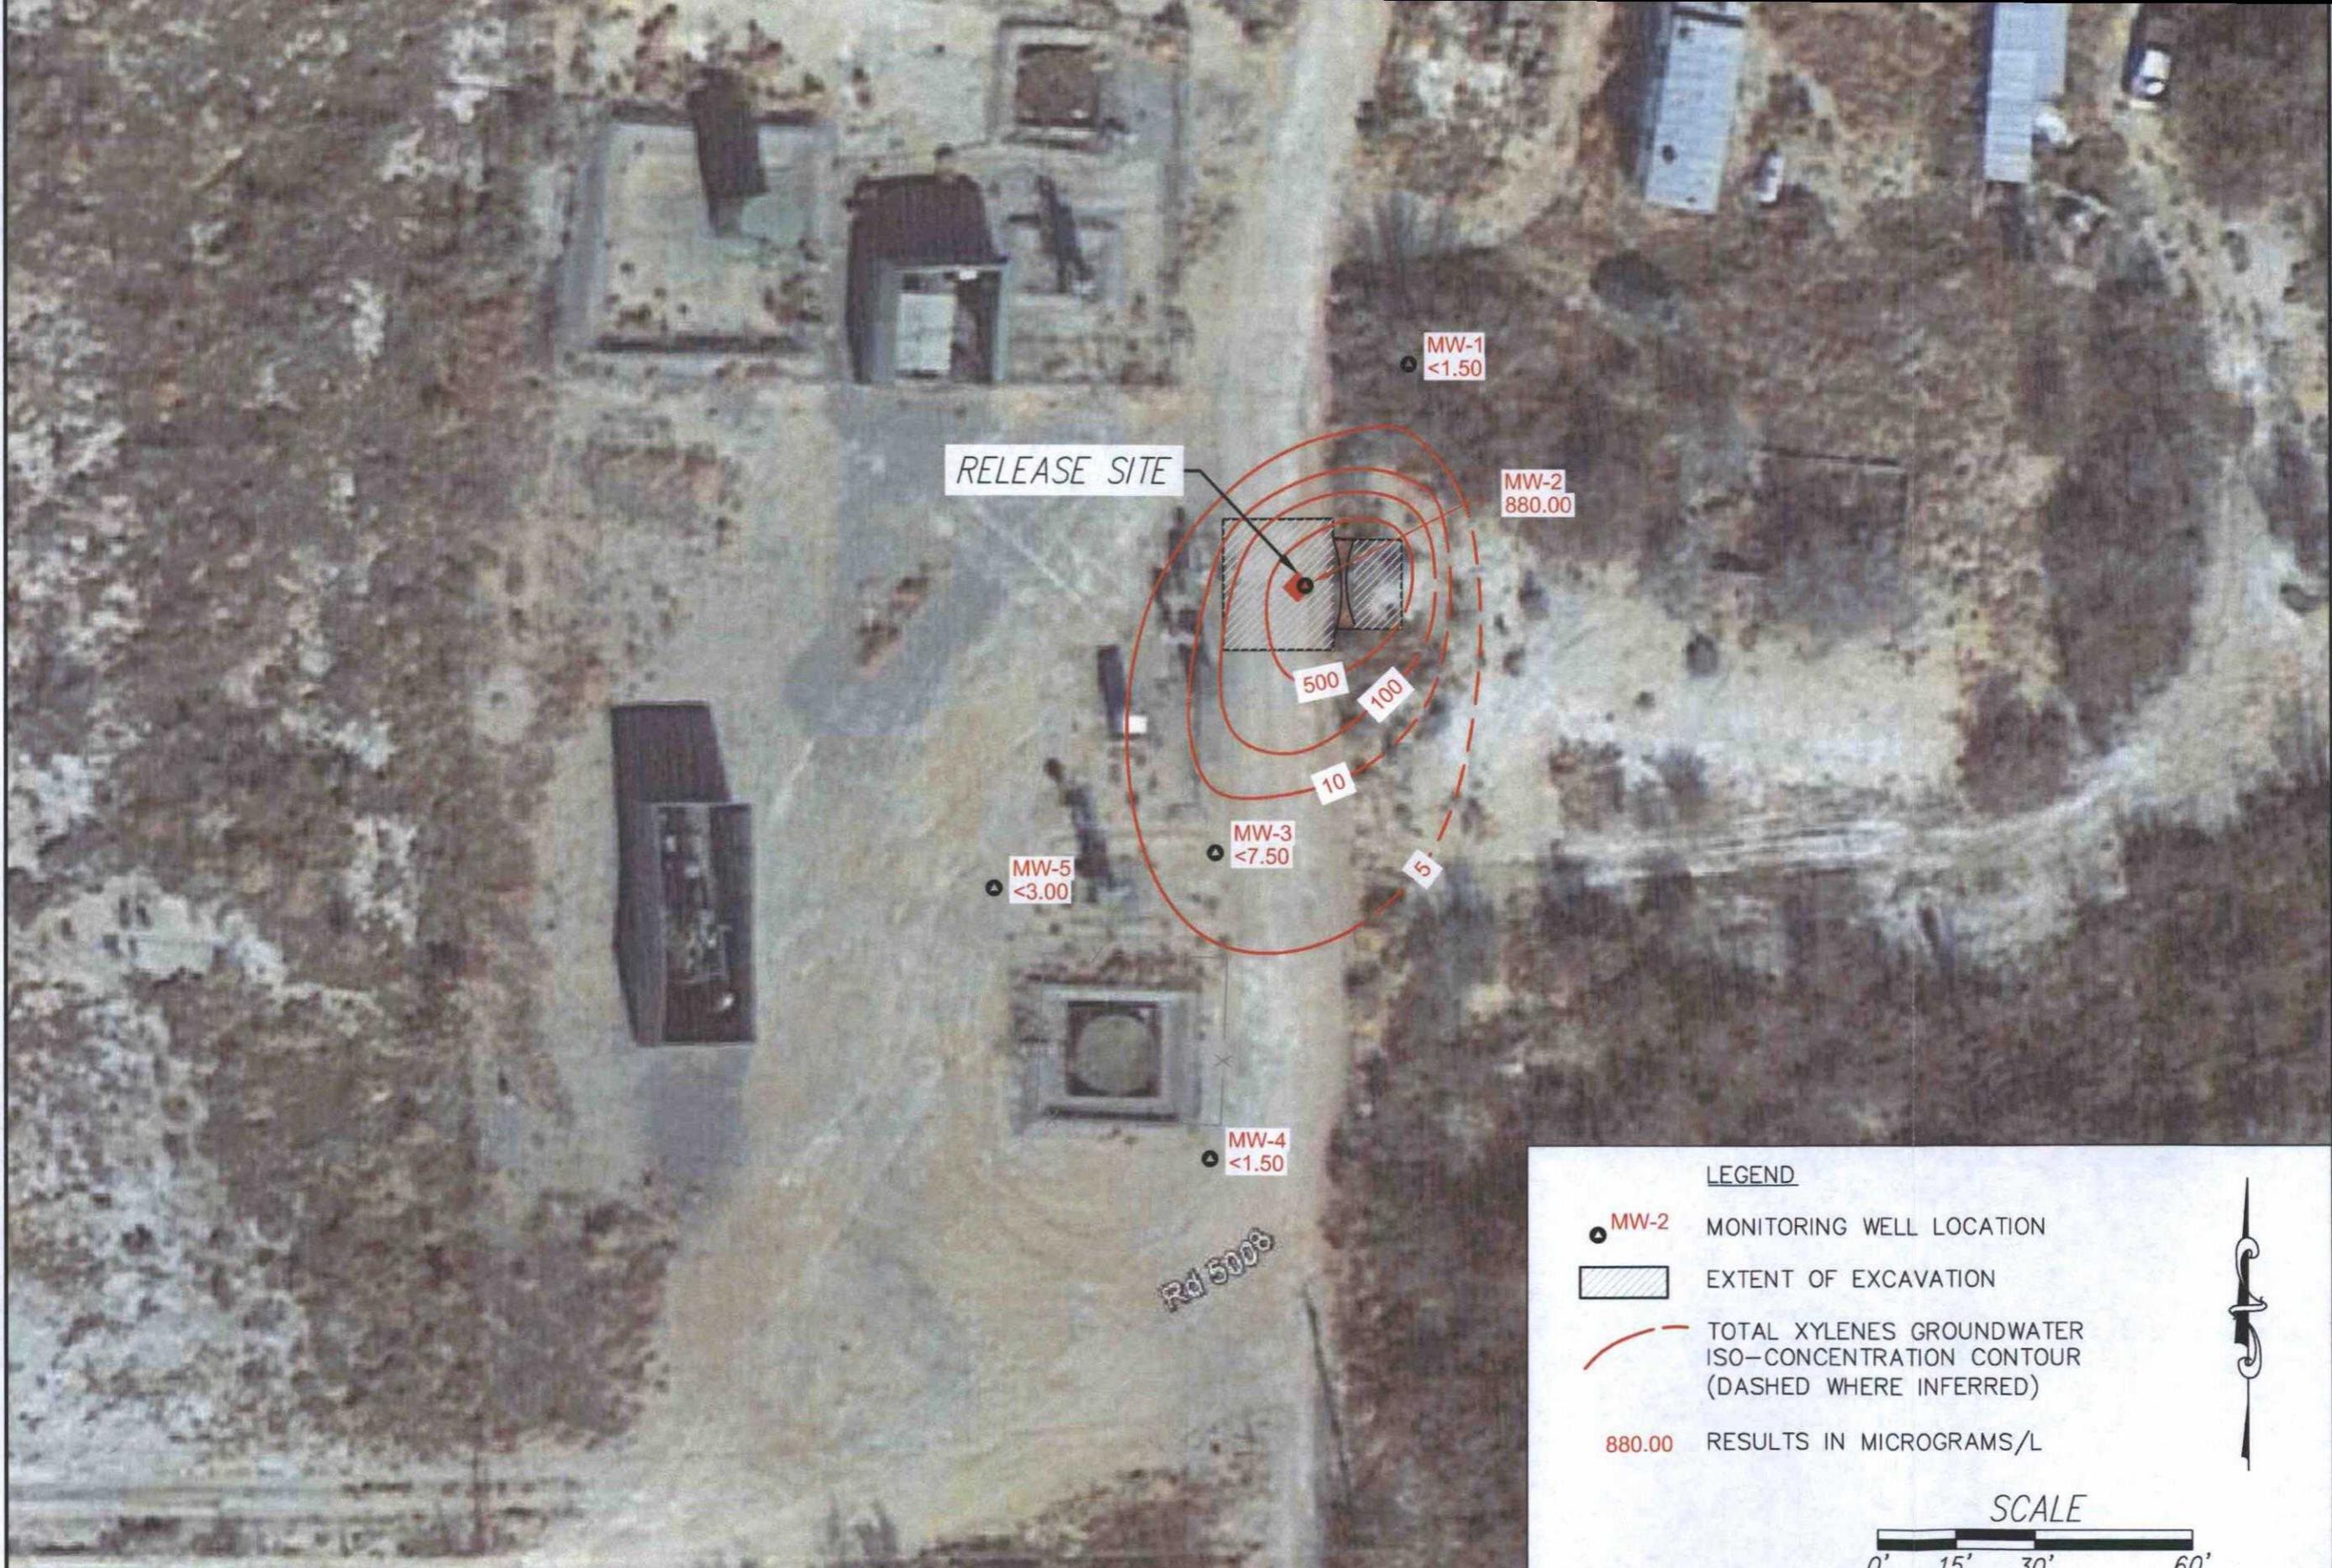
- MW-2 MONITORING WELL LOCATION
- EXTENT OF EXCAVATION
- TOTAL XYLENES GROUNDWATER ISO-CONCENTRATION CONTOUR (DASHED WHERE INFERRED)
- 880.00 RESULTS IN MICROGRAMS/L

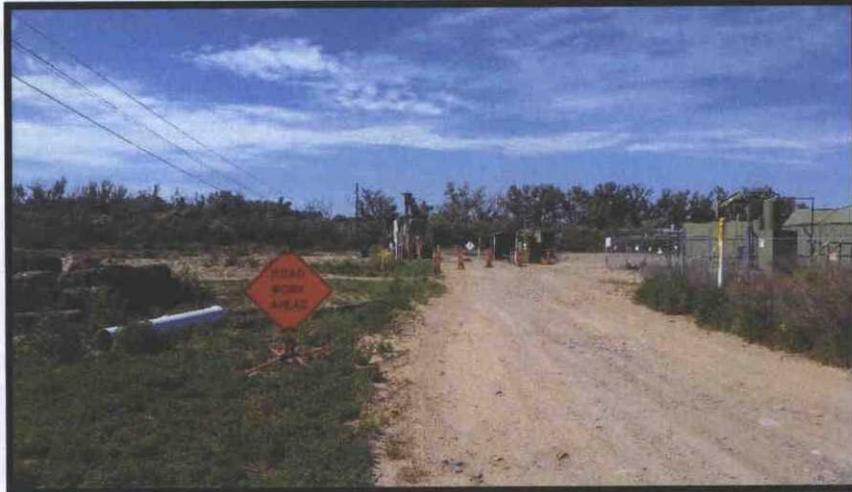
**Photo 1:** Masden Gas Com #1E location in County Road 5008, appropriate Traffic controls in place.

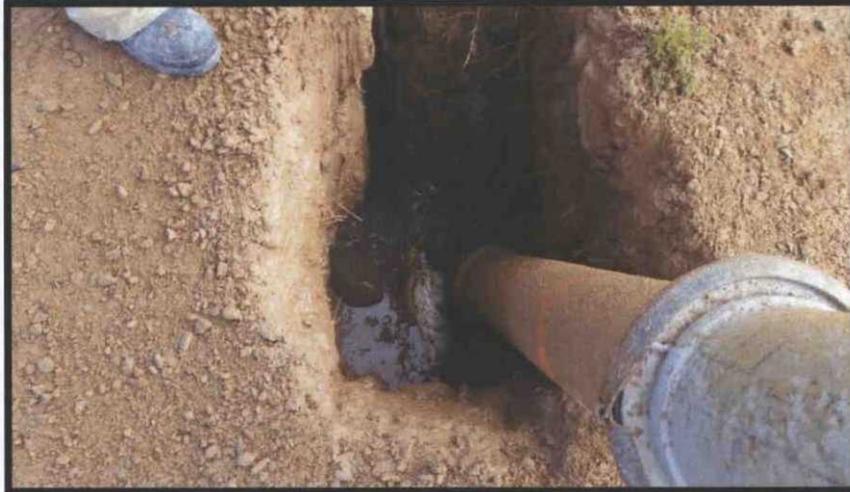
**Photo 3:** Exposure of the 6 inch PVC waterline in the vicinity of the Masden Gas Com #1E release point.

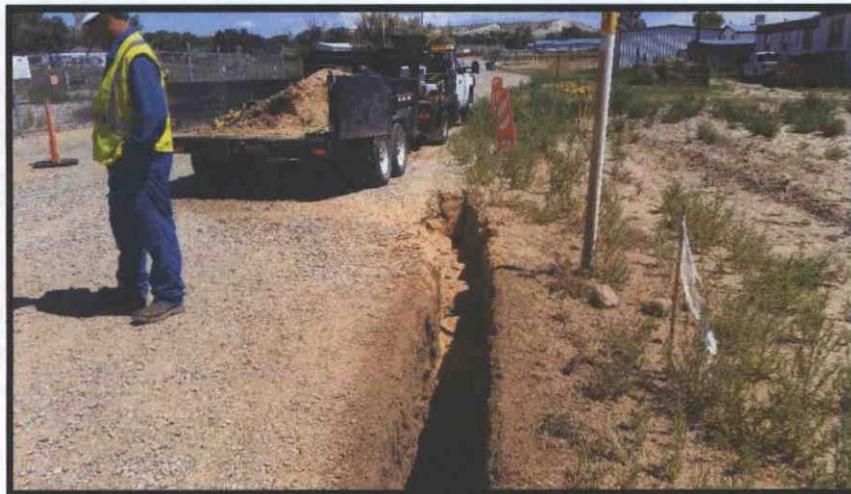
**Photo 4:** Trench along the waterline completed and backfilling with imported material.

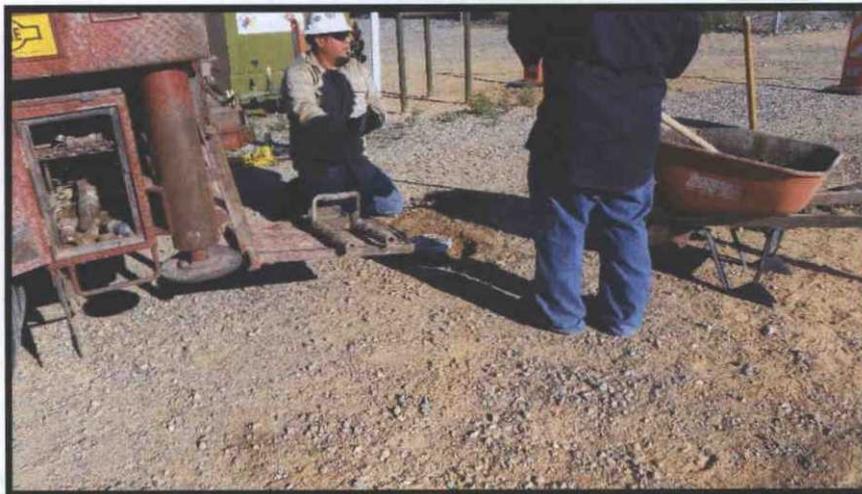
**Photo 6:** Surface completions in the road and the on the well pad feature flush, traffic-rated well vaults. MW-2 pictured.

Wells MW-1, MW-3, and MW-4 were completed with aboveground steel well shrouds cemented into 2 foot diameter, round concrete pads with a minimum thickness of 4-inches. Each well was fitted with 3 protective bollards to prevent damage from vehicle collisions, livestock or wildlife. Wells MW-2 and MW-5 are located in County Road 5008 and on the oil and gas well pad respectively, and were completed with flush mount, traffic rated surface casings set in 2 foot diameter concrete well pads.

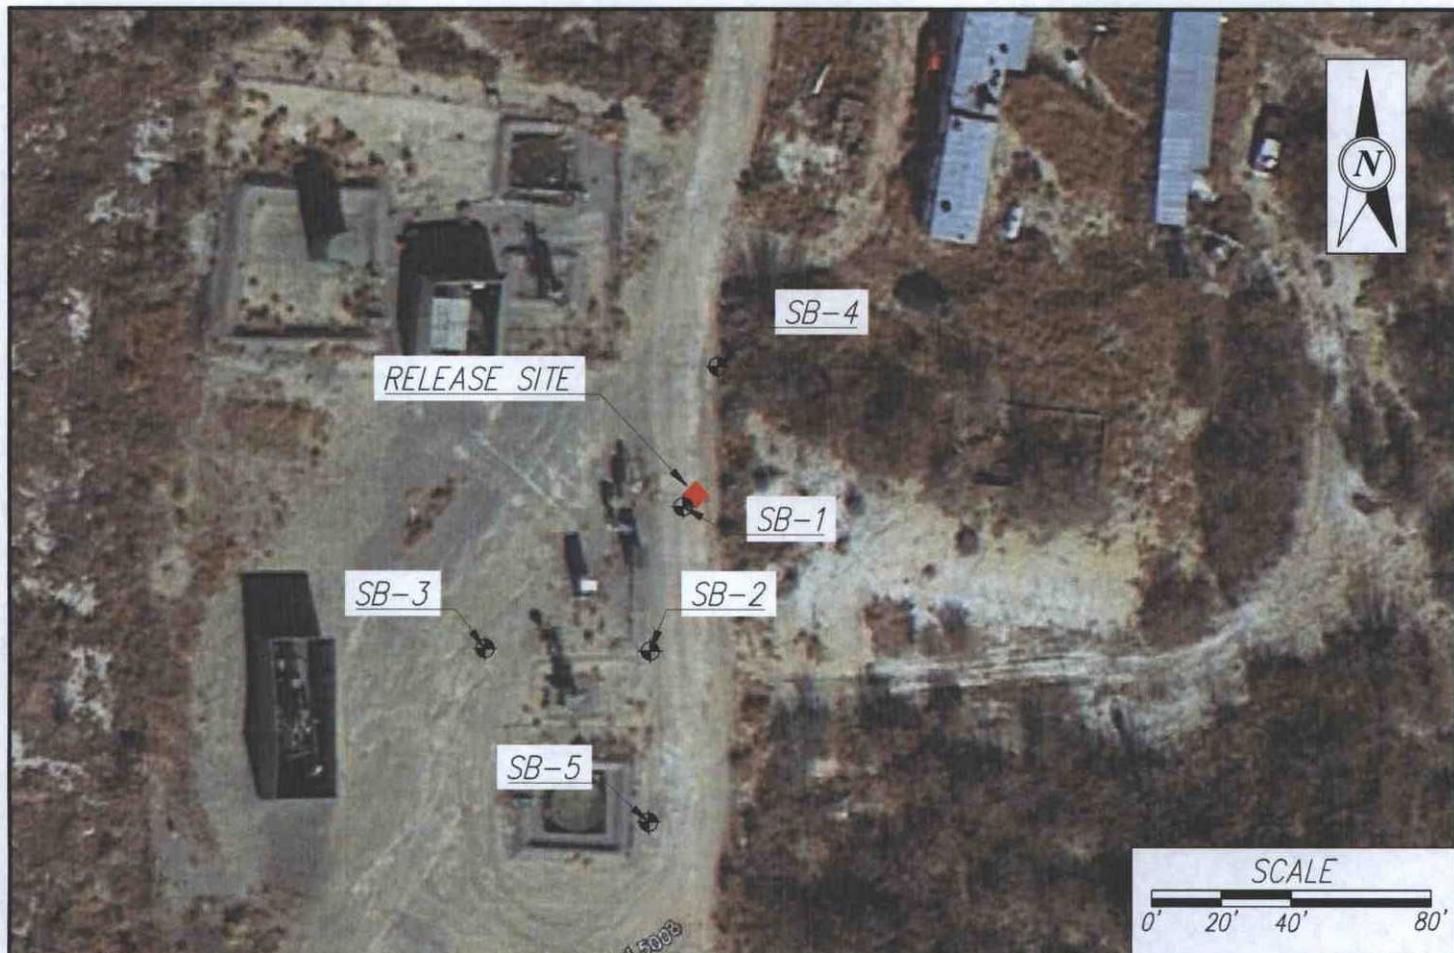
Attached:  
Figure 1- Site Vicinity Map  
Figure 2 - Proposed Monitoring Well Location Map  
Masden #1 E Subsurface water Investigation Cost Estimate
