**Release Notification and Corrective Action**

Name of Company	John H. Hendrix Corporation	Contact	Carolyn Doran Haynes
Address	110 N. Marienfeld, Midland, TX 79702	Telephone No.	432-684-6631
Facility Name	Brunson C	Facility Type	area east-northeast of facility
Surface Owner	P. Brunson West	Mineral Owner	Lease No.

John H. Hendrix Corporation  
 Brunson C Battery  
 T22S - R37E - Section 3 - Unit P  
 Lea County, New Mexico

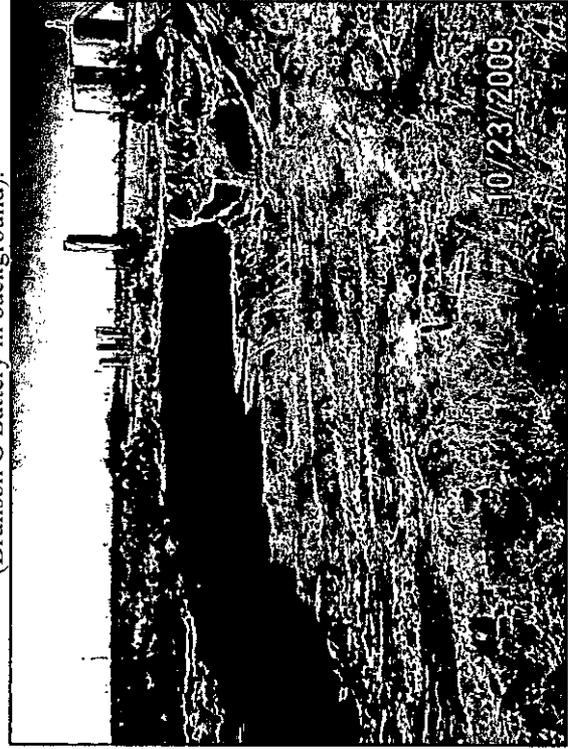
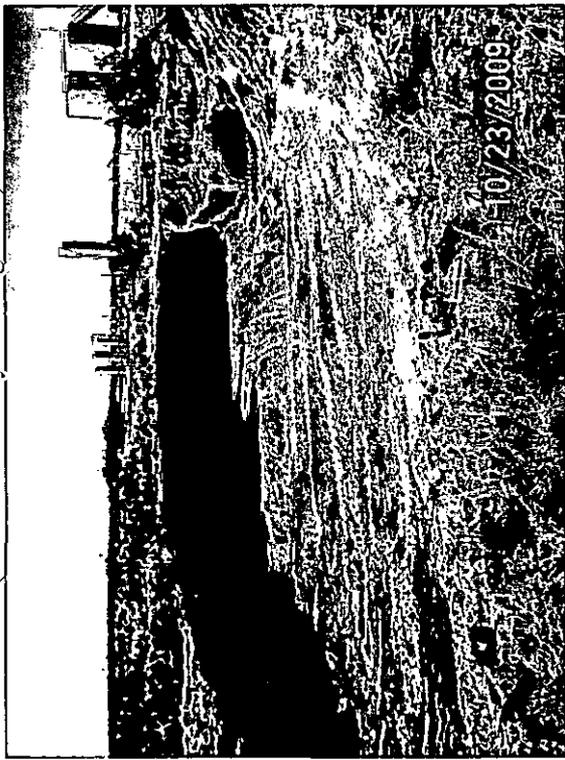
4: View facing southwest showing south wall and tank battery in background.
