Release Notification and Corrective Action

SEMU Permian Skaggs Pool Water Line (1RP-5-12-2817)

Termination Request

ConocoPhillips SEMU Permian Skaggs Pool Water Line

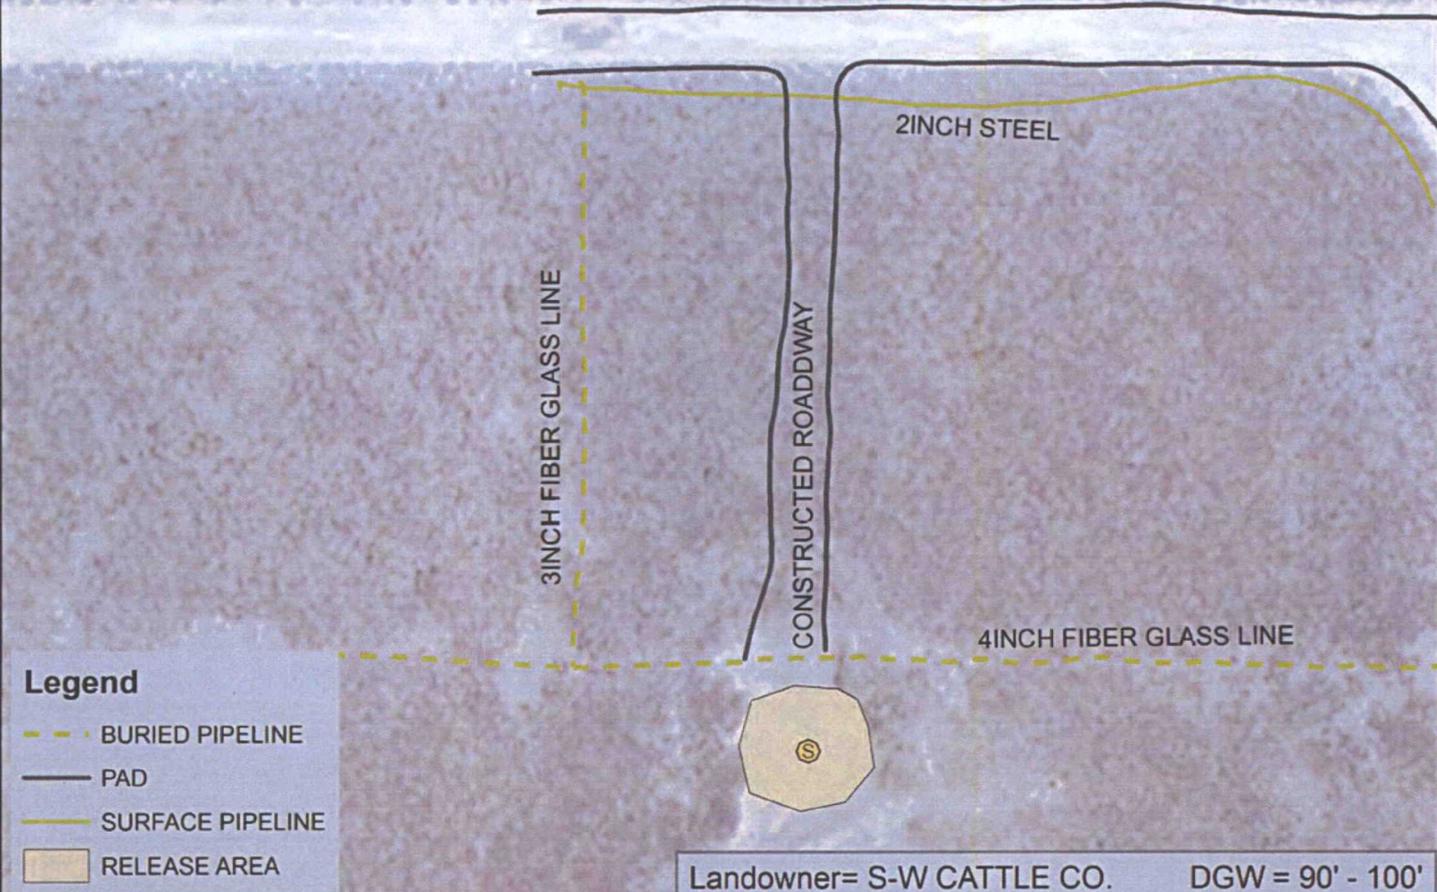
Figure 1

Soil Bore Installation

Soil Bore #1

Depth	Cl-	GRO	DRO	B	T	E	X
5'	1280	<10	<10	<0.05	<0.05	<0.05	<0.15
10'	752	<10	101	<0.05	<0.05	<0.05	<0.15
15'	160	<10	11.7	<0.05	<0.05	<0.05	<0.15
20'	176	<10	55.2	<0.05	<0.05	<0.05	<0.15
30'	1150	<10	44.2	<0.05	<0.05	<0.05	<0.15
40'	1440	<50	60	<0.05	<0.05	<0.05	<0.15
50'	1010	<10	139	<0.05	<0.05	<0.05	<0.15
60'	576	<10	53.7	<0.05	<0.05	<0.05	<0.15
70'	224	<10	<10	<0.05	<0.05	<0.05	<0.15

RECS took over the site on June 19th, 2013 from another environmental company. Prior to RECS acquiring the site, the previous environmental company conducted a soil bore installation at the site on October 17th, 2012. One soil bore was installed to a depth of 70 ft bgs. As the bore was advanced, samples were taken by split spoon and sent to a commercial laboratory for analysis (Figure 1). Laboratory sampling showed chloride levels that dropped to 576 mg/kg at 60 ft bgs and 224 mg/kg at 70 ft bgs. Gasoline Range Organics (GRO), Diesel Range Organics (DRO) and BTEX readings were either non-detect or below regulatory standards (Appendix B).

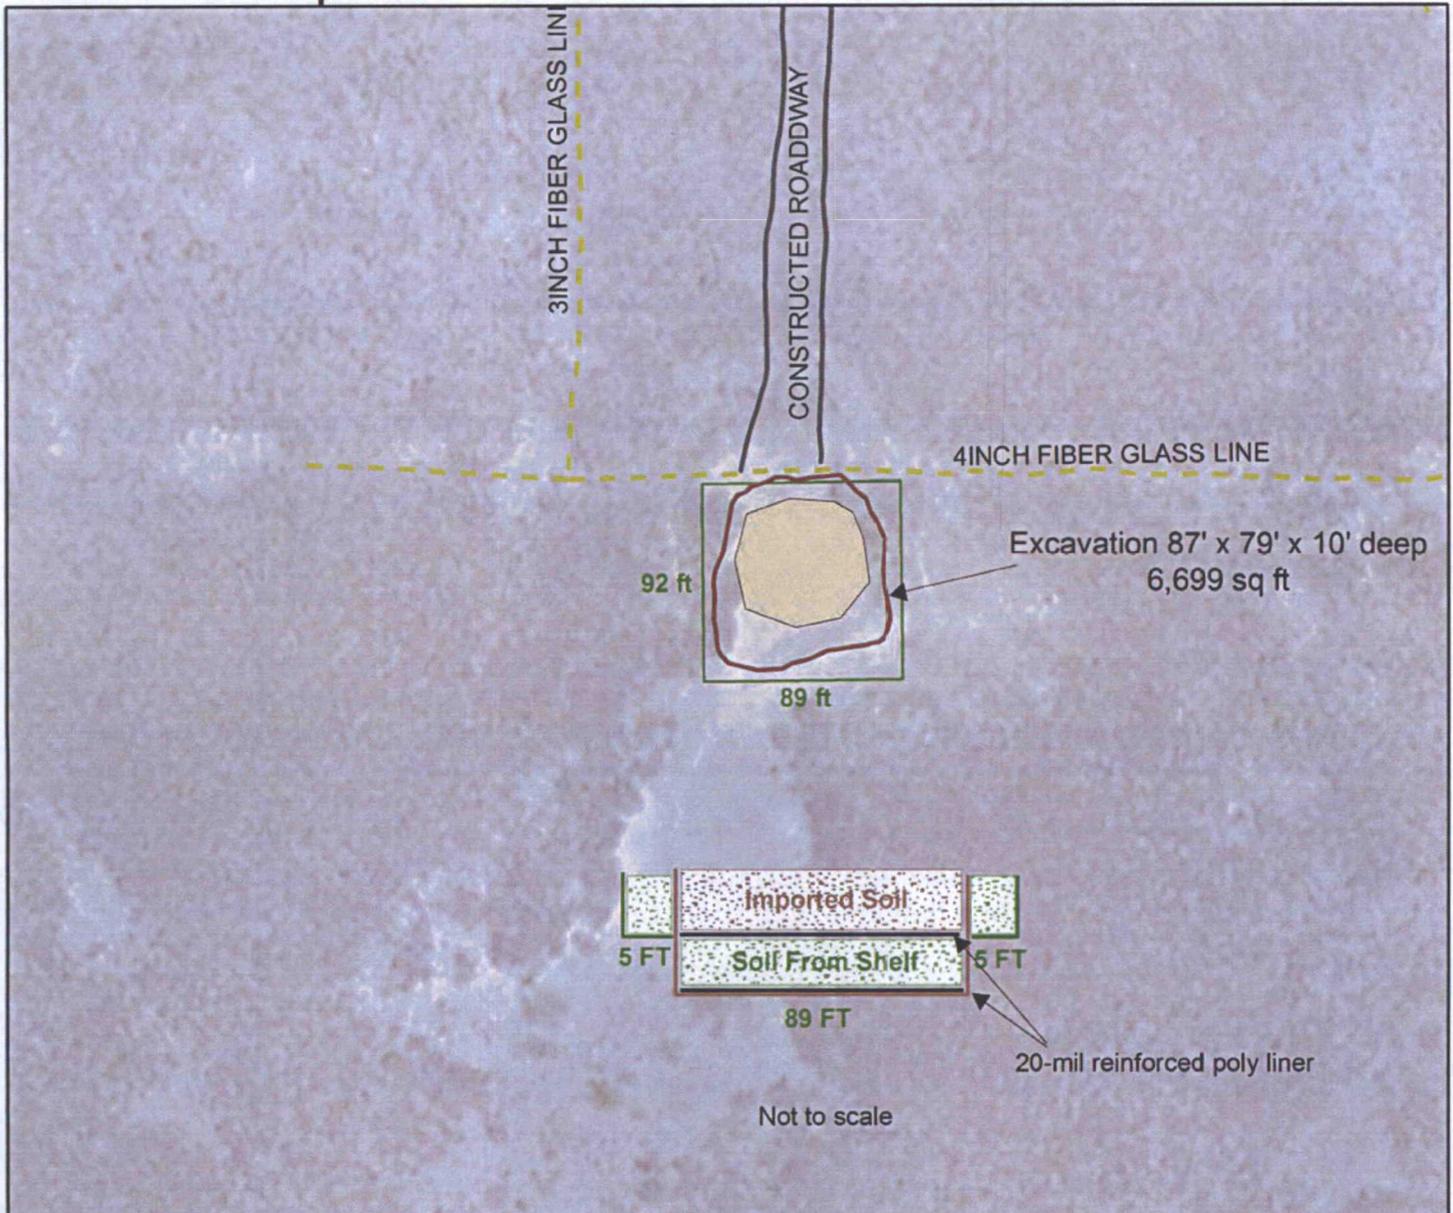
Figure 2

Proposed Excavation and Liner Installation

Based on the soil bore analysis, the previous environmental company created a Work Plan for the site. In the Work Plan, the site was to be excavated to 10 ft bgs across entire spill area, generating approximately 1,444 cubic yards of impacted material. The excavated material was to be disposed of at an NMOCD approved facility. Once the

excavation was completed, clay would be imported to the site and 2 feet of clay would be installed into the base of the excavation. The site would be backfilled with clean, imported top soil, re-contoured to the surrounding area and seeded.

When RECS acquired the site, the area had already been excavated to 80 ft x 60 ft to a depth of 10 ft bgs. RECS personnel field tested the walls of the excavation and found that the field chloride readings were above regulatory standards. Based on the wall field data, the excavation was expanded to 87 ft x 79 ft. The walls were again field sampled for chlorides and although the results were lower, they were still found to be above regulatory standards.

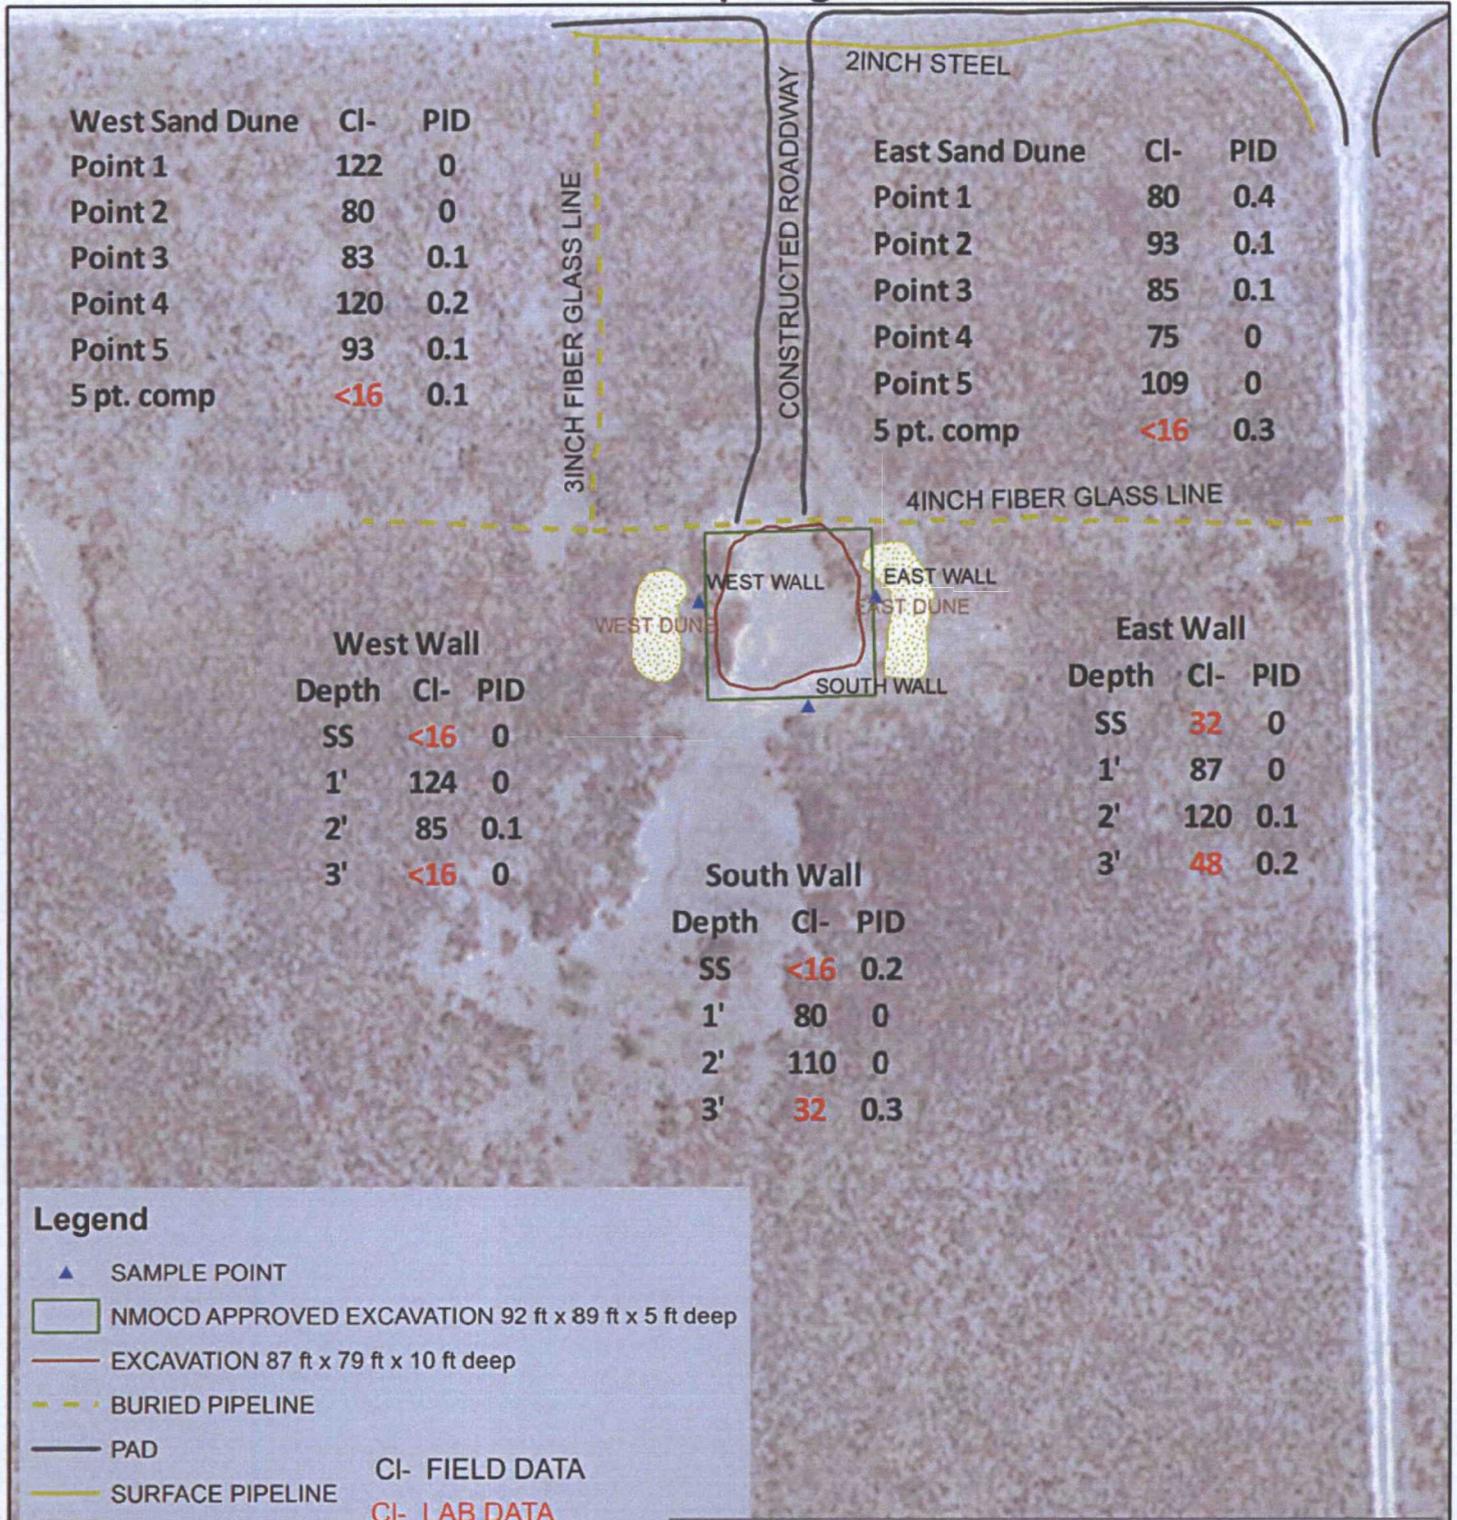
Final Sampling Data

On August 19th, 2013, NMOCD approved the Addendum to the Work Plan. On October 31st, 2013, a 20-mil reinforced poly liner was installed and properly seated into the base of the 10 ft excavation. The excavation was then expanded to dimensions of 92 ft x 89 ft at 5 ft bgs and that soil was used to backfill the excavation to 5 ft bgs. Wall samples from the west, south and east wall to a depth of 3 ft bgs were taken from the 92 ft x 89 ft excavation (Figure 3). Representative samples were sent to a commercial laboratory for analysis (Appendix C). All wall samples returned chloride laboratory results below regulatory standards. The sand dunes to the west and east of the excavation were also sampled and a 5 point composite of each dune was taken to a commercial laboratory for analysis. Both sand dunes returned laboratory chloride results of non-detect.

At 5 ft bgs, another 20-mil reinforced poly liner was installed and properly seated into the base of the 92 ft x 89 ft excavation. The remaining sand dunes and 1,428 yards of imported soil were used to backfill the excavation to ground surface and to contour the area to the surrounding location. A sample of the imported soil was taken to a commercial laboratory and returned a result of non-detect. On February 18th, 2014, the site was seeded with BLM mix #2.

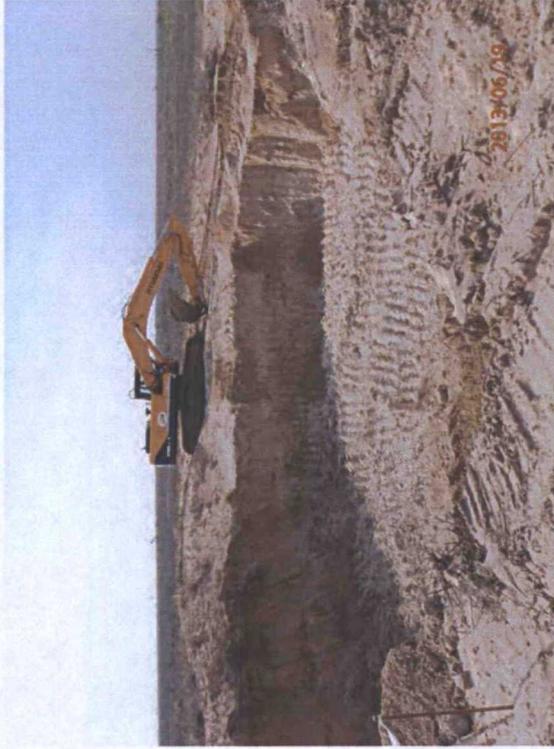
Initial excavation, facing east 6/19/13

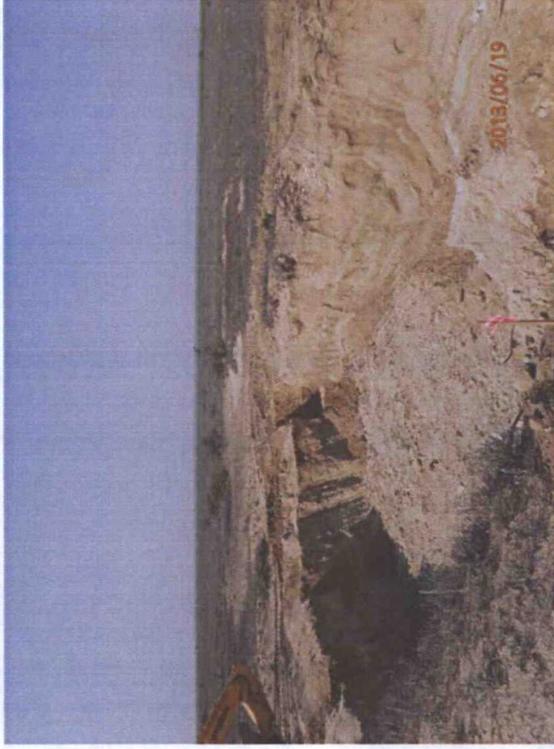
Initial excavation, facing south-southwest 6/19/13

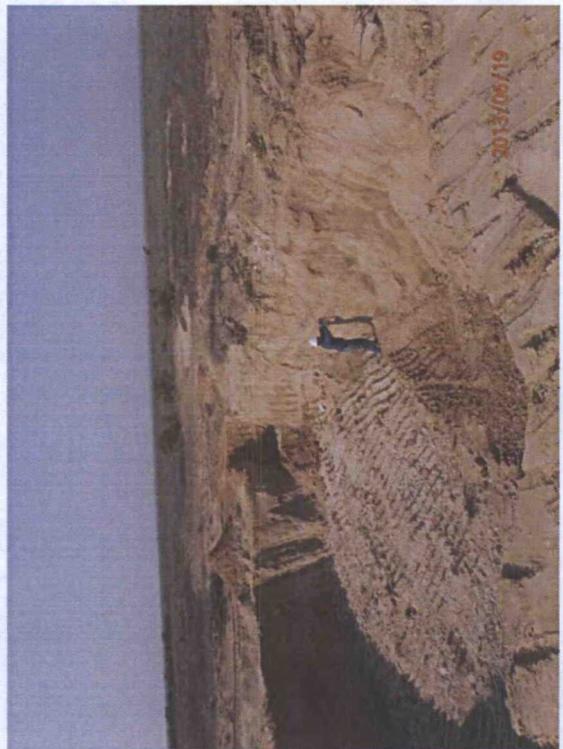
Taking wall sample, facing south 6/19/13

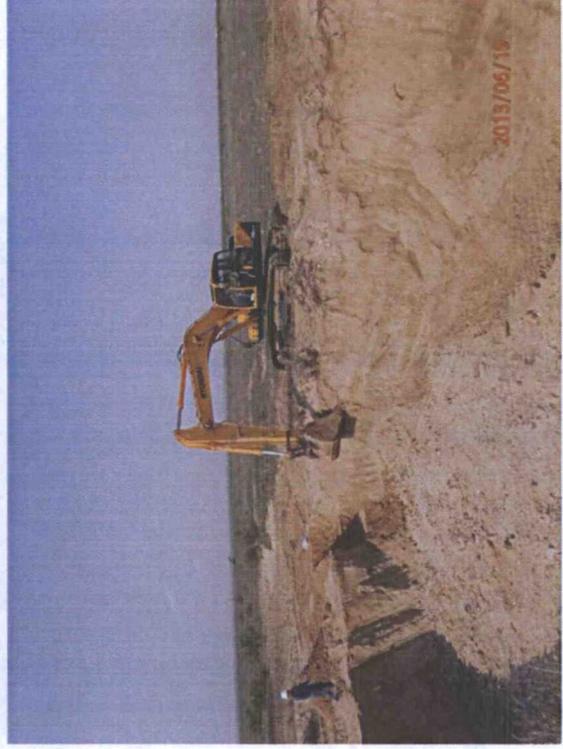
Taking wall sample, facing southwest 6/19/13

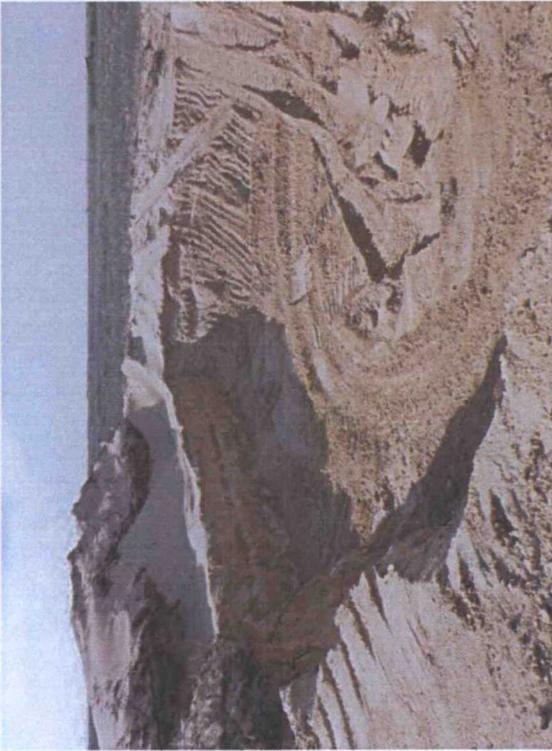
Excavation, facing south-southeast 6/24/13

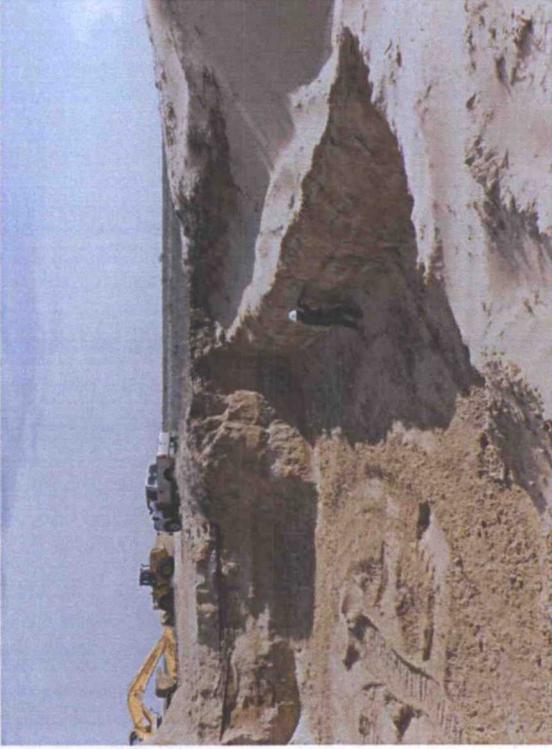
Sampling excavation, facing north 6/24/13

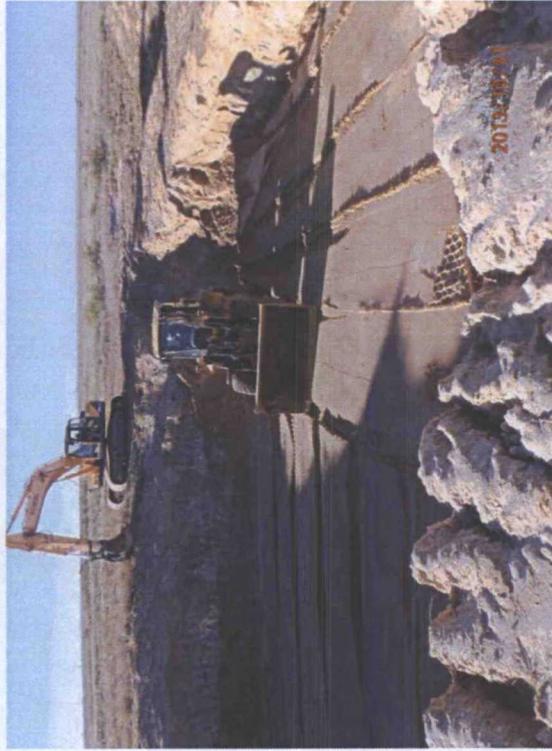
Padding the base of the excavation for liner installation, facing south 10/31/13

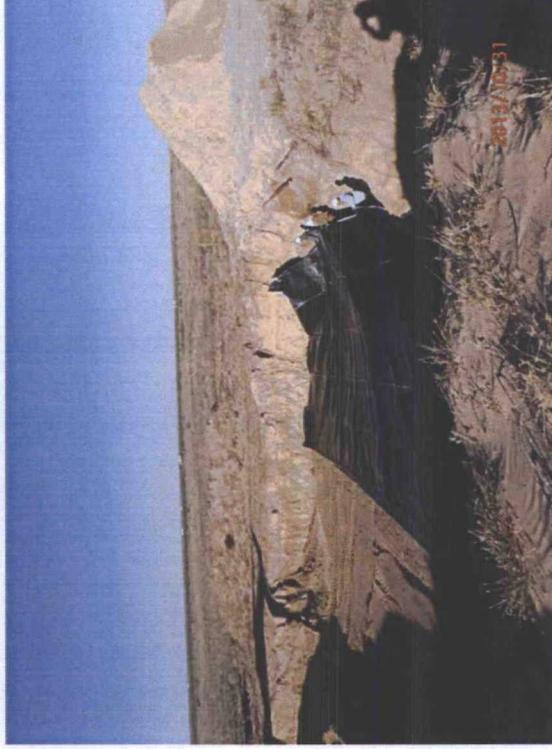
Installing 20-mil poly liner at 10 ft bgs, facing west 10/31/13

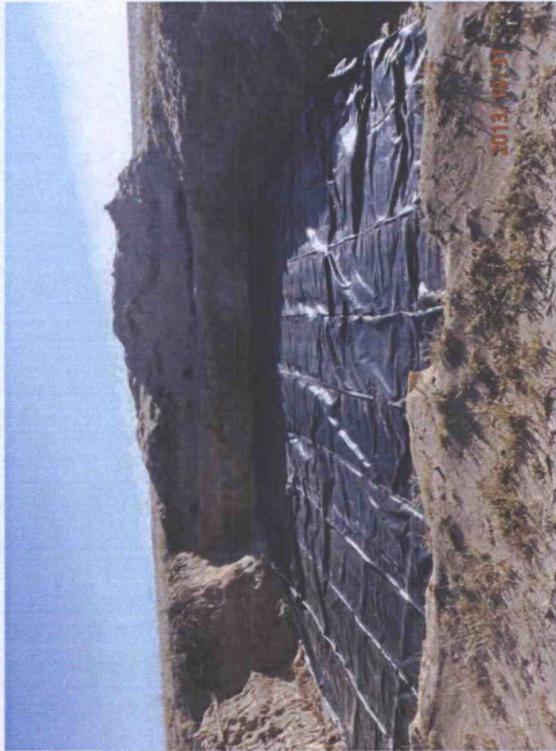
Liner installation at 10 ft bgs completed, facing east
10/31/13

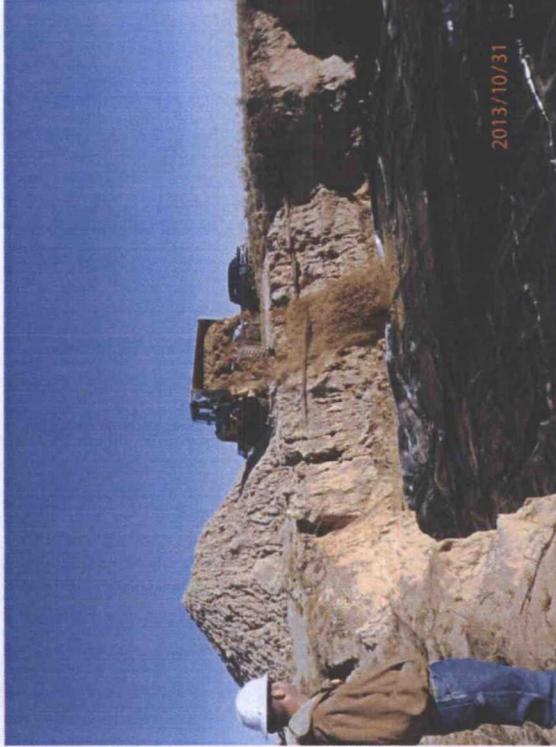
Backfilling over the liner, facing north
10/31/13

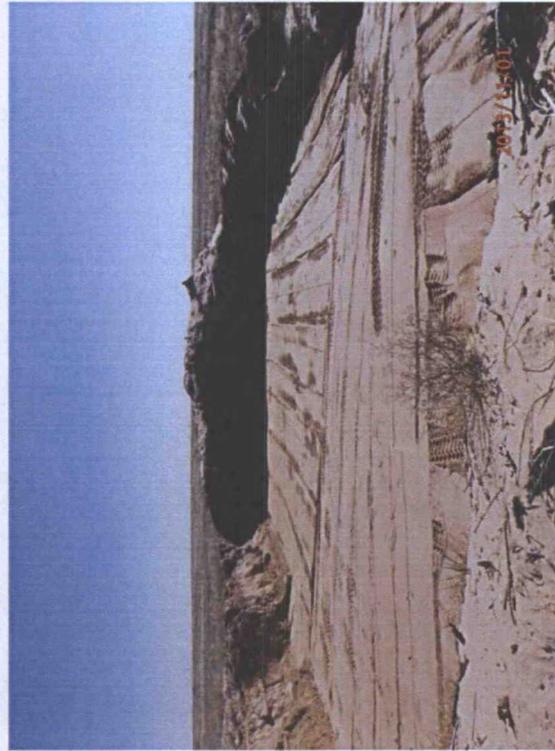
Backfilling over liner completed and benched for 5 ft
bgs liner, facing east
11/1/13

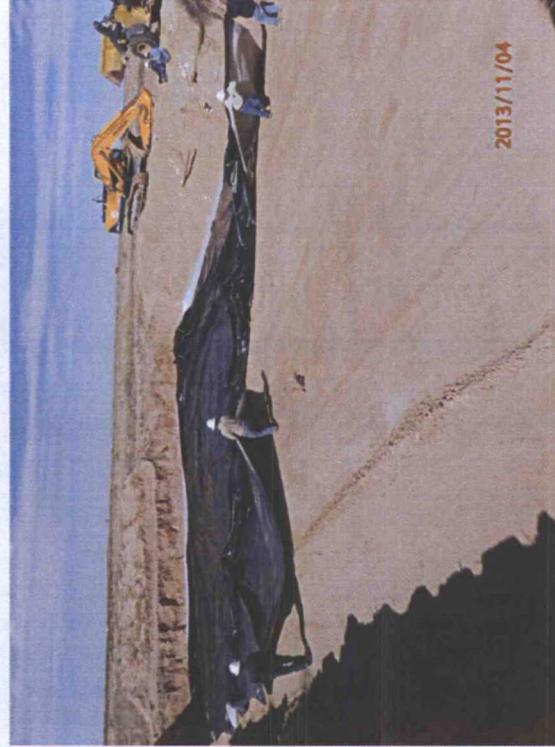
Installing 20-mil poly liner at 5 ft bgs, facing west
11/4/13

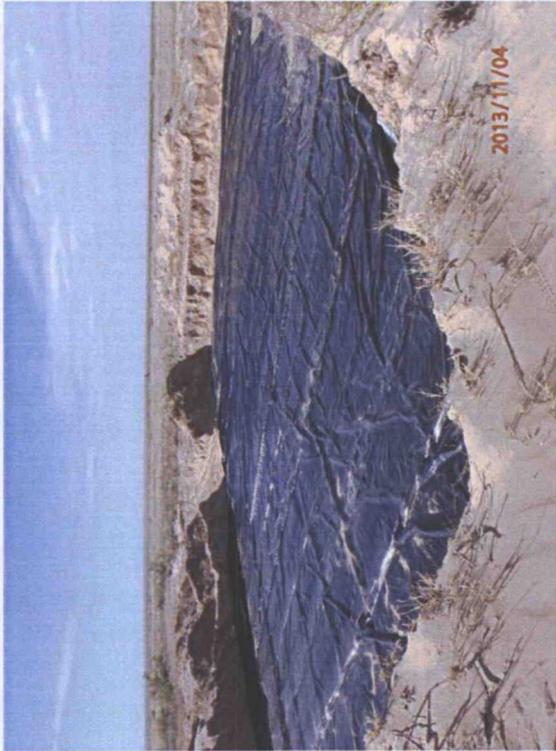
Liner installation at 5 ft bgs completed, facing south
west 11/4/13

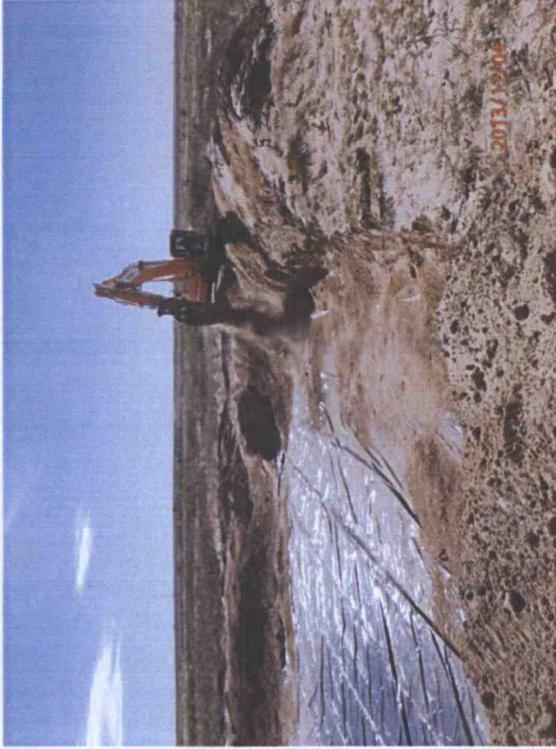
Backfilling over liner, facing south
11/4/13

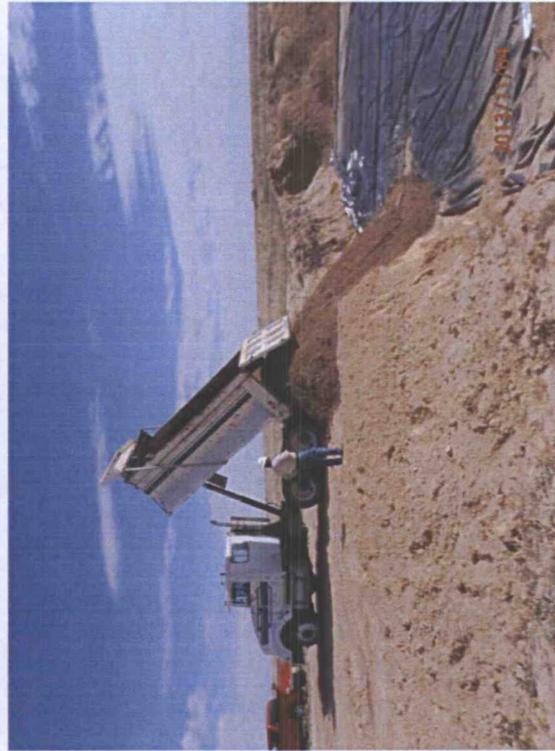
Importing soil, facing east
11/4/13

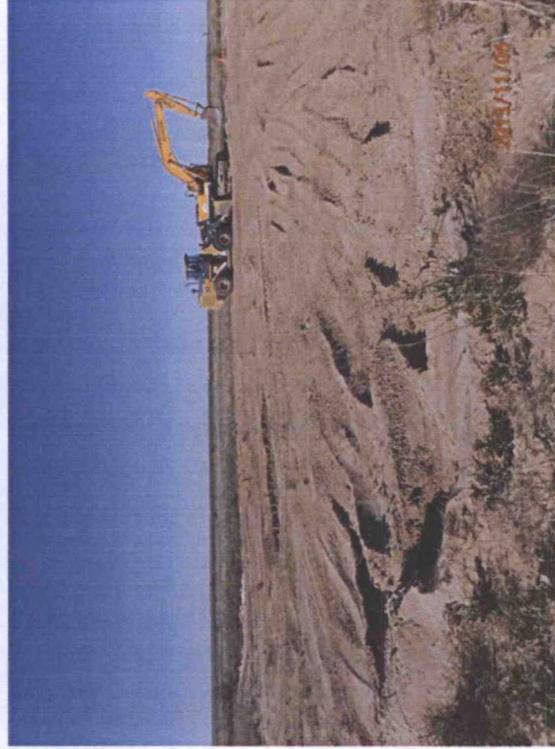
Backfilling completed, facing south
11/6/13

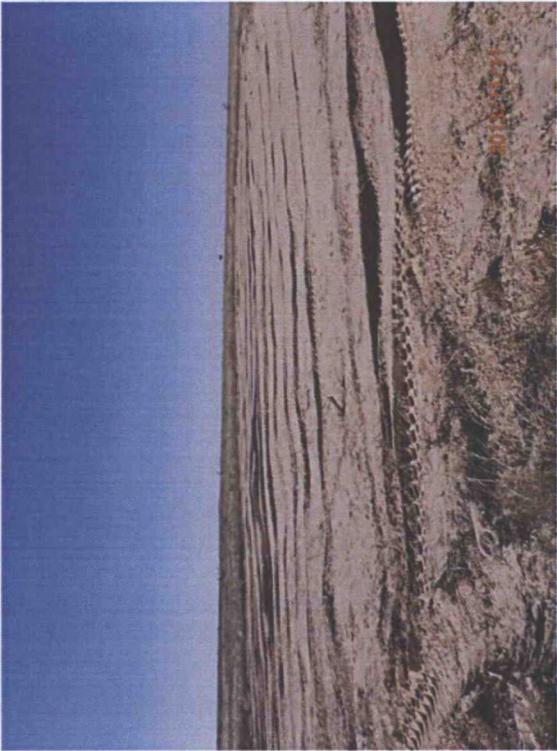
11/11/13

Backfilling completed, facing north

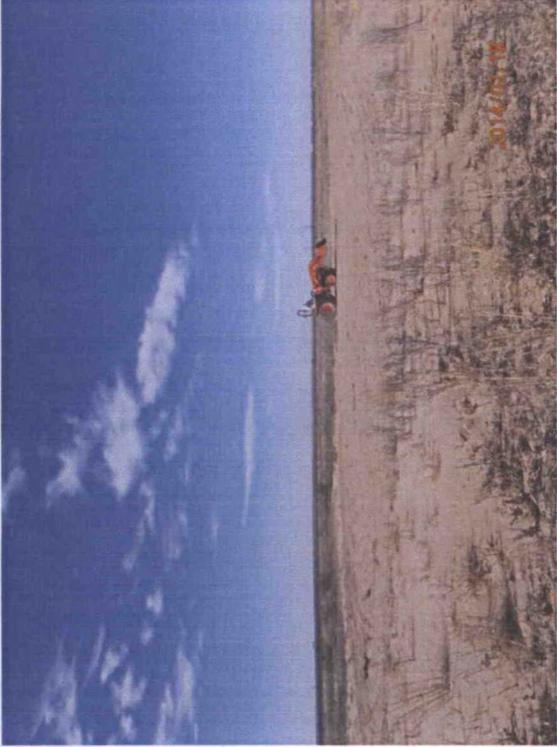
2/18/14

Seeding site, facing west
