Release Notification and Corrective Action

Name of Company: Targa Midstream Services L.P.	Contact: Ralph England
Address: P.O. Box 1689, Lovington, NM 88260	Telephone No.: 575-396-3221
Facility Name: Saunders Plant	Facility Type: Gas Processing

Remediation and Site Restoration Protocol

Field #2 Leak

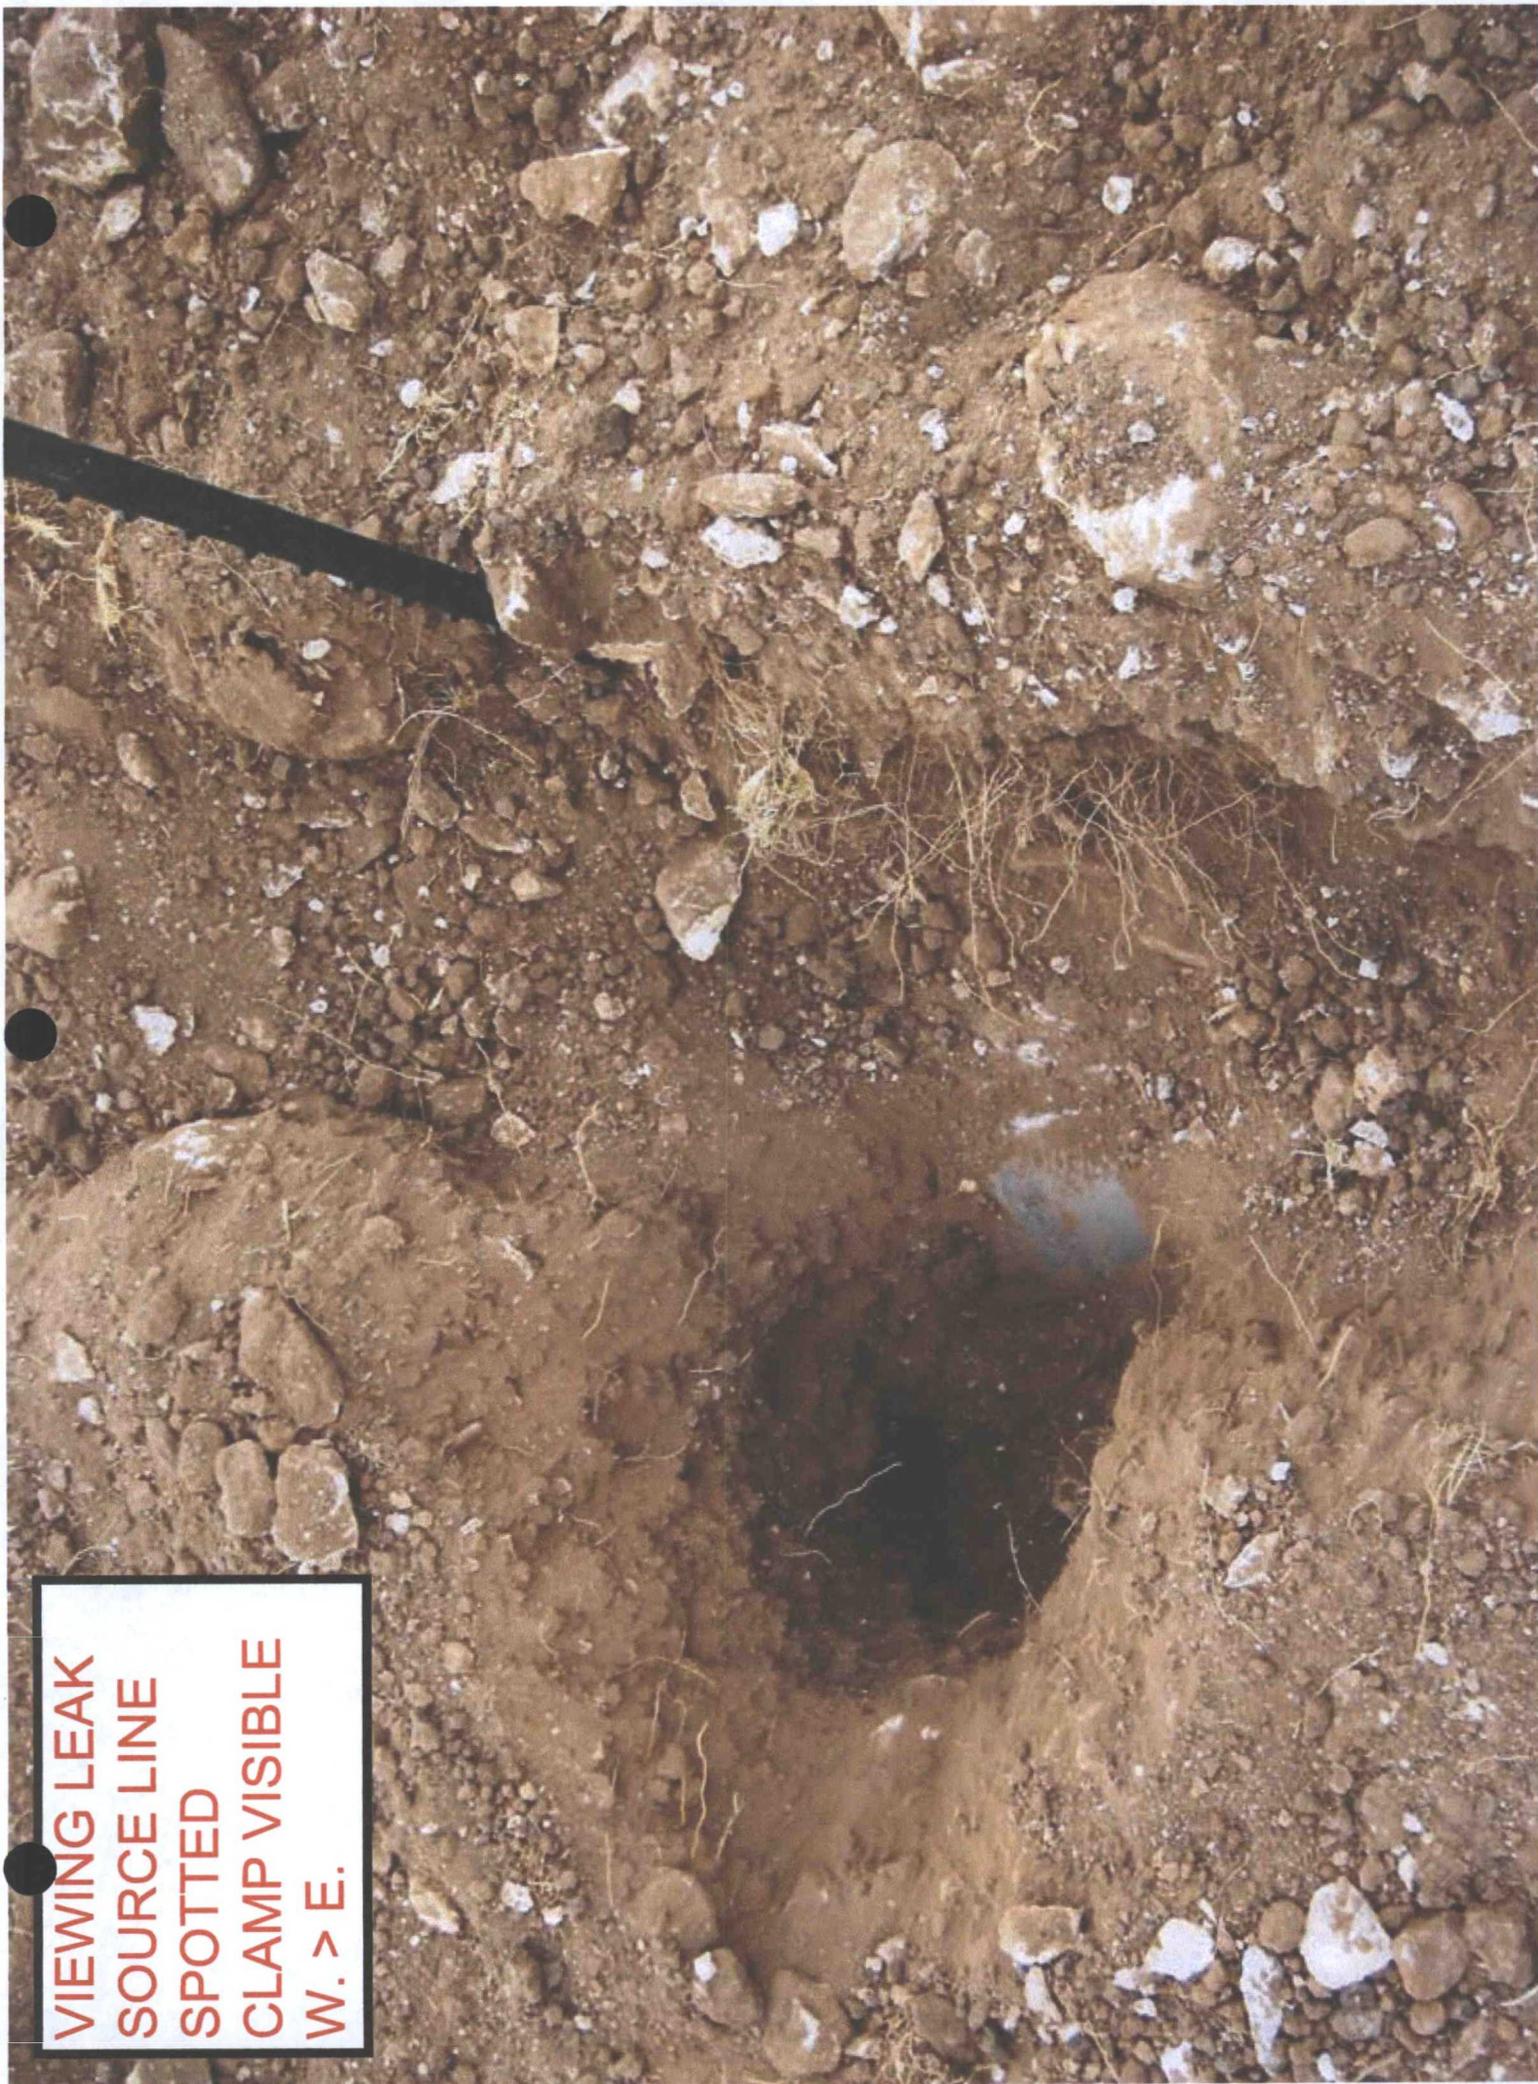
**VIEWING LEAK
SOURCE LINE
SPOTTED
CLAMP VISIBLE
W. > E.**

Gas pipeline leak discovered by Targa personal while performing routine line inspection. Watson Const. Co. was called out, pipeline was excavated and leak was clamped off. Site backfilled and ETNM / WEE Inc. were contacted to clean up leak.
DEPTH TO GROUND WATER ACCORDING TO TEXACO/CHEVRON 2005 WATER DATA MAP FOR LEA COUNTY IS APPROXIMATELY 57' bgs +/-

CLEAN UP ACTION: leak area was clamped off and backfilled. Targa is in the process of ordering new poly pipe for replacement of old pipe. ETNM / WEE Inc. has been contracted to perform clean up of leak area. Site will be cleaned up in accordance with NMOCD Leak Clean up standards.

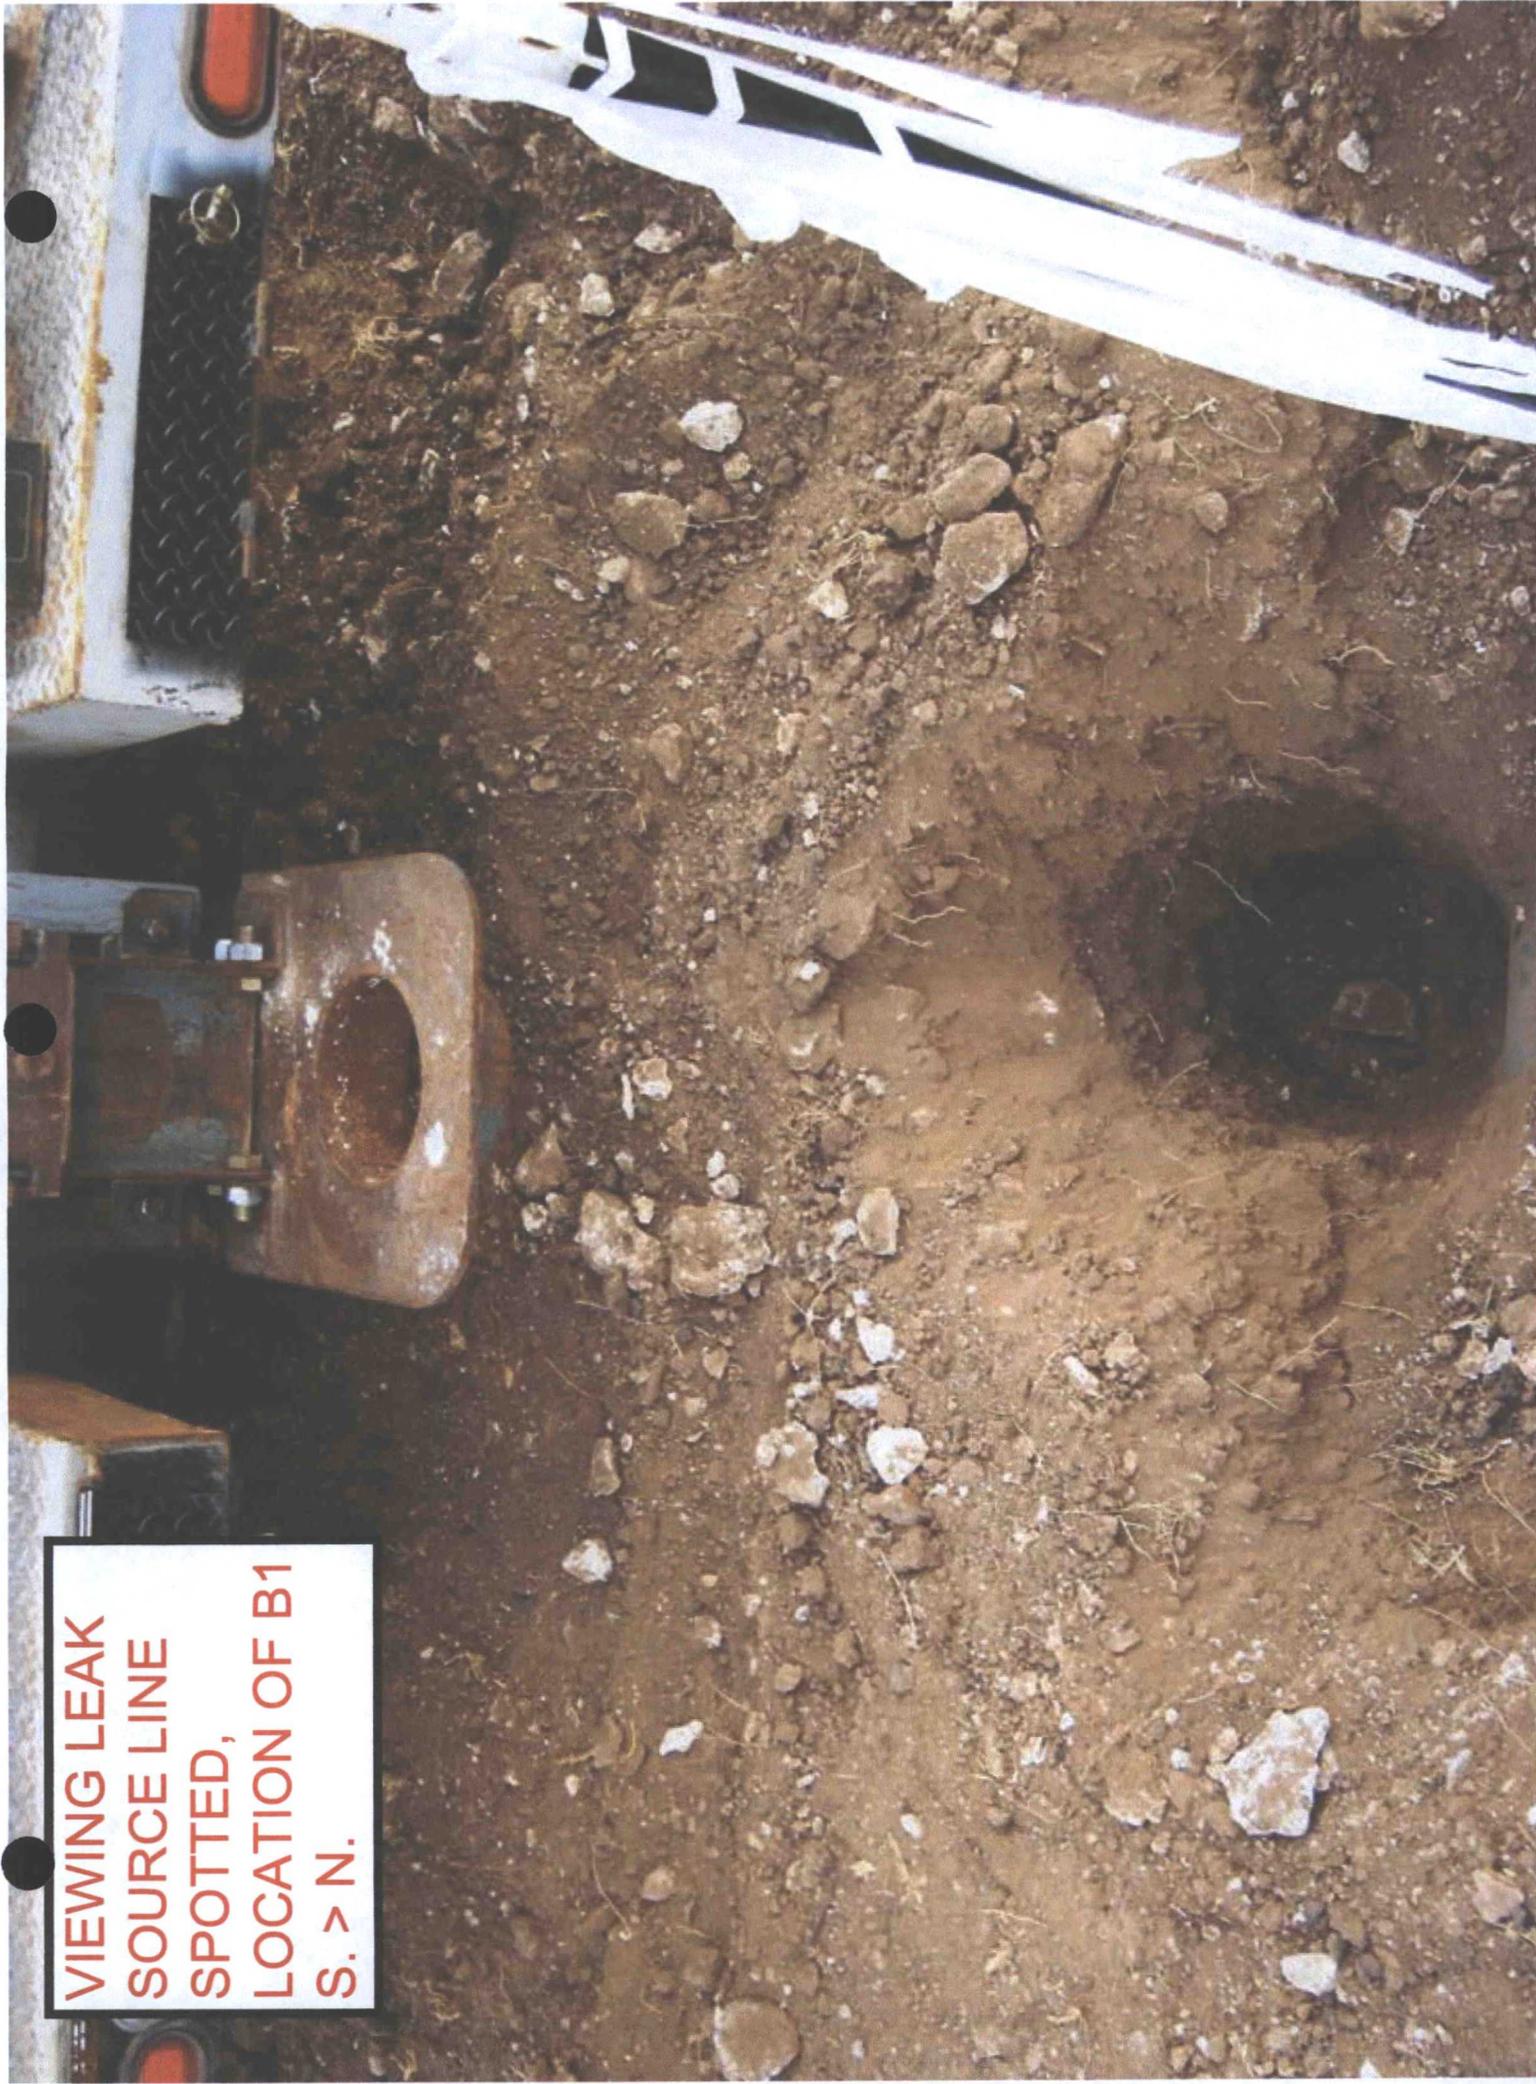
**VIEWING LEAK
SOURCE LINE
SPOTTED,
LOCATION OF B1
S. > N.**

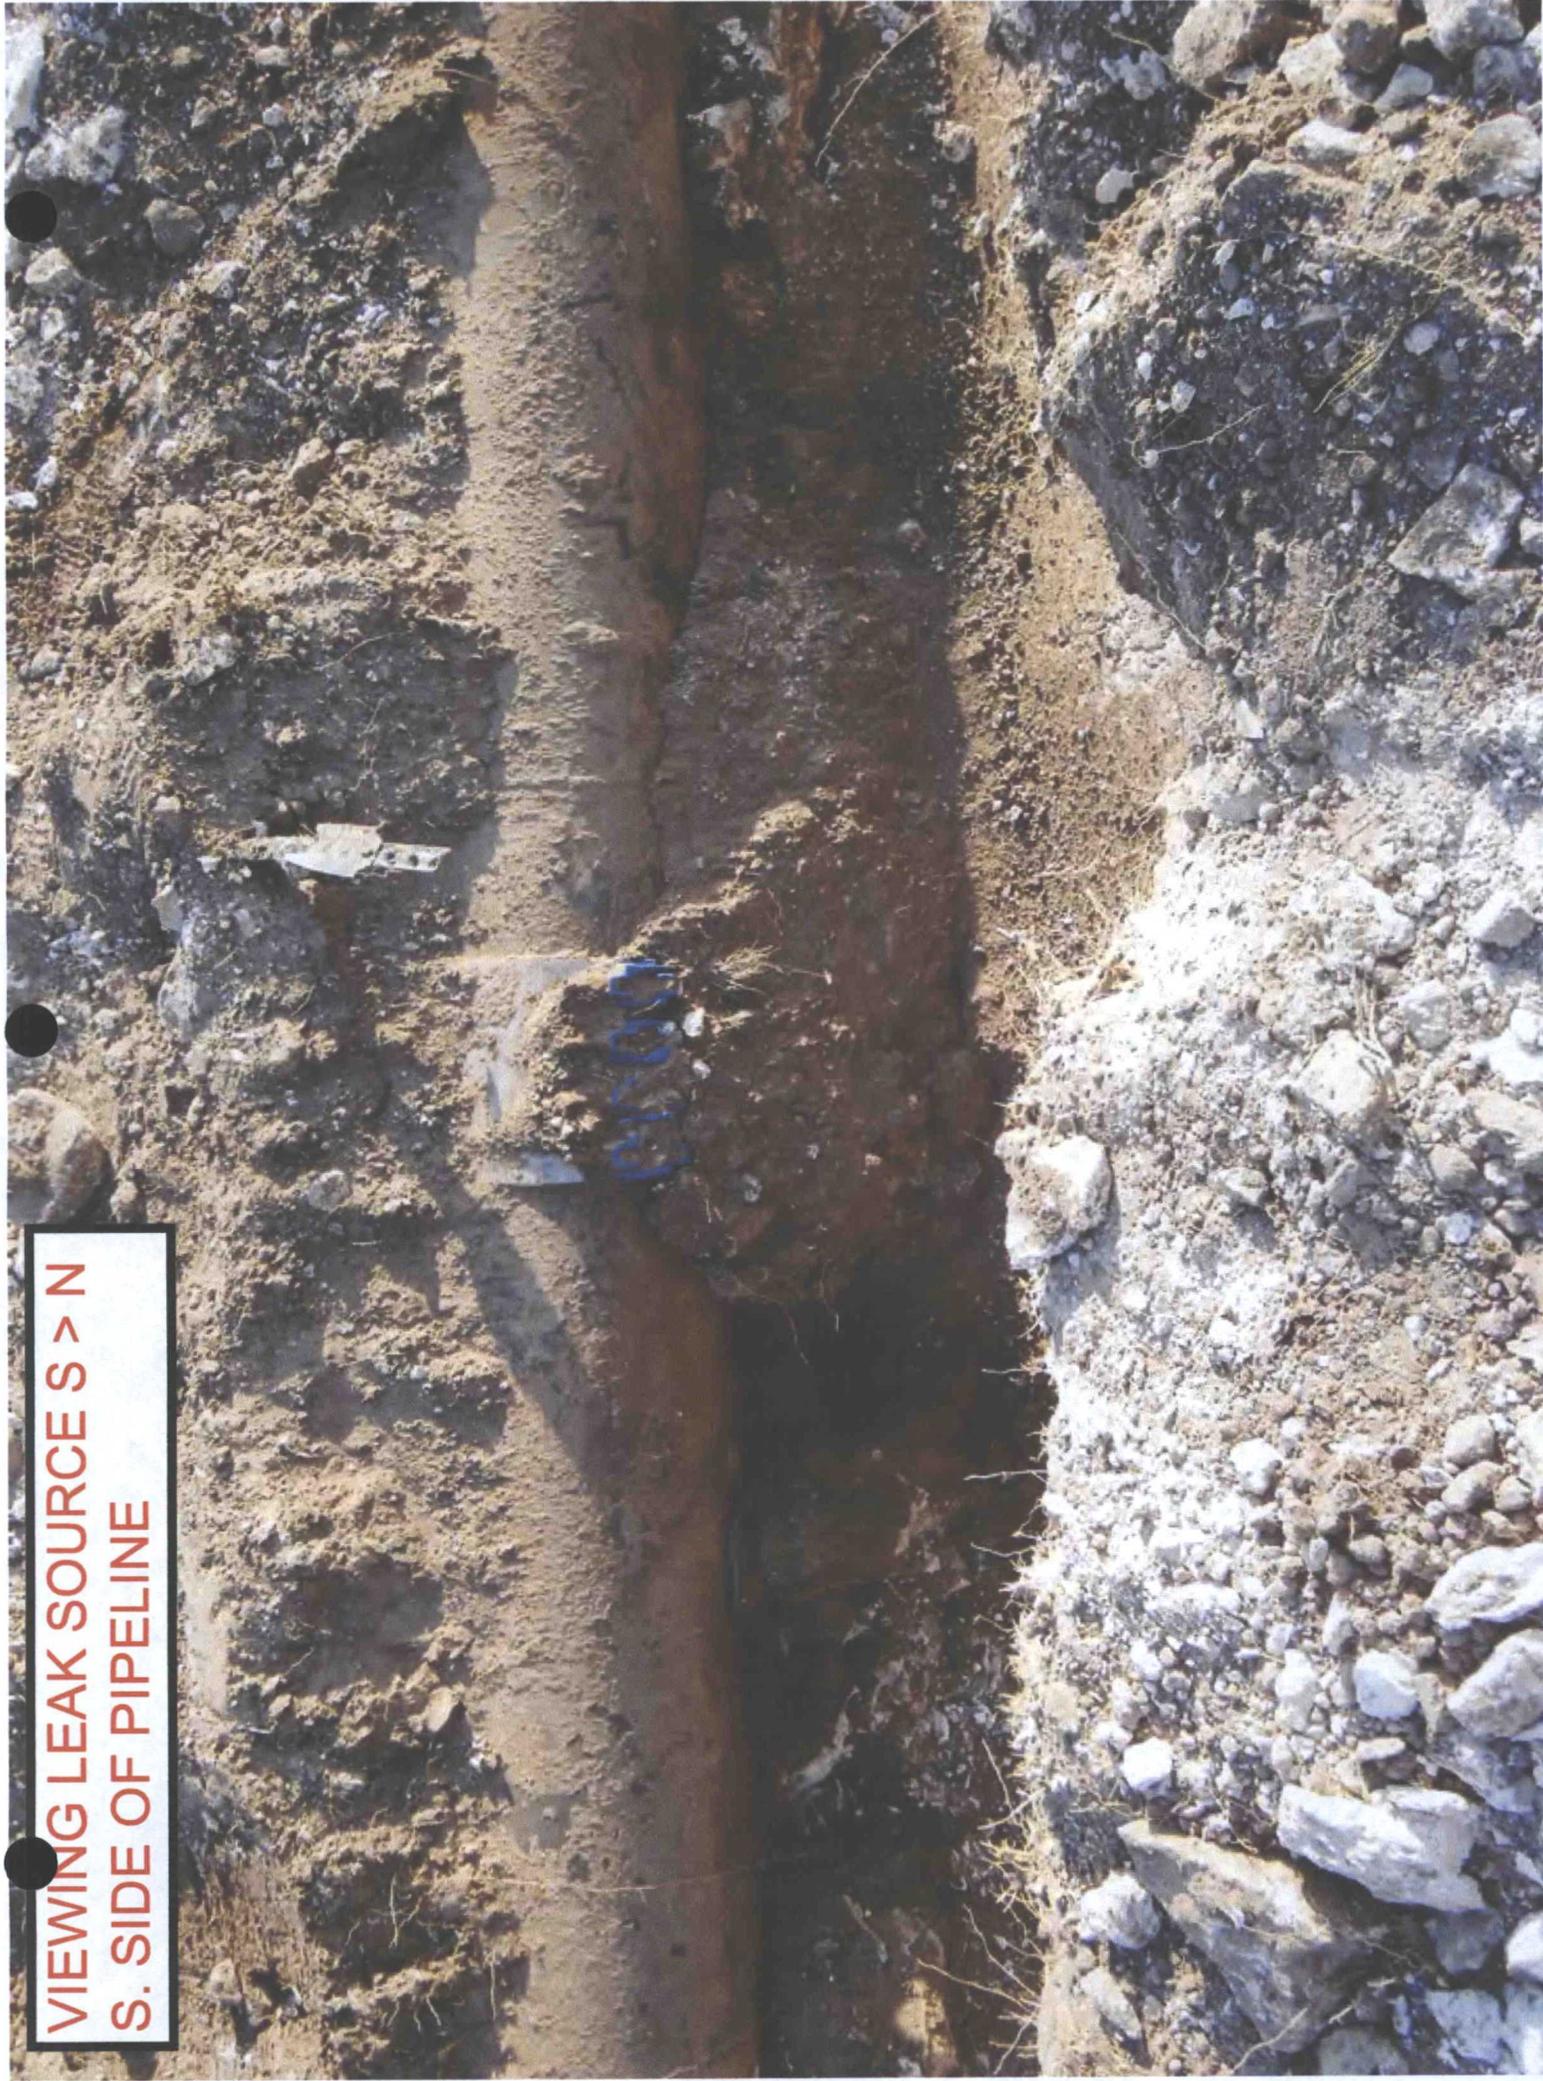
**VIEWING LEAK SOURCE S > N
S. SIDE OF PIPELINE**

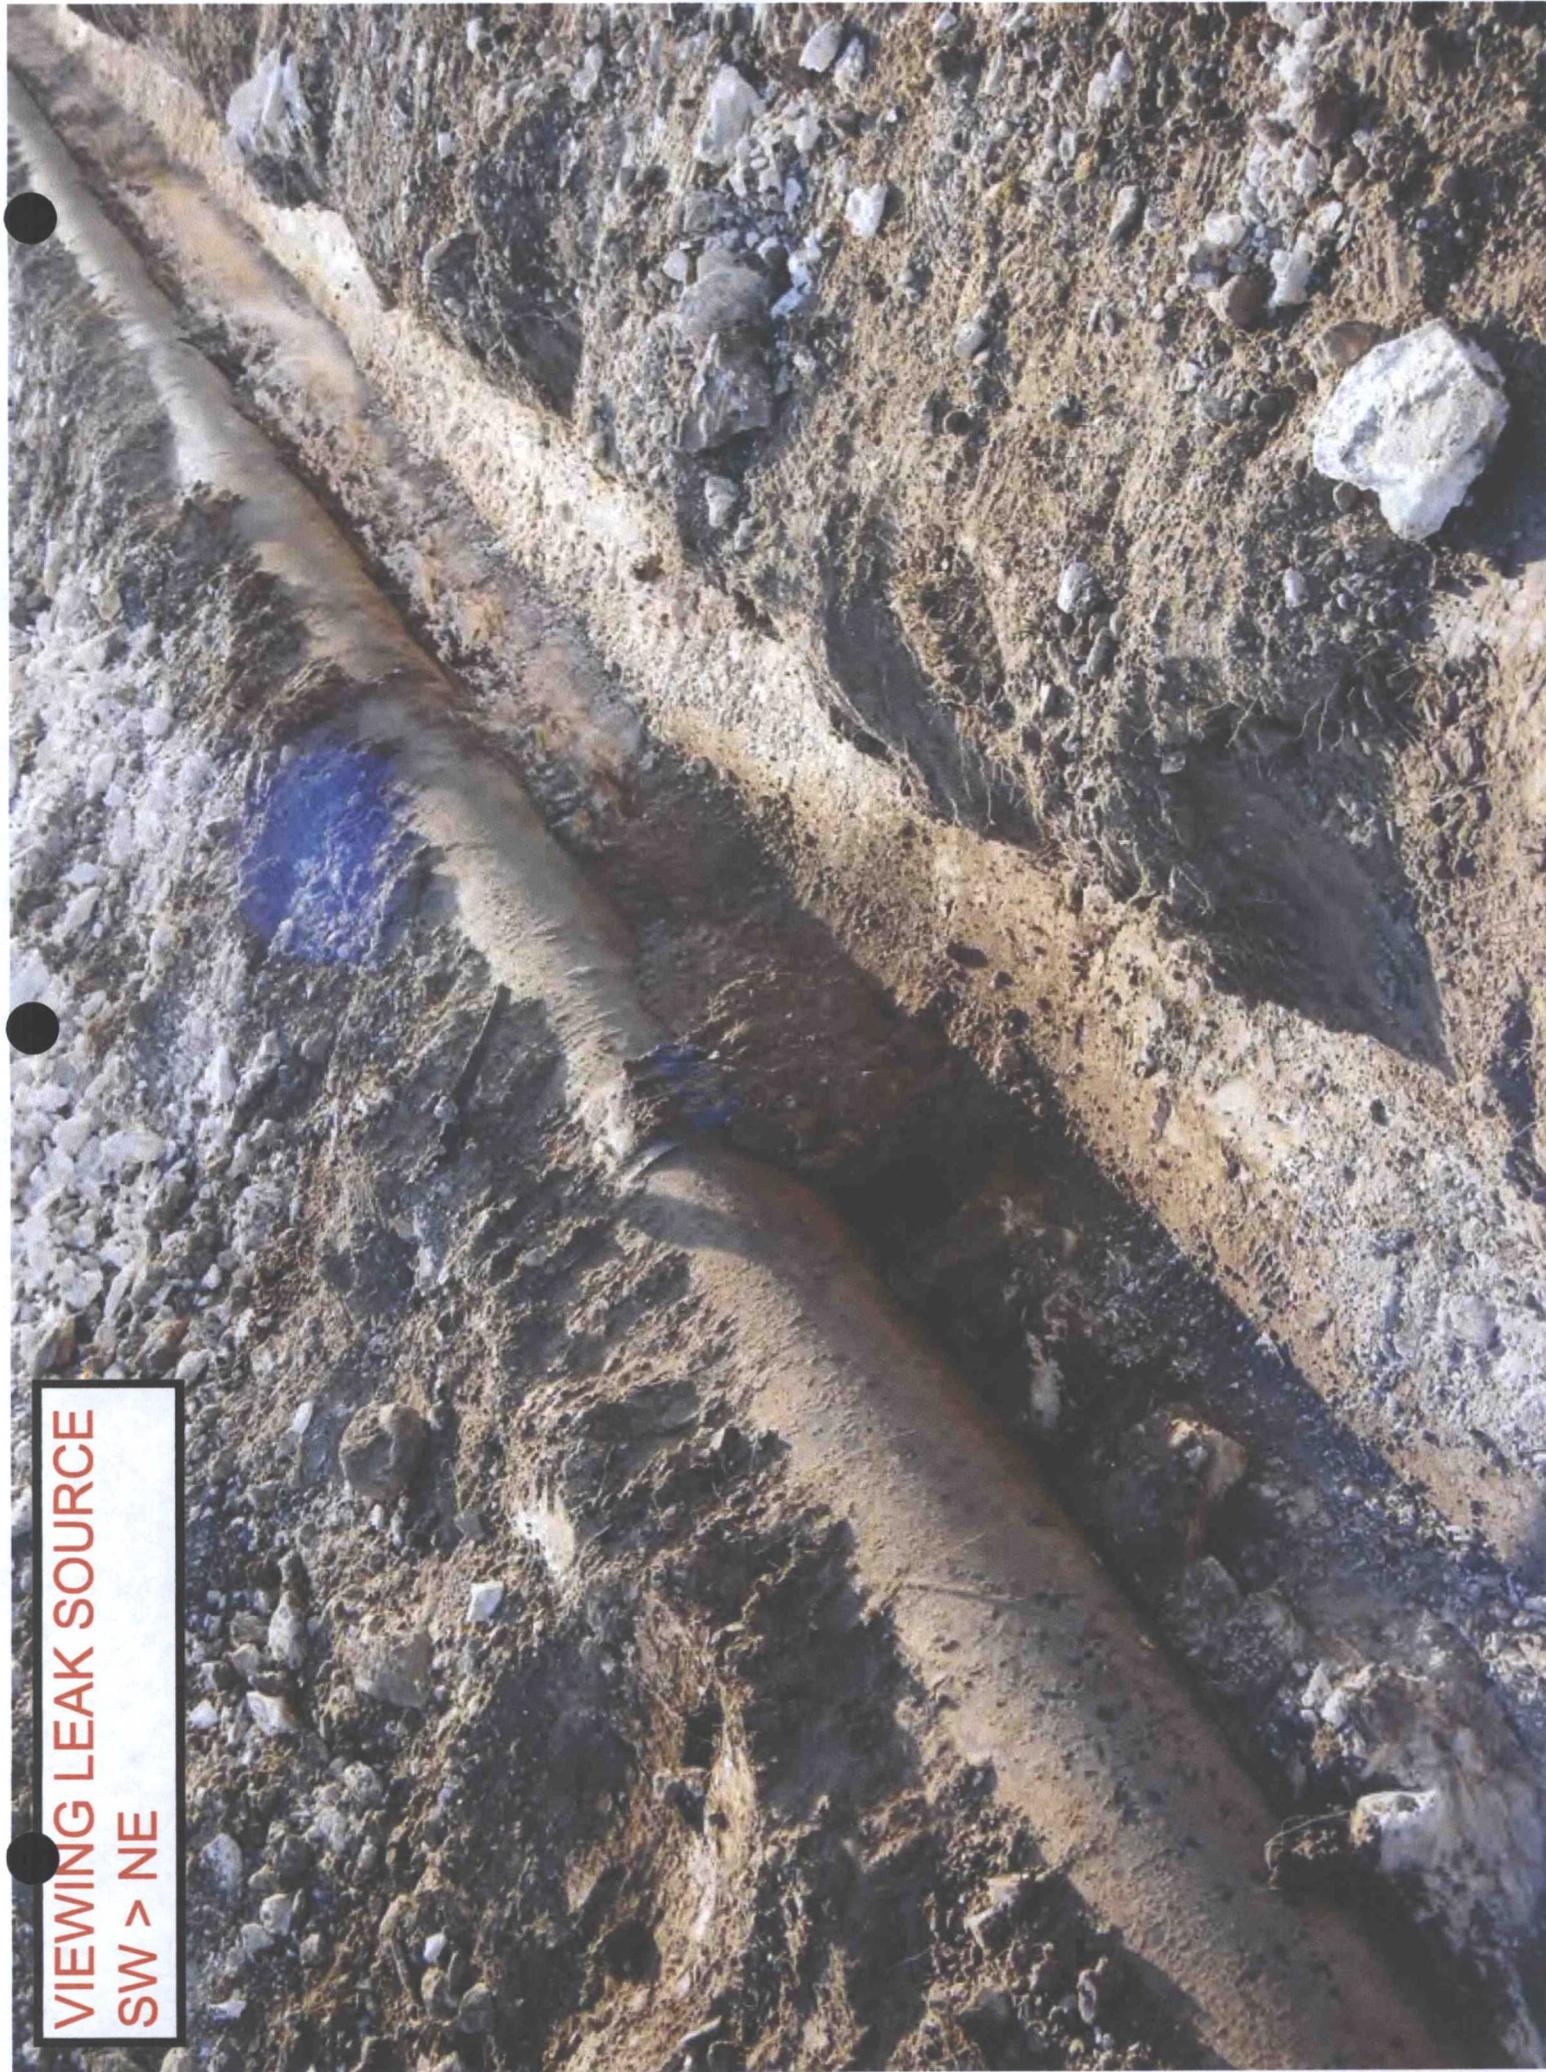
**VIEWING LEAK SOURCE
SW > NE**

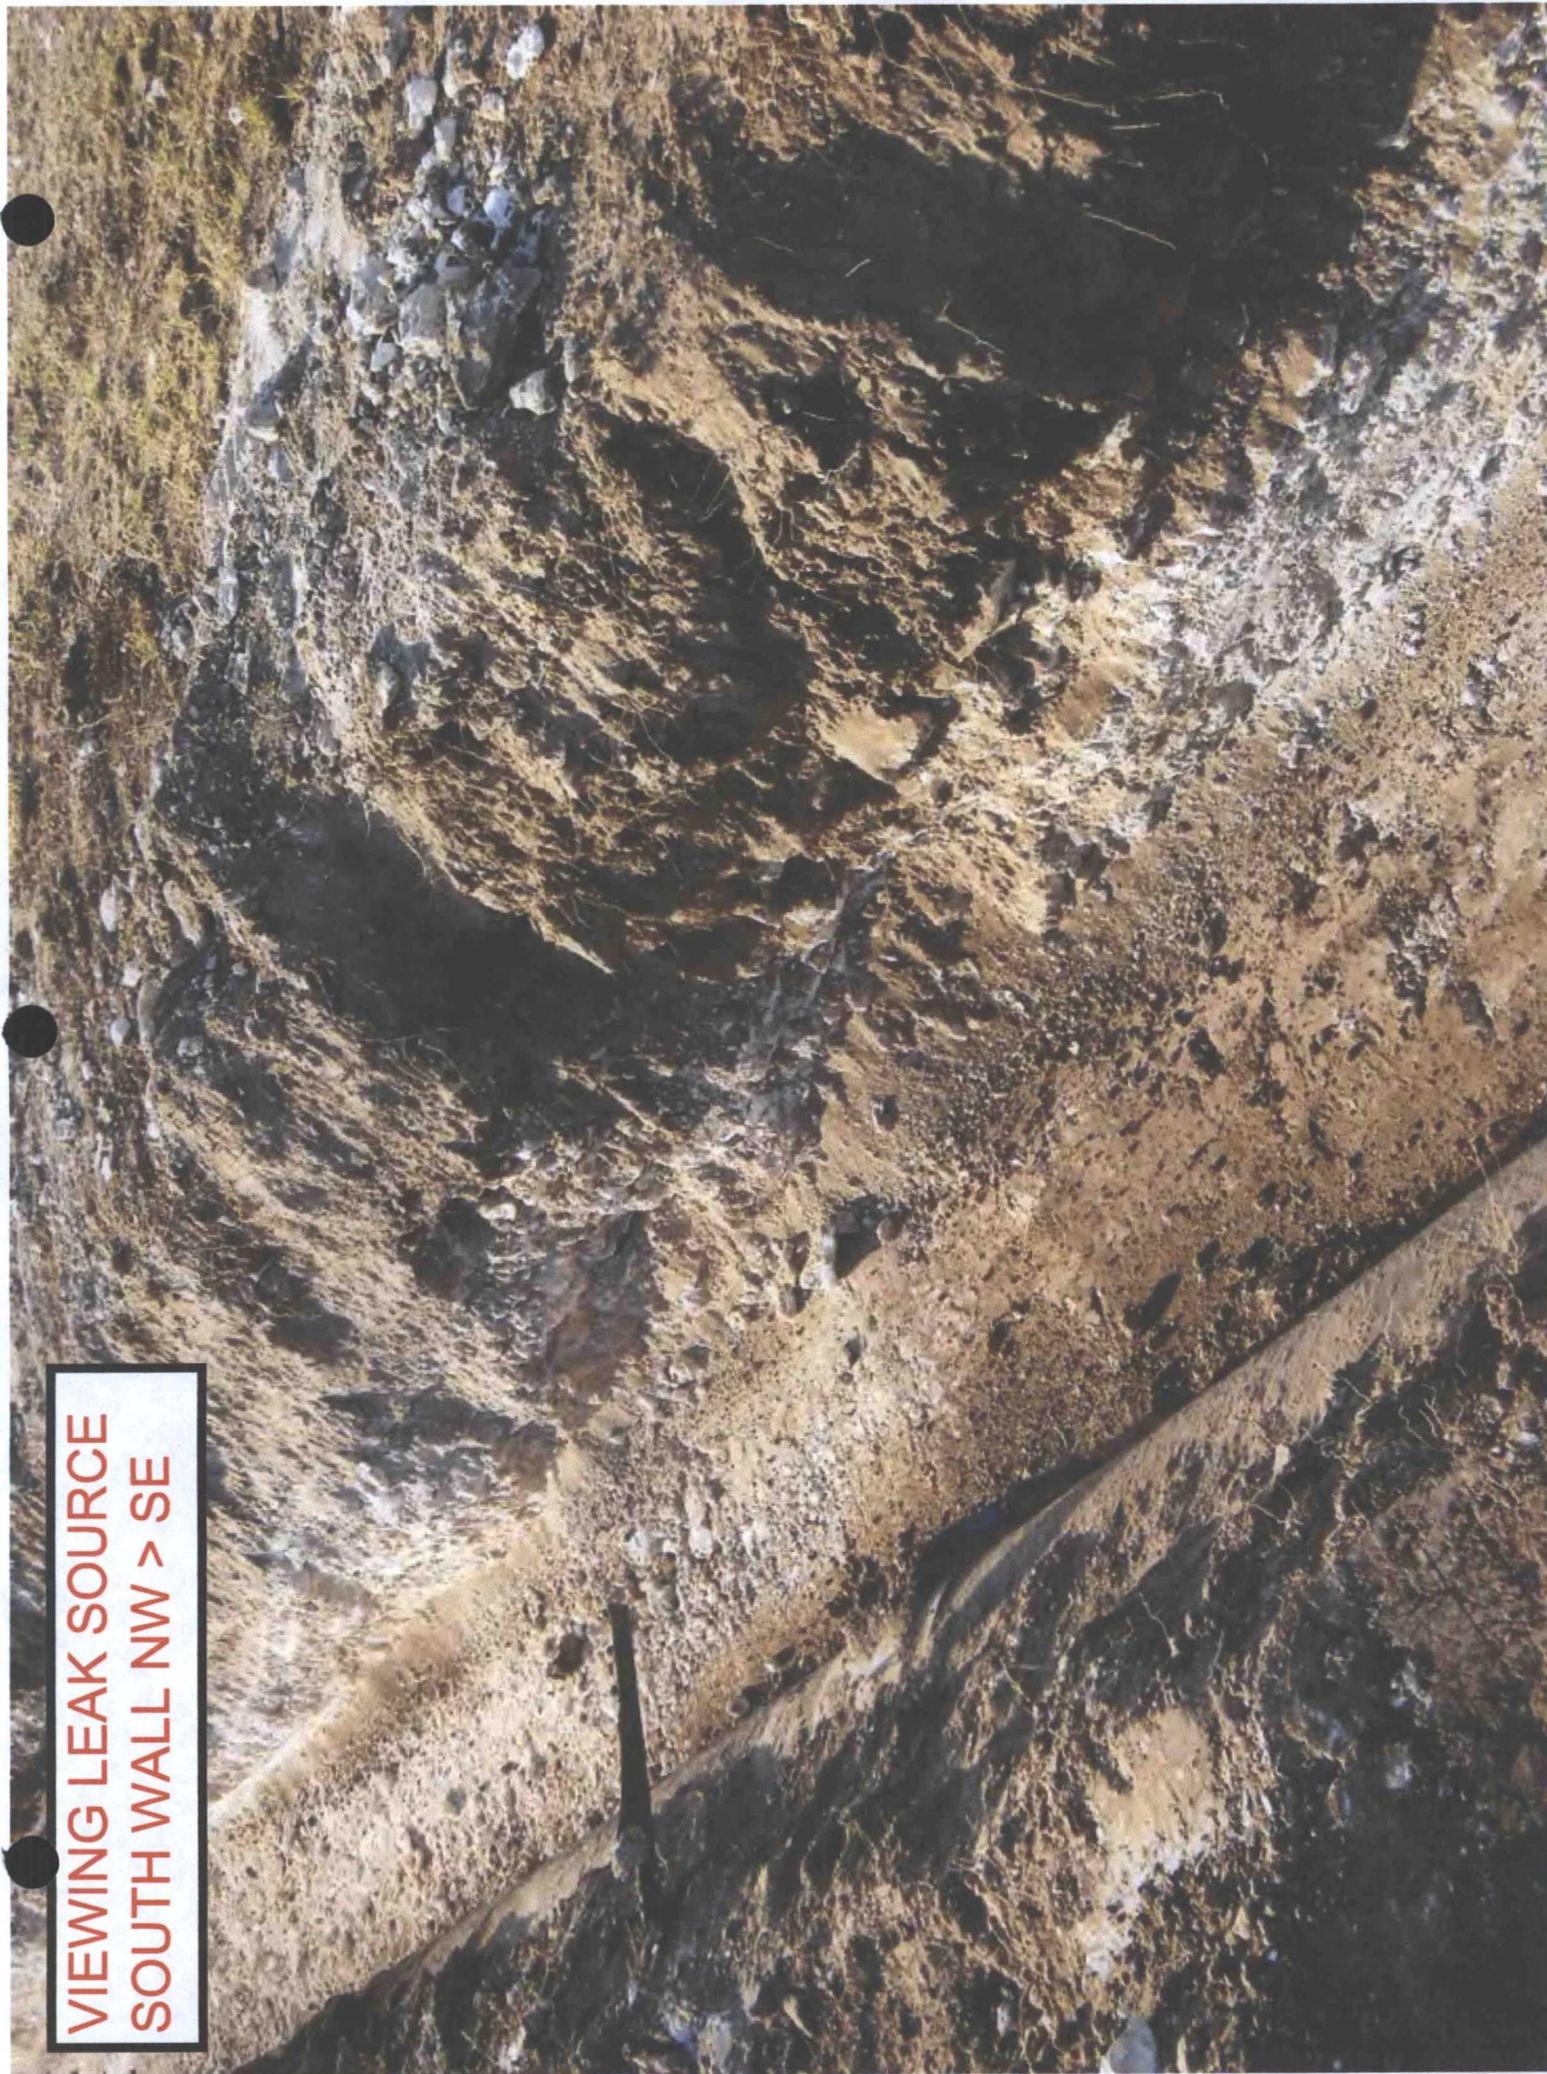
**VIEWING LEAK SOURCE
SOUTH WALL NW > SE**
