CLOSURE REPORT

PRINCIPLE 1 & 2 BATTERY

EPI REF: #160032

NMOCD REF: 1RP-1037

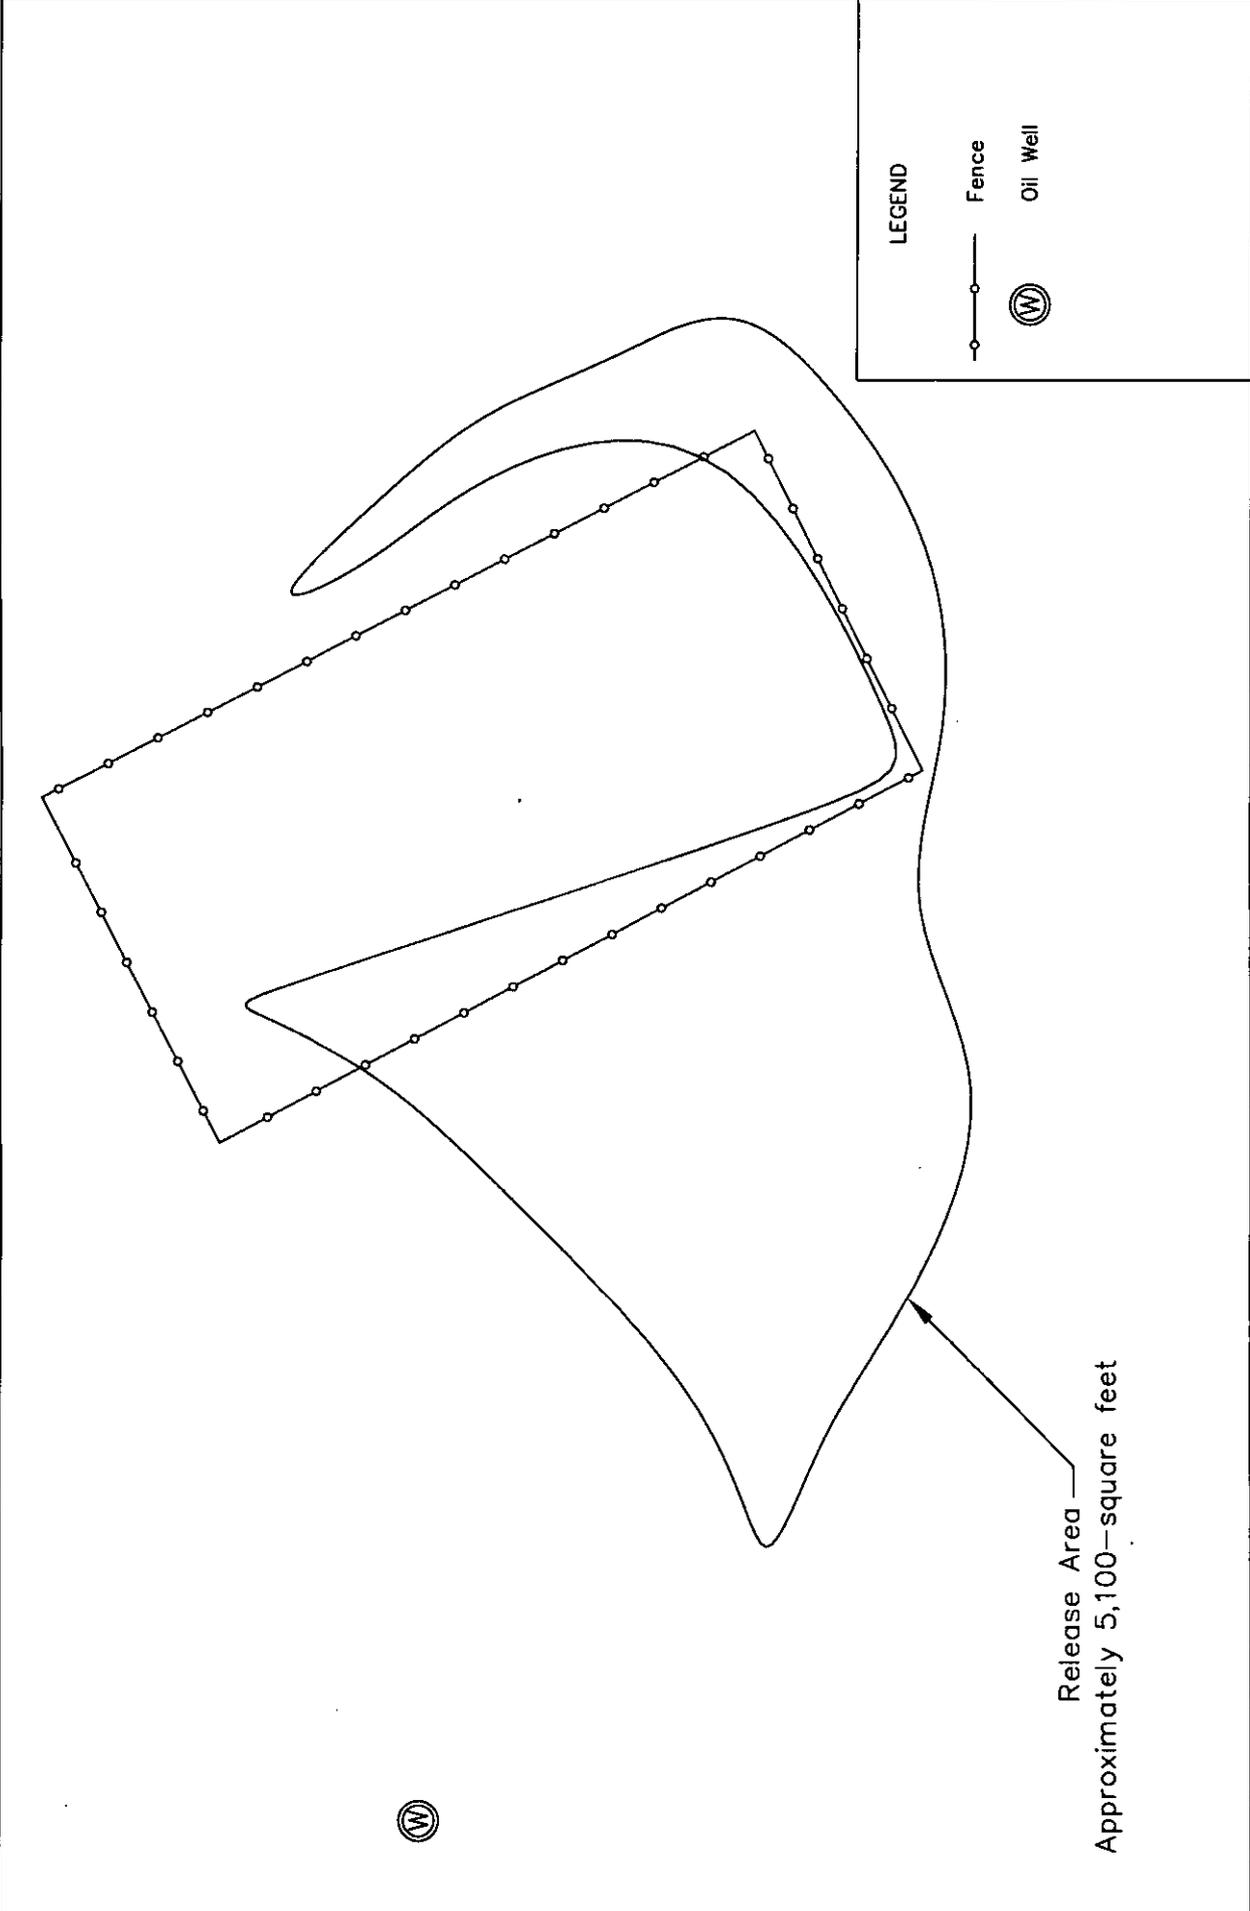
Figure 3
 Site Map
 Chesapeake Energy
 Principle 1 & 2 Battery

Release Area
 Approximately 5,100-square feet

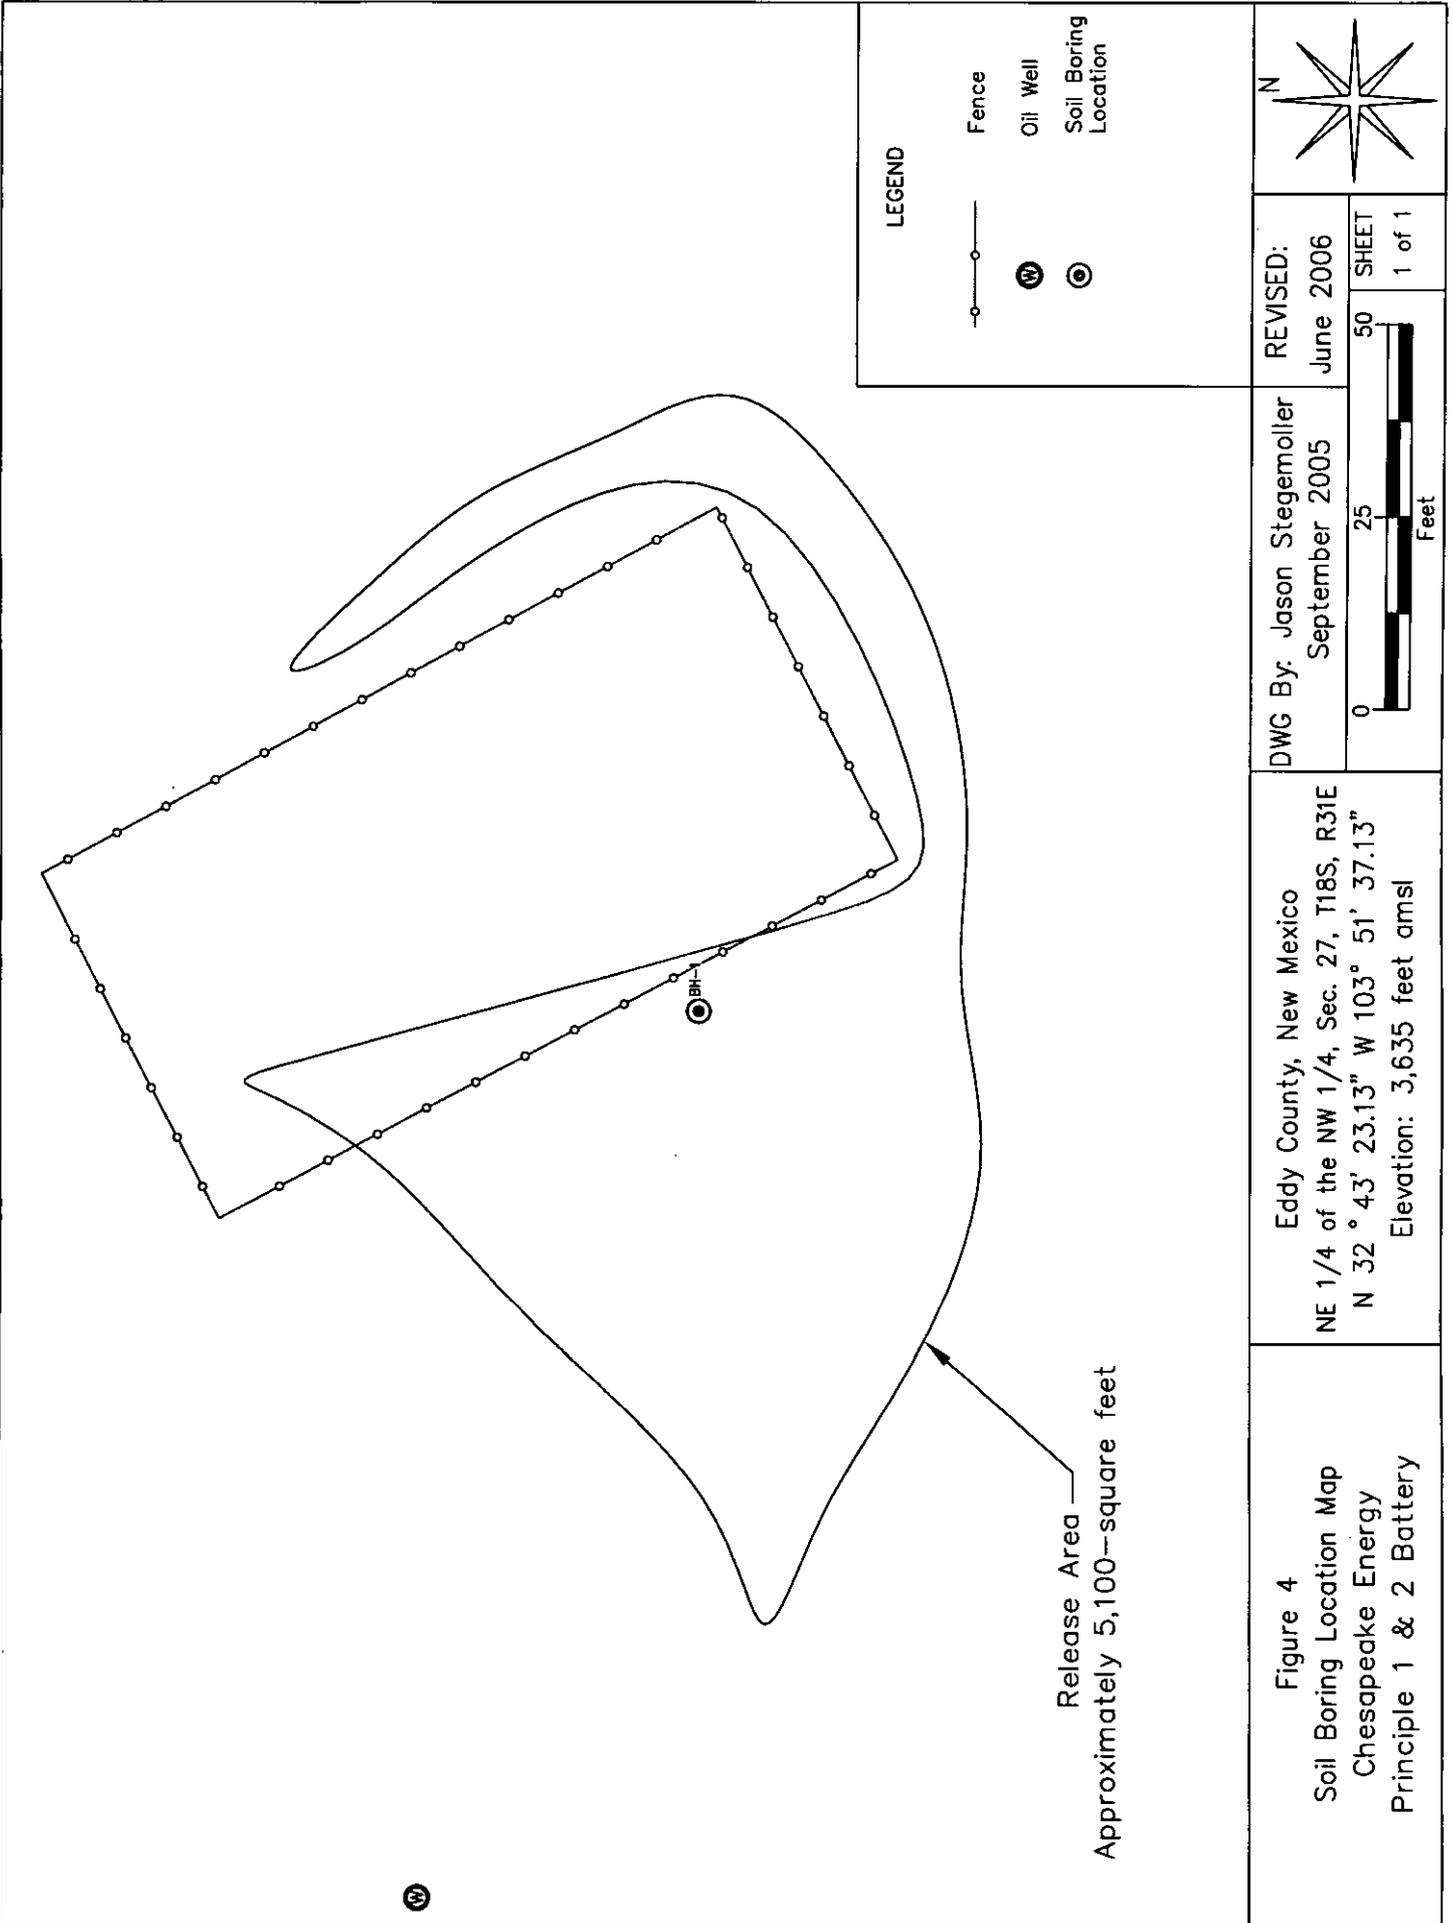
Figure 4
Soil Boring Location Map
Chesapeake Energy
Principle 1 & 2 Battery

Release Area
Approximately 5,100--square feet

One (1) soil boring (BH-1) was advanced to a depth of thirty (30) feet bgs within the perimeter of the release area on October 18, 2005 to delineate vertical extent of contamination (reference *Figure 4*). Soil boring hole BH-1 was advanced to a total depth of thirty (30) feet bgs. Locale for BH-1 was chosen to be within the perimeter of the release area in the vicinity of the most visually contaminated zone.

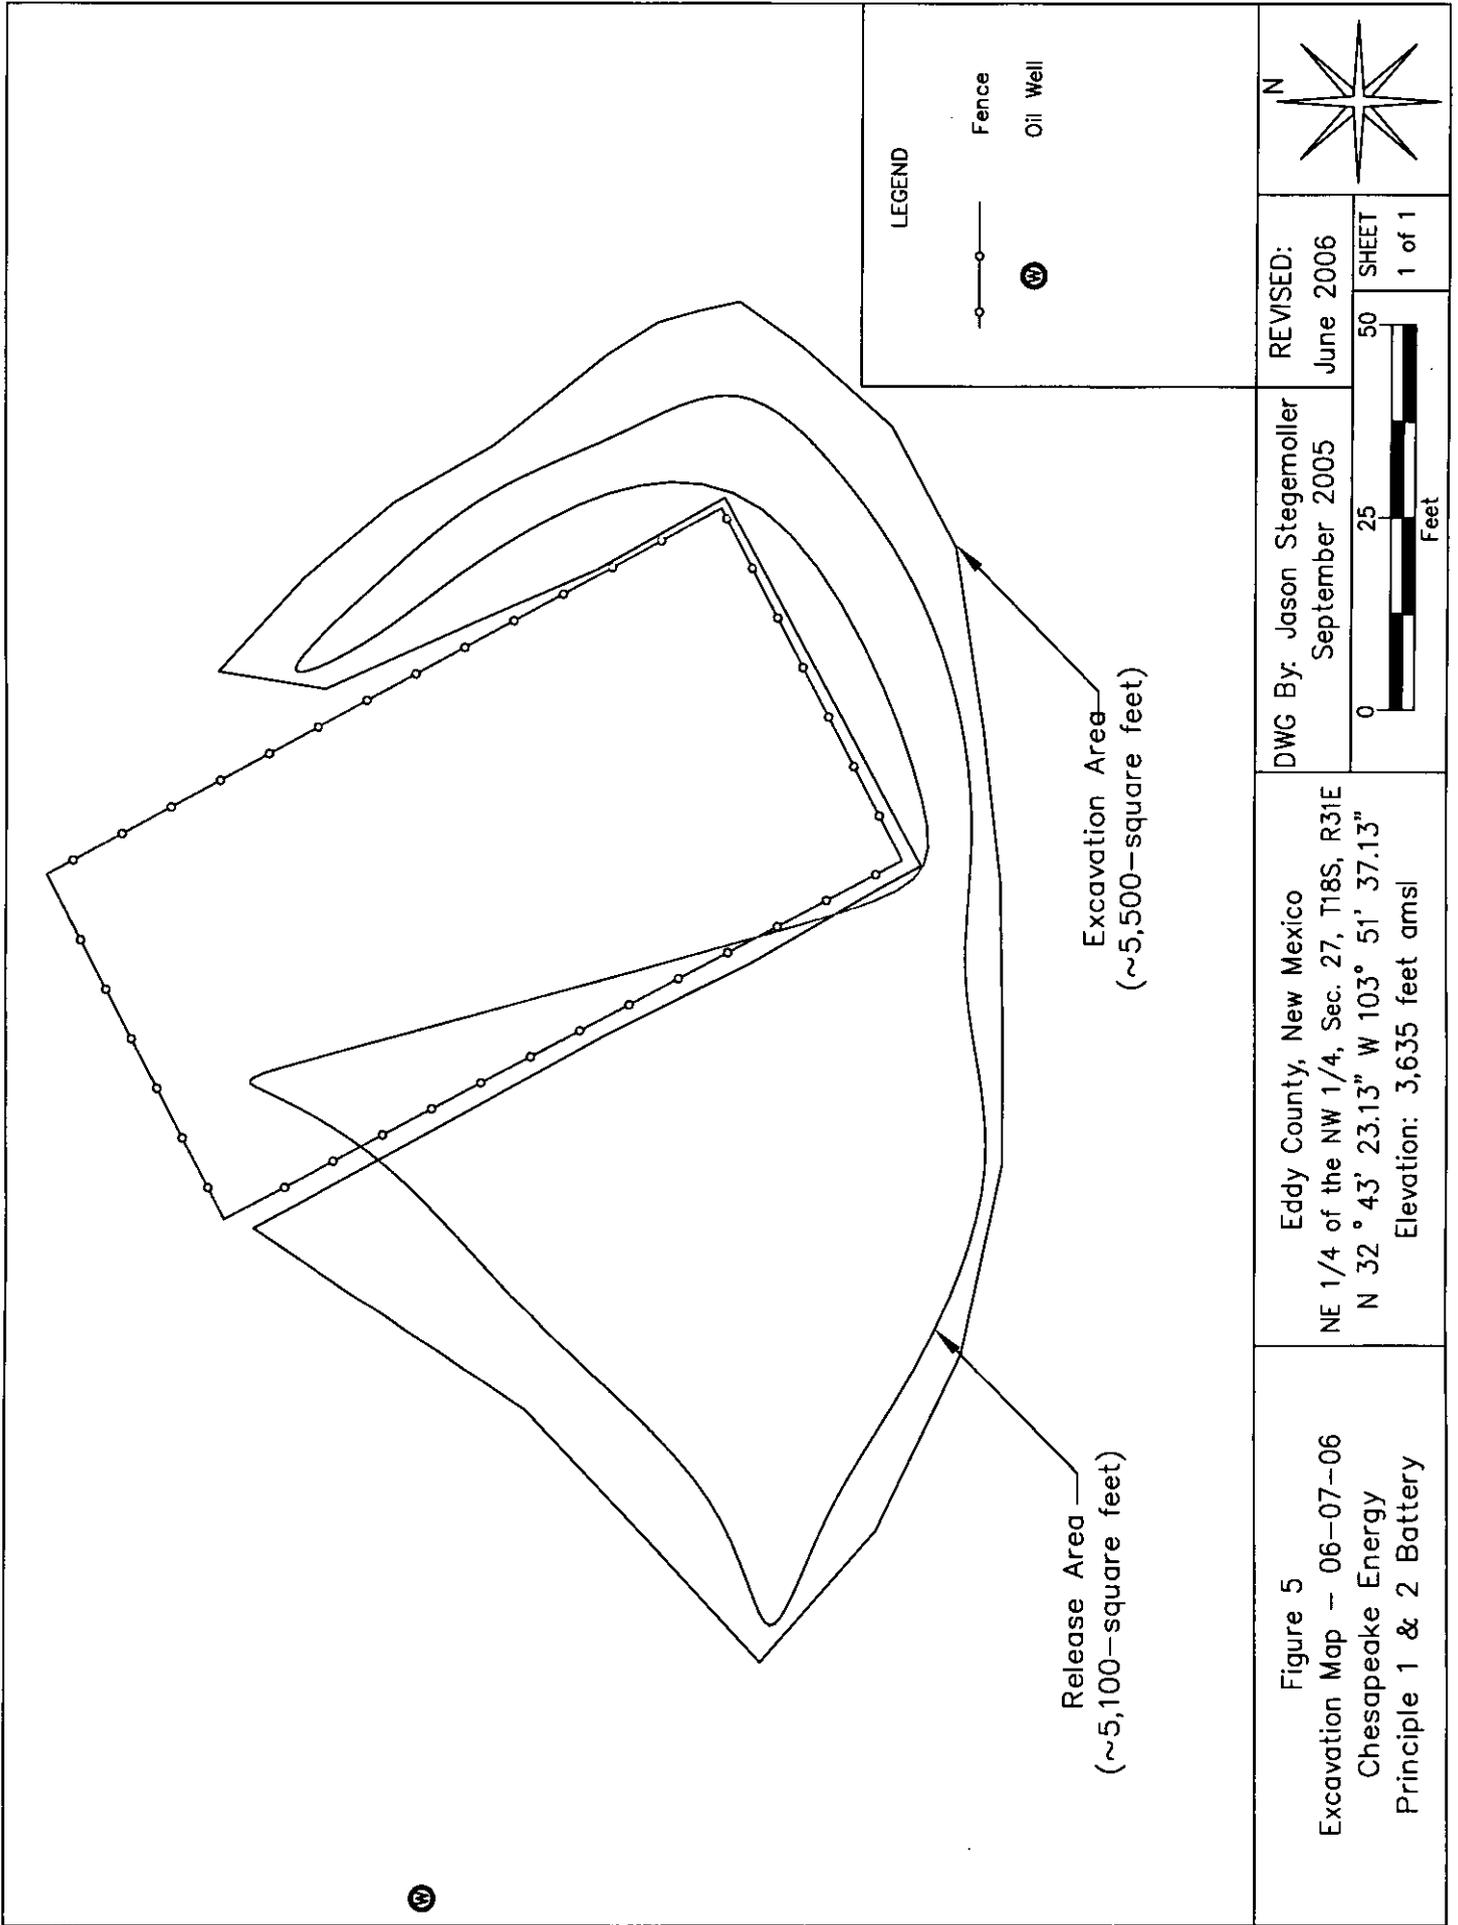
Figure 5
Excavation Map -- 06-07-06
Chesapeake Energy
Principle 1 & 2 Battery

Release Area
(~5,100-square feet)

Excavation Area
(~5,500-square feet)

In compliance with this agreement, EPI started removal of impacted soil from the release area on April 11 and concluded the process on April 17, 2006. Approximately 240 yds³ of impacted soil were excavated from the release area with disposal at Lea Landfill, Inc. After extracting impacted soil to a depth of approximately two-feet (2-ft.), six (6) soil samples were collected from the bottom of the excavation and analyzed in the field for organic vapors and chlorides utilizing methods outlined in Section 4, *Subsurface Soil Investigation*. Two (2) areas in the bottom of the excavation were over-excavated due to high chloride concentrations. Four (4) soil samples collected from the bottom of the excavation on April 12, 2006 and three (3) soil samples collected from the sidewalls on April 13, 2006 were transported to an independent laboratory for analyses of BTEX, TPH, chlorides and sulfates. A review of Table 3, *Summary of Excavated Soil Sample Field Analyses and Laboratory Analytical Results*, indicates all soil samples were below site remedial threshold goals with the exception of BH-1 (2') which indicated chloride concentrations of 260 mg/Kg. This value is slightly above site remedial threshold goals of 250 mg/Kg. However, due to the depth of groundwater (>381-ft), possibility of contamination above NMWQCC Groundwater Standards of 250 mg/L was very remote.

Backfilling of the excavation started on April 17 and ended on April 18, 2006. Approximately 200 yds³ of caliche were transported from a BLM approved pit for use as backfill material. The use of caliche for backfill material was justified as the primary release area was located within the tank battery perimeter. A secondary area contiguous with the primary area was backfilled with sandy soil from nearby dunes. The disturbed surface around the release area was graded to allow natural drainage. Although the sandy soil used to backfill the secondary

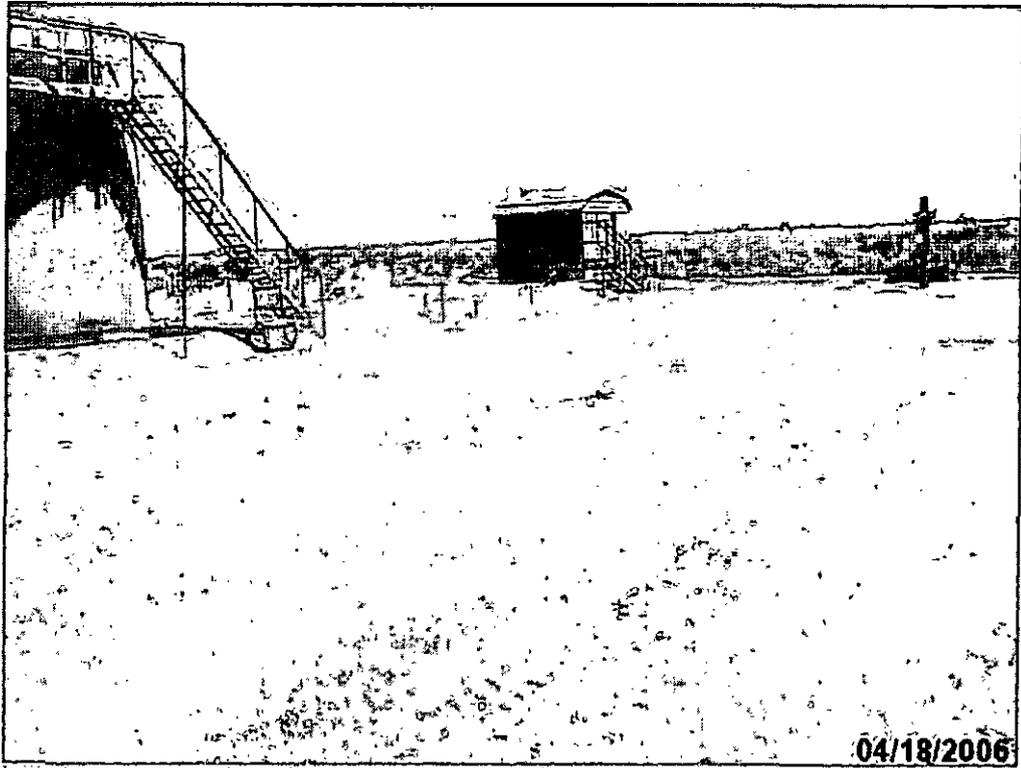
Photograph #7 – Looking northerly at Tank Battery and remediated caliche pad

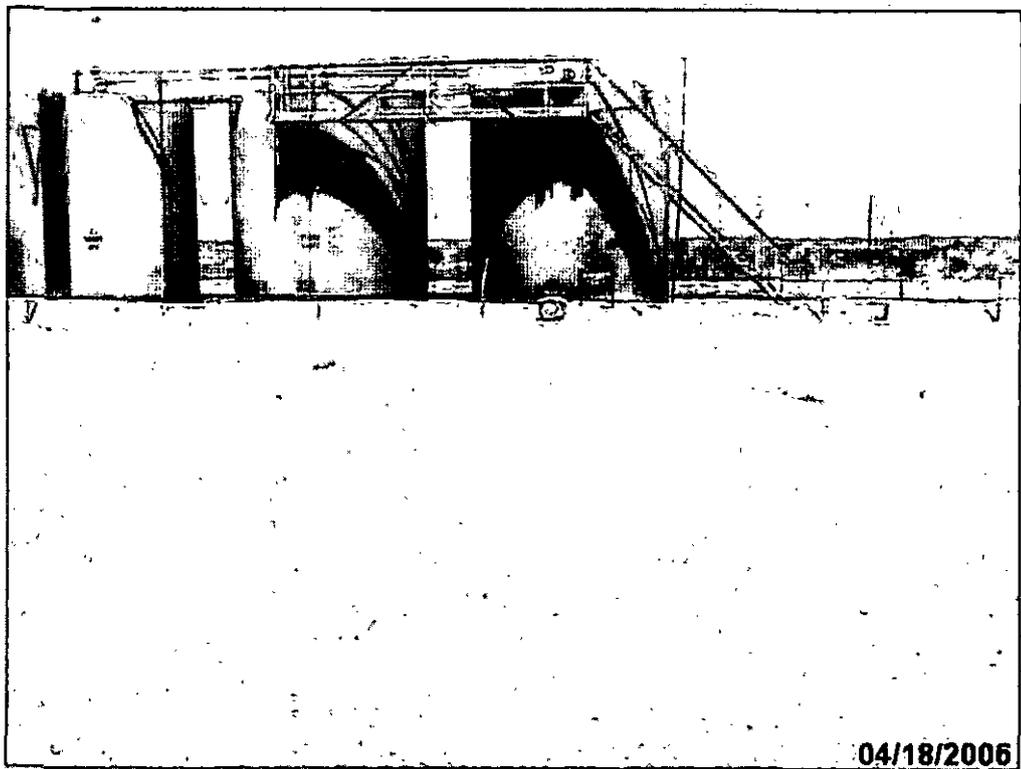
Photograph #8 – Looking westerly at Tank Battery and remediated caliche pad
