RE: Request for Closure  
MCA 2A Header Fiberglass Trunk Line  
Lea County, New Mexico  
Unit G, Sec. 29, T17S, R32E  
1RP 2223

Tetra Tech submits this suggested request for closure for the soil remediation performed February 6, 2010 through October 29, 2010, at ConocoPhillips' MCA 2A Header 3-inch Trunk Line oil/produced water release site (Site). This work was in support of ConocoPhillips' efforts to remediate soil affected by a 1 barrel crude oil and 21 barrel produced water release reported to the New Mexico Oil Conservation Division (NMOCD; C141 attached). The Site is located below the Mescalero Ridge, approximately 1.4 miles southwest of the ConocoPhillips MCA Unit office in Lea County, New Mexico (32.807717°N, 103.784688°W). The U.S. Bureau of Land Management (USBLM) is the land administrator.

<b>FIGURE 1</b>

EXCAVATION AREAS

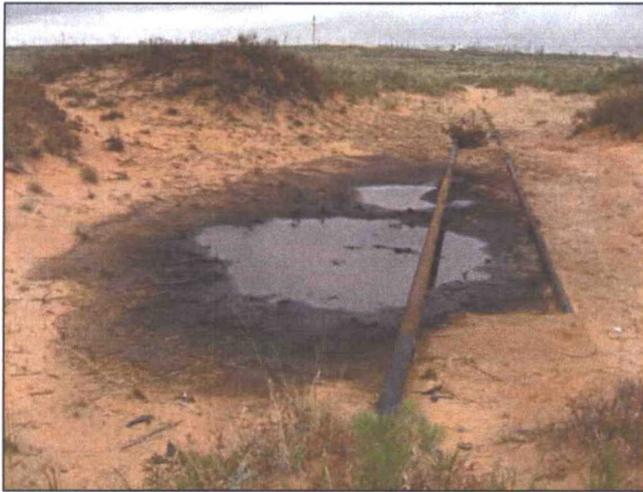
**EXCAVATION AREA A**

July 23, 2009

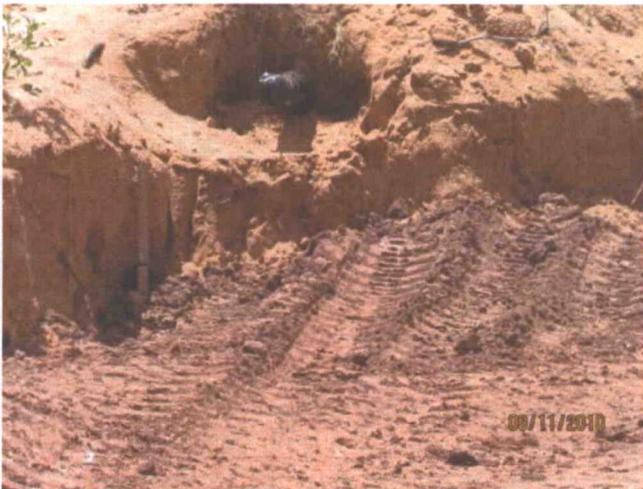
August 11, 2010  
4" Lines cut in  
July 2010

On July 21, 2010, ConocoPhillips removed segments of the two 4-inch steel lines that were out-of-service to allow unrestricted access to the affected Area A. Remediation of all affected areas resumed on August 3, 2010 and was completed October 29, 2010, with the closing of the access road.

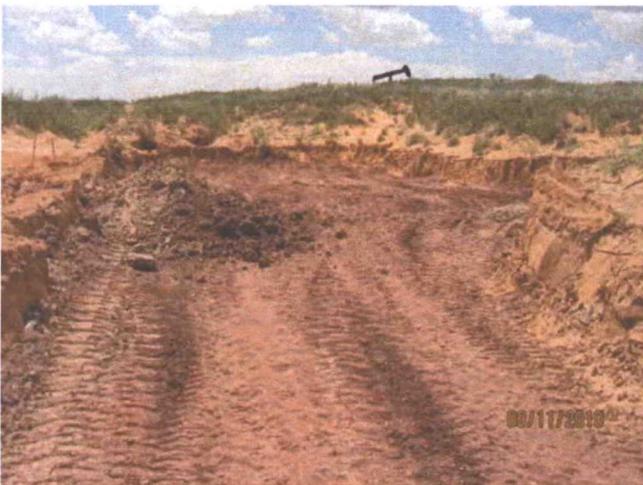
August 11, 2010  
Clay Barrier

A laboratory analysis of the over-excavations indicates clean boundaries in Areas A and B were achieved (Photo Log). Clay barriers were placed in Area A and under the transite pipeline (Area C) to prevent potential downward migration of residual chloride in soil due to precipitation.

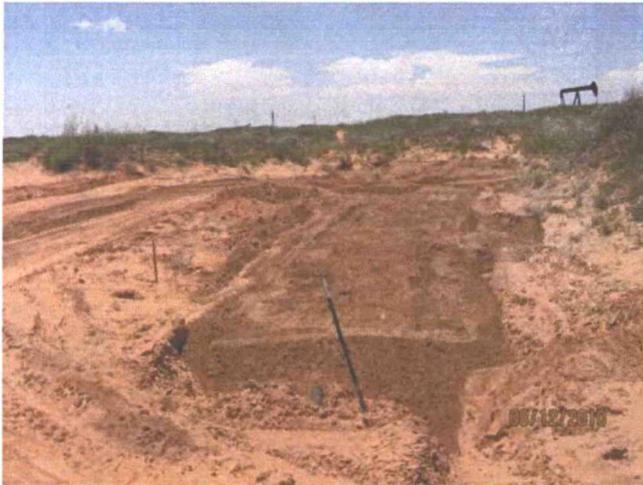
August 12, 2010

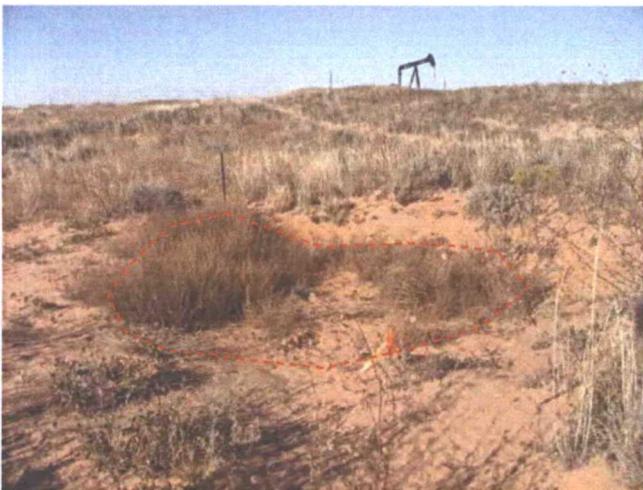
**EXCAVATION AREA B (No Before Photo)**

November 3, 2010  
Native Soil Backfill

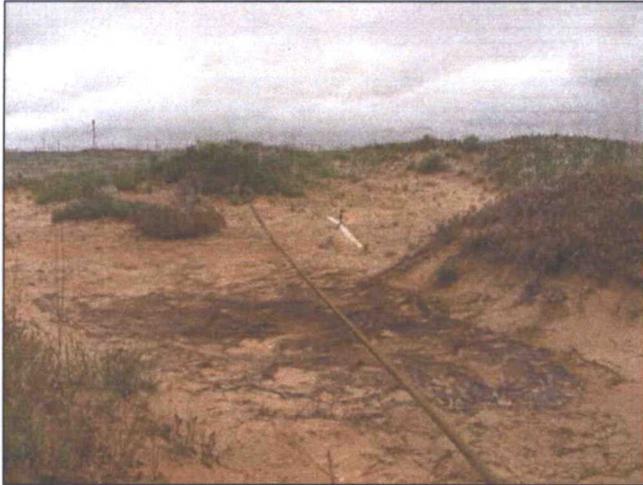
**EXCAVATION AREA C**

July 23, 2009

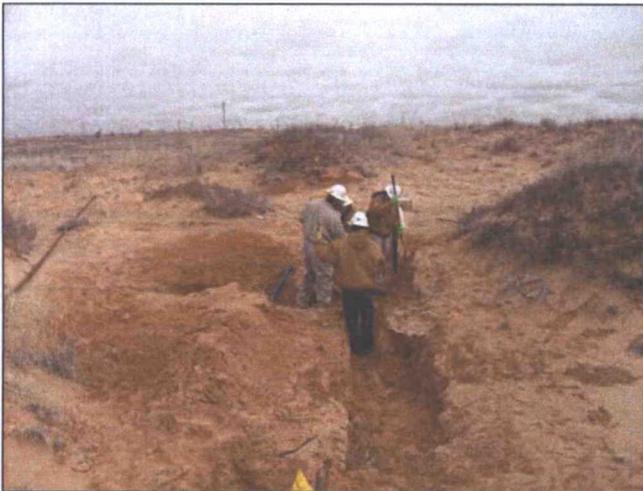
February 11, 2010

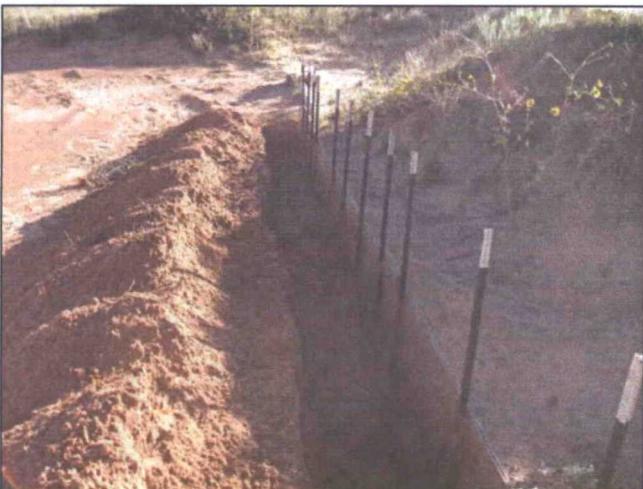
August 3, 2010

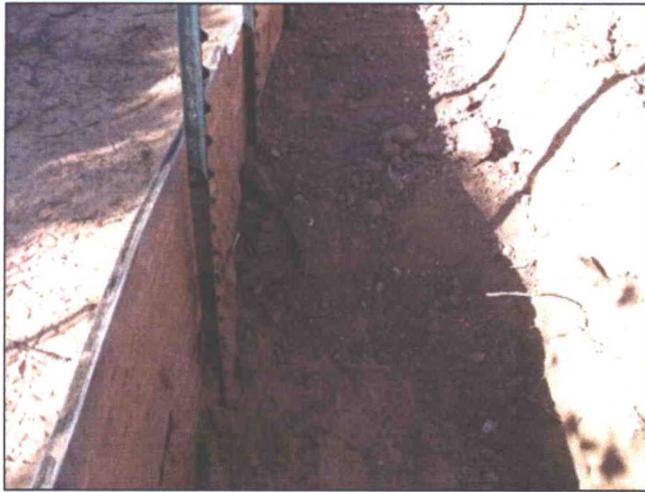
August 4, 2010  
Clay Barrier

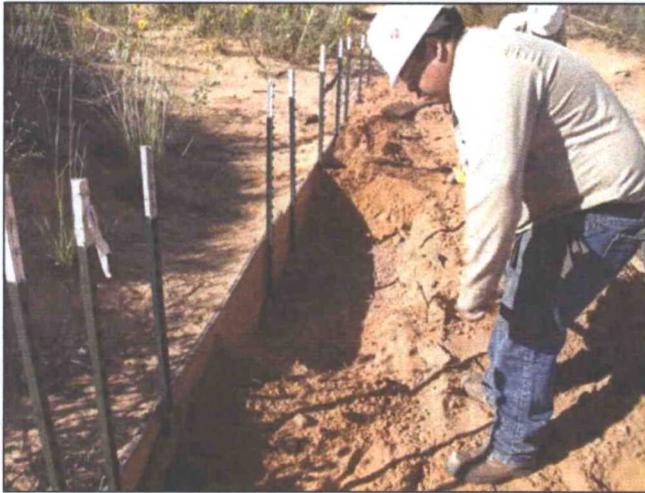
August 6, 2010
