**Re: 1RP04-12-2801 - Remediation Report Boyd 9 Inch Pipeline Release
Targa Midstream Services, L.P., Unit K (NE/4, SW/4), Section 23,
Township 22 South, Range 37 East, Lea County, New Mexico**

REMEDIATION REPORT
Boyd 9 Inch Pipeline Release
1RP-04-12-2802

LAI Project No. 12-0118-01

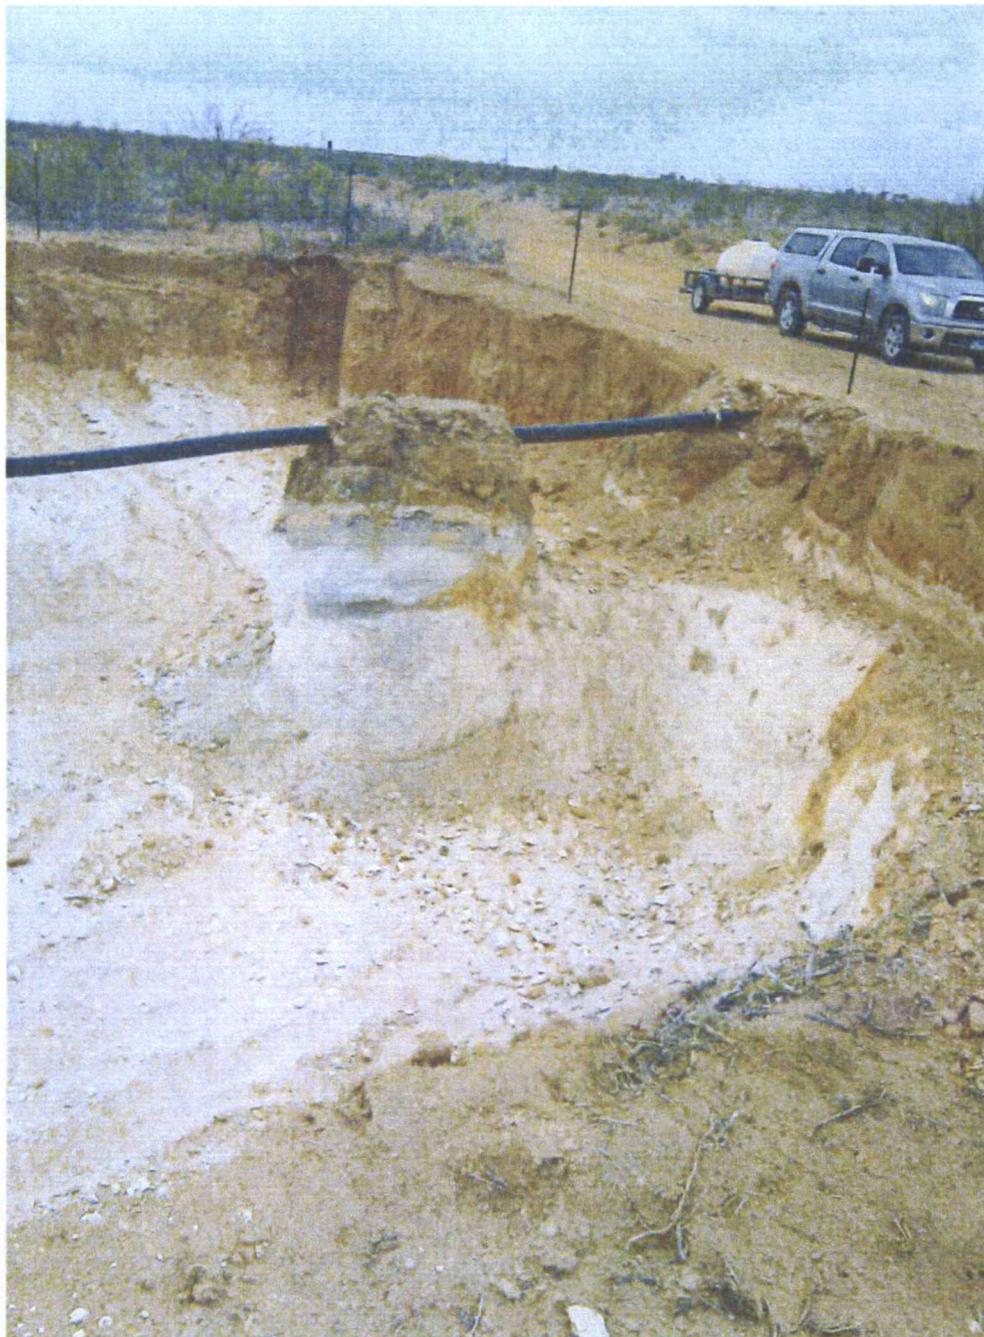
North Excavation Viewing Northwest, March 12, 2012

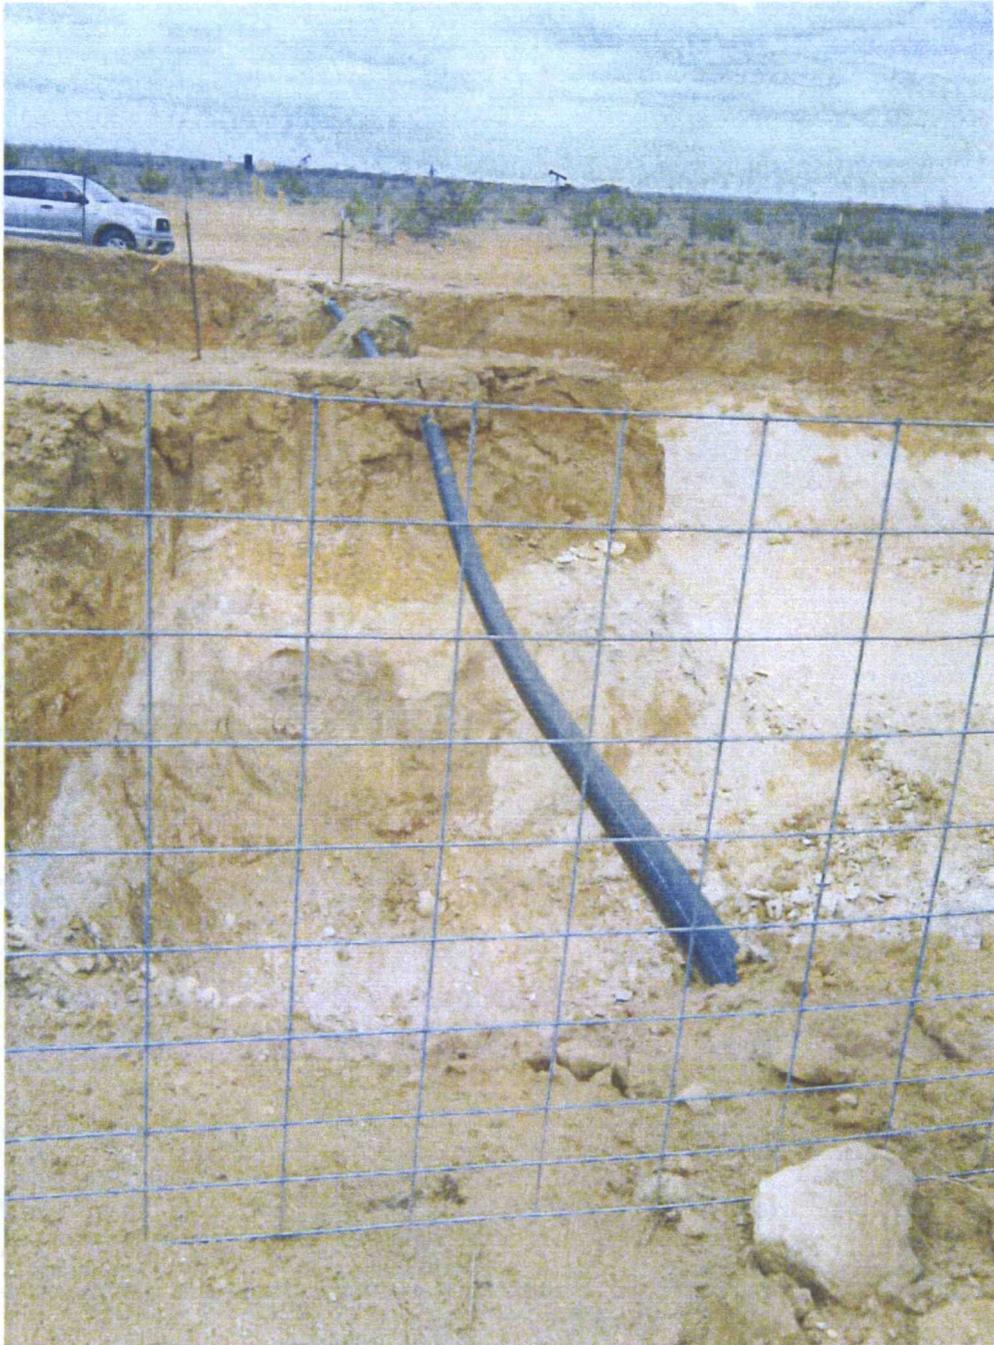
South Excavation Viewing North, March 12, 2012

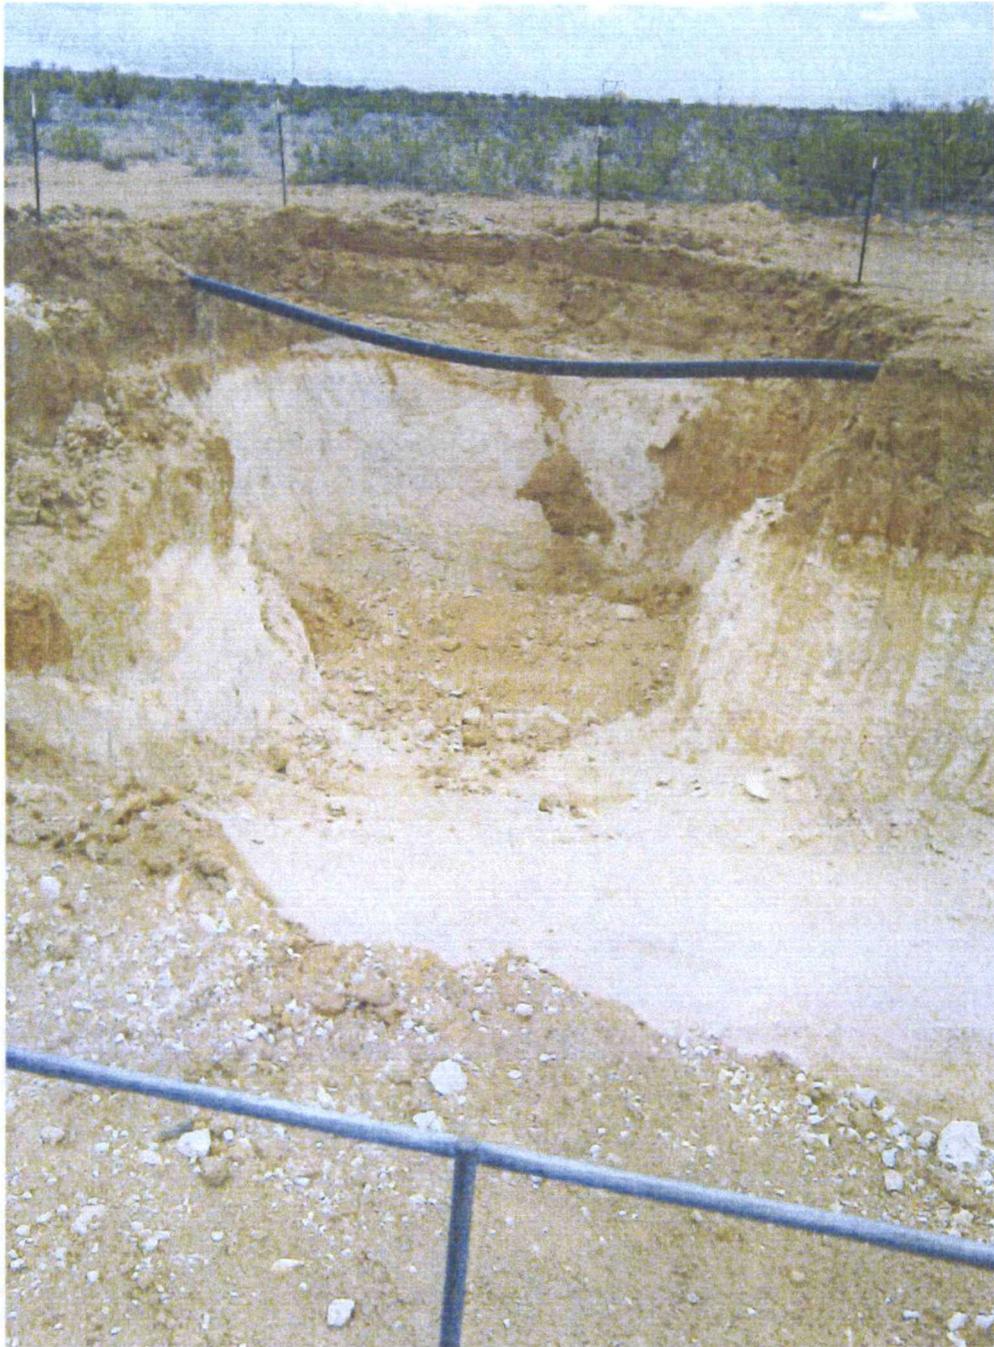
South Excavation Viewing South, March 12, 2012

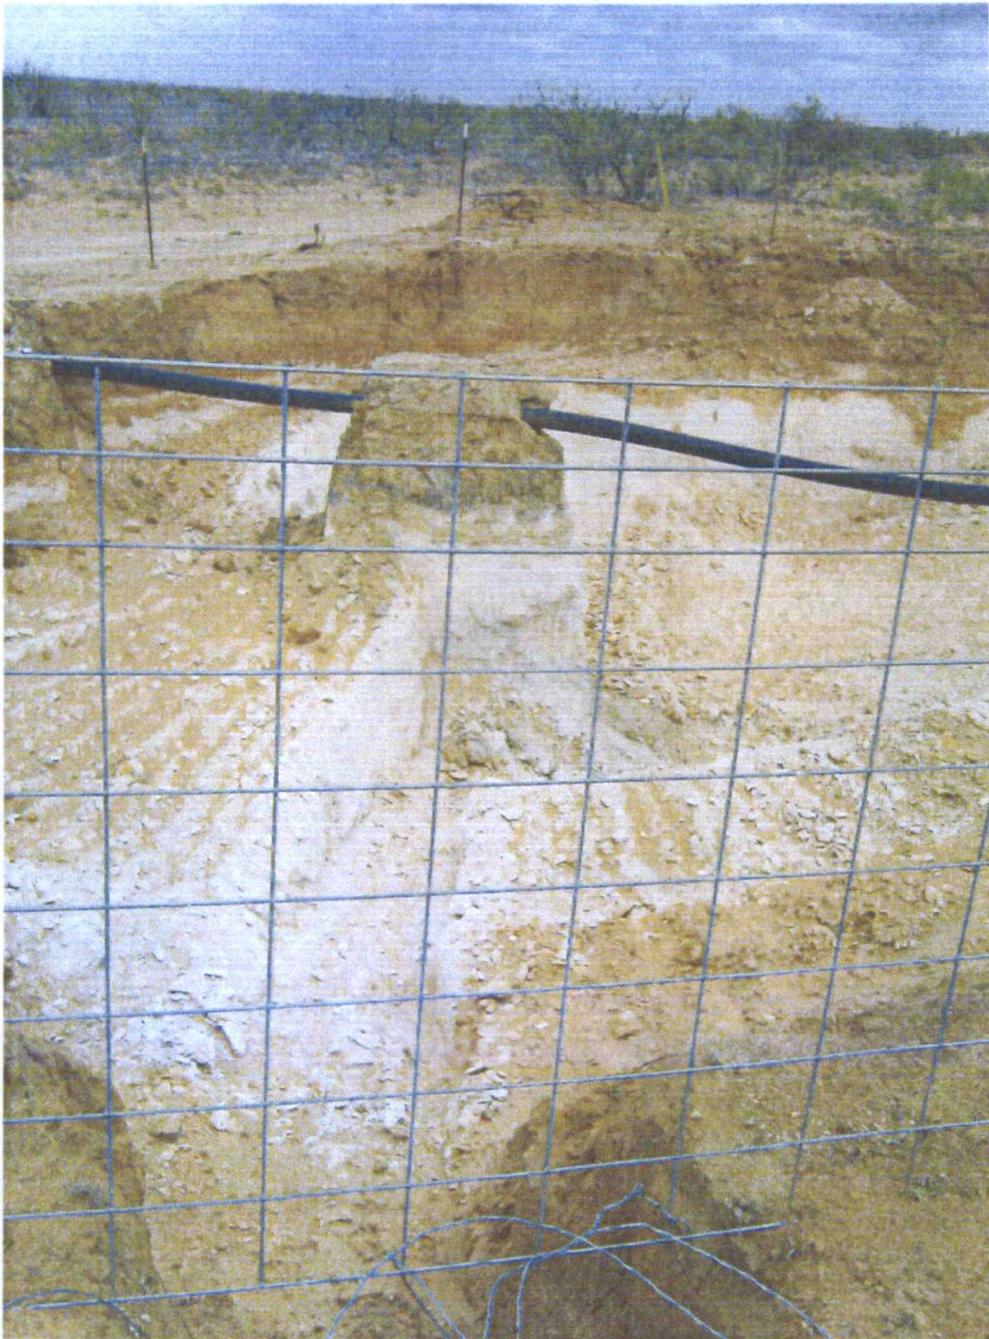
North Excavation Viewing West, March 12, 2012
