REMEDIATION SUMMARY & SITE CLOSURE REQUEST

**SOUTHERN UNION GAS SERVICES
TRUNK "O" #5**

**HISTORICAL RELEASE SITE
Lea County, New Mexico**

**Unit Letter "D" (NW/NW), Section 31, Township 23 South, Range 37 East
Latitude 32° 15.410' North, Longitude 103° 11.734' West
NMOCD Reference # 1RP-1826**

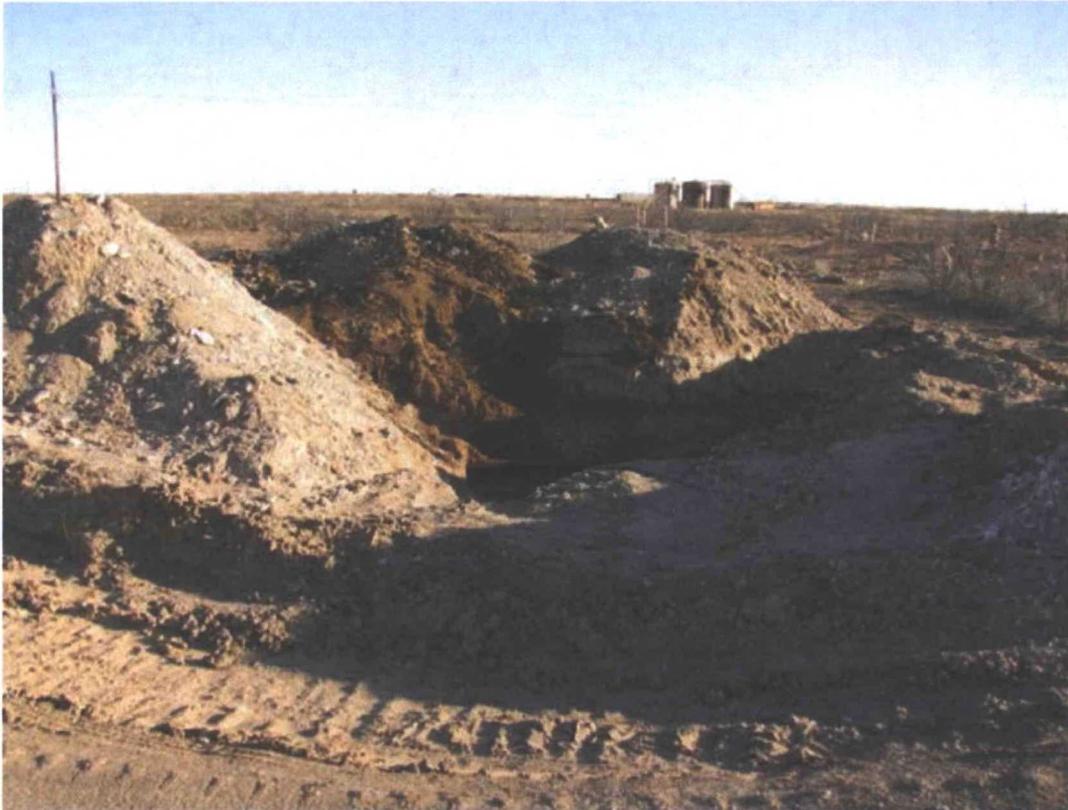
Photograph of the initial release at the Trunk "O" #5 Historical Release Site.

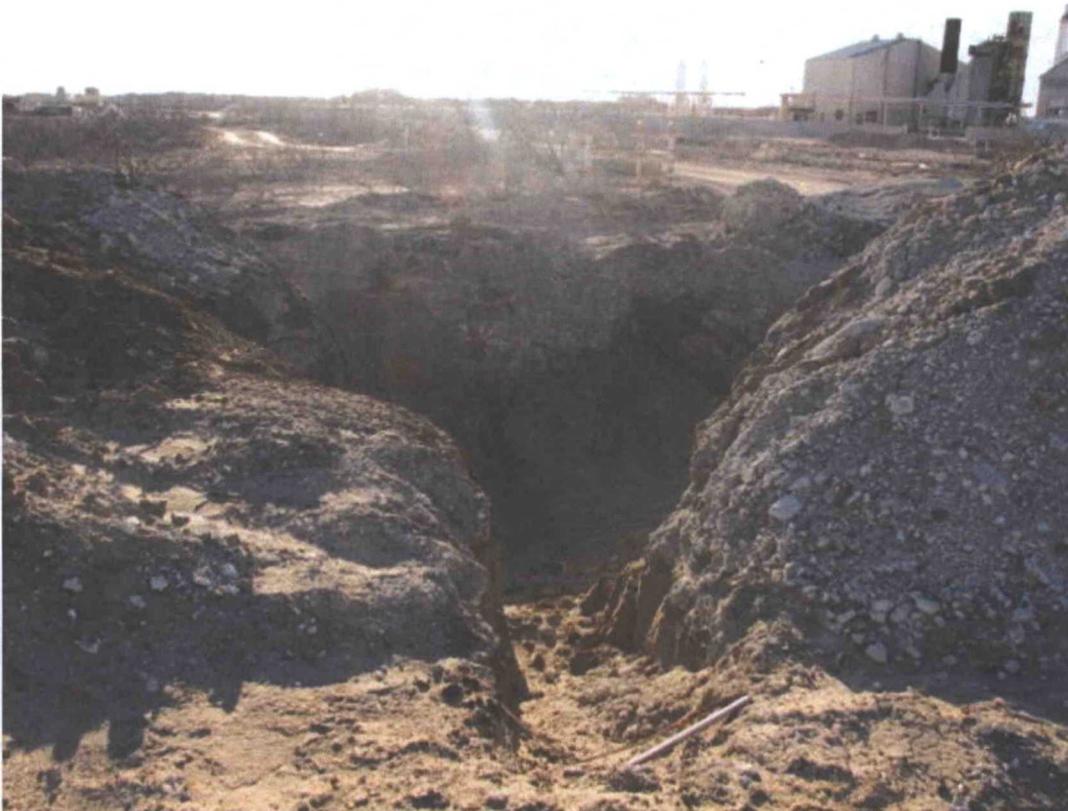
Photograph of previous excavation activities at the Trunk "O" #5 Historical Release Site.

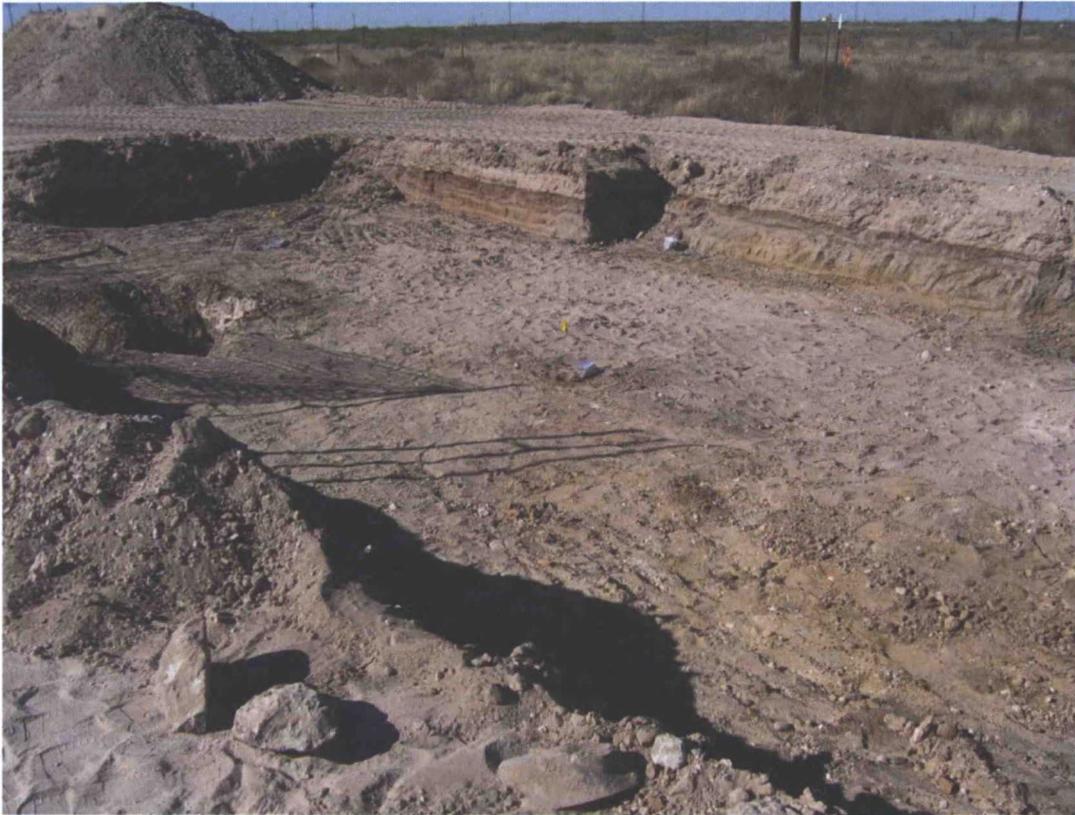
Photograph of recent excavation activities at the Trunk "O"#5 Historical Release Site.

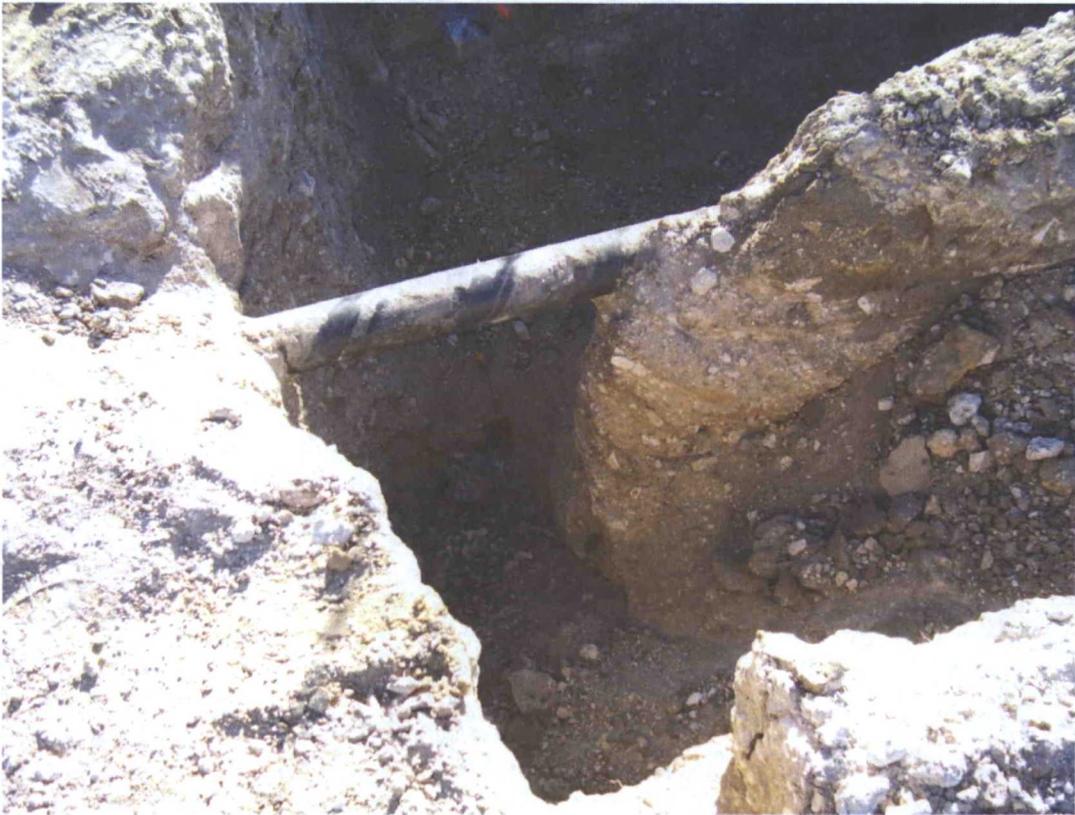
Photograph of recent excavation activities at the Trunk "O"#5 Historical Release Site.

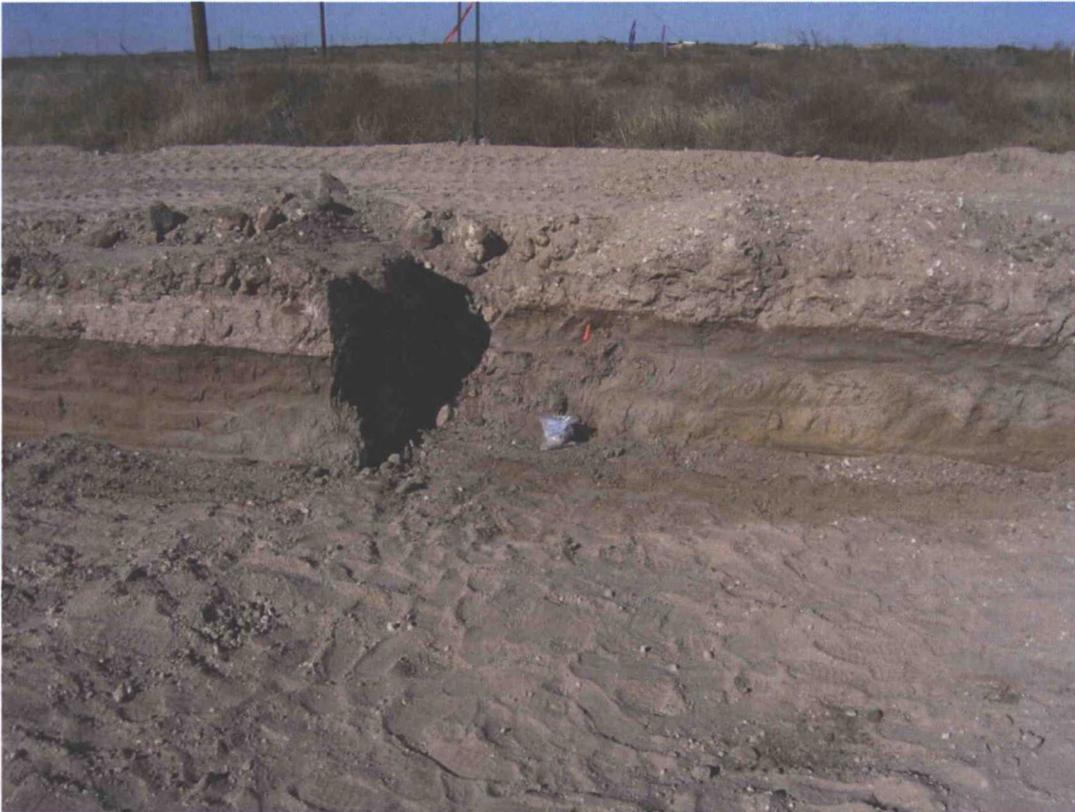
Photograph of recent excavation activities at the Trunk "O" #5 Historical Release Site.

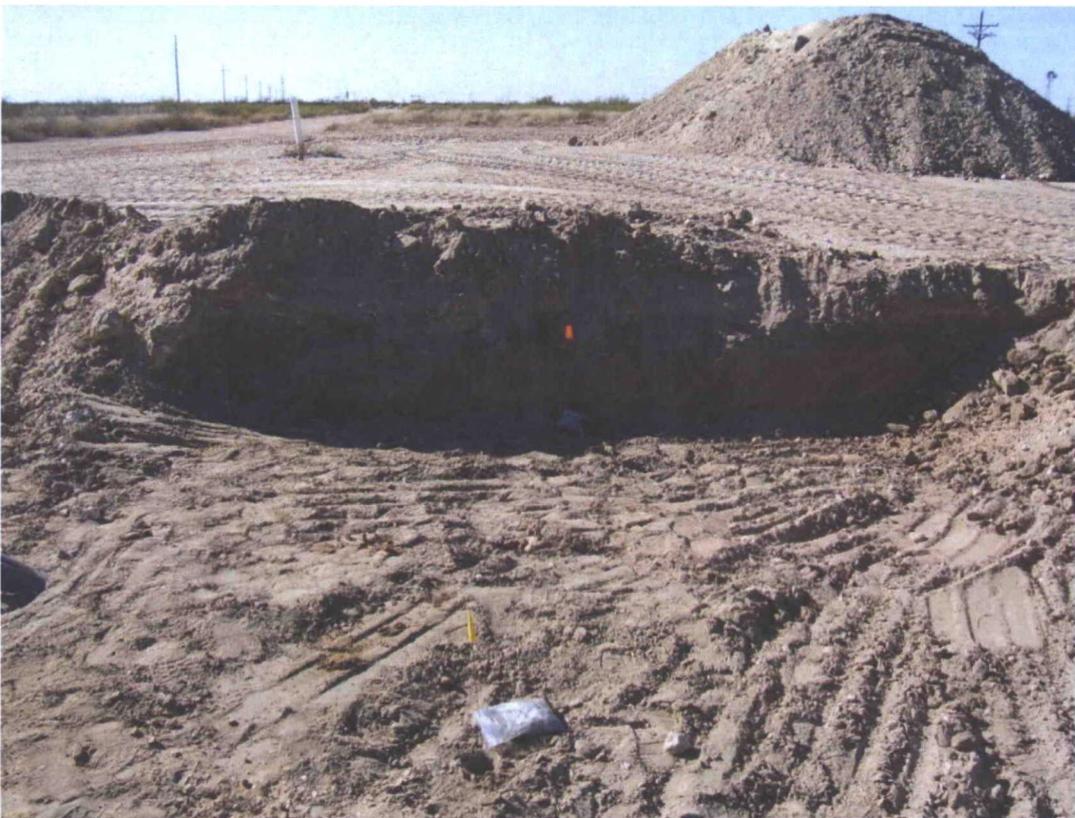
Photograph of recent excavation activities at the Trunk "O" #5 Historical Release Site.

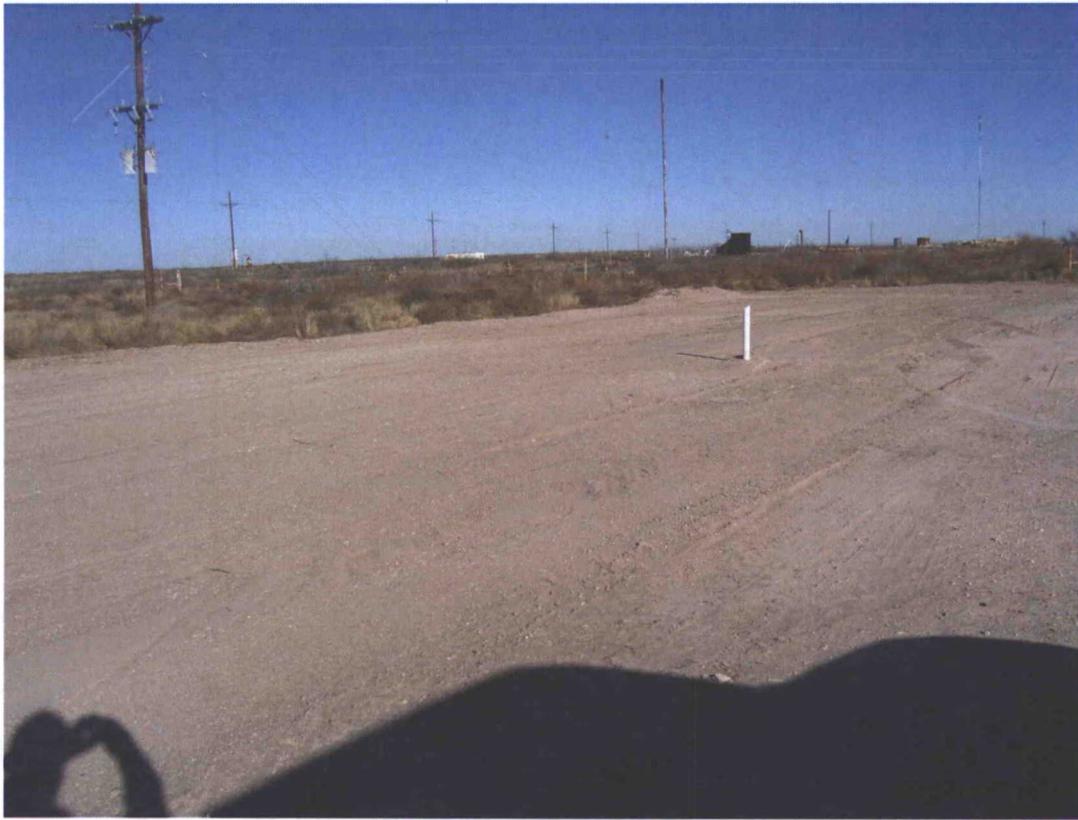
Photograph of the backfilled excavation at the Trunk "O" #5 Historical Release Site.

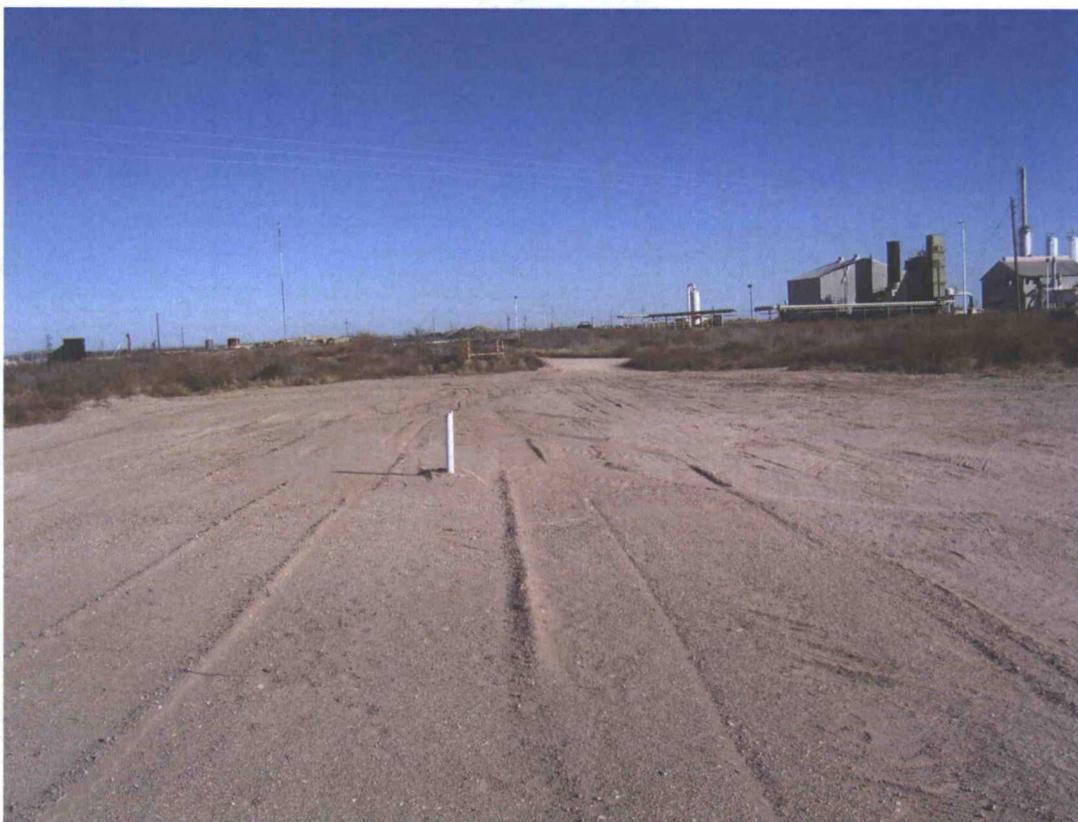
Photograph of the backfilled excavation at the Trunk "O" #5 Historical Release Site.
