**Release Notification and Corrective Action**

**Reference: 1RP-11-10-2648 Targa Eidson Ranch LC-61 #4**

**Executive Summary**  
**Targa Eidson Ranch LC-61 #4**  
**Remediation Project**  
**1RP-2648**

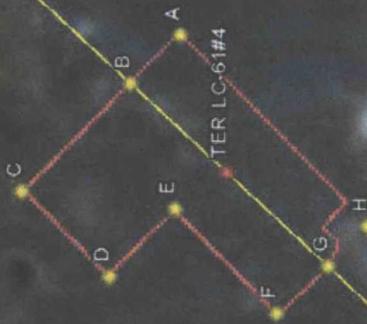
**Targa Eldson Ranch LC-61 #4**  
**SW/4 SW/4 UL/M SEC 26 - T16S - R35E**  
**GPS LAT & LON NAD27 (DECIMAL)**  
**N32.88567 / W103.433963**  
**Site dimensions**  
**A>B 16'**  
**B>C 36'**  
**C>D 25'**  
**D>E 14'**  
**E>F 34'**  
**F>G 16'**  
**G>H 29'**  
**H>A 39'**  
**Excavation depth approx. 15'D**
