# CLOSURE REPORT

**G-28-4 (REF. #130002)**

**UL-P (SE¼ OF THE SE¼) OF SECTION 21 T22S R36E**

**LEA COUNTY, NEW MEXICO**

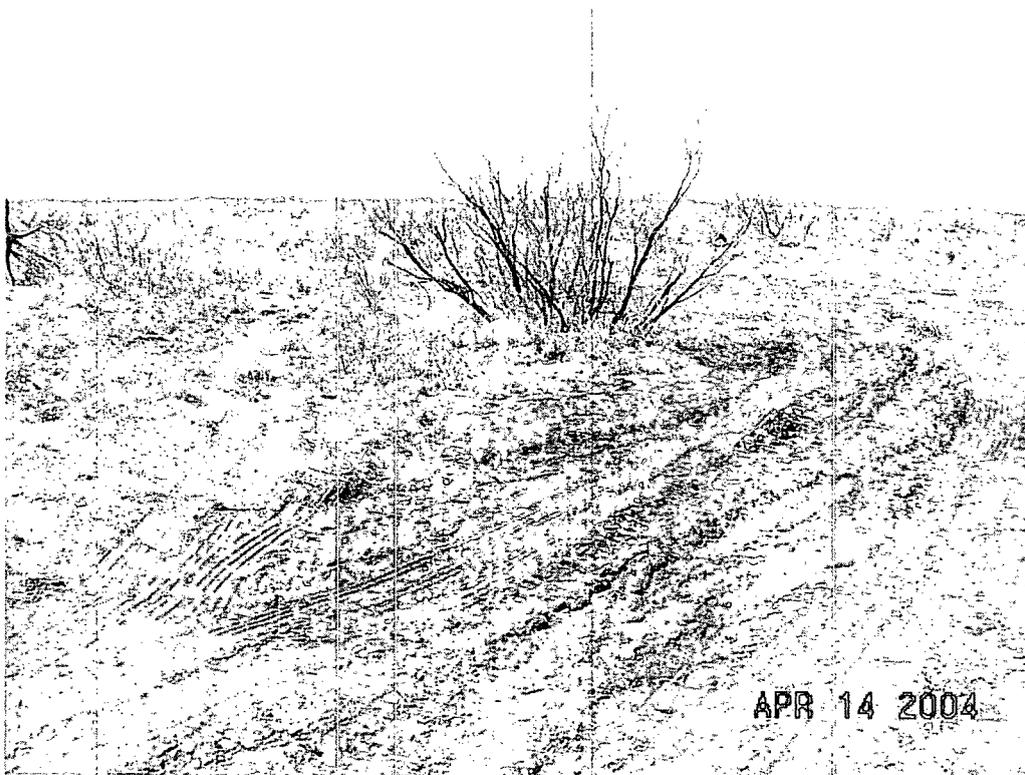
**Photograph #1:** Stained soil indicating release area, looking westerly.

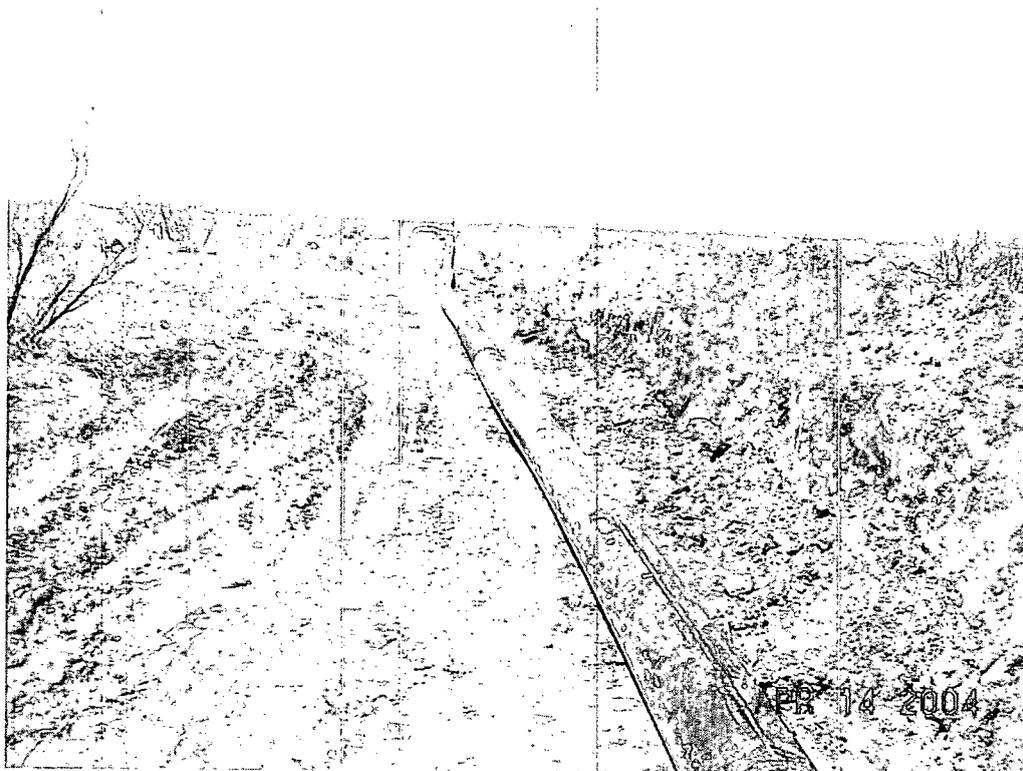
**Photograph #2:** New pipeline being installed, looking westerly.

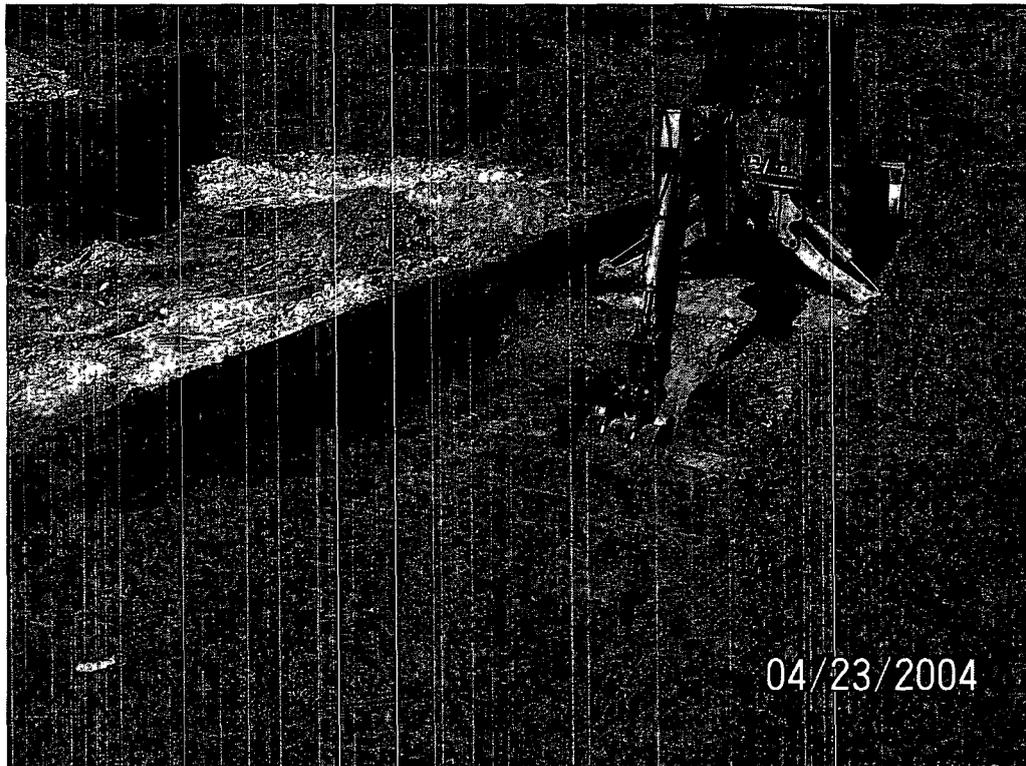
**Photograph #4:** Excavation and test trench, looking westerly.

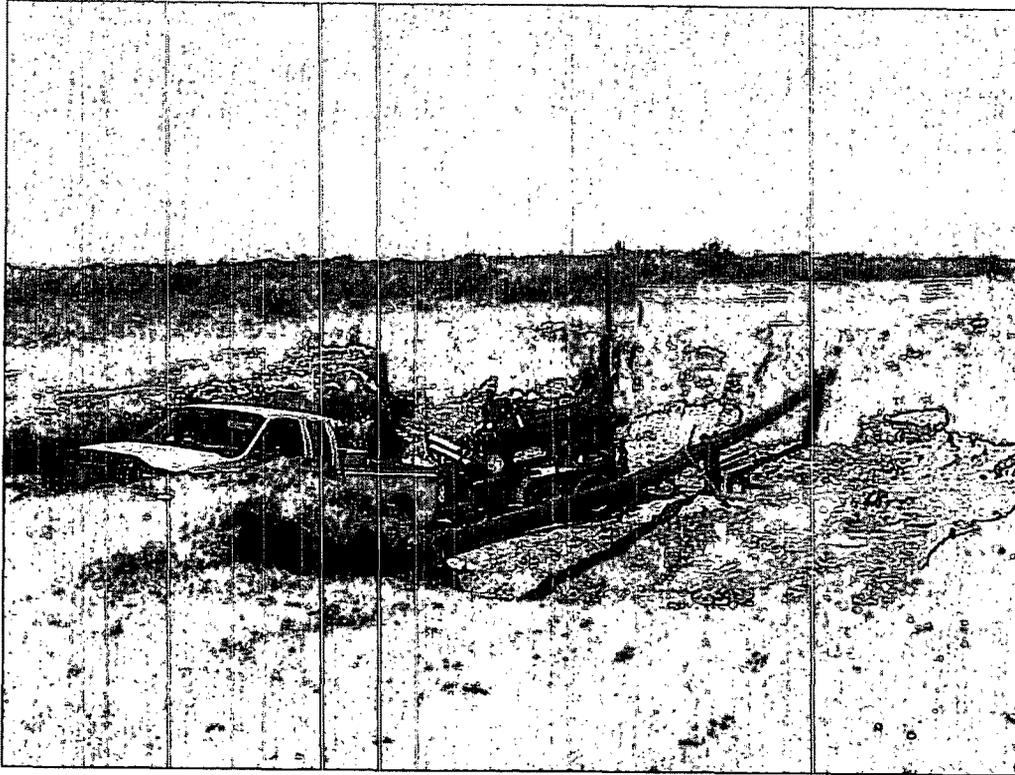
**Photograph #5:** Advancement of original soil boring, looking southwesterly across the excavation.

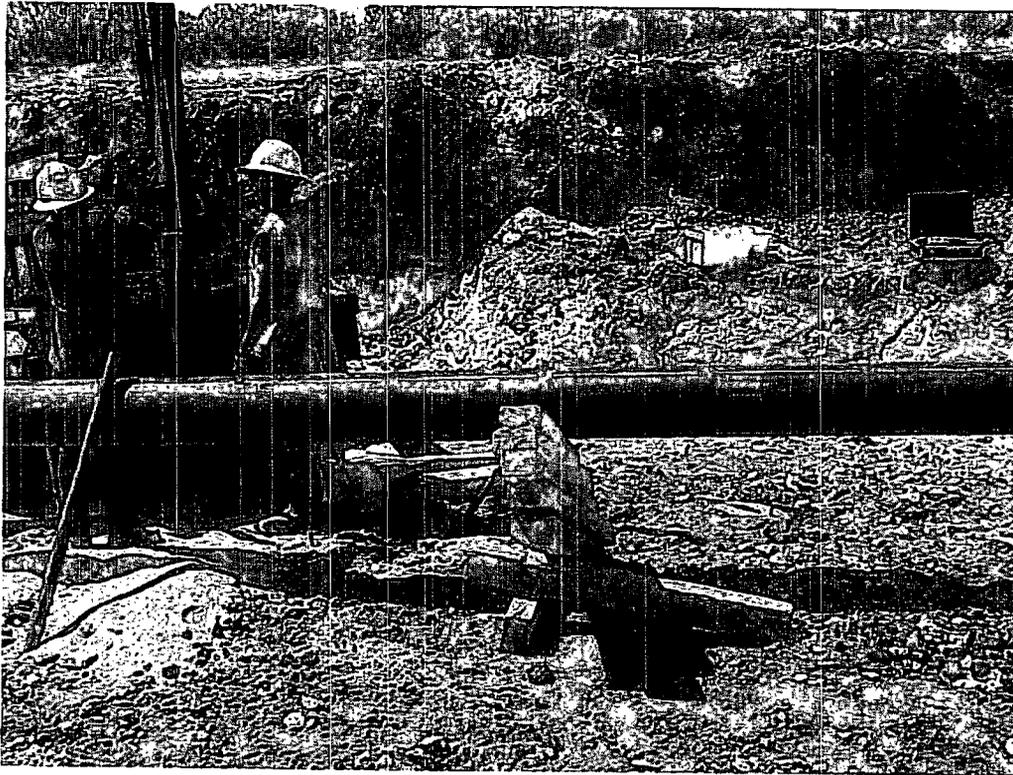
**Photograph #6:** Advancement of original soil boring, looking southerly.

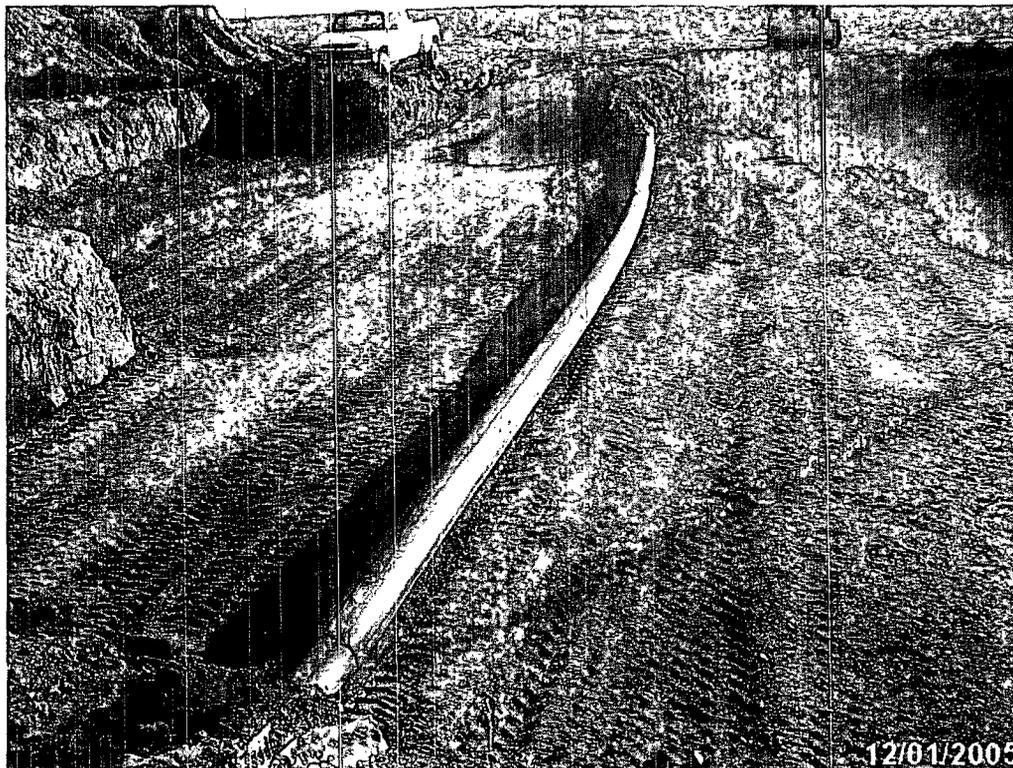
**Photograph #8:** Excavation after installation of clay barrier, looking easterly.

The excavated soil, ~1,450 yds<sup>3</sup>, was transported to the Environmental Plus, Inc. (EPI) land treatment facility located south of Eunice, New Mexico. To isolate the remaining contamination, a one-foot clay liner was installed in two 6-inch lifts in the excavation floor and compacted within 95% of its' Proctor Density. Upon verification of proper compaction of the clay liner by an independent engineering firm, approximately 1,200 yds<sup>3</sup> of clean soil purchased from the landowner was utilized to backfill the excavation.

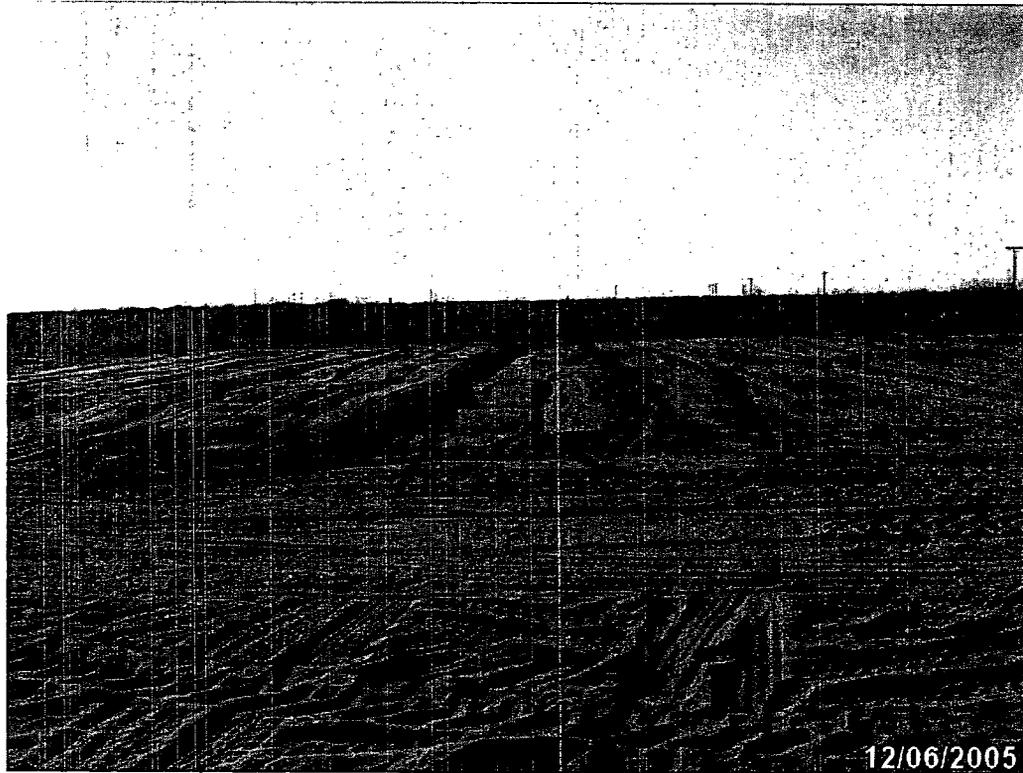
**Photograph #9:** Site graded and contoured, looking easterly.
