## **REMEDIATION SUMMARY & SITE CLOSURE REQUEST**

**SOUTHERN UNION GAS SERVICES**

**MF-16" BETTIS (IRP-837)**

**NMOCD Reference # IRP-837**

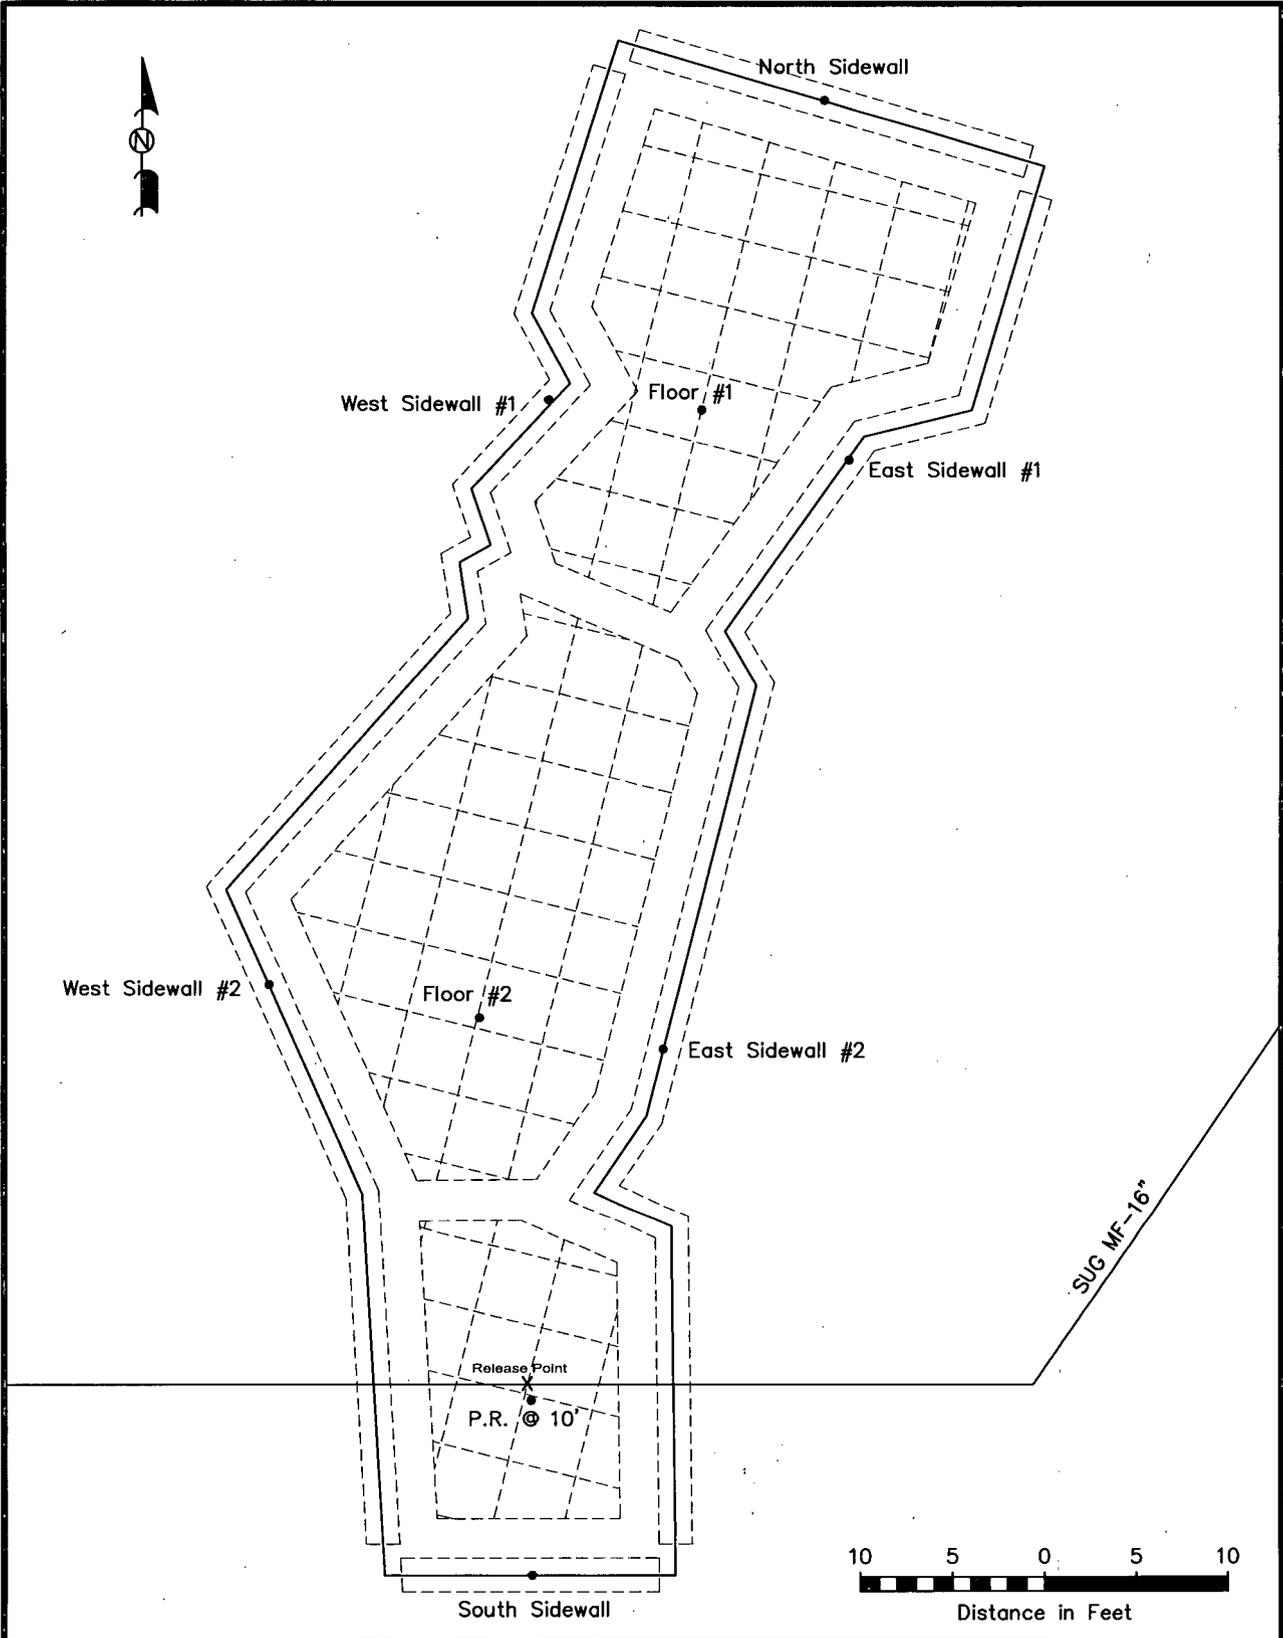
**Figure 2**  
**Site & Sample Location Map**  
**Southern Union Gas Services**  
**MF-16" Bettis (RP-837)**  
**Lea County, NM**

On April 26, 2006, eight (8) soil samples (P.R. @ 10', WW-Comp., S-Comp., A-Comp., B-Comp., NW-Comp., SW-Comp. and EW-Comp.) were collected from the excavation floor and sidewalls and submitted to the laboratory for analysis of TPH concentrations. Soil samples WW-Comp., S-Comp., A-Comp., B-Comp., NW-Comp., SW-Comp. and EW-Comp. were composite samples. Analytical results indicated TPH concentrations were less than the laboratory MDL in each of the soil samples submitted, with the exception of soil sample S-Comp., which had a concentration of 85.8 mg/Kg. Soil sample P.R. @ 10' was also analyzed for BTEX constituent concentrations, which were less than the appropriate laboratory MDL. Soil samples were not analyzed for chloride concentrations.

Environmental records indicated the excavation was backfilled with locally purchased material on or around May 3, 2006. Prior to backfilling the final dimensions of the excavation were approximately one hundred and five feet (105') in length, twenty feet (20') to thirty feet (30') in width, and ranged in depth from approximately four feet (4') to ten feet (10').

On December 5, 2012, Basin responded to the MF-16" Bettis Historical Release Site in an effort to determine if soil containing BTEX, TPH and chloride concentrations above NMOCD regulatory standards remained in-situ and to collect confirmation soil samples. A hand auger was utilized to locate native soil representing the former excavation floor and sidewalls. Eight (8) soil samples (North Sidewall, South Sidewall, East Sidewall #1, East Sidewall #2, West Sidewall #1, West Sidewall #2, Floor #1 and Floor #2) were collected from the location and submitted to the

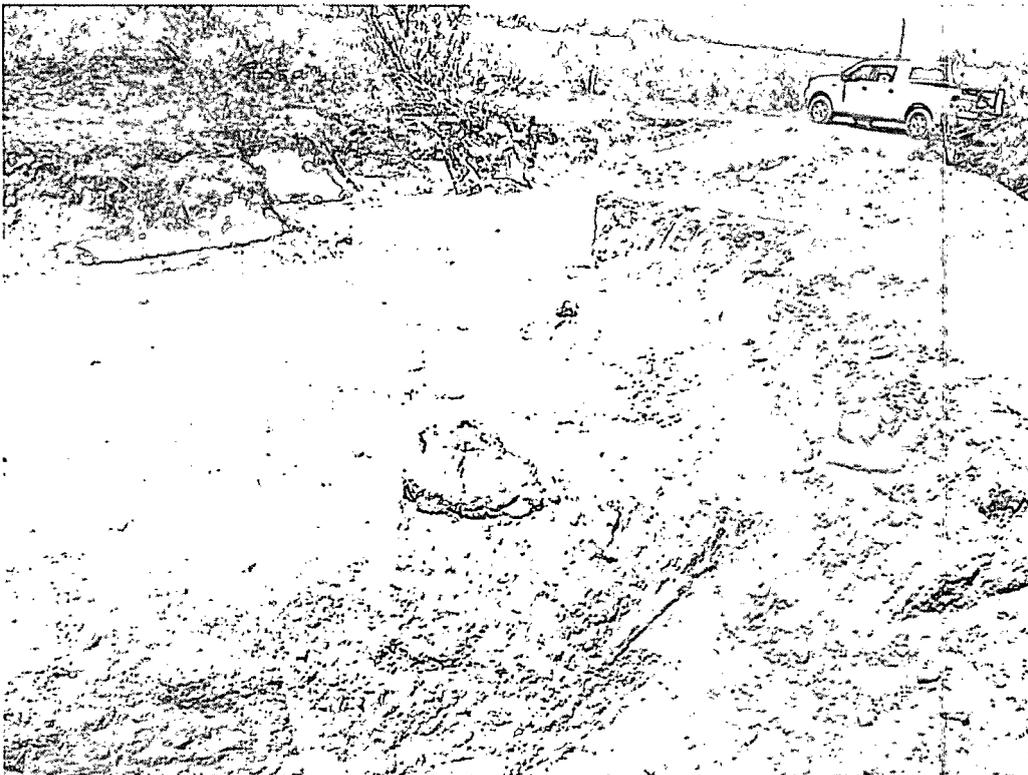
Photograph of the 2006 excavation at the MF-16" Bettis Historical Release Site.

Between April 12, 2006, and May 5, 2006, remediation activities were conducted at the MF-16" Bettis Historical Release Site. Environmental records indicate at least five hundred and sixty-four cubic yards (564 yd<sup>3</sup>) of impacted material was excavated from the location and transported to Southern Union Gas Services' Landfarm (Discharge Permit # NM-02-0019) for treatment.

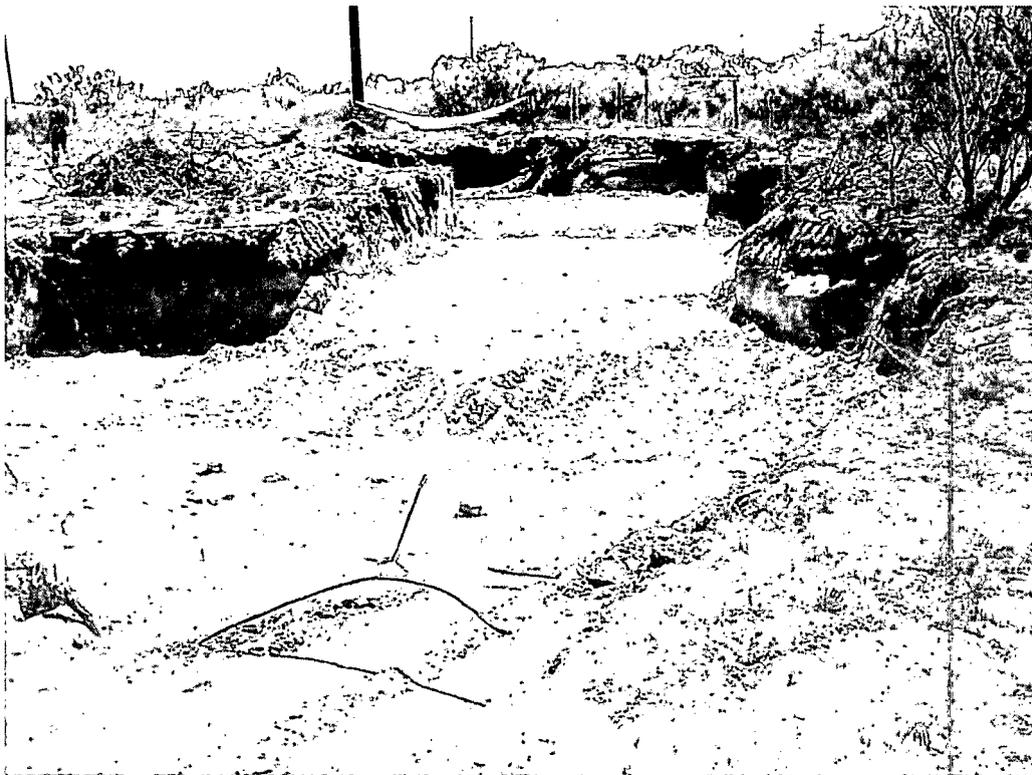
Photograph of the 2006 excavation at the MF-16" Bettis Historical Release Site.

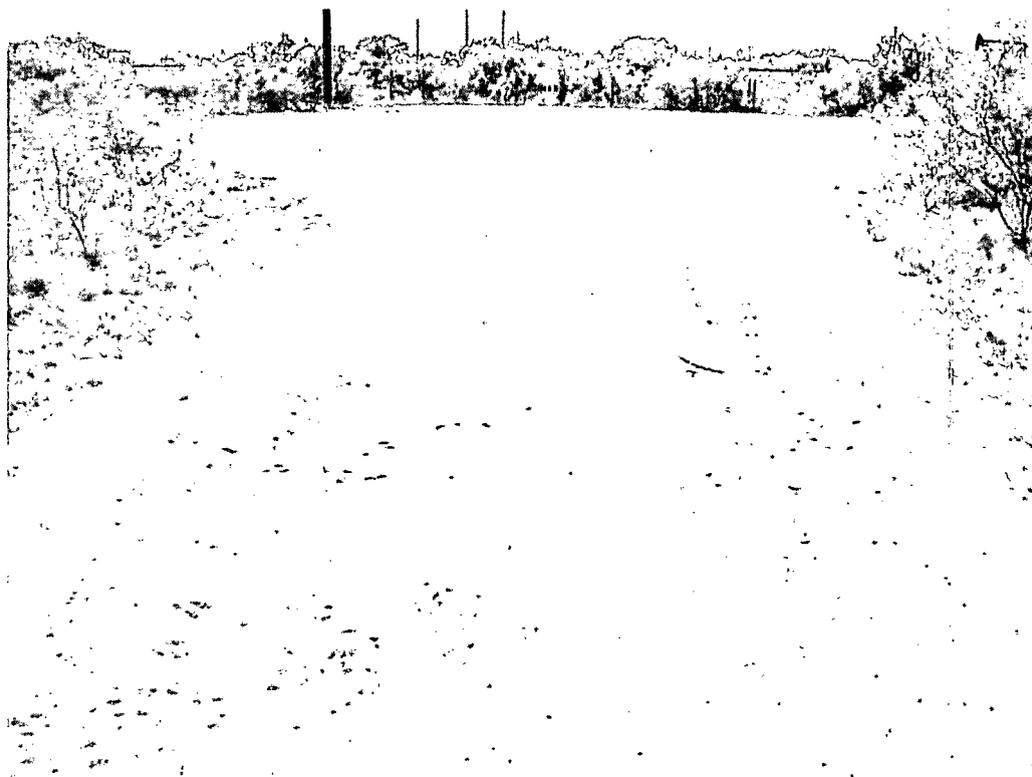
Photograph of the remediated area at the MF-16" Bettis Historical Release Site.

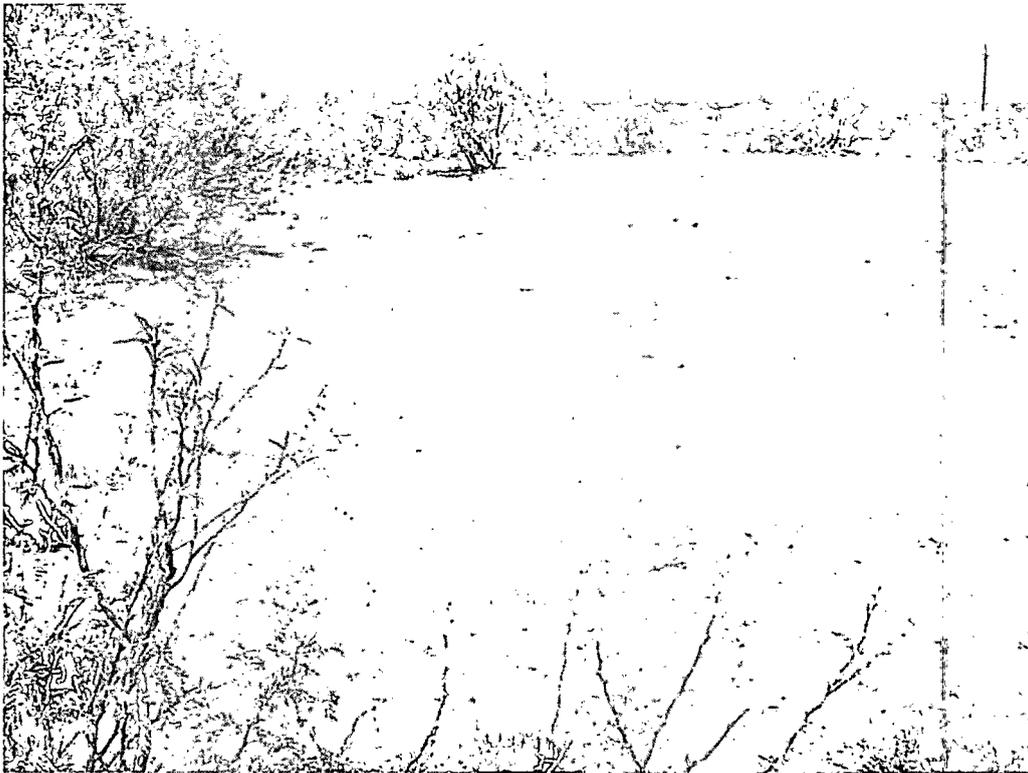
Photograph of the remediated area at the MF-16" Bettis Historical Release Site.

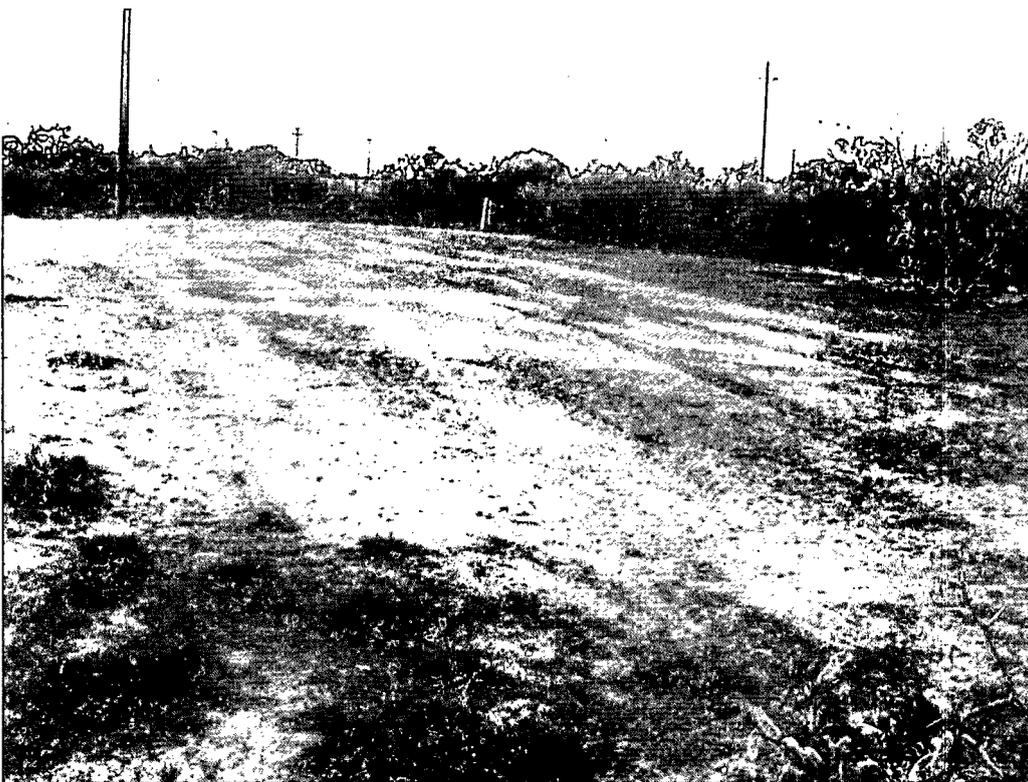
Photograph of the remediated area at the MF-16" Bettis Historical Release Site.

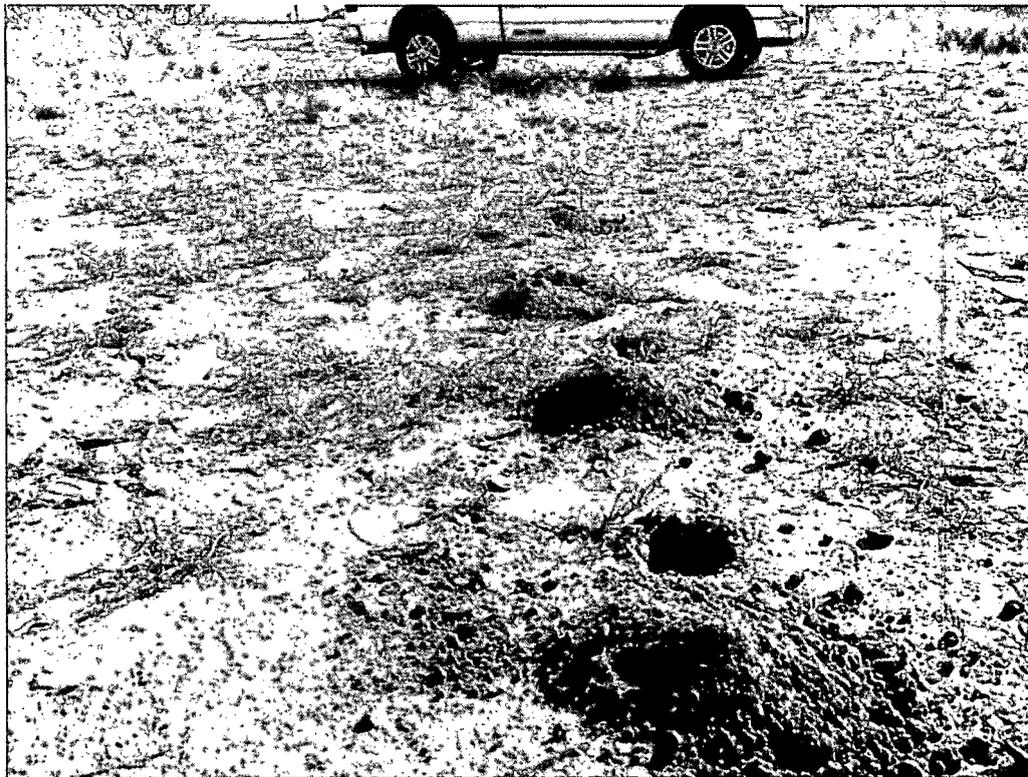
Photograph of collection of confirmation soil samples at the MF-16" Bettis Historical Release Site.
