Release Notification and Corrective Action

REMEDIATION SUMMARY & SITE CLOSURE REQUEST

**SOUTHERN UNION GAS SERVICES
TRUNK "M" HISTORICAL
Lea County, New Mexico
Unit Letter "E" (SW/NW), Section 30, Township 22 South, Range 37 East
Latitude 32° 21' 57.49' North, Longitude 103° 12' 36.612' West
NMOCD Reference #1RP-08-11-2727**

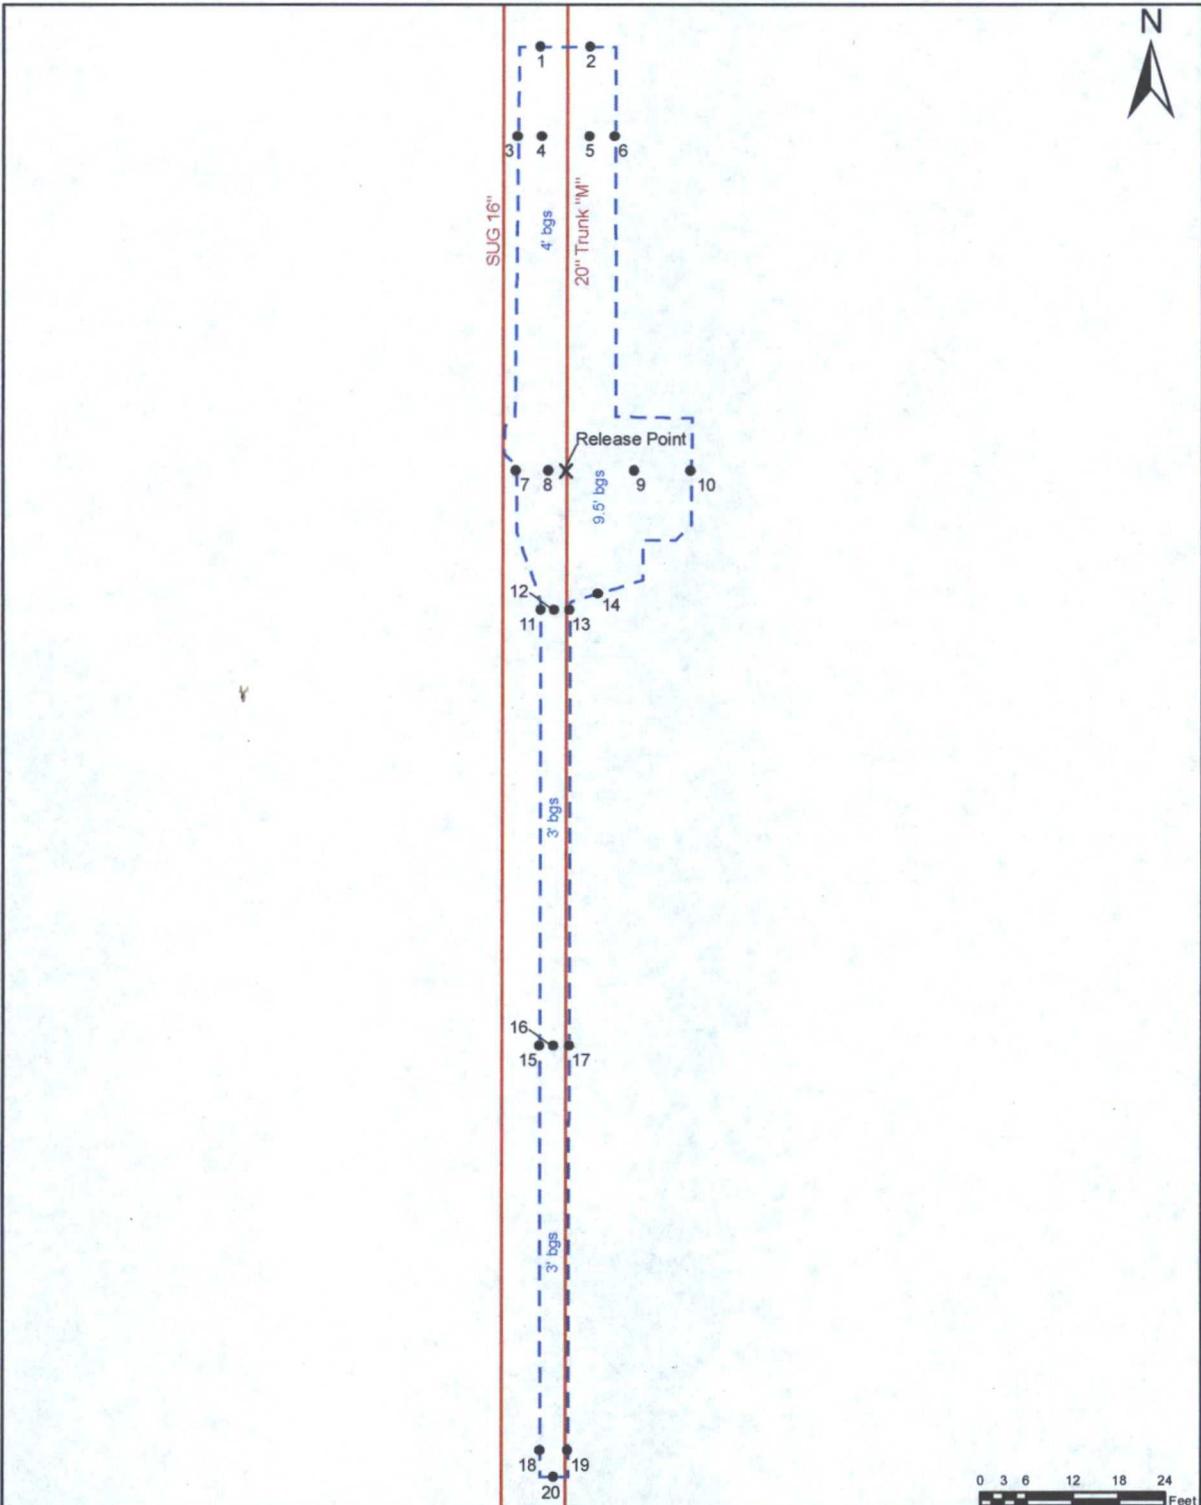
- - - Excavation Extent
- Pipeline
- Sample Location

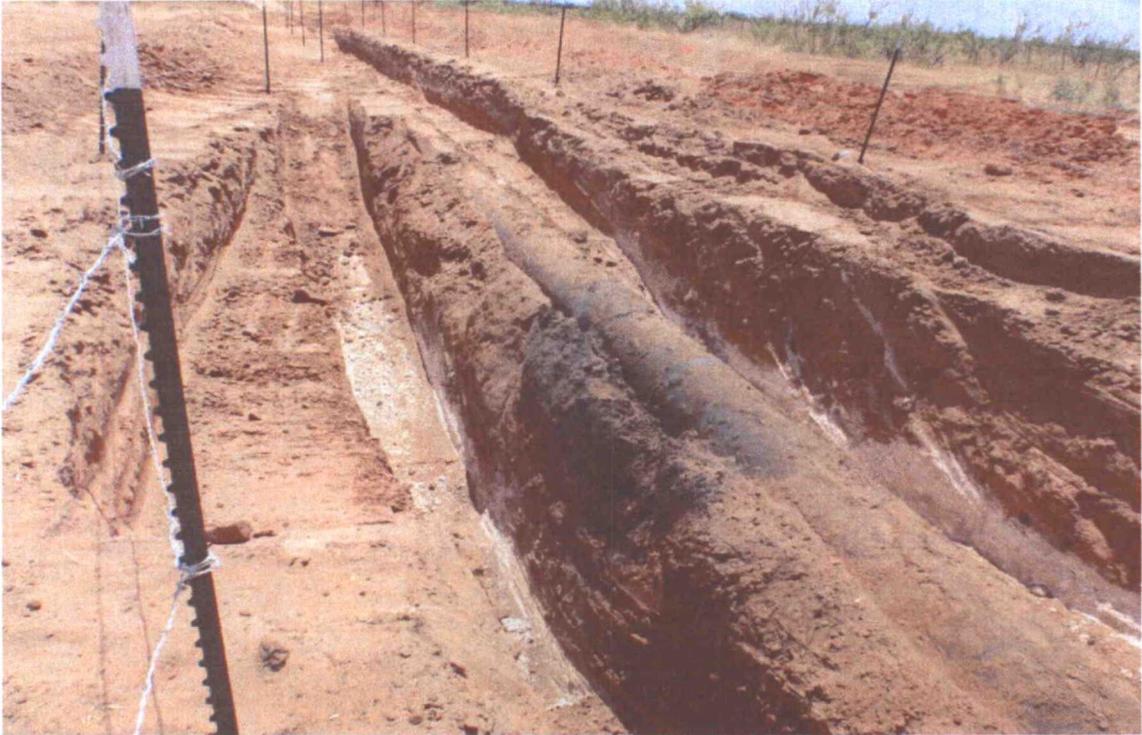
Trunk "M" Historical - Release Site

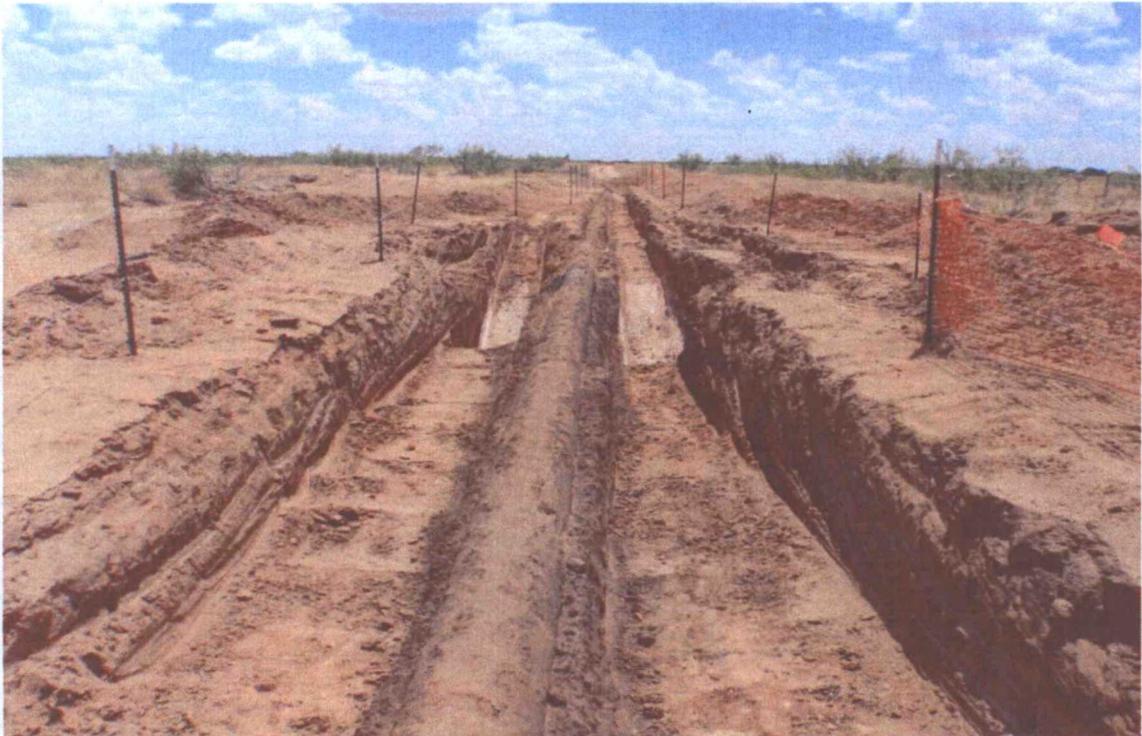
Trunk "M" Historical - Excavation (Looking South)

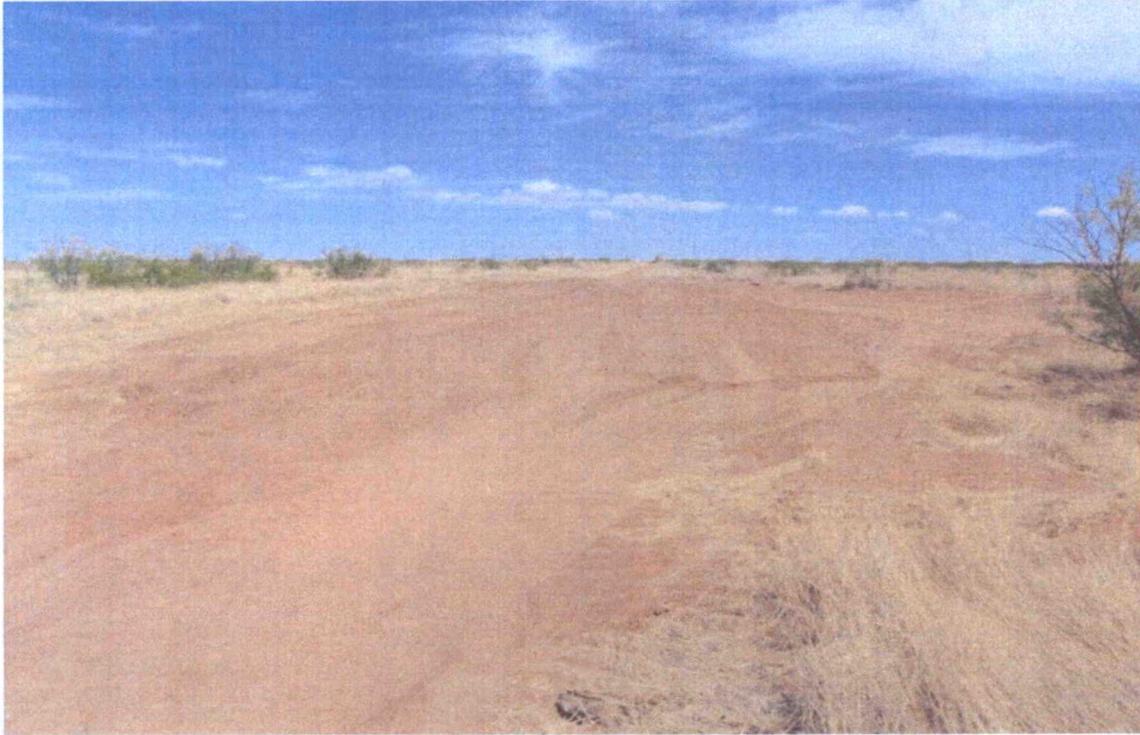
Trunk "M" Historical - Excavation (Following Backfill)
