# **Closure Compliance Report**

**Max Friess # 1  
T17S, R31E, Section 30, UL-B  
Eddy County, New Mexico**

**January 24, 2007**

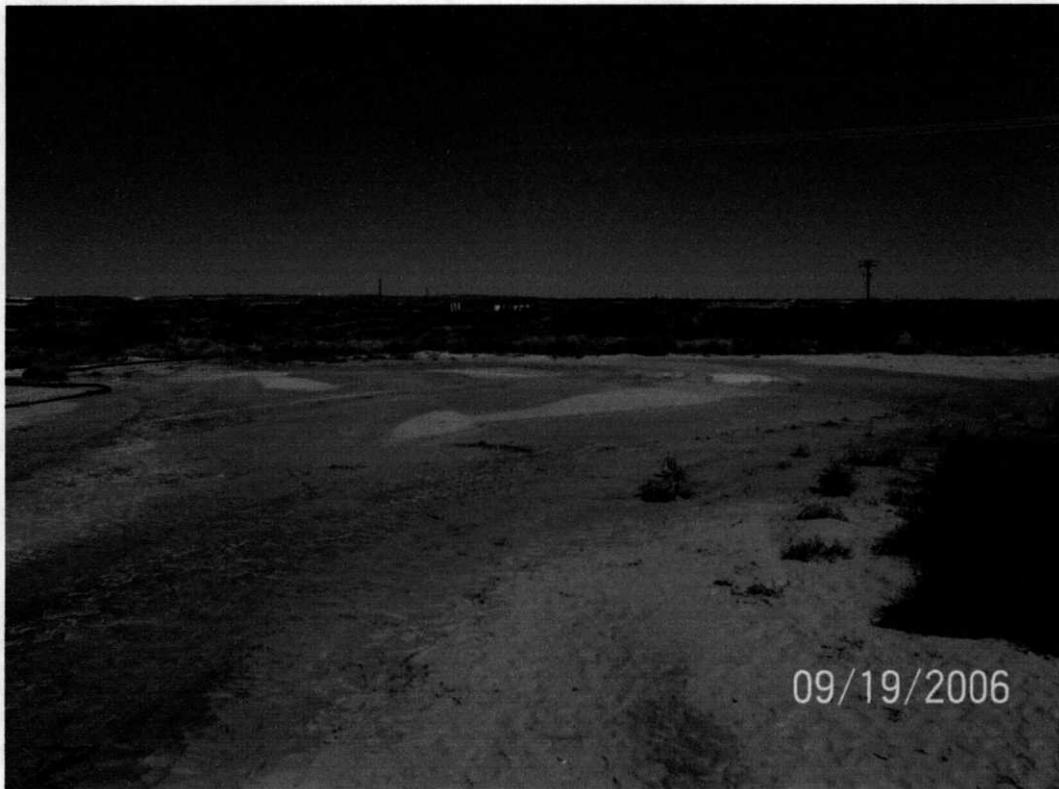
**Figure 3. Fren # 23 well location**

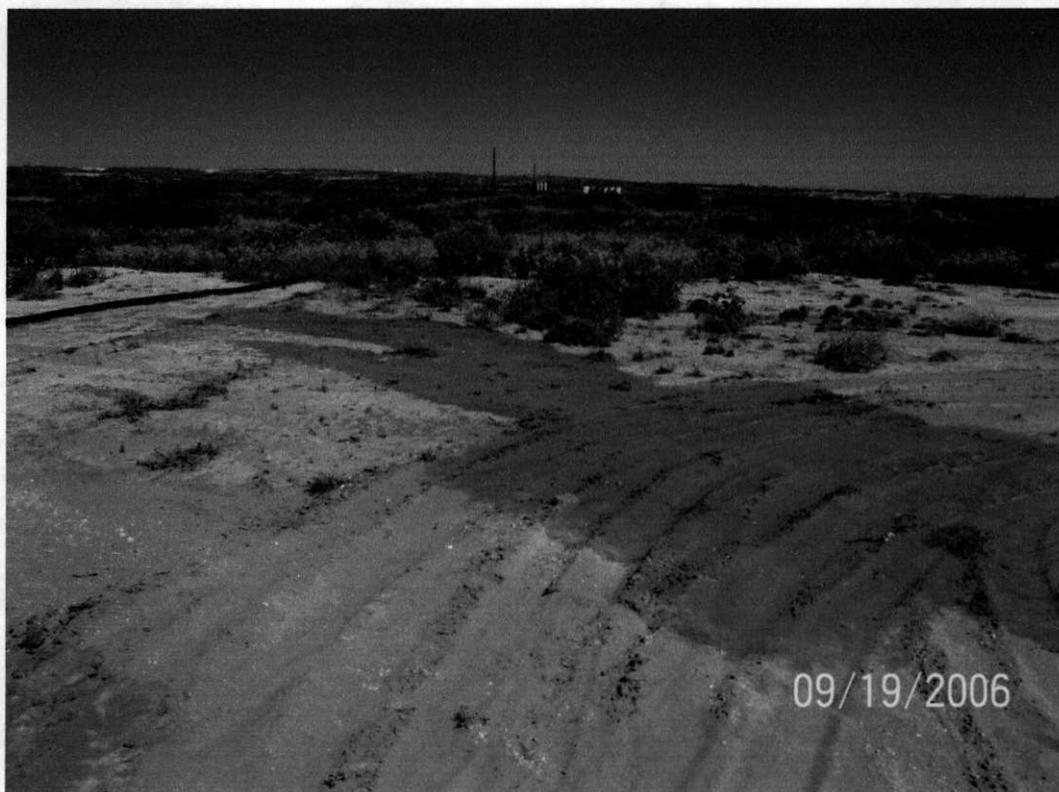
**Figure 4. End of release**
