CLOSURE PROPOSAL

WILL 7A FEE #1 DRILLING PIT

REF: 160025

EDDY COUNTY, NEW MEXICO

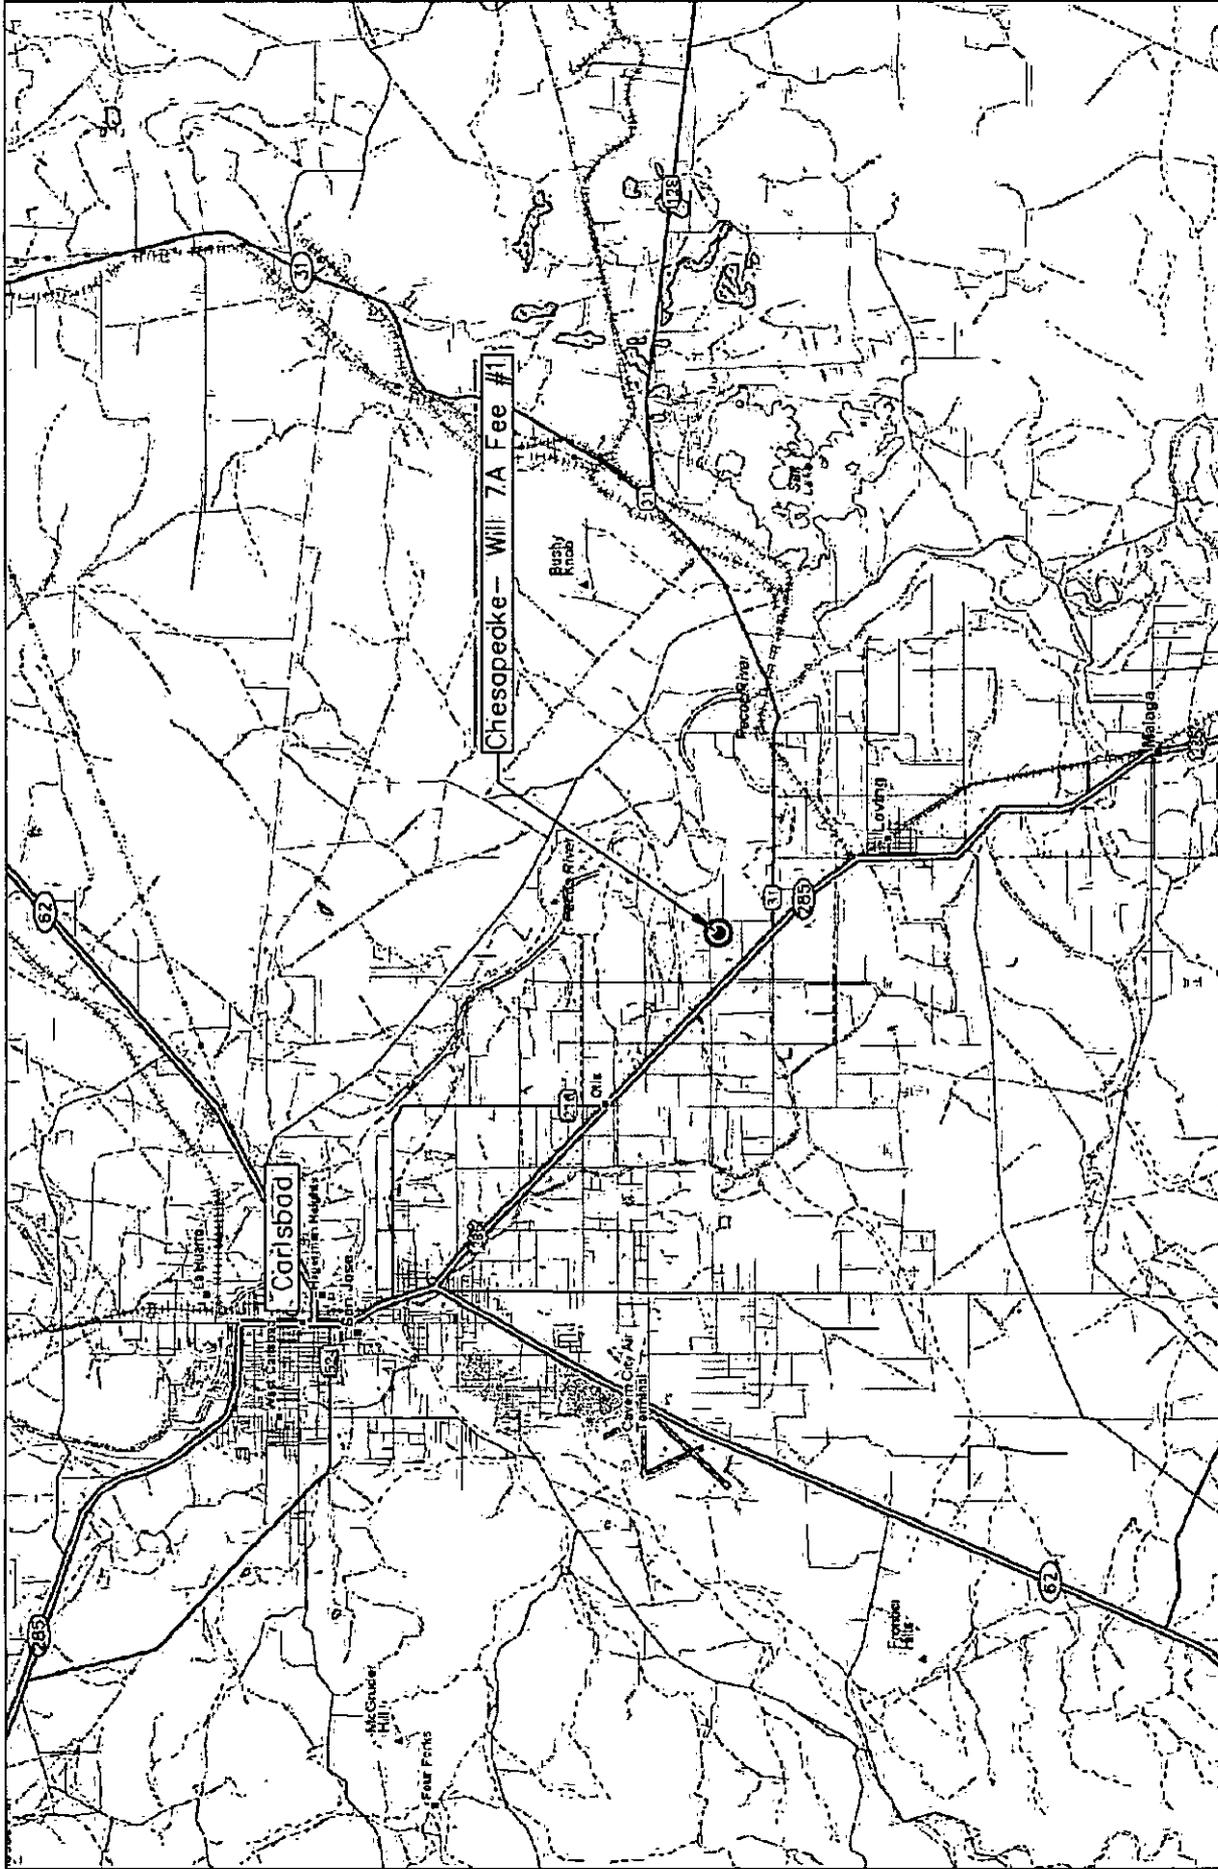
Figure 1
Area Map
Chesapeake
Will 7A Fee #1

This release site is located in Unit Letter A, (NE¹/₄ of the NE¹/₄), Section 7, T23S, R28E, N32° 19' 30.76" and W104° 07' 16.97". The site is approximately 9-miles southeast of Carlsbad, New Mexico on property owned by Mr. John Brantley (reference *Figures 1 through 3*).

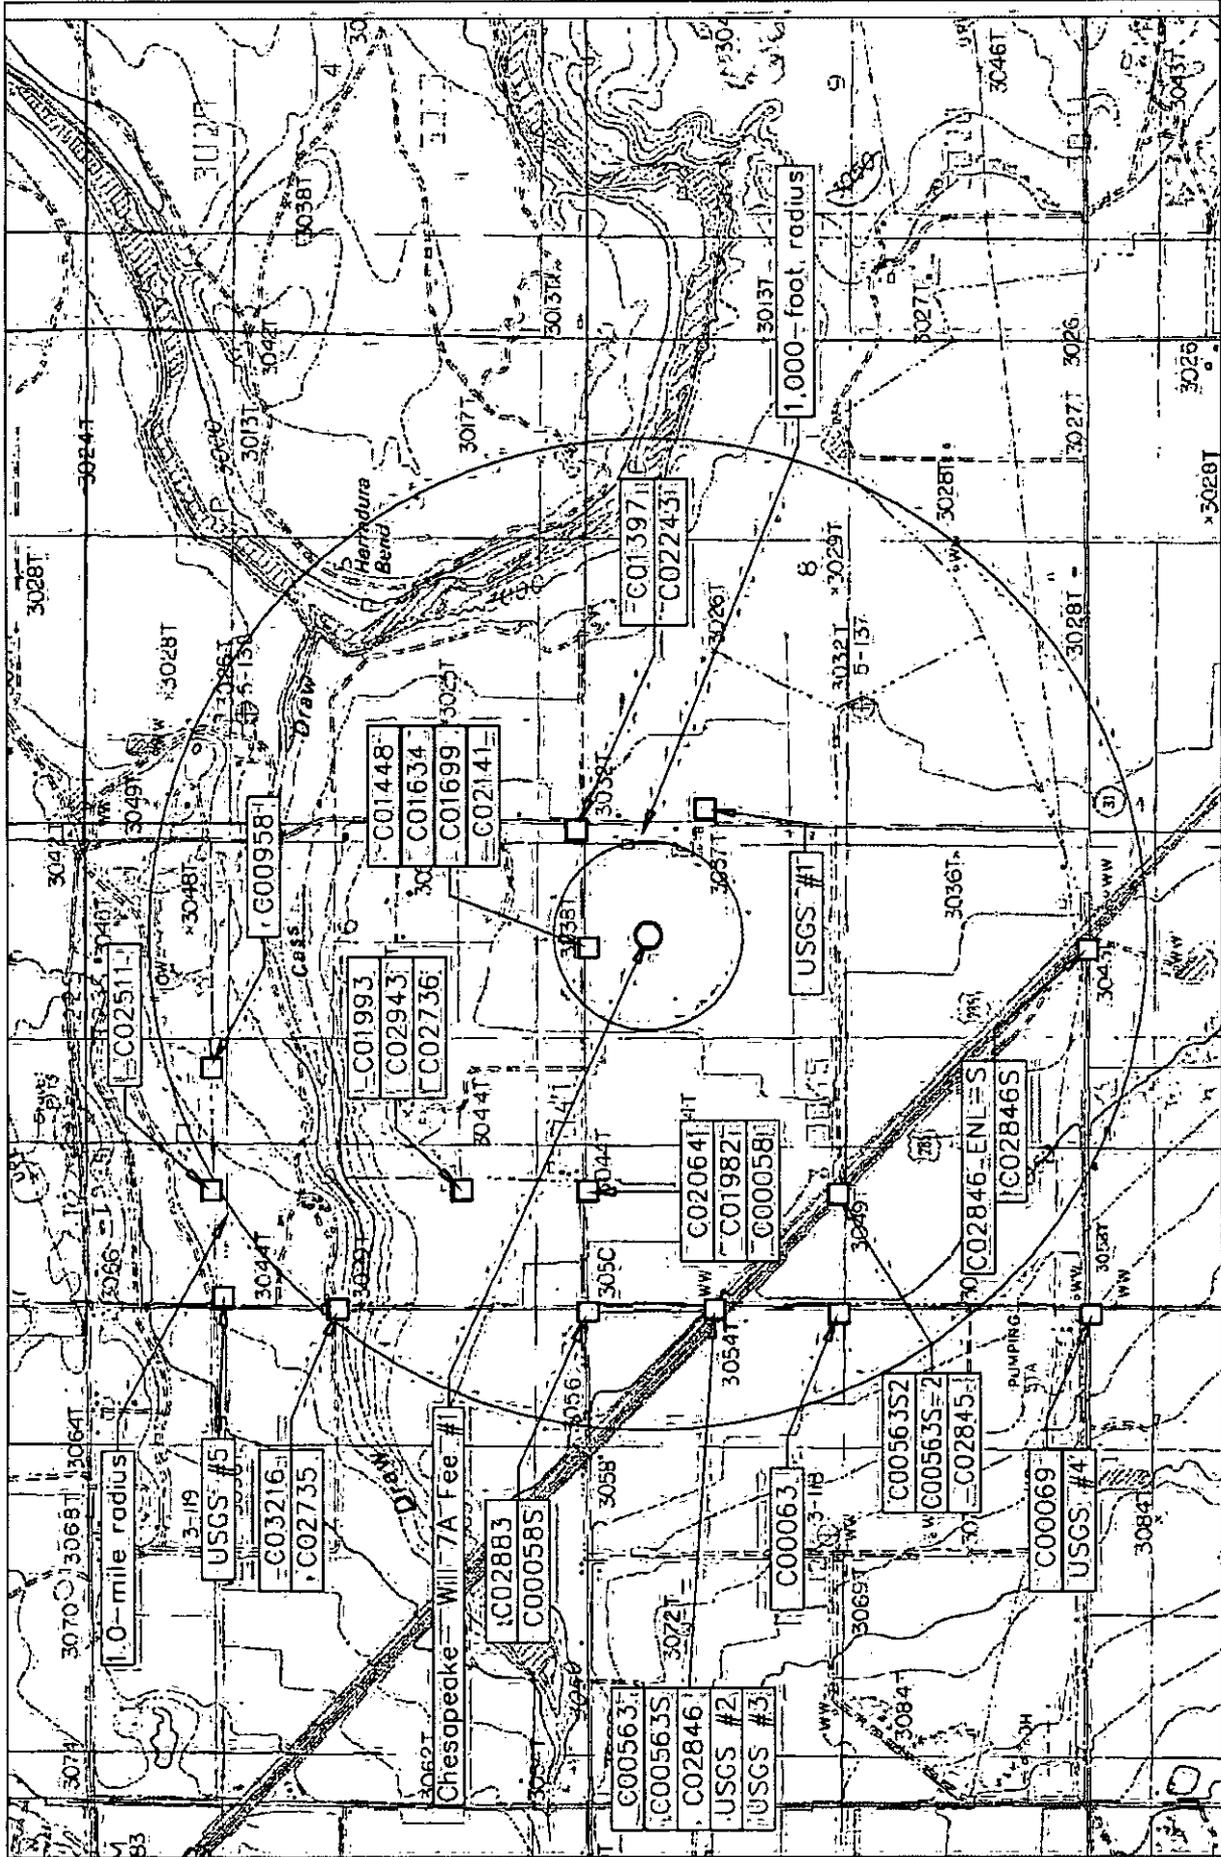
Figure 2
 Site and Well Location Map
 Chesapeake
 Will 7A Fee #1

There are four water supply wells (C 01448, C 01634, C 01699 and C 02141) located within a 1,000 foot radius of the release site.

Well locations shown on Figure 2

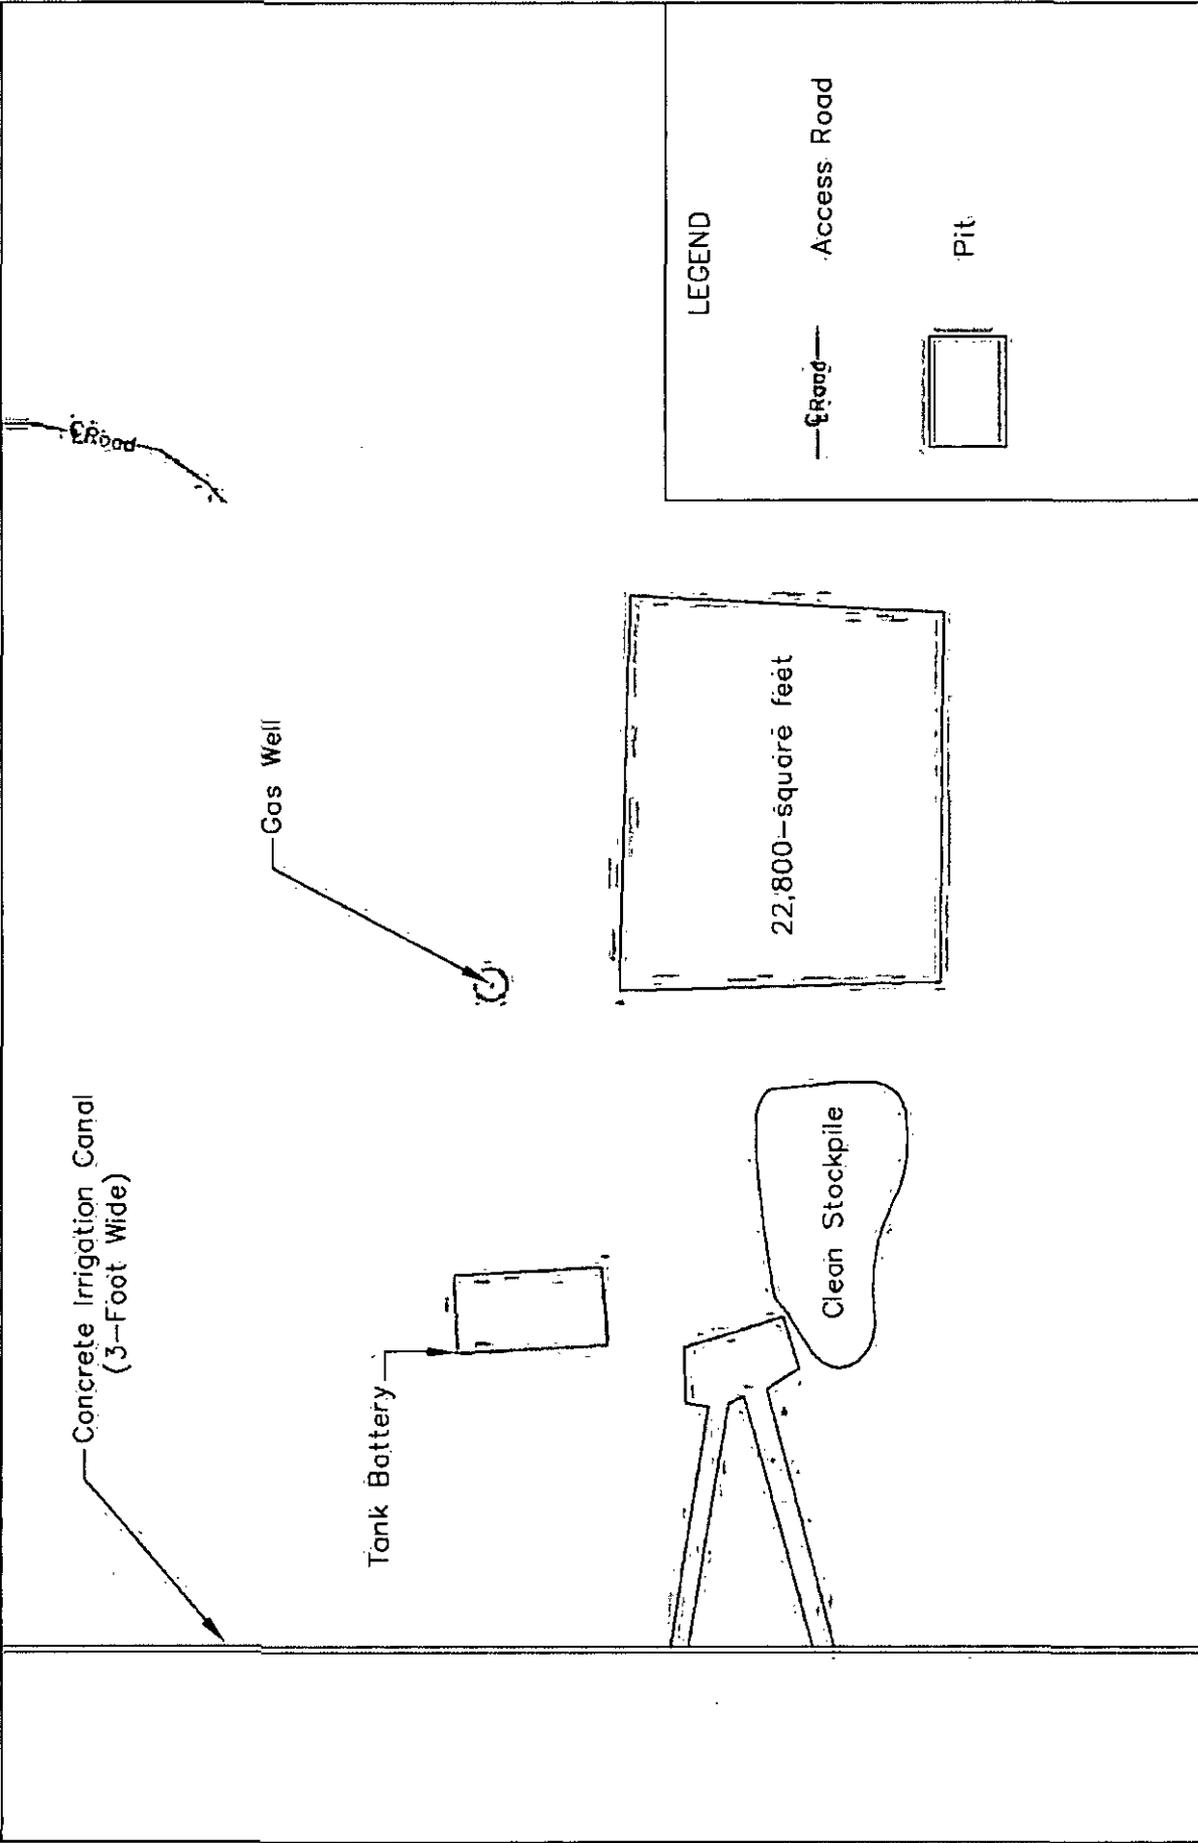
On August 19, 2005, Chesapeake Operating, Inc. retained Environmental Plus, Inc. (EPI) to perform site delineation, remediation and closure of the Will 7A Fee #1 drilling pit. This site is located approximately 9.0 miles southeast of Carlsbad, Eddy County, New Mexico (reference *Figure 1*). EPI performed GPS surveying, photography and characterization of the site on August 19, 2005. Form C-103 was submitted to the New Mexico Oil Conservation Division (NMOCD) on August 31, 2005 documenting the site and proposed operations. The drilling pit entailed an area of approximately 22,800 square feet (ft²) to a depth of 8-feet below ground surface (bgs) (reference *Figure 3*).

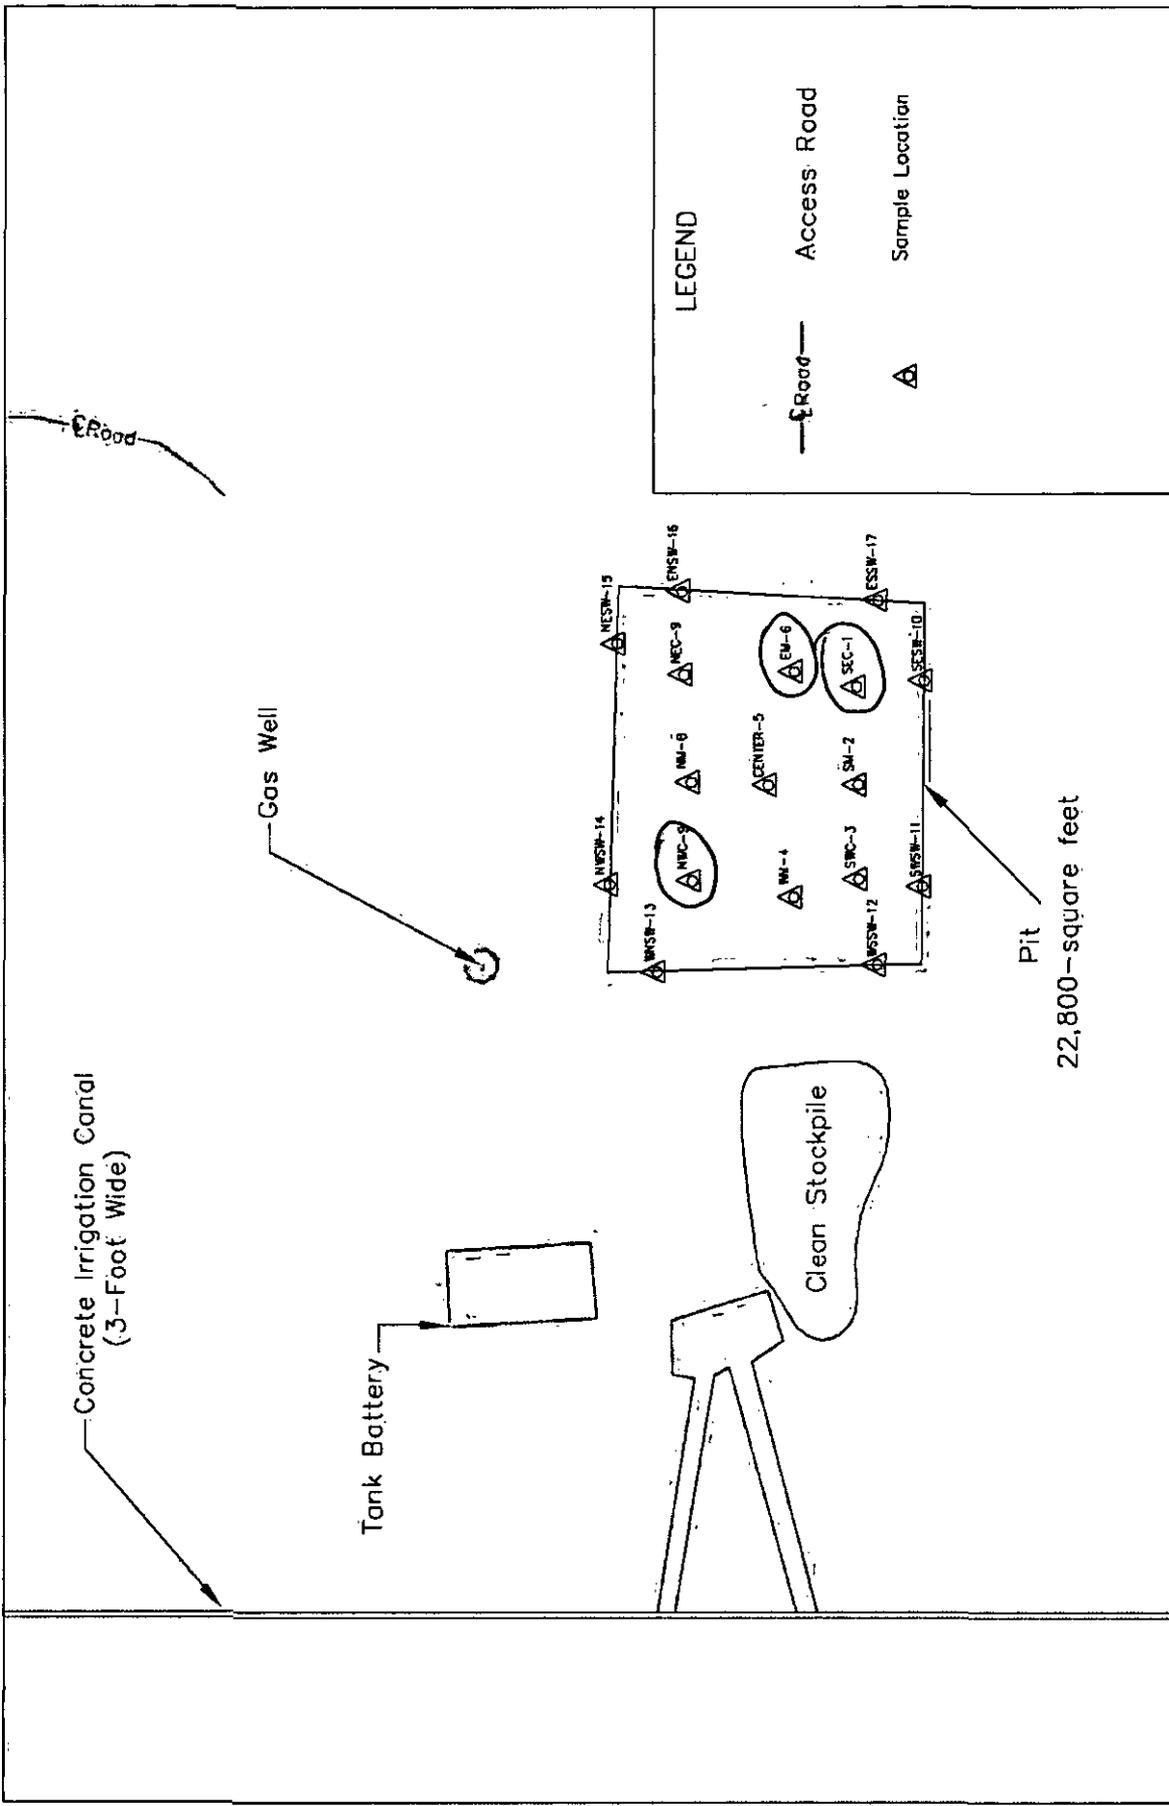
Soil samples were collected from the pit sidewalls and floor on October 12 and 14, 2005. A portion of each sample was placed in a laboratory provided container and submitted to an independent laboratory for analyses. The remaining portion was analyzed in the field for the presence of organic vapors utilizing a PID and chloride concentrations utilizing a La Motte Chloride Test Kit. Field analyses indicated that organic vapor concentrations ranged from 0.0 to 15.5 ppm and chloride concentrations ranged from 480 to 13,640 mg/Kg (reference *Figure 4*).

Pit
22,800-square feet

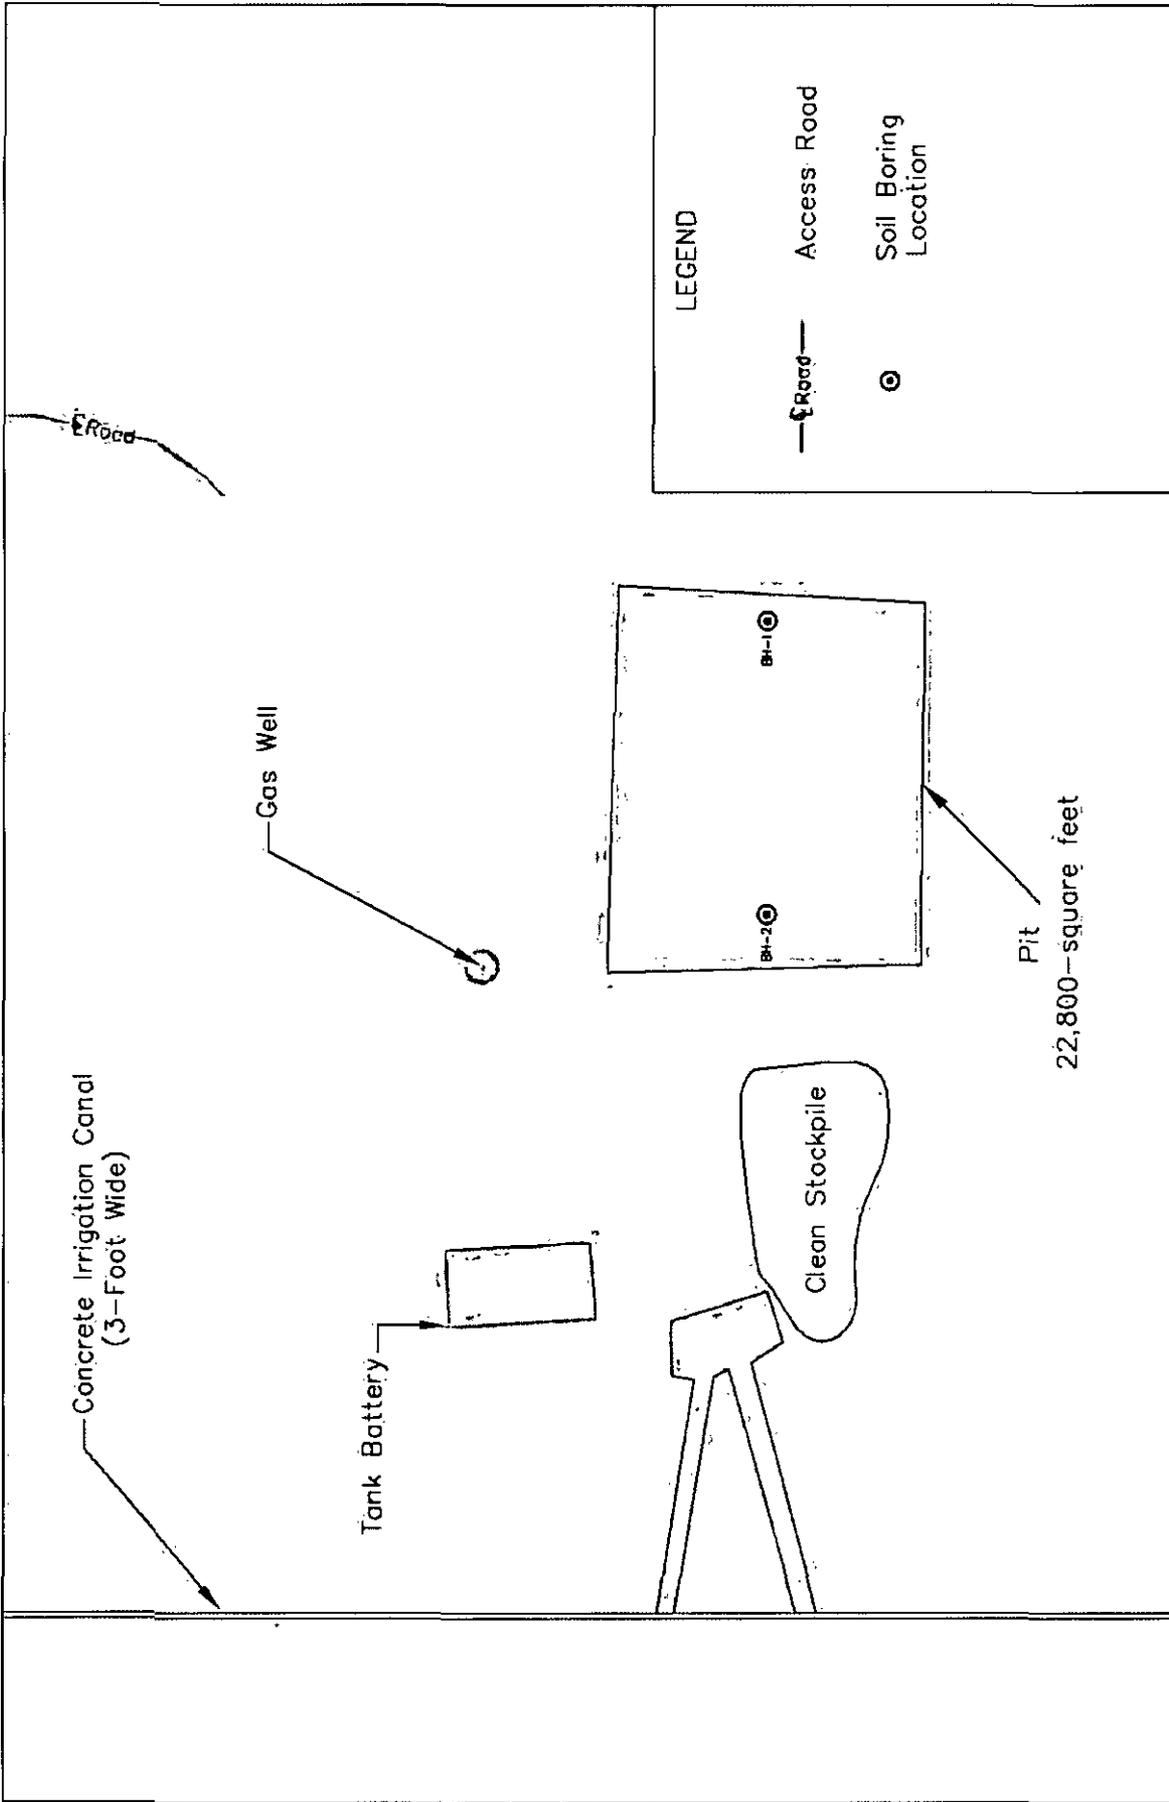
Figure 5
 Soil Boring Location Map
 Chesapeake
 Will 7A Fee #1

The vertical extent of contamination from the drill pit materials was determined via two soil borings (BH-1 and BH-2) to depths of 20-ft bgs on October 20, 2005. During the advancement of the soil borings, soil samples were collected at 10, 15 and 20-feet bgs. A portion of each sample was submitted for laboratory analyses. The remaining portion of each sample was analyzed in the field for organic vapor and chloride concentrations. Field analyses indicated organic vapor concentrations ranged from 2.9 to 5.0 ppm and chloride concentrations ranged from 560 to 2,560 mg/Kg (reference *Figure 5*).

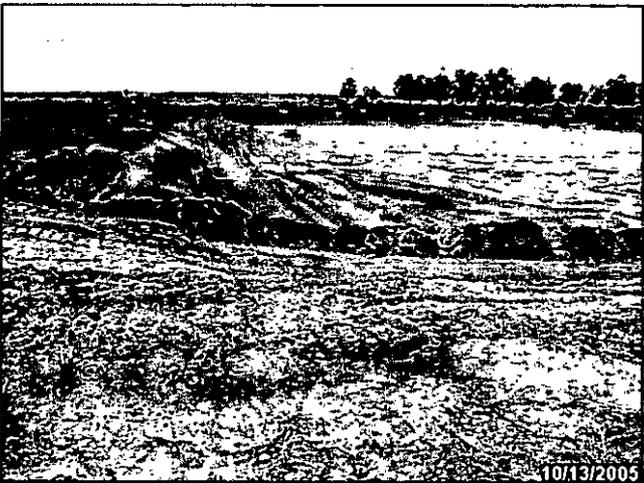
Photo #5: Current status of pit looking southerly.

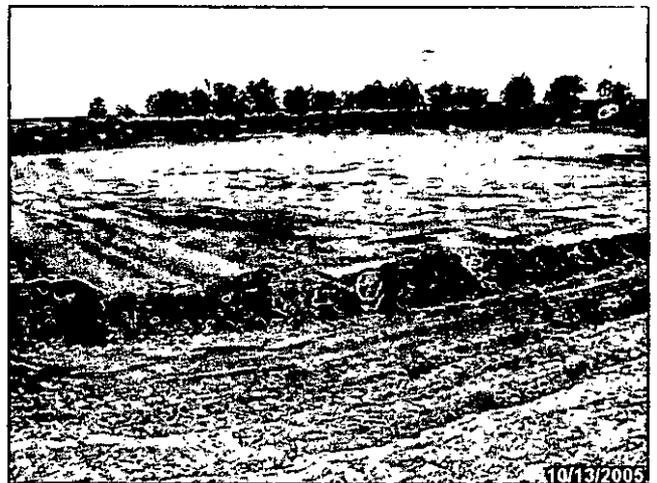
Photo #6: Current status of pit looking southwesterly.
