CLOSURE REPORT

WILL 7A FEE #1 DRILLING PIT

EPI REF: 160025

FEBRUARY 2007

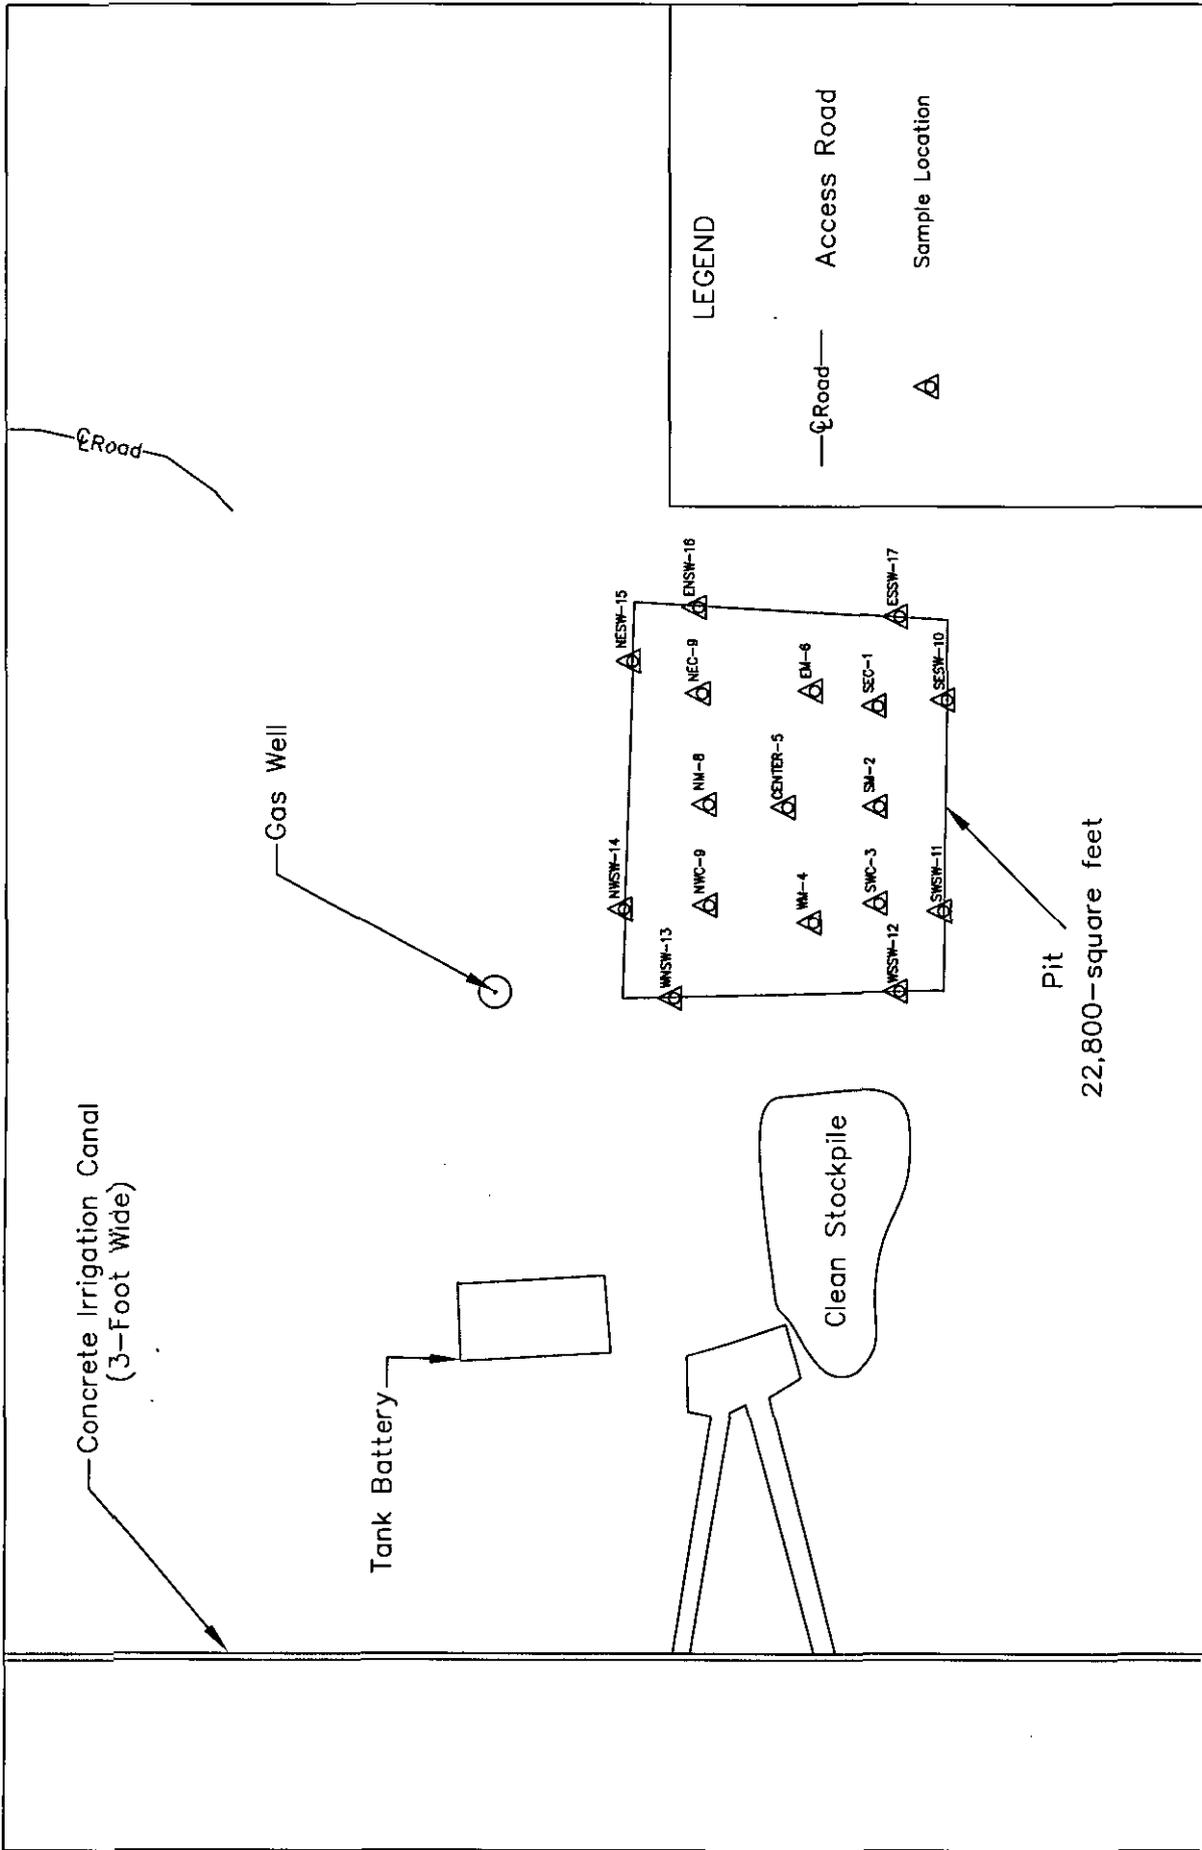
Figure 4
Sample Location Map - 10/12/05
Chesapeake
Will 7A Fee #1

On October 12, 2005 nine (9) soil samples were collected from the pit floor. On October 14, 2005 eight (8) soil samples were collected from the pit sidewalls (reference *Figure 4* for locations).

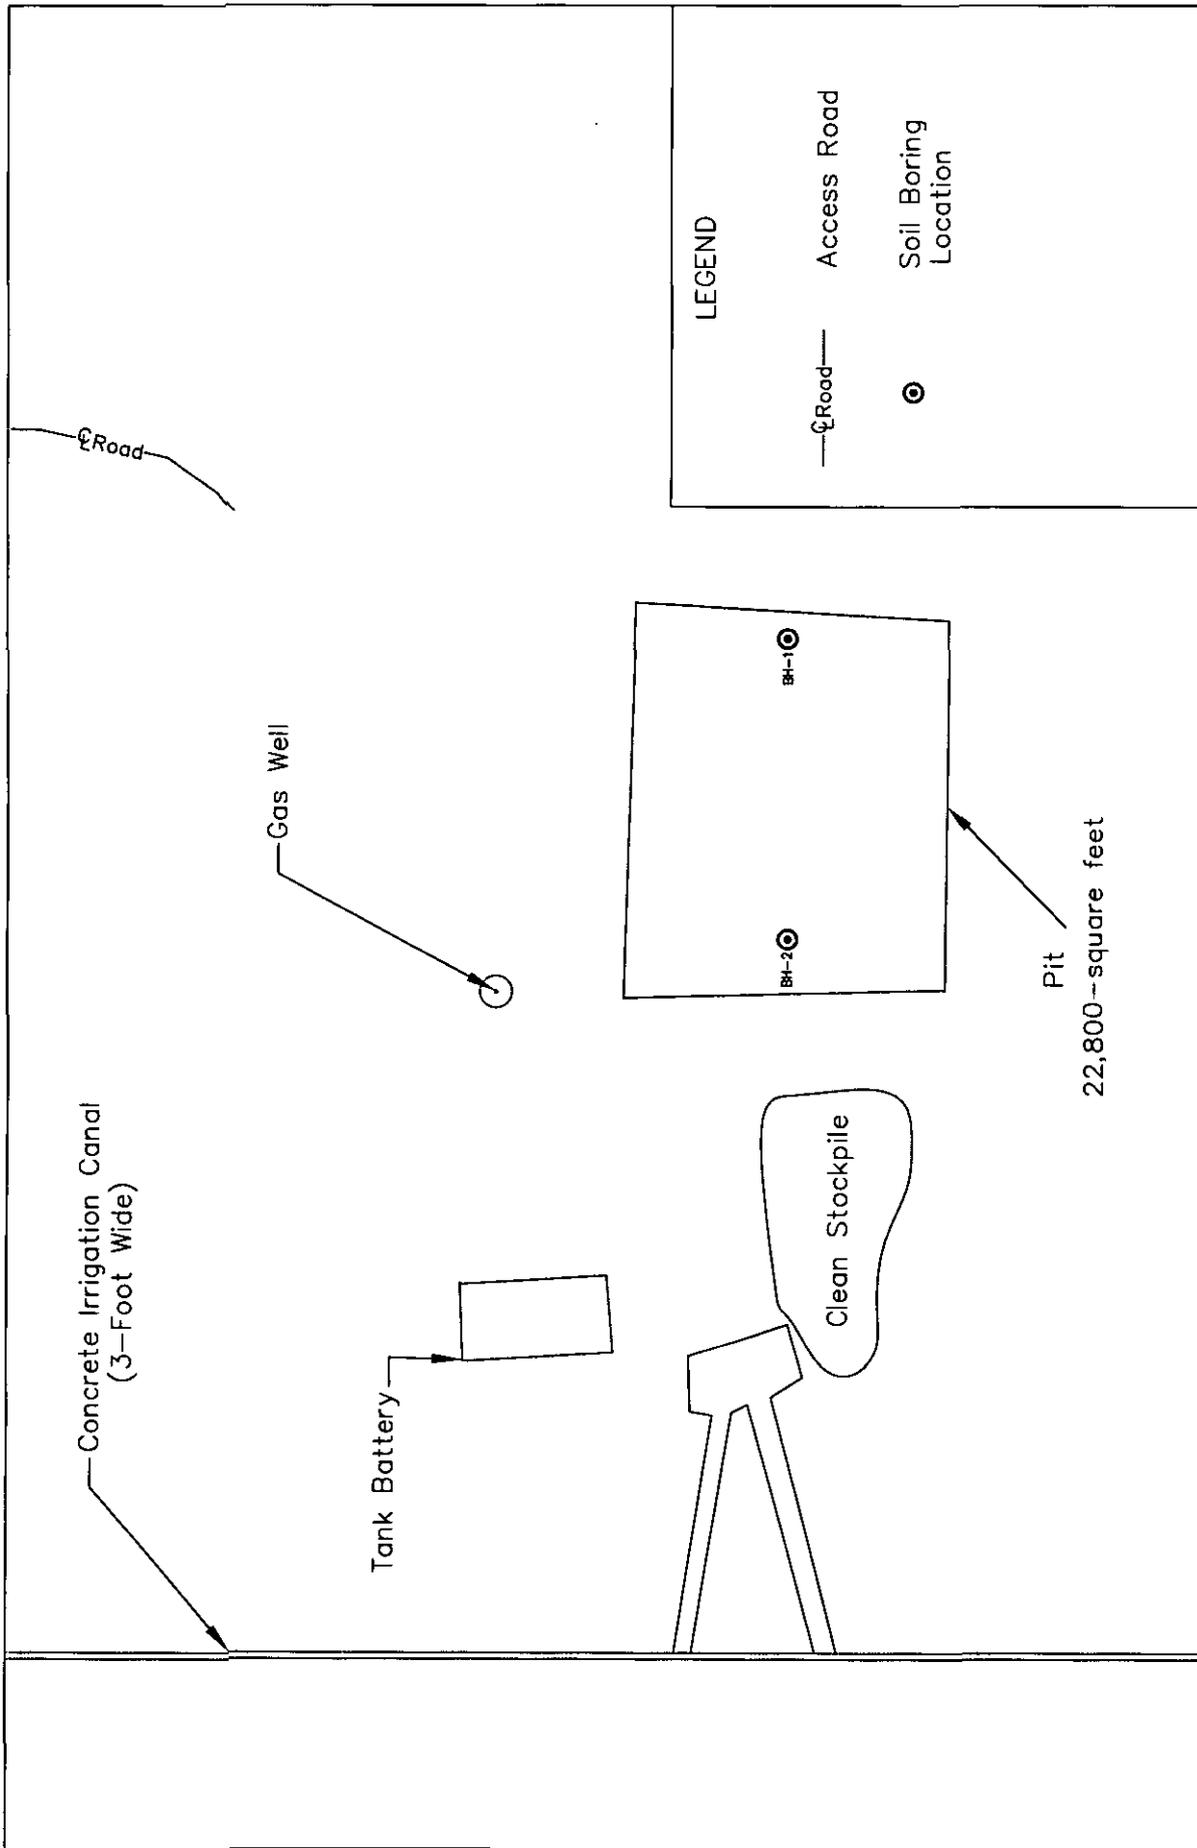
Figure 5
Soil Boring Location Map - 10/20/05
Chesapeake
Will 7A Fee #1

On October 20, 2005 two soil borings (BH-1 and BH-2) were advanced to approximately 20-feet bgs. Soil samples were collected from the soil borings at intervals 10-, 15- and 20-feet bgs (reference *Figure 5* for locations).

A review of Table 3, *Summary of Soil Boring Soil Sample Field and Laboratory Analytical Results*, for soil samples collected on October 20, 2005 from soil boring BH-1 and BH-2 indicated BTEX and TPH constituents were not detected at or above each analytes respective MDL. However, analytical data indicated chloride concentrations ranged from 455 mg/Kg (BH-2 @ 20-ft bgs) to 3,120 mg/Kg (BH-1 @ 10-ft bgs).

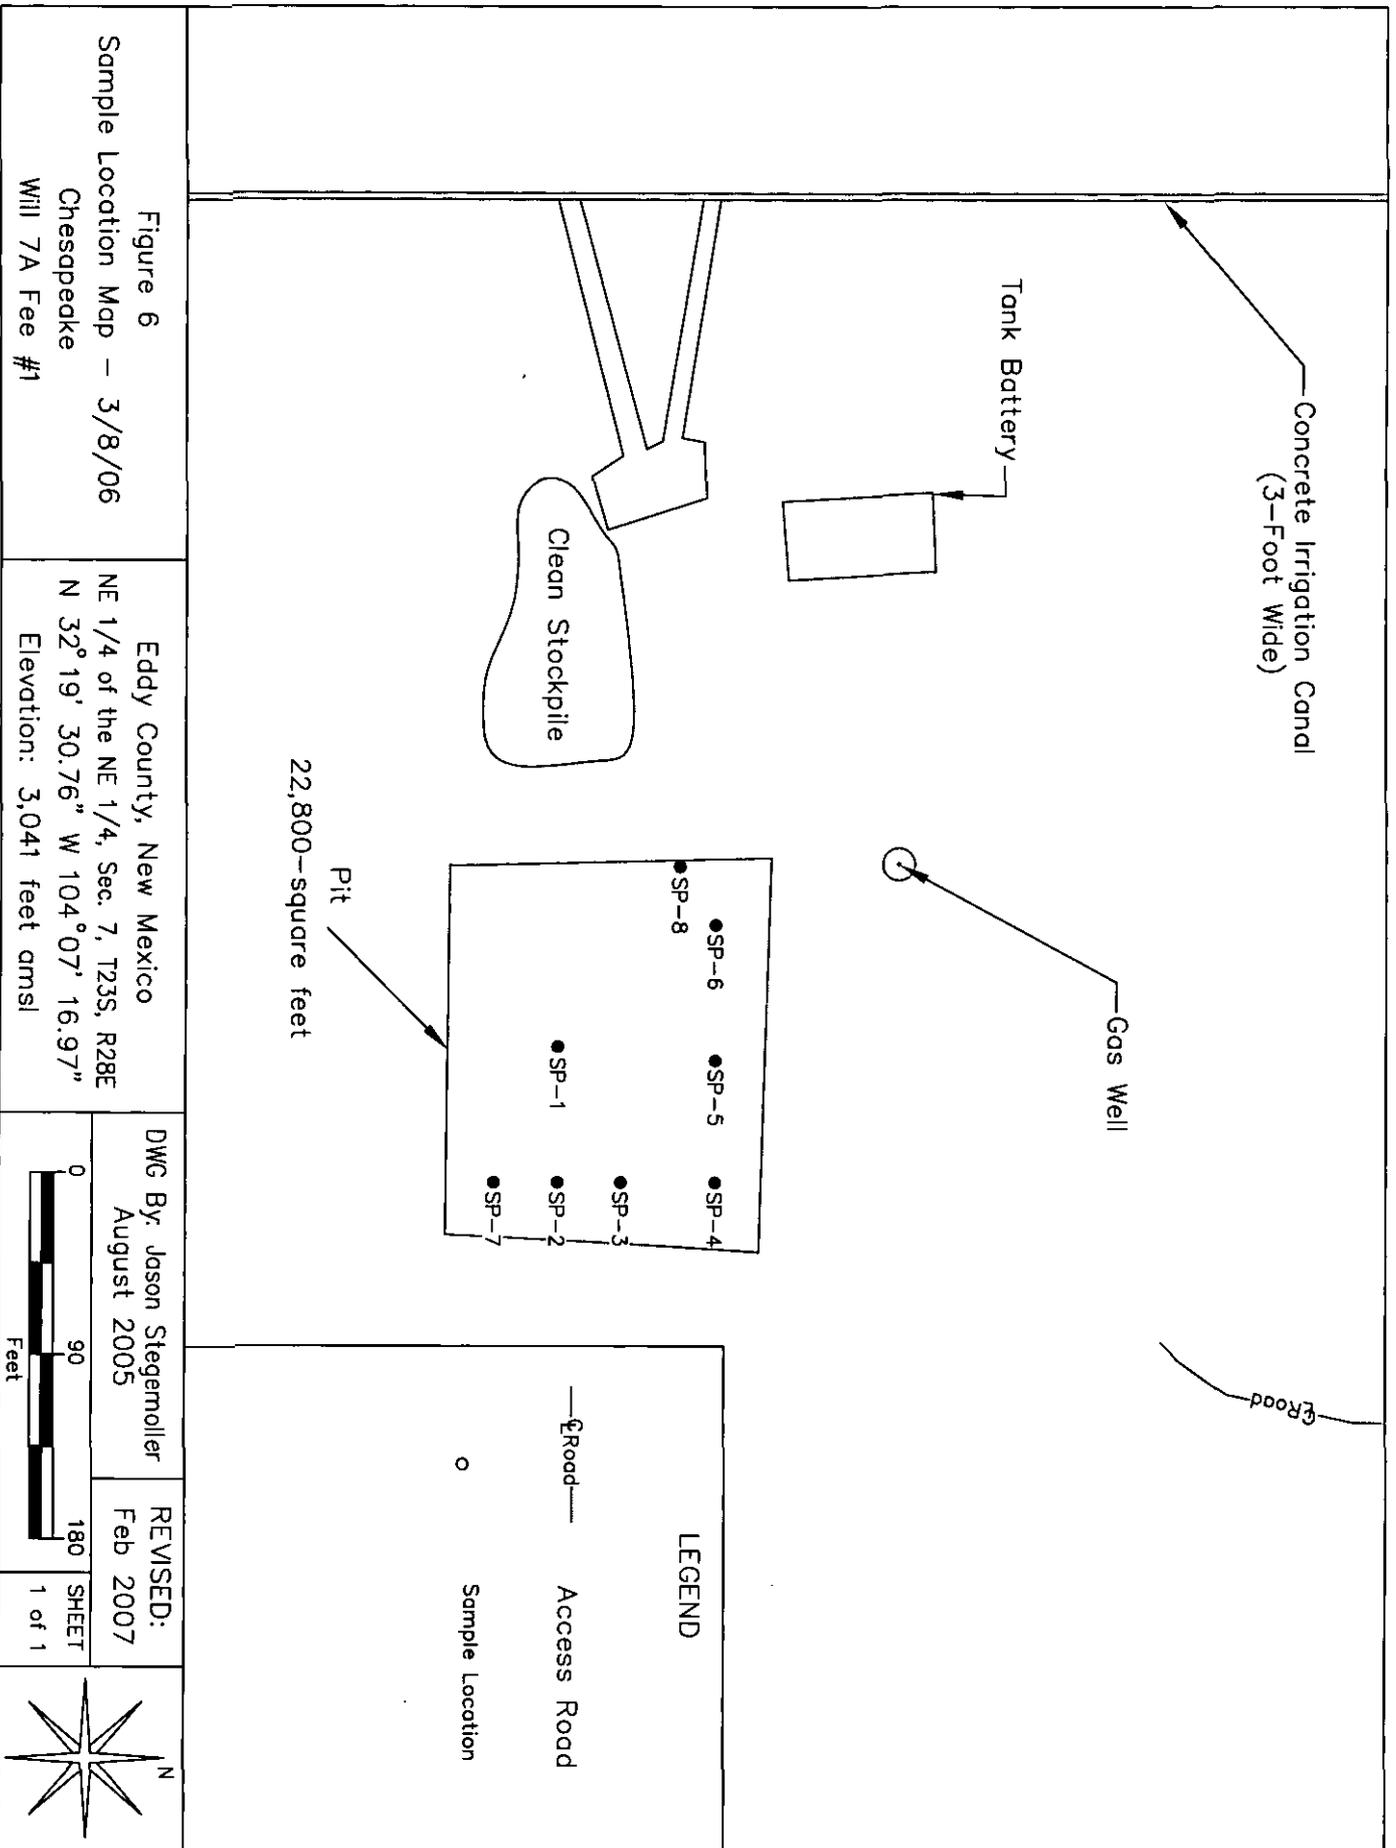
Figure 6
 Sample Location Map – 3/8/06
 Chesapeake
 Will 7A Fee #1

On March 8, 2006 eight (8) soil samples were collected from the pit floor (reference *Figure 6* for locations).

Laboratory analytical results for soil samples collected on March 8, 2006 indicated chloride concentrations ranged from 128 mg/Kg (SP-1 @ 1-ft bgs) to 5,198 mg/Kg (SP-8 @ 2.5-ft bgs) (reference *Table 1* for laboratory analytical data).

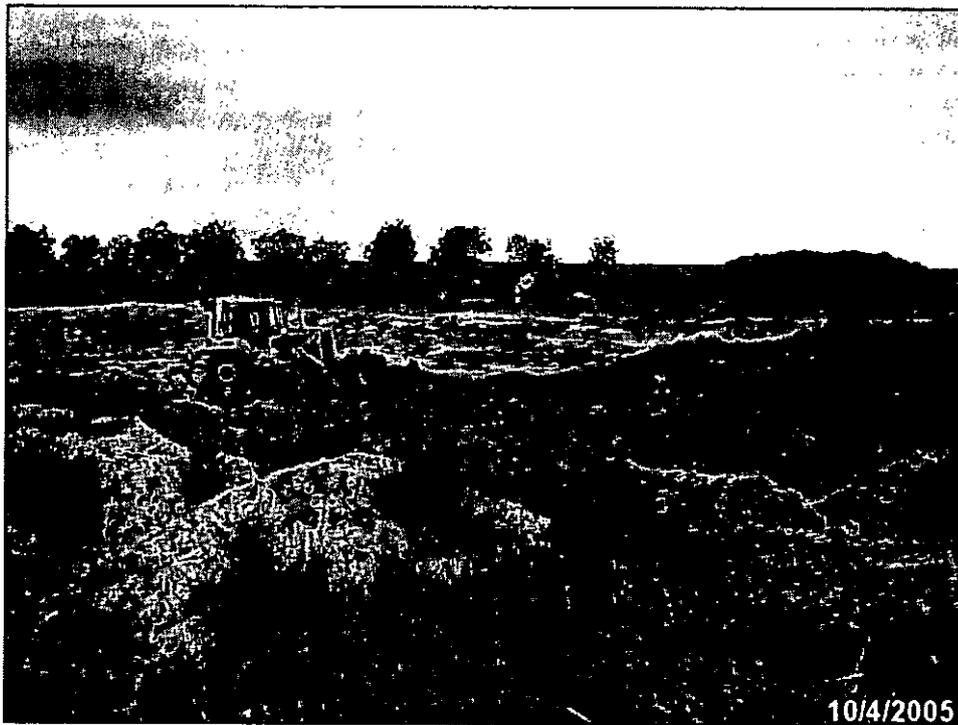
Photograph #4 – Looking southwesterly at excavation and clean stockpile.

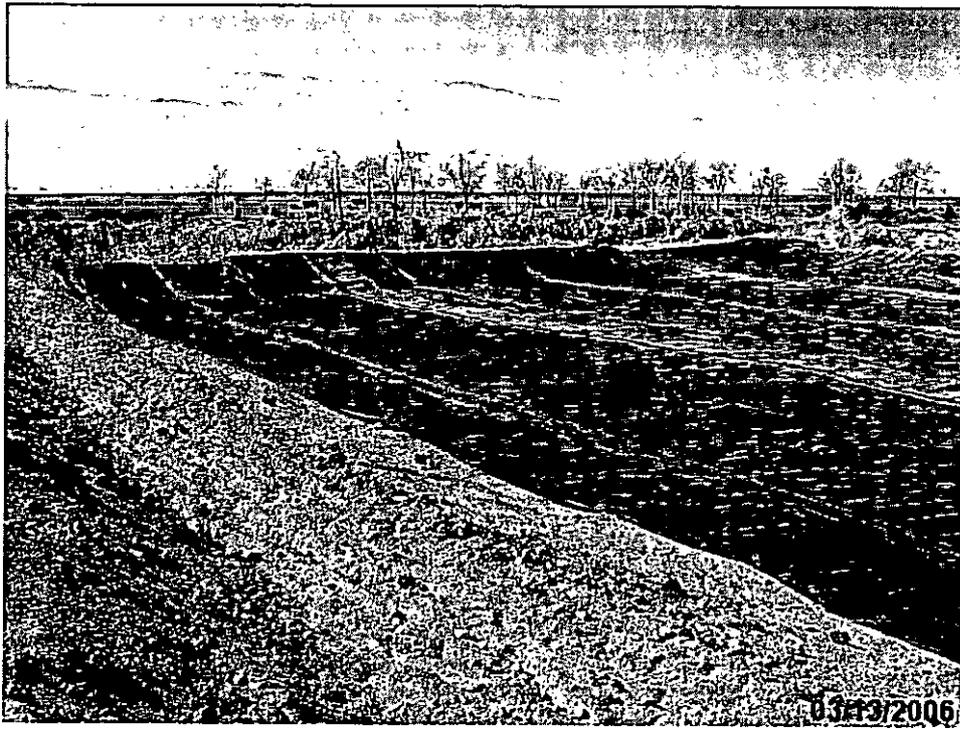
Photograph #8 – Looking southwesterly at liner.

An impervious 20-mil thick polyethylene liner was installed in the bottom of the pit over areas of elevated chloride concentrations. The polyethylene liner was sandwiched between two (2) one (1) foot layers of cushion sand. After backfilling operations were completed, the disturbed area was graded and contoured to allow natural drainage.

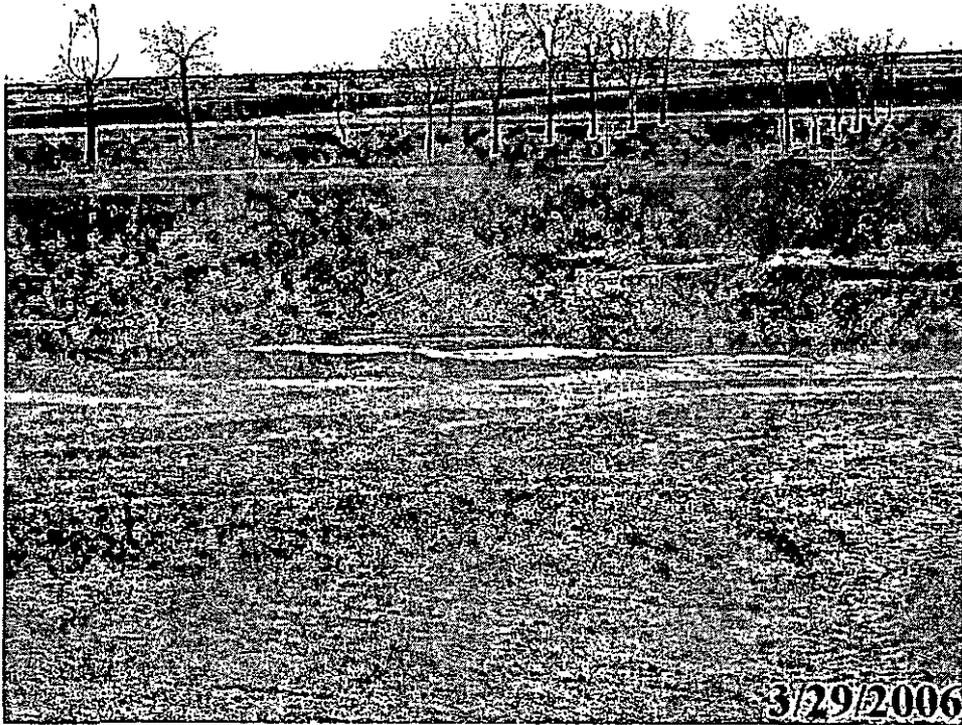
Photograph #9 – Looking southerly at closed site, contoured and ready for seeding.
