REMEDICATION SUMMARY AND SITE CLOSURE REQUEST

**PLAINS PIPELINE, L.P. (231735)
Loco Hills Station Bypass Line
Eddy County, New Mexico
Plains SRS# 2009-251
UNIT "G" (SW/NE), Section 23, Township 17 South, Range 31 East
Latitude 32° 49' 23.4" North, Longitude 103° 50' 15.6" West**

February 2010

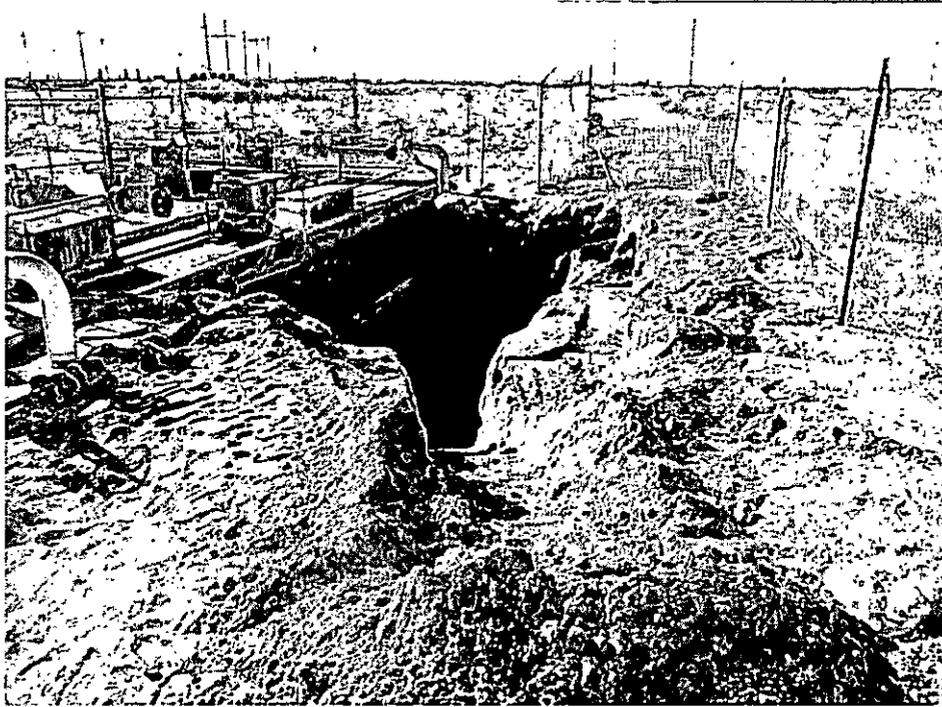
Loco Hill Station Bypass Line Excavation, looking west

On November 24 and 25, 2009, hydrocarbon impacted soil was excavated at the release site. Approximately 150 cubic yards (cy) of impacted soil was stockpiled adjacent to the excavation pending final disposition. The final dimensions of the excavation were approximately eighteen (18) feet in length and ten (10) feet in width and approximately ten (10) feet bgs in depth. An irregular shaped flowpath extended to the west and south of the release point, measuring approximately ninety (90) feet in length and two (2) to twelve (12) feet in width and one (1) to two (2) feet in depth.

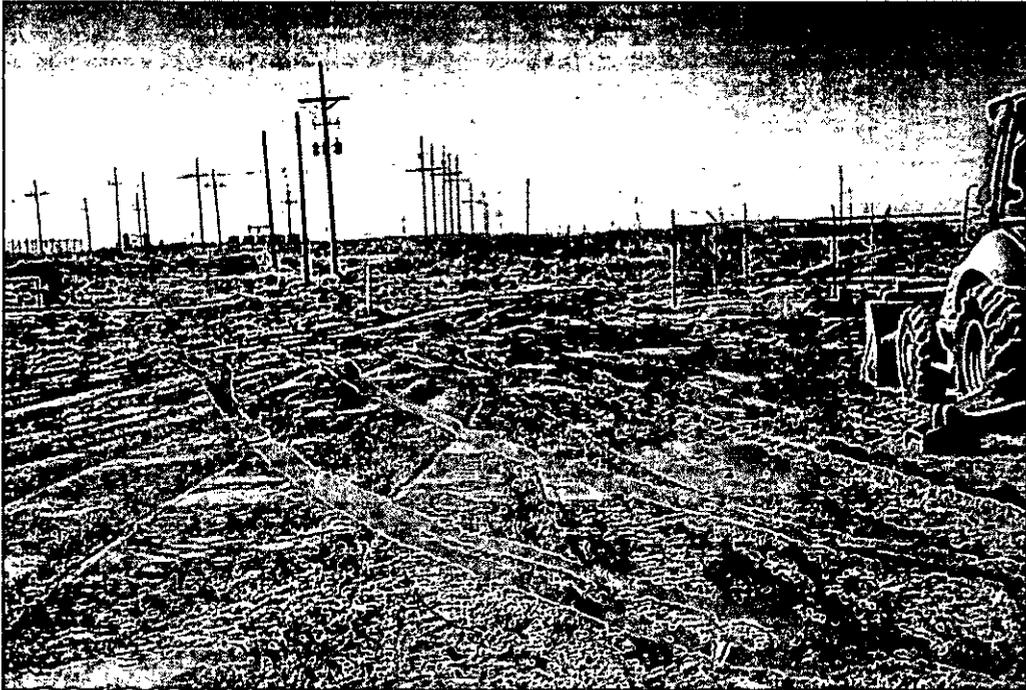
Loco Hills Station Bypass Line, south flowpath backfilled, looking west

On January 4, 2010, in a meeting with Basin and NMOCD representatives, Plains requested NMOCD approval to backfill the excavation with the on-site stockpiled soil. The NMOCD approved the backfilling activities and on January 12, 2009, the excavation was backfilled with the on-site soil and compacted with the aid of fresh water transported to the site. Following the backfill activities the site was contoured to fit the surrounding topography.
