Release Notification and Corrective Action

Enterprise Products
Lateral 2C-55 October 13, 2015 Pipeline Release
Latitude 36.38203°, Longitude -107.61250°
Unit Letter O Section 19 T25N R7W
Rio Arriba County, New Mexico
November 25, 2015

Site Photographs
Enterprise Products Lateral 2C-55 October 13, 2015 Pipeline Release

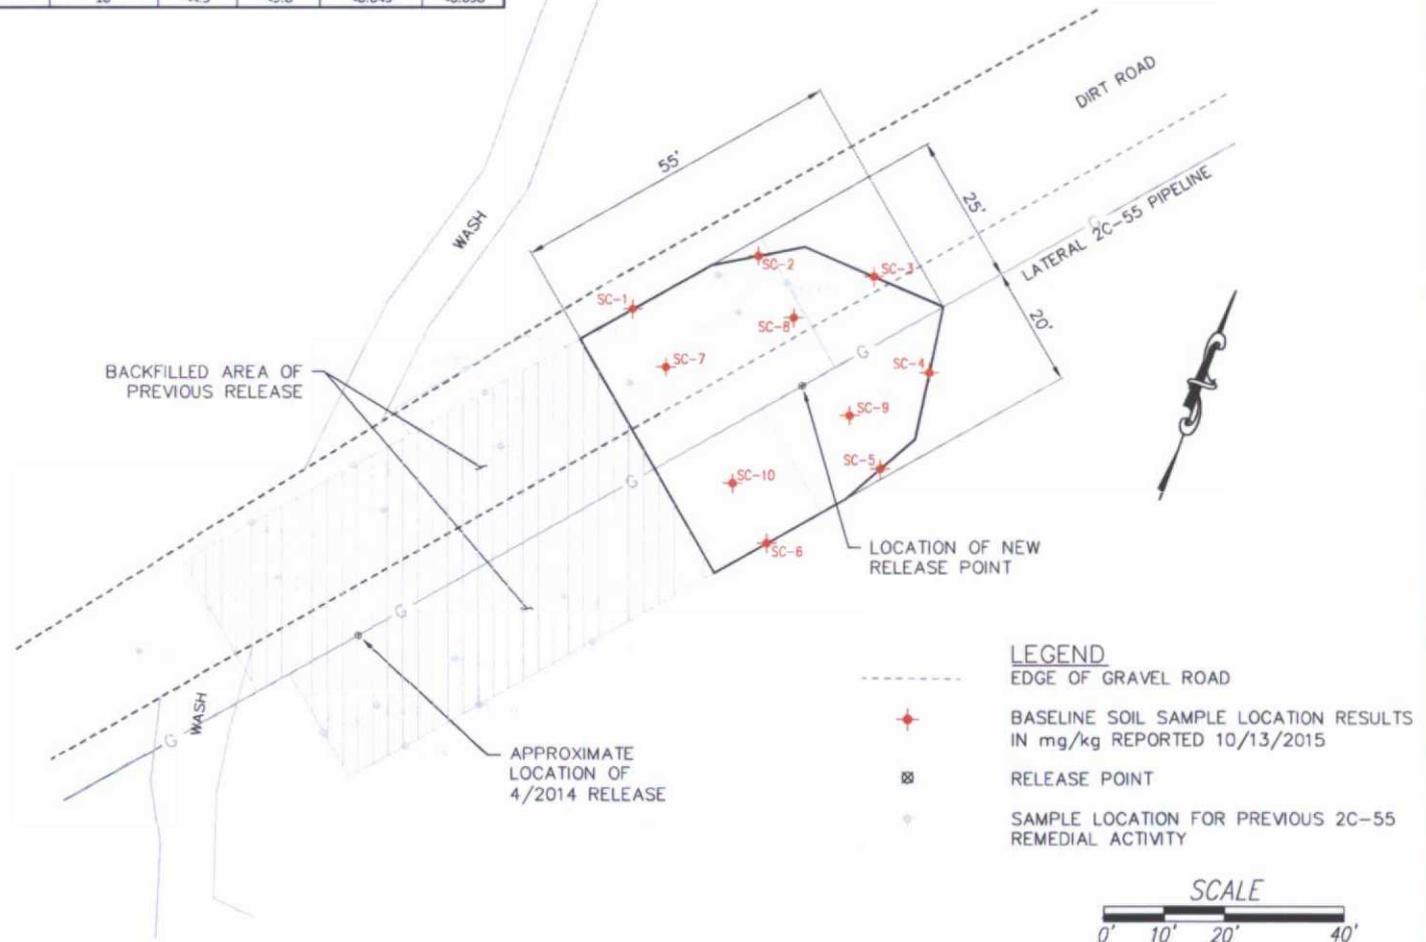
Date: December 2015
Scale: Horizontal: 1" = 20'
Vertical: Not to Scale
Project No: 5123699
Figure 3

NOTE:
ALL MATERIAL BELOW PIPELINE
REMOVED THROUGH ENTIRE
EXTENT OF BOTH EXCAVATIONS

ENTERPRISE FARMINGTON, NEW MEXICO
SOIL SAMPLE LOCATION MAP
OCTOBER 13, 2015
LATERAL 2C-55
SECTION 19, T29N, R7W

The final excavation measured approximately 60 feet long by 45 feet wide with a depth of 10 feet, covering an area of approximately 2700 square feet. A detailed excavation map is enclosed as Figure 3. In total, approximately 562 cubic yards of contaminated soil

Soil contaminant concentrations are illustrated in Figure 3. A summary of laboratory analysis is included in Table 3. Laboratory reports are included in Appendix C.

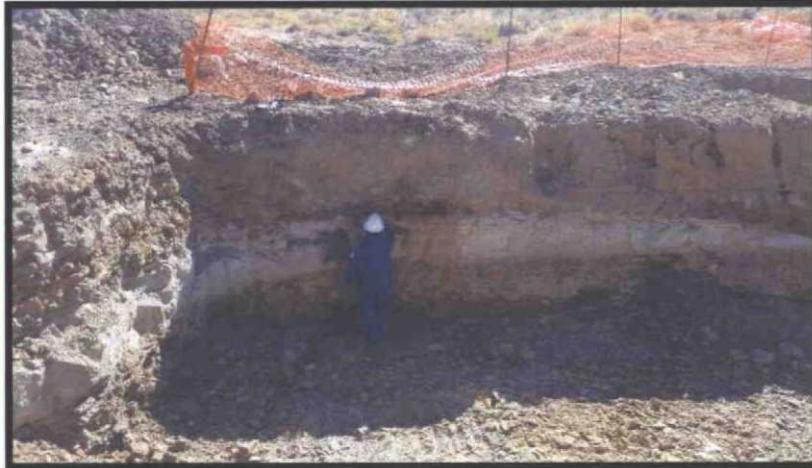
Photo 1: Enterprise personnel verify the October, 2015 release during the excavation of material associated with the February, 2014 release.

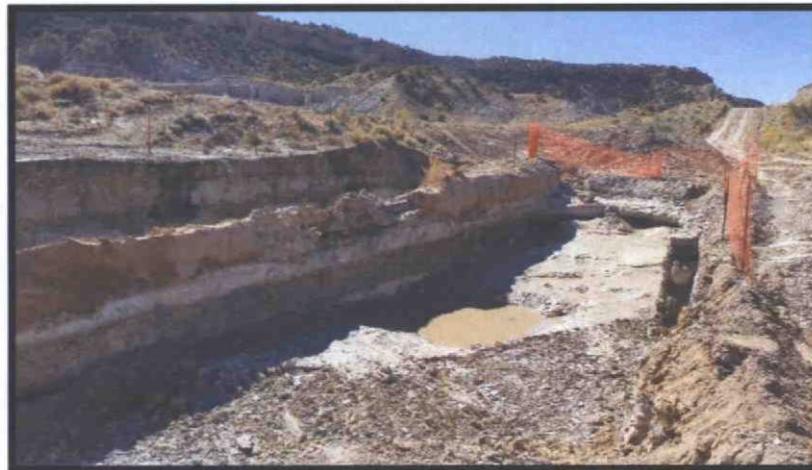
Photo 2: After the verification of the second release, samples were collected from the extents of the existing excavation. The second release and related remaining work was assigned to a new project.

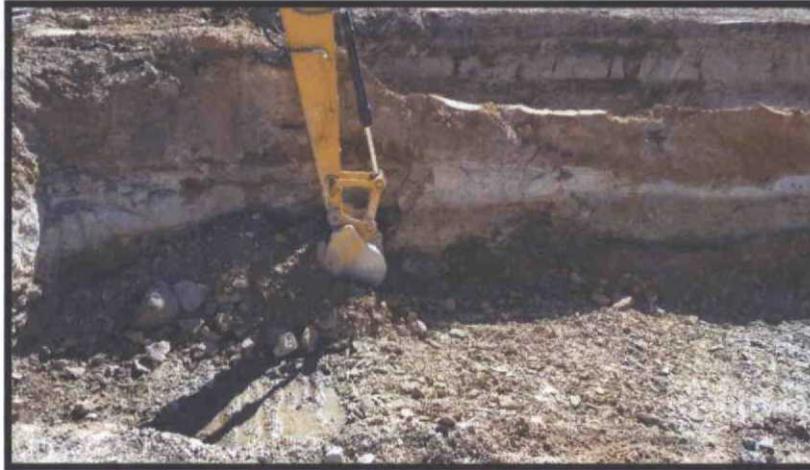
Photo 3: Excavating beyond the newly discovered release.

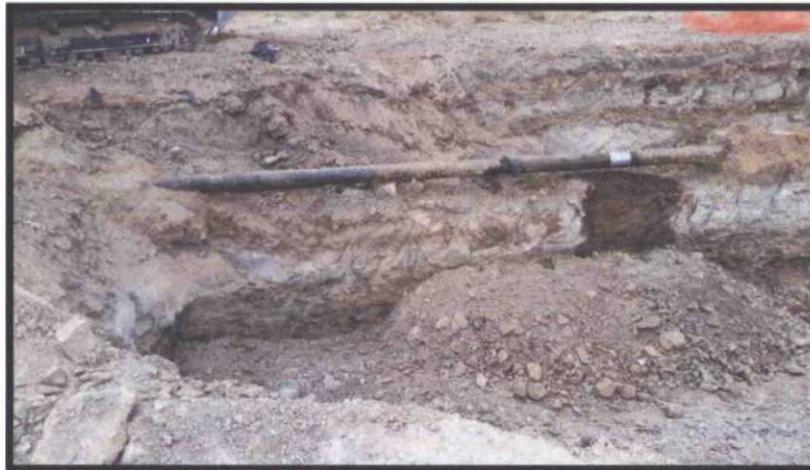
Photo 4: A temporary clamp was installed to prevent further contamination and to allow the requisite pre-repair activities to take place.

A clamp was installed over the point of release #2. Pipeline repairs and remedial activities took place between October 15 and November 6, 2015. SMA guided the excavation activities by collecting composite soil samples for field screening with a calibrated photo-ionization detector (PID). When field screening suggested the extents of the excavation had been advanced beyond the contamination, SMA collected ten samples from the excavation for lab analysis. Samples are 5-point composites collected with the track-mounted excavator.

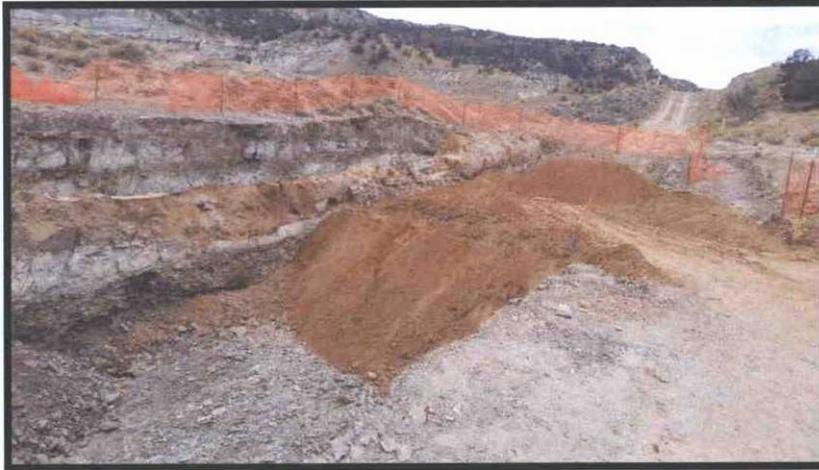
Photo 5: Backfill of the previous excavation extents while excavation on the new release continued was cleared with the NMOCD.

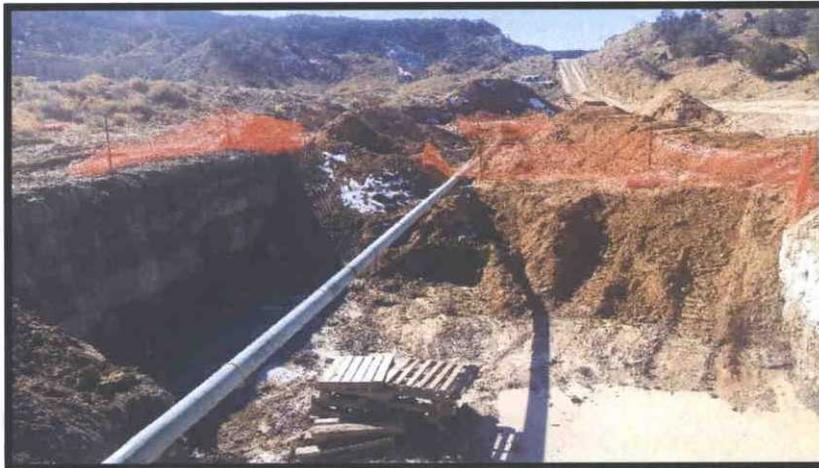
Photo 6: After repairs were completed over 150 of new pipe was installed. All material below the pipeline was removed during repair activities.

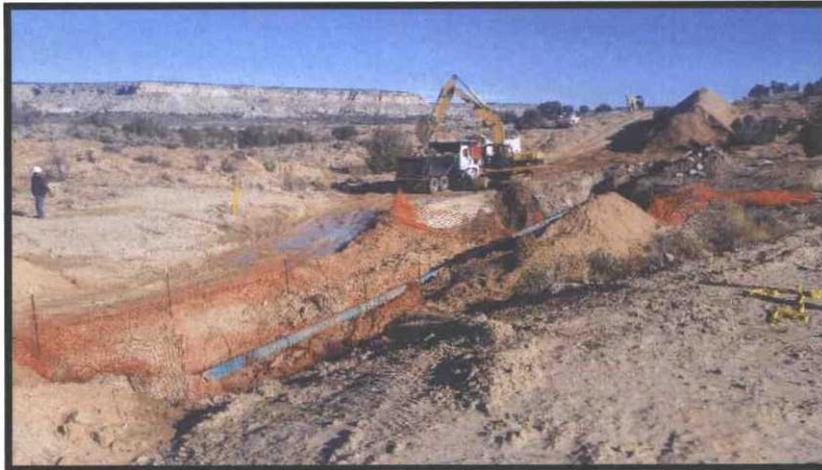
Photo 7: Excavation of the remaining contaminated soils after repair activities concluded.

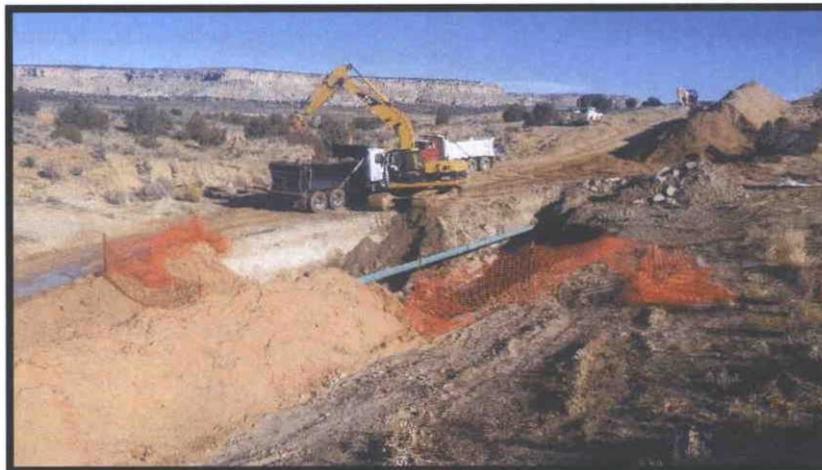
Photo 8: The October, 2015 2C-55 excavation nearing the final extents, just prior to sampling. Note dirty (gray) stockpile and clean imported (red and tan) backfill stockpiles in background.
