**Tocito Central
Tank Battery**

Delineation Report

**CONTAMINATION DELINEATION REPORT
TOCITO CENTRAL TANK BATTERY**

October 23, 2015

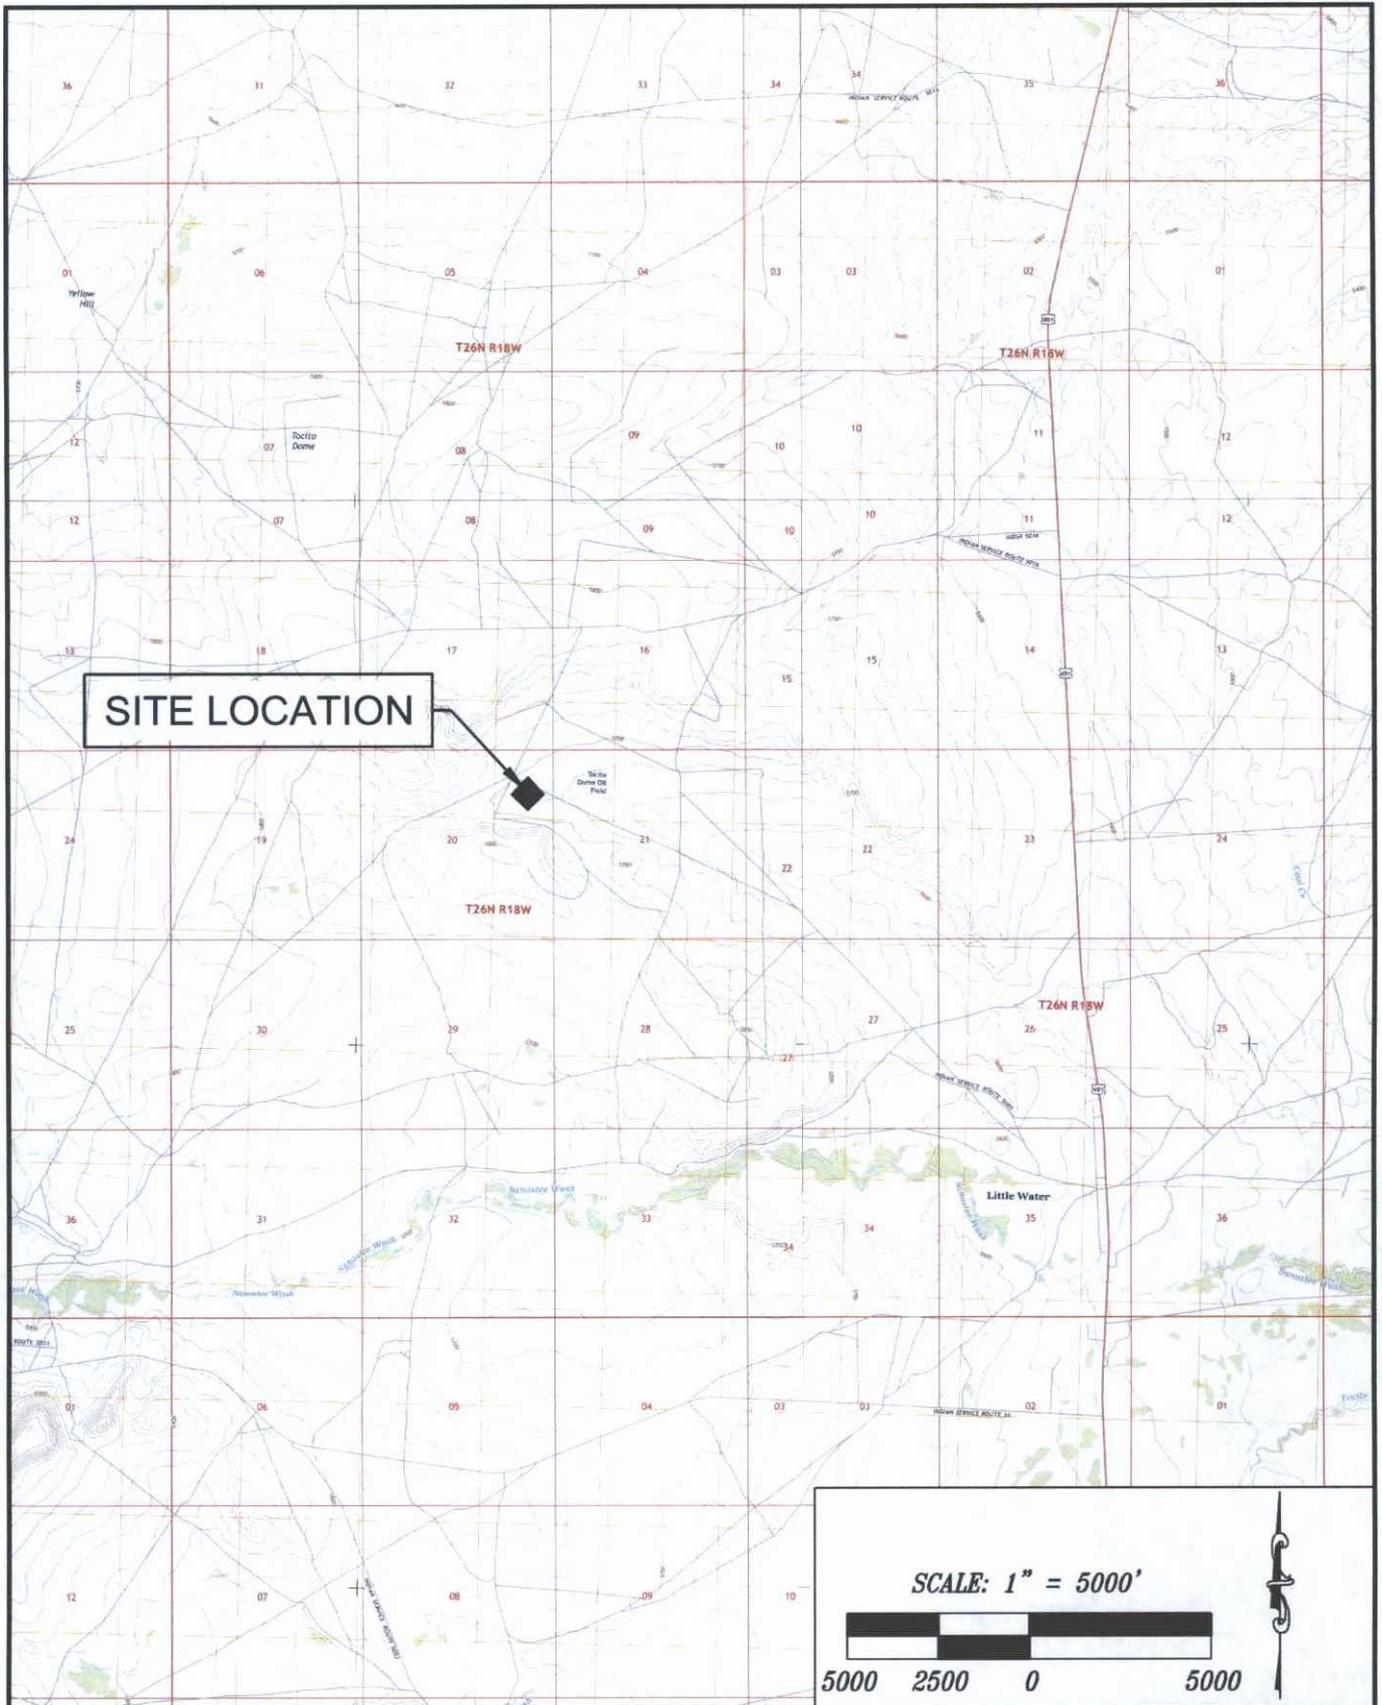
initial excavation measured approximately 30 feet wide by 40 feet long by 25 feet deep. The excavation has been left open and was fenced off to prevent injury to personnel, livestock or wildlife. After the initial excavation activities, the full extent of the contaminant impact was still unknown. The extent of the release appeared to be greater than that of the documented 41 barrel release. It was determined that in addition to the current release, there exists an unknown mass of contamination that is the result of an improperly closed historic production pit dated prior to Bayless's acquisition of the Tocito Central Tank Battery. The Tocito Central Tank Battery pipeline release is located in Unit A (NE $\frac{1}{4}$ NE $\frac{1}{4}$), Section 20, Township 26 North, Range 18 West; GPS: 36.478275°, -108.775919°, San Juan County, New Mexico. Figure 1, Vicinity Map, illustrates the location of the release.

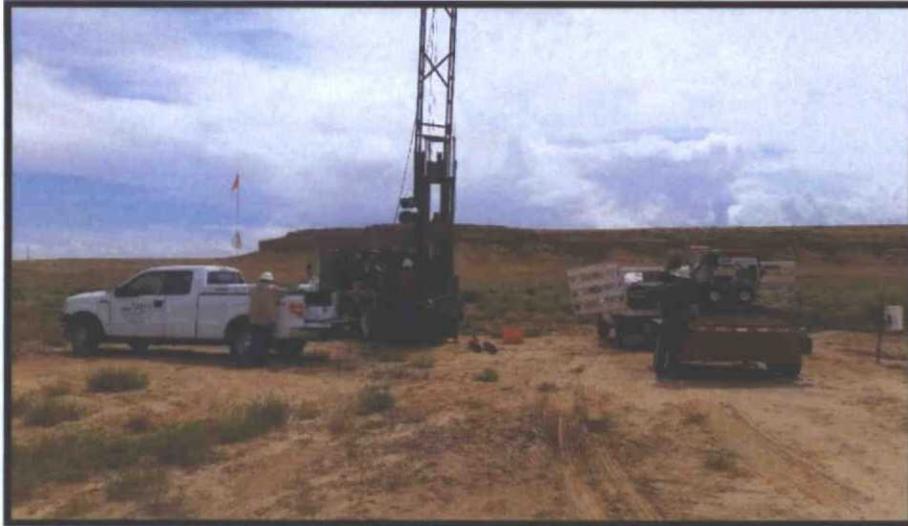
Photo 1: Work commences at the Tocito Central Tank Battery.

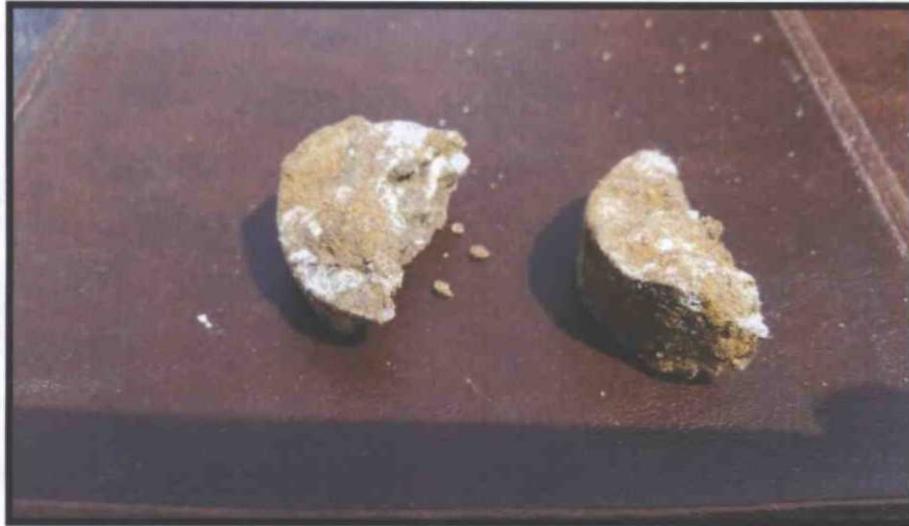
Photo 2: Split spoon sample of the silty clay material containing gypsum and other evaporite crystals.

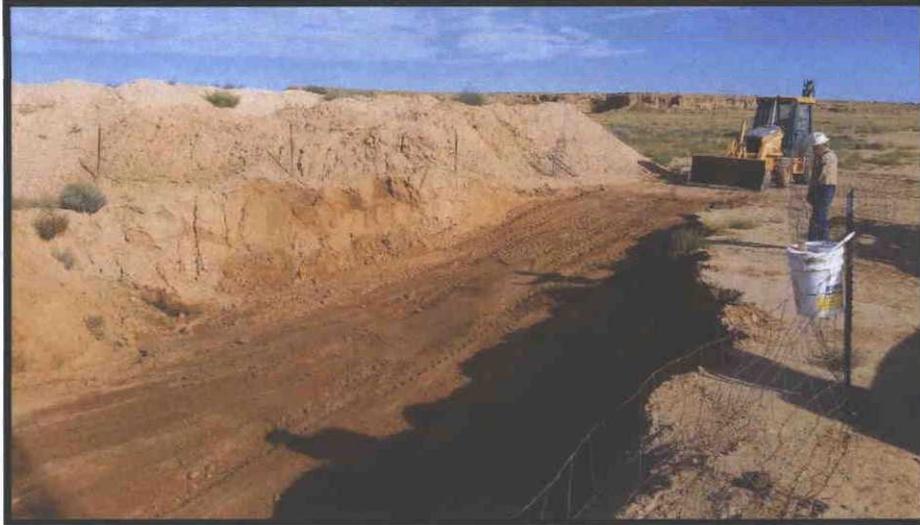
Photo 3: Constructing the ramp and pad for the installation of SB-6 within the existing excavation.

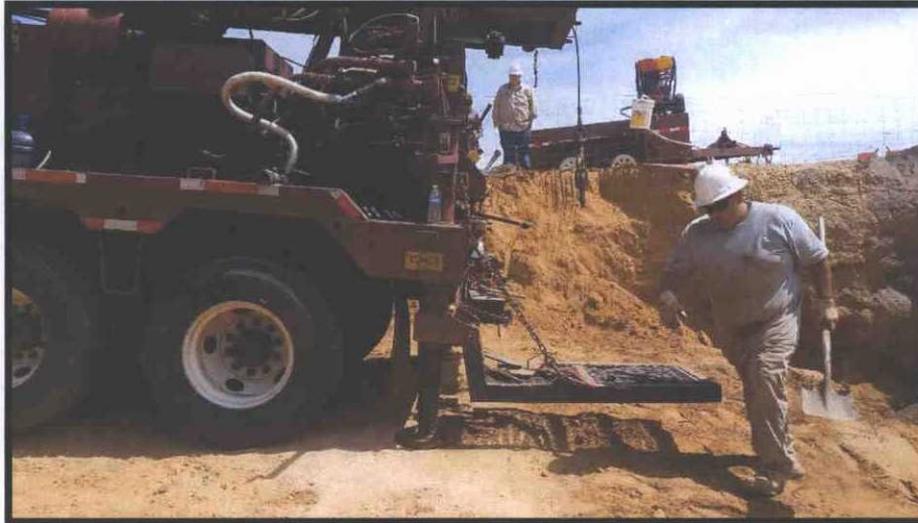
Photo 4: Leveling the CME-85 drill rig within the excavation, concrete pads were used to support the hydraulic jacks.

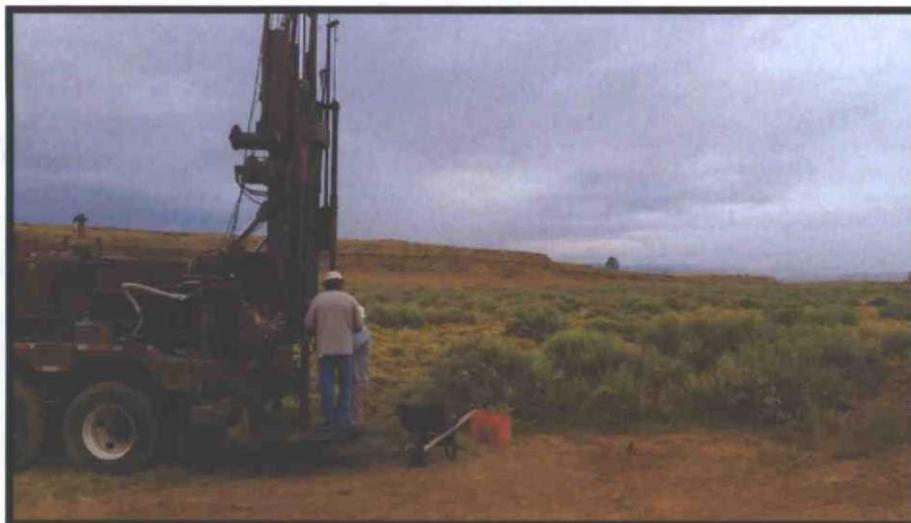
Photo 5: Installing a soil boring near the edge of the disturbed area, in the vicinity of the improperly closed pit.
