Big George State #3 Battery

ENVIRONMENTAL SITE INVESTIGATION

CLOSURE REPORT

Re: Closure plan for COG Operating LLC, Big George State #3 Battery,
Unit J, Section 12, Township 17 South, Range 28 East, Eddy County, NM

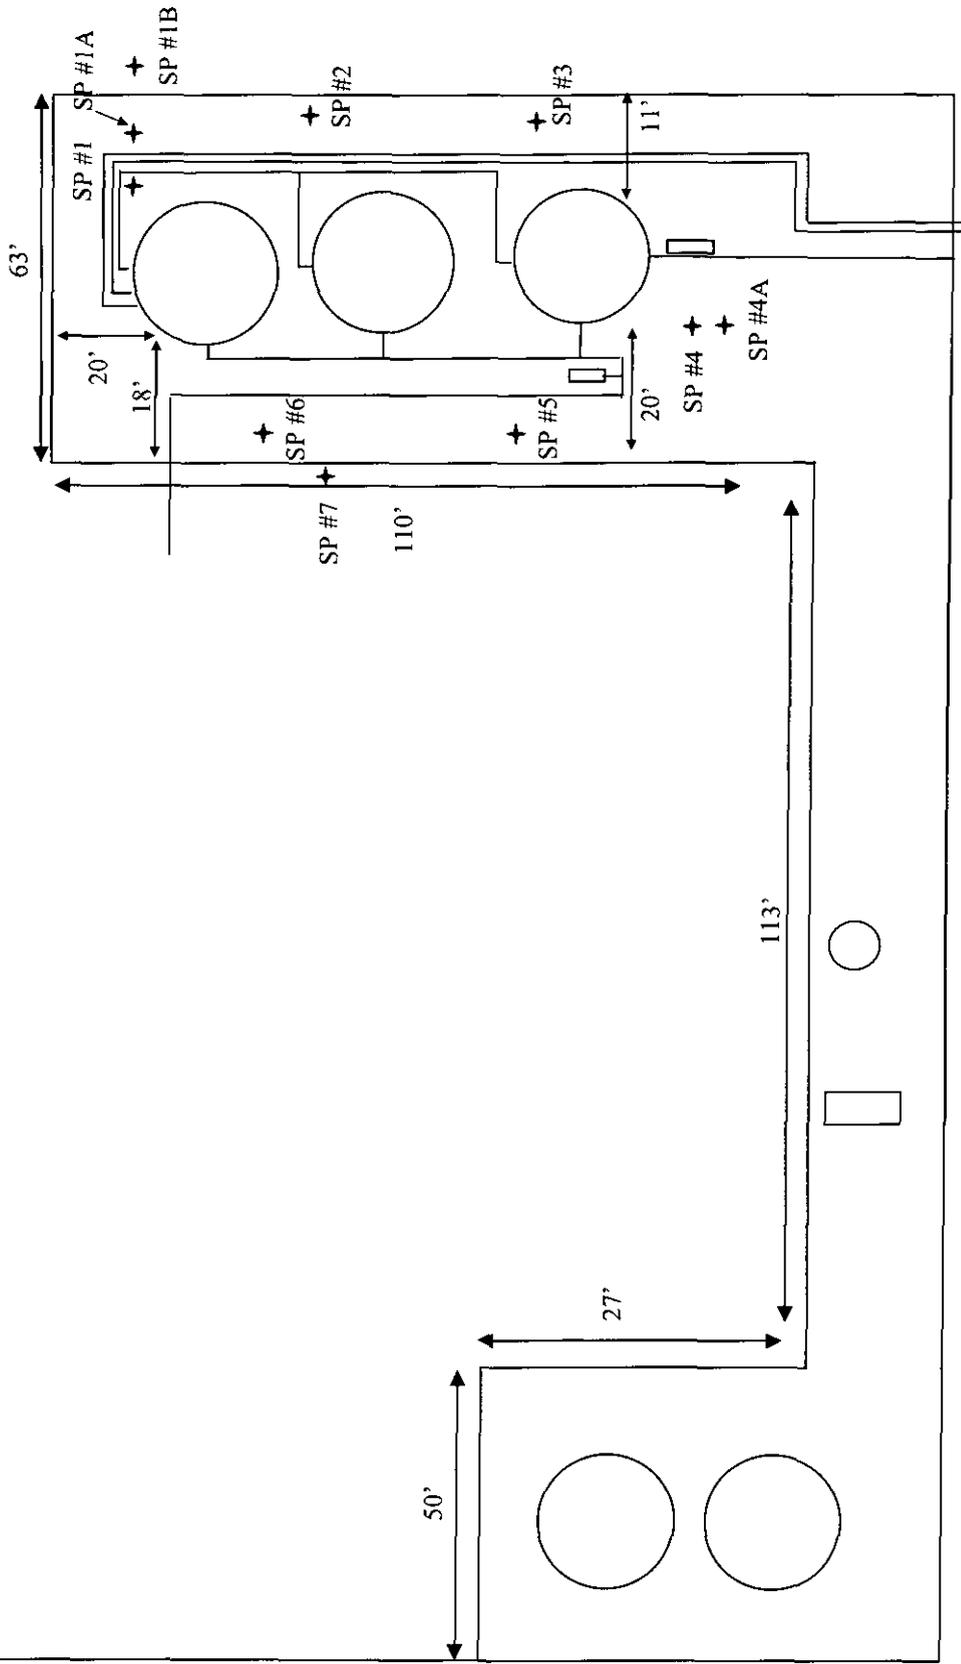
Site Diagram
September 2011

Sample Point Distance from Tanks

- SP#1 - 5'
- SP#2 - 8'
- SP#3 - 7'
- SP#4 - 10'
- SP#5 - 14'
- SP#6 - 15'

A diagram of the location including the sample points can be reviewed in Appendix I of this report. The surface soil is tan to brown fine sand and sandy caliche. There is no water source within 1,000 feet of this site. Based on the data from the Eddy County Groundwater Trend Map, the depth to groundwater in Section 12, Township 17 South, and Range 28 East is 50' to 75'. The initial C-141s for both leaks are at the end of this report in Appendix III.

feet, and 272 ppm at 5 feet. Laboratory analysis for SP4 was 3,680 ppm at 1 foot, 10,200 ppm at 4 feet, and 4,720 ppm at 6 feet. Laboratory analysis for SP5 was 5,600 ppm at 1 foot, 12,800 ppm at 3 feet, and 1,960 ppm at 7 feet. Laboratory analysis for SP6 was 4,240 ppm at 1 foot and 2,200 at 3 feet. After further discussion with the NMOCD, all parties involved agreed that additional sampling was warranted. Therefore, additional samples were taken at the agreed upon locations of SP1, SP4, and SP7. Five samples were taken from SP1(A) at depths of 2 feet, 4 feet, 7 feet, 12 feet, and 17 feet. Three samples were taken from SP1(B) at depths of 1 foot, 4 feet, and 7 feet. Three samples were taken from SP4(A) at 7 feet, 12 feet, and 17 feet. And, three samples were taken from SP7 at 1 foot, 3 feet, and 6 feet. These samples were also taken to Cardinal Laboratories for chloride analysis. Laboratory analysis for SP1(A) is 14,200 ppm at 2 foot, 2,560 ppm at 4 foot, 2,920 ppm at 7 foot, 11,400 ppm at 12 feet, and 4,720 ppm at 17 feet. Laboratory analysis for SP1(B) is 6,480 ppm at 1 foot, 8,260 ppm at 4 feet, and 6,720 ppm at 7 feet. Laboratory analysis for SP4(A) is 6,800 ppm at 7 feet, 3,520 ppm at 12 feet, and 2,120 ppm at 17 feet. Laboratory analysis for SP7 is 1,800 ppm at 1 foot, 1,500 ppm at 3 feet, and 368 ppm at 6 feet. The results of the analysis are located in Appendix II of this report. The sample point locations can be viewed on the site diagram in Appendix I of this report.

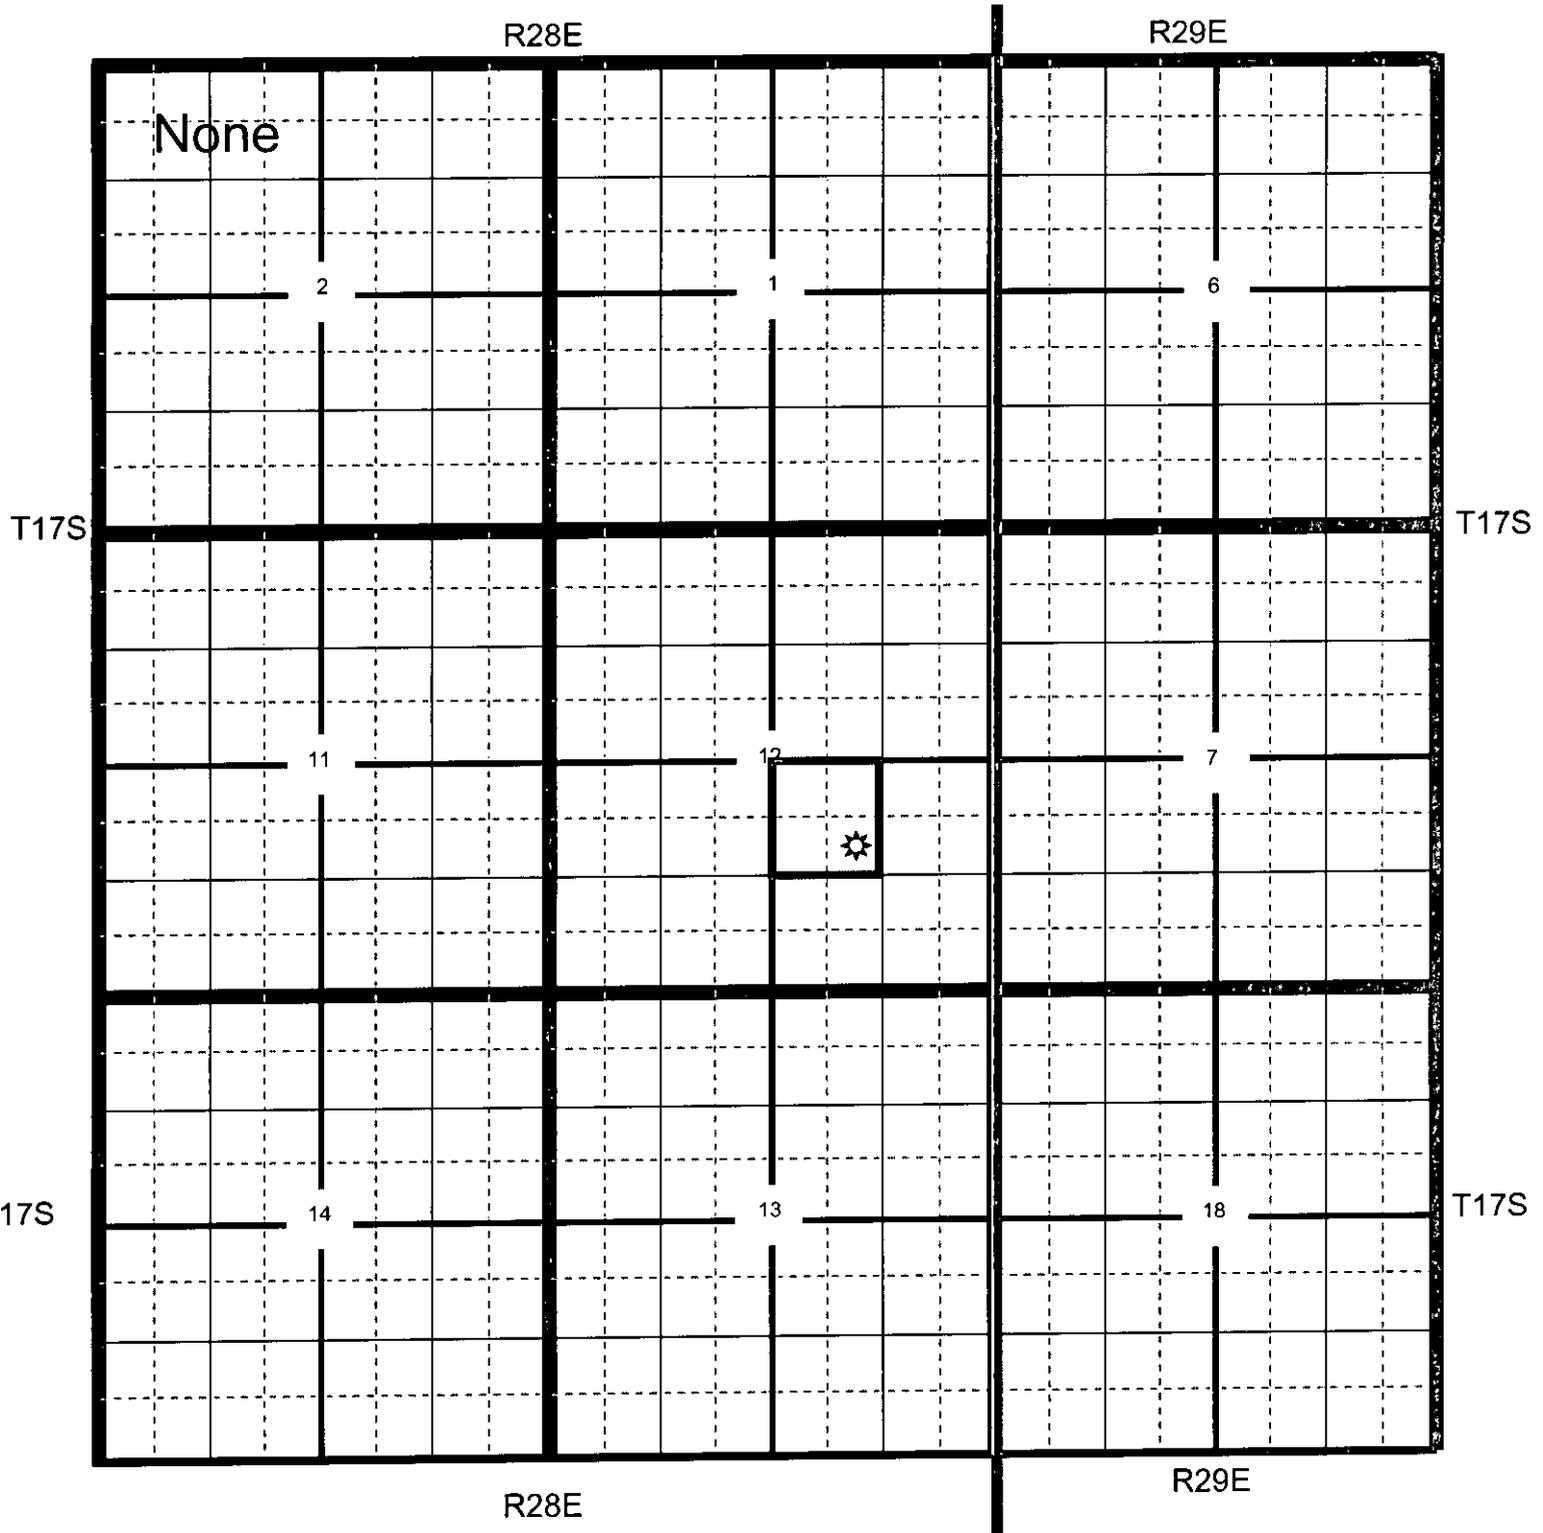
Groundwater Plot

Trend Map: 50'-75'
