**Range Operating New Mexico, Inc.
Greenwood Battery
Section 9, Township 22S, Range 37E
Lea County, New Mexico**

Closure Report

July 27, 2009

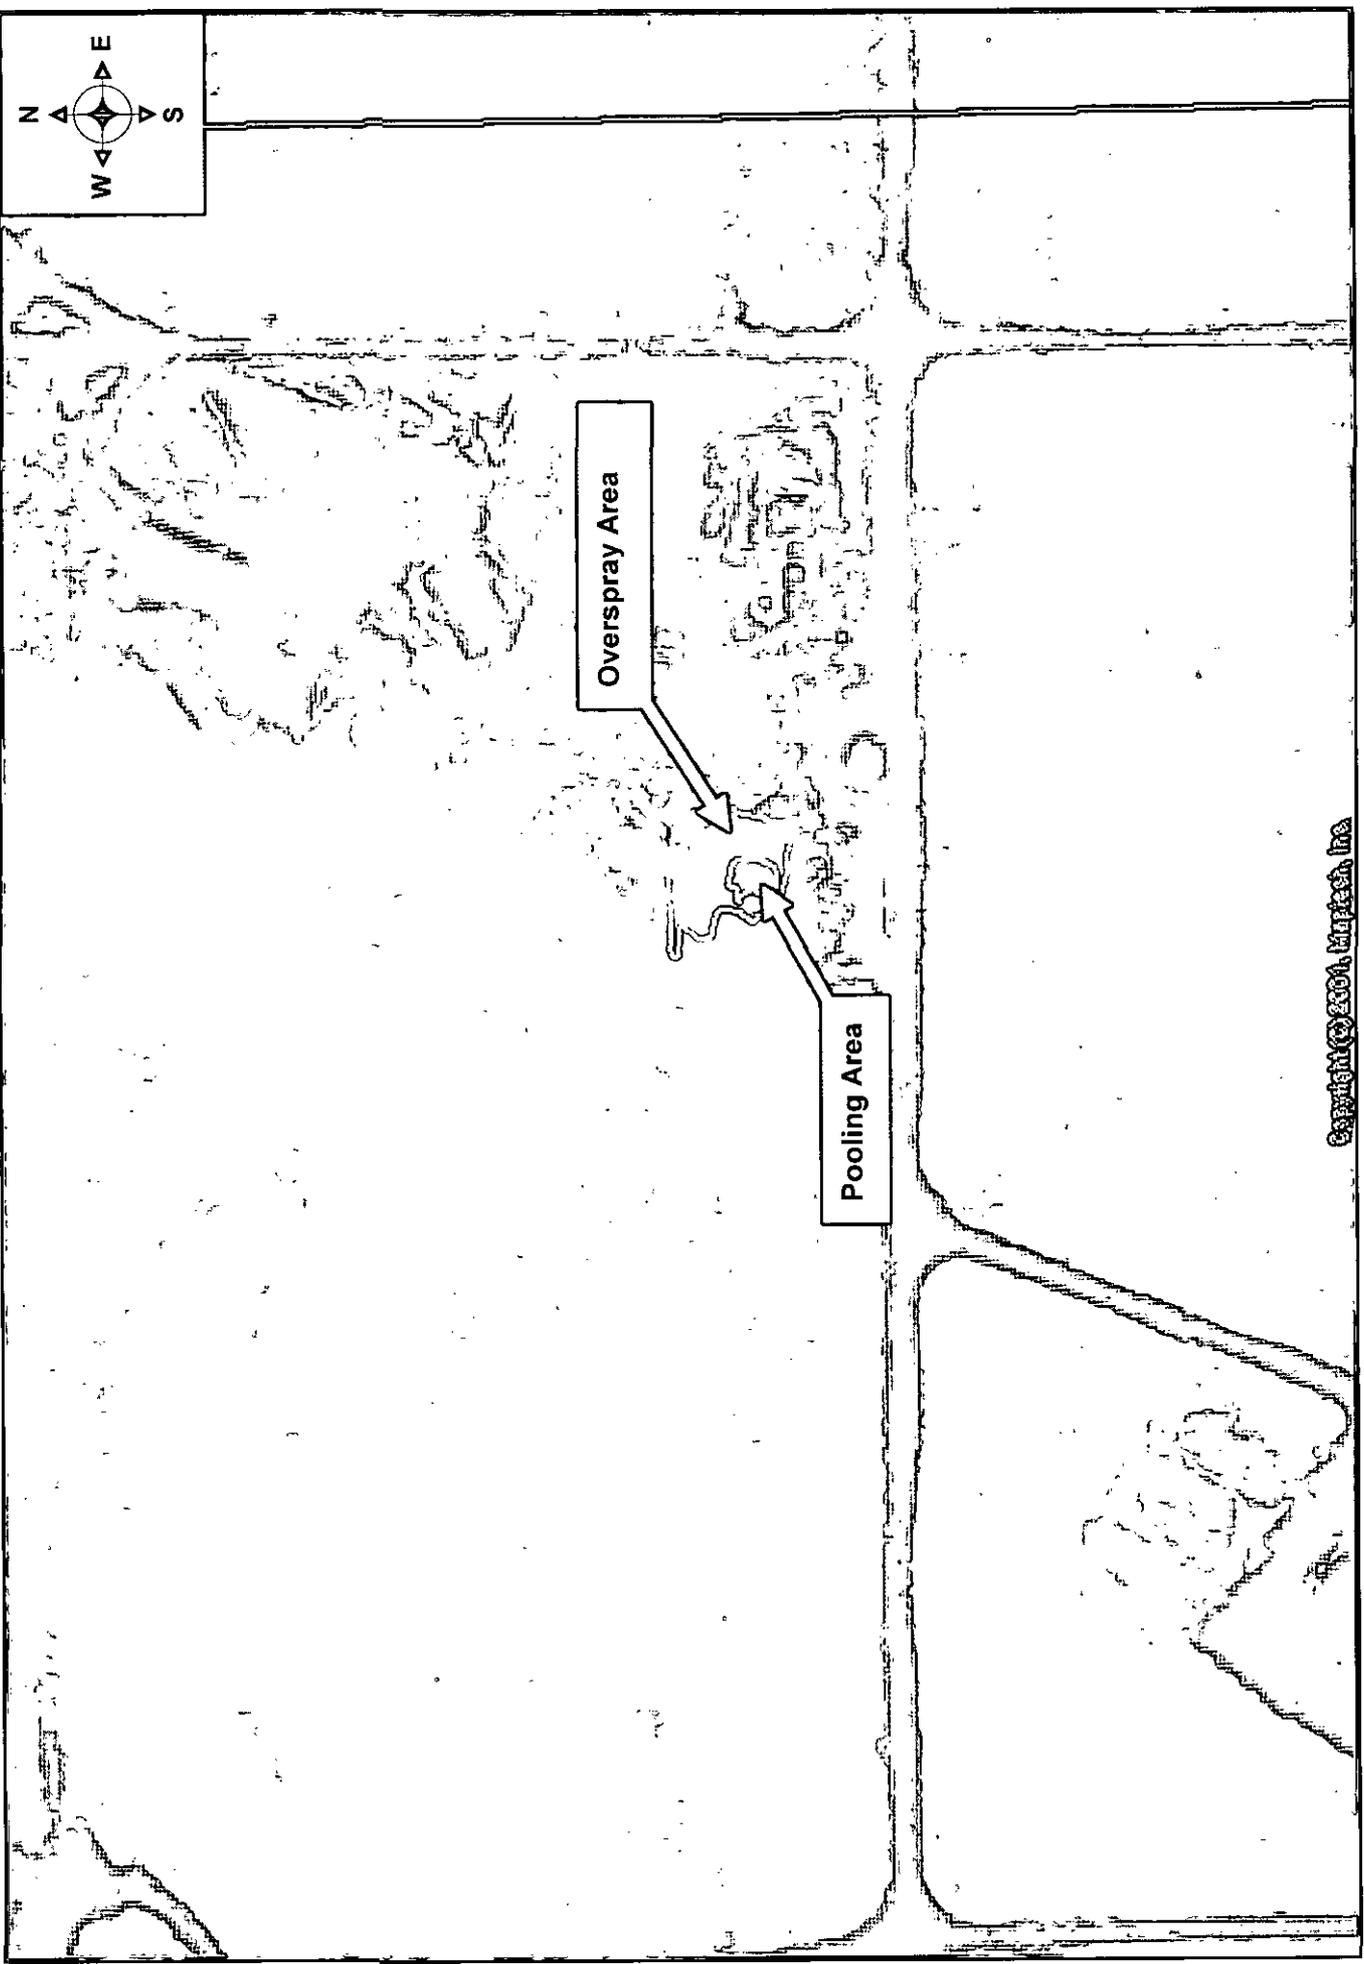
**Figure 2
Site Plan**

On July 1, 2009, SESI was onsite with Environmental Plus Inc (EPI). A test trench was installed in the center of the pooling area, the release point (See Figure 2). Grab samples were collected at 1' intervals from within the trench and transported under chain of custody to Cardinal Laboratories of Hobbs, New Mexico for analysis. The samples were analyzed for Chlorides (EPA Method 4500-Cl⁻B).

Overspray Area

Pooling Area

Based upon the analytical results, the vertical extent of TPH contamination was determined at a depth of 7'. Therefore, the entire pooling area was excavated to a depth of 7' bgl.

The overspray area surrounding the pooling area was excavated from a depth of 6" to 12" bgl. Grab samples were collected from the excavated areas and transported under chain of custody to Cardinal Laboratories for analysis. The samples were analyzed for Chlorides (EPA Method 300.0), Total Petroleum Hydrocarbons (EPA Method 418.1), and BTEX (EPA Method SWA-846 8021B).

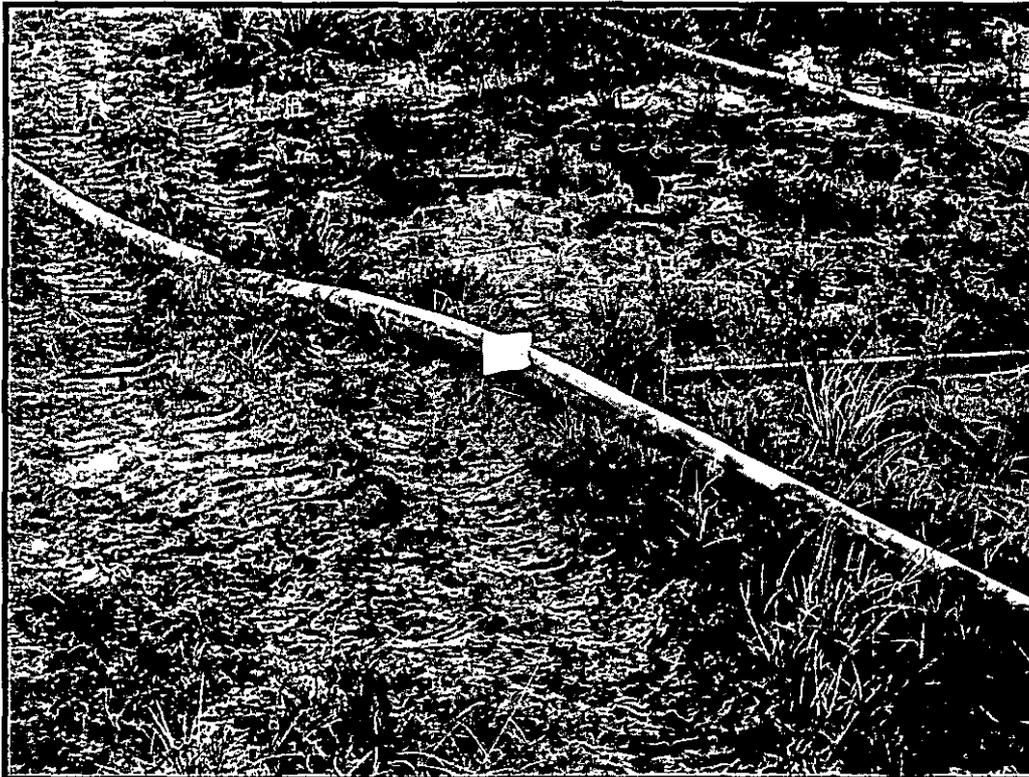
SESI utilized a hand auger to attempt to delineate the spill area at the release point. Auger refusal was encountered at a depth of 3'7" below ground level (bgl) due to the hard caliche layer. Grab samples were collected and transported under chain of custody to Cardinal Laboratories of Hobbs New Mexico, for analysis. In compliance to the New Mexico Oil Conservation Division (NMOCD) set of required sampling conditions, the samples were analyzed for Chlorides (EPA Method 4500-Cl⁻B), Total Petroleum Hydrocarbons (EPA Method 418.1), and Benzene, Toluene, Ethyl Benzene, and Xylenes (BTEX) (EPA Method SWA-846 8021 B).

Auger Hole #1 Facing West

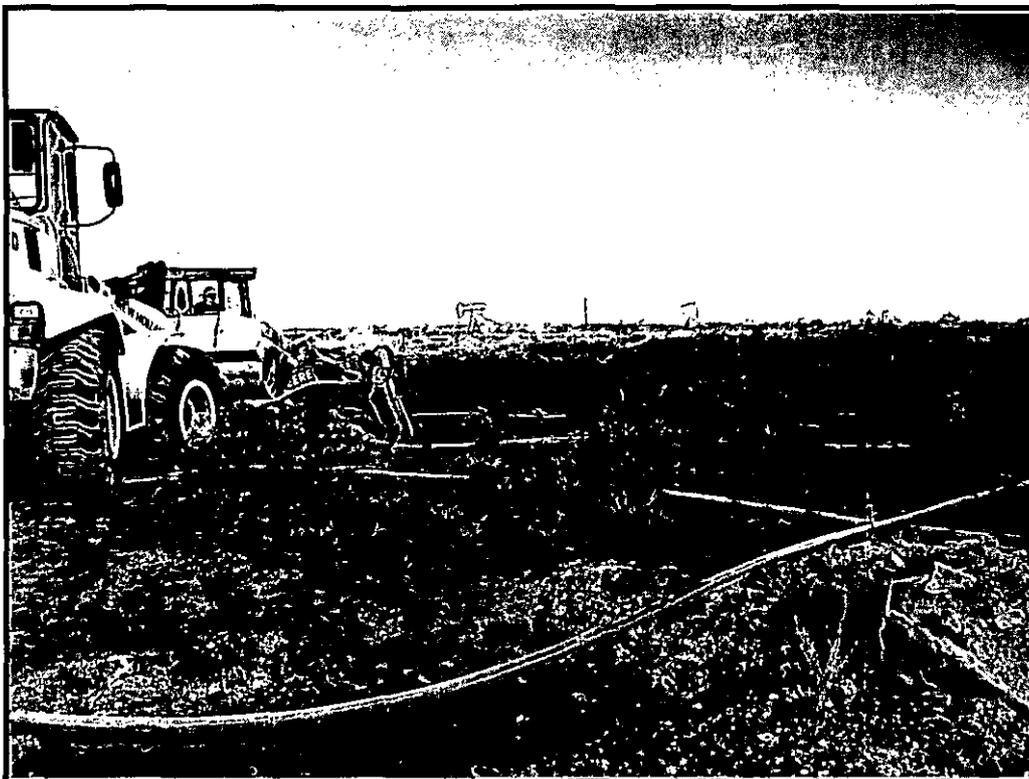
On June 26, 2009, SESI was onsite to map the affected area. The area was mapped using a Trimble Geo XM GPS. SESI observed overspray to the North of the battery with minor staining to vegetation and soil. Produced fluid ran off location and mixed with rain water on lease road. Two (2) vacuum trucks were utilized to recover 200 barrels of produced fluid, which included the standing rain water on the lease road.

Impacted Area Facing NW

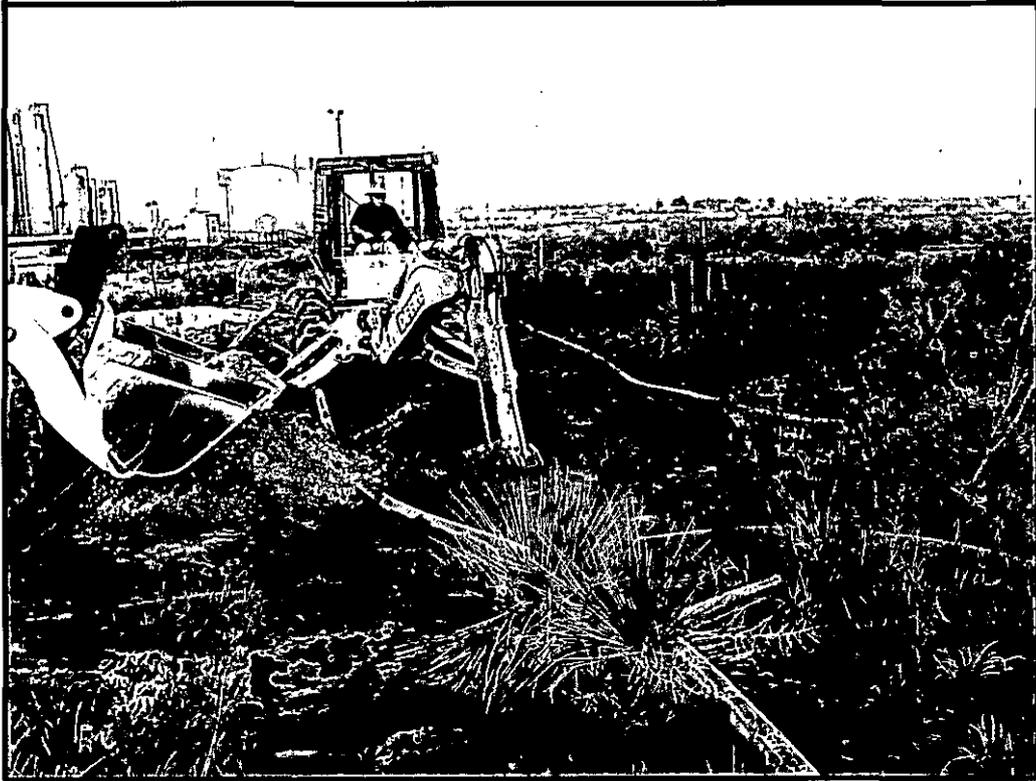
Excavating Test Trench Facing West

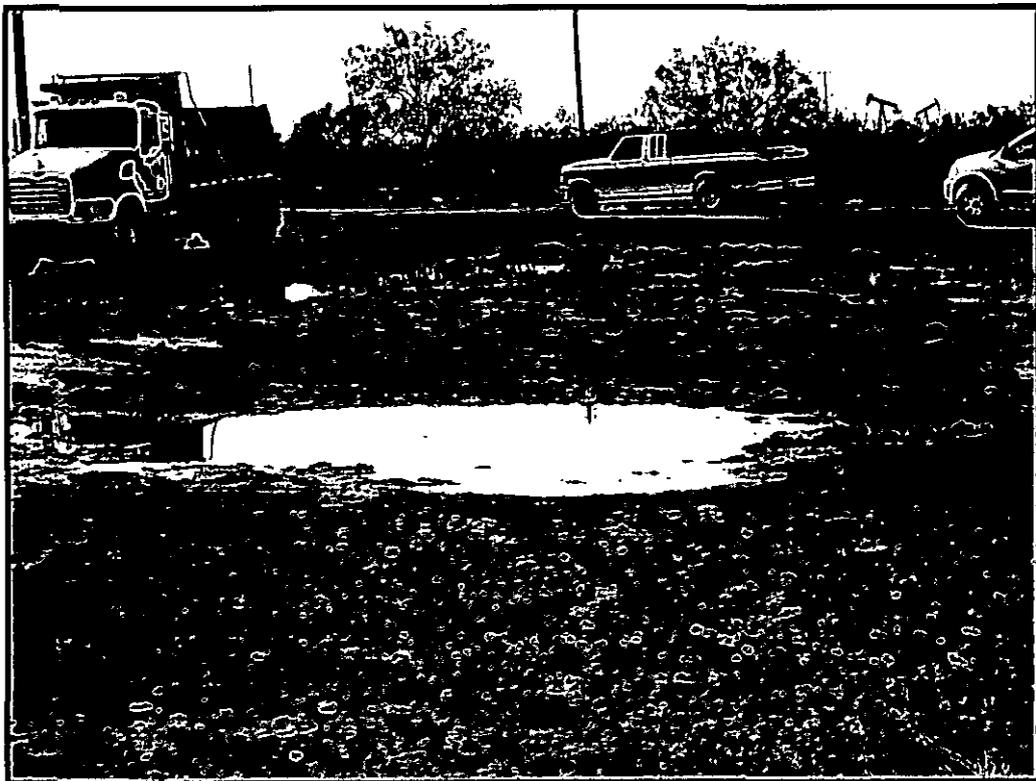
Run Off Area on Location Pad

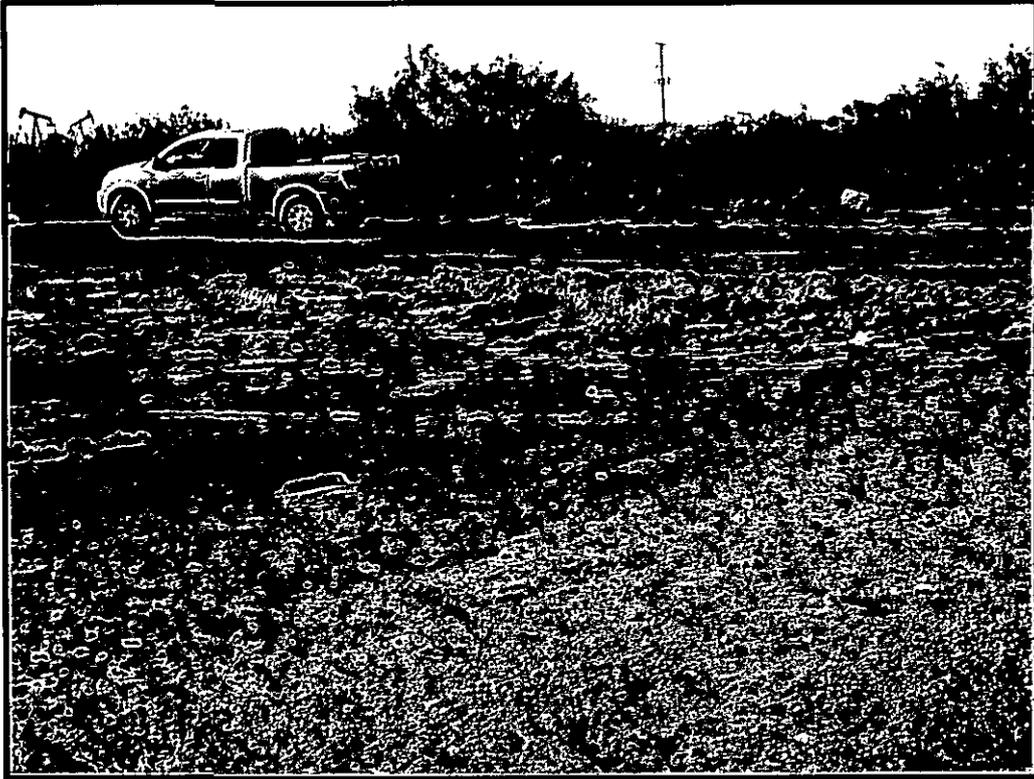
Run Off Area on Location Pad and Edge of Road

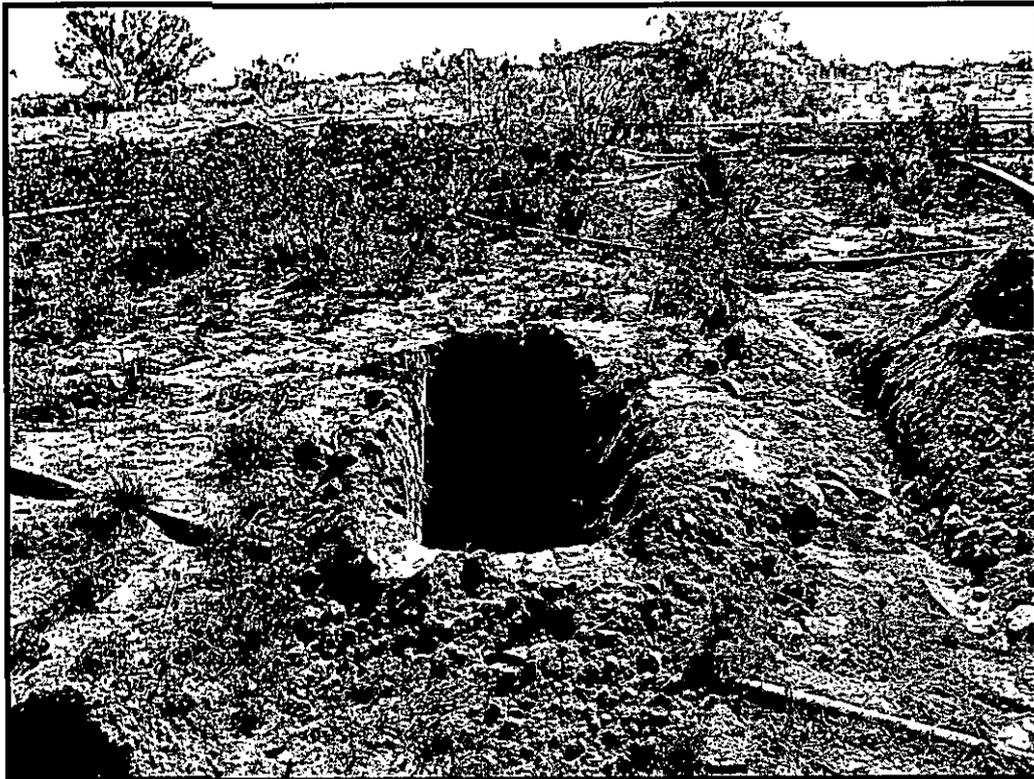
On July 2, 2009 SESI was onsite. Composite samples were collected from each of the walls and from the bottom of the test trench. Field analysis indicated the chloride levels to be below 250 ppm. Comparative samples were collected and transported under chain of custody to Cardinal Laboratories, of Hobbs New Mexico for analysis. The samples were analyzed for Chlorides (EPA Method 4500-Cl⁻B).

Test Trench #1

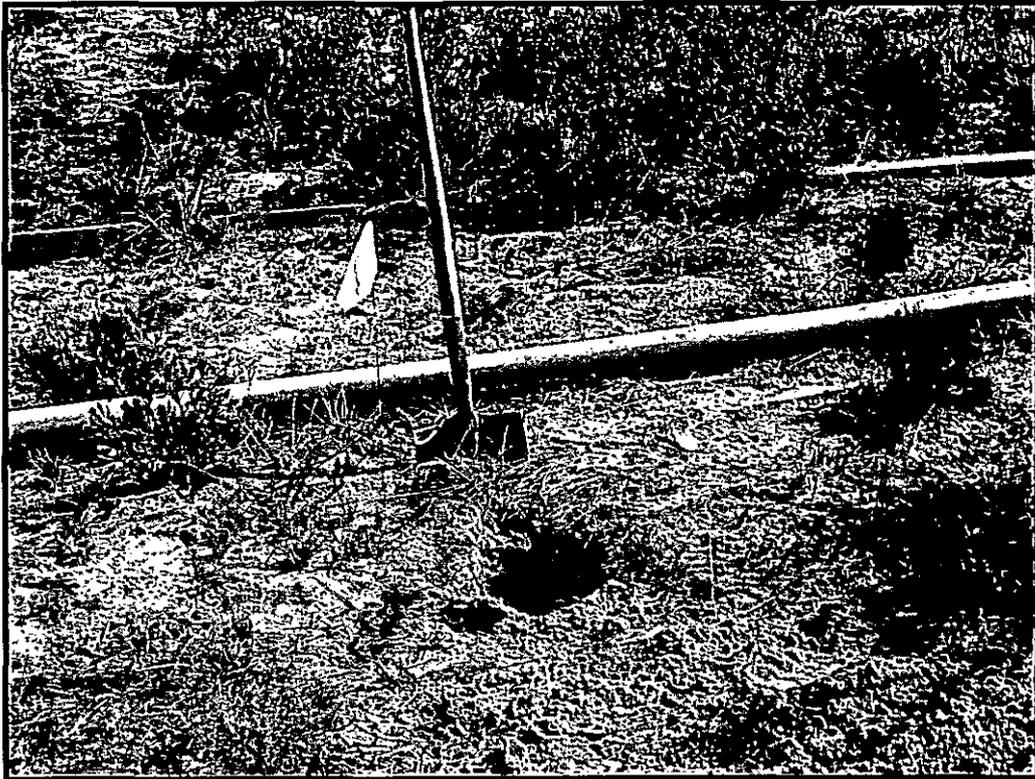
Sample Point #2

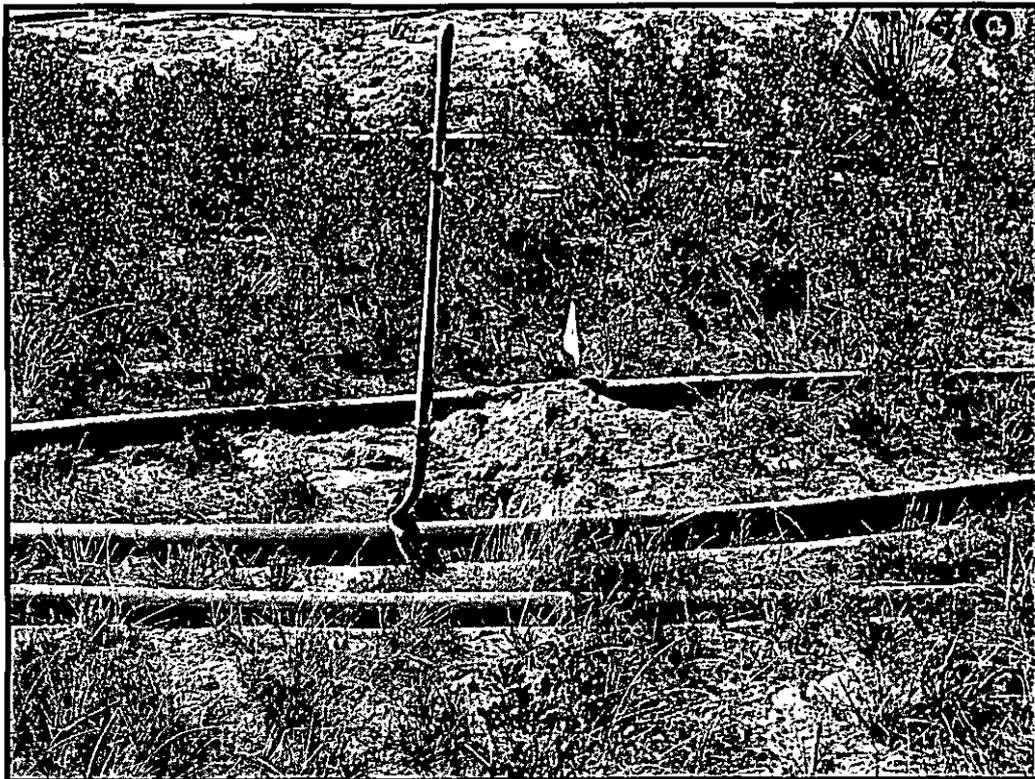
Sample Point #3

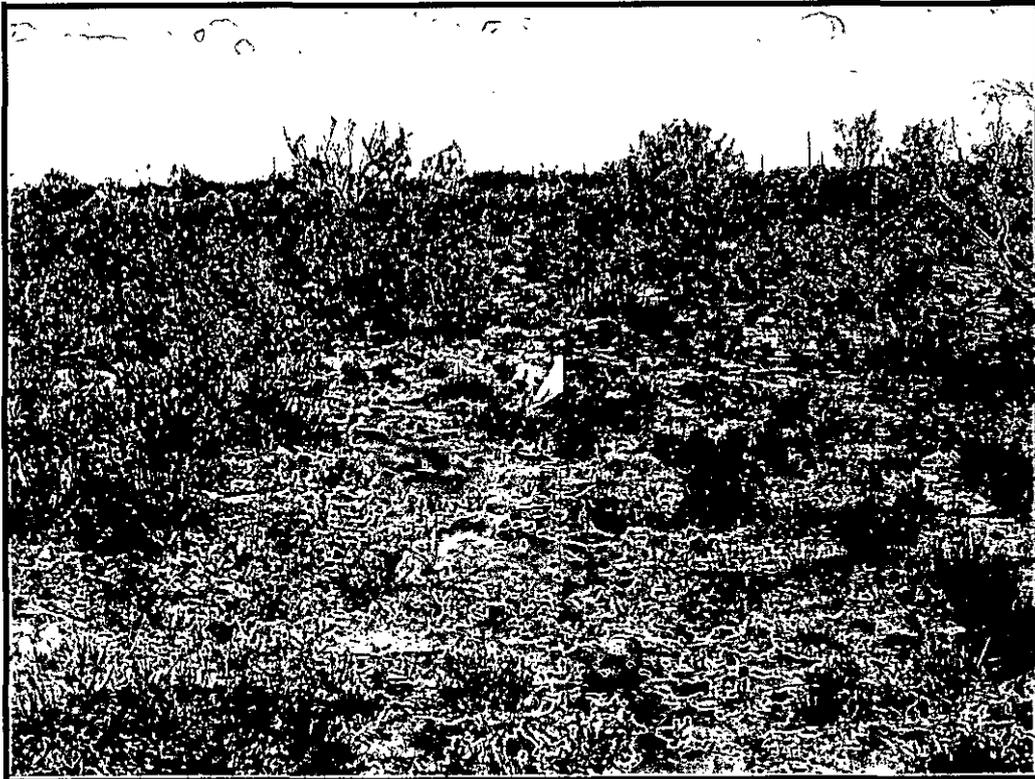
Sample Point #4

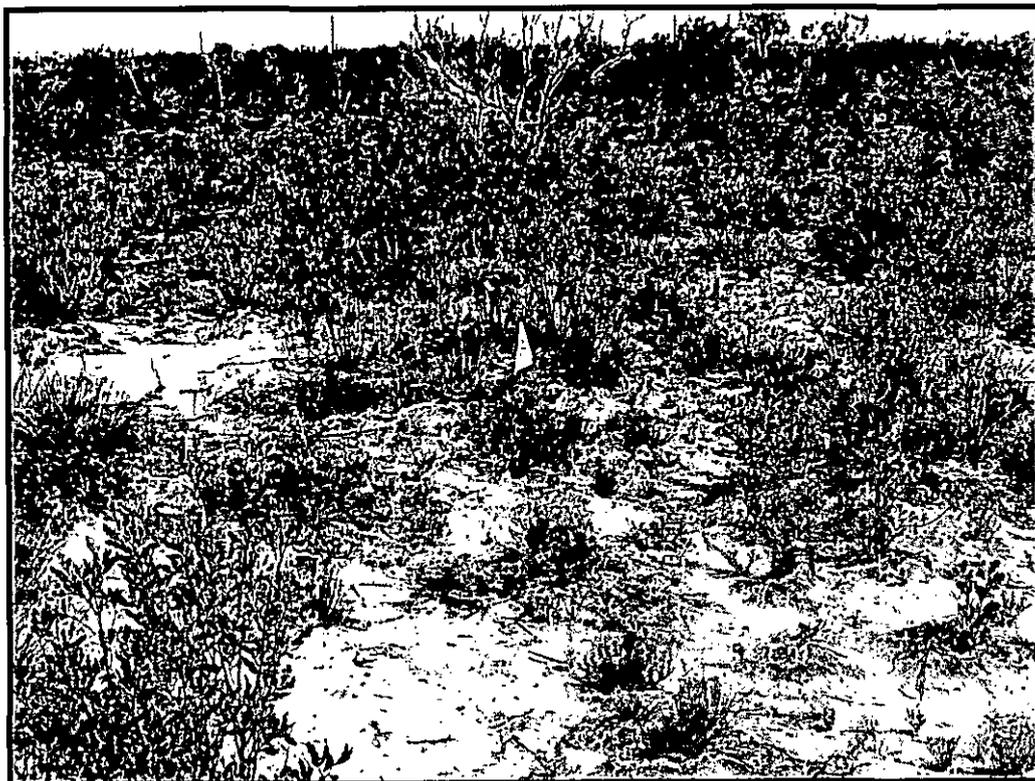
Sample Point #5

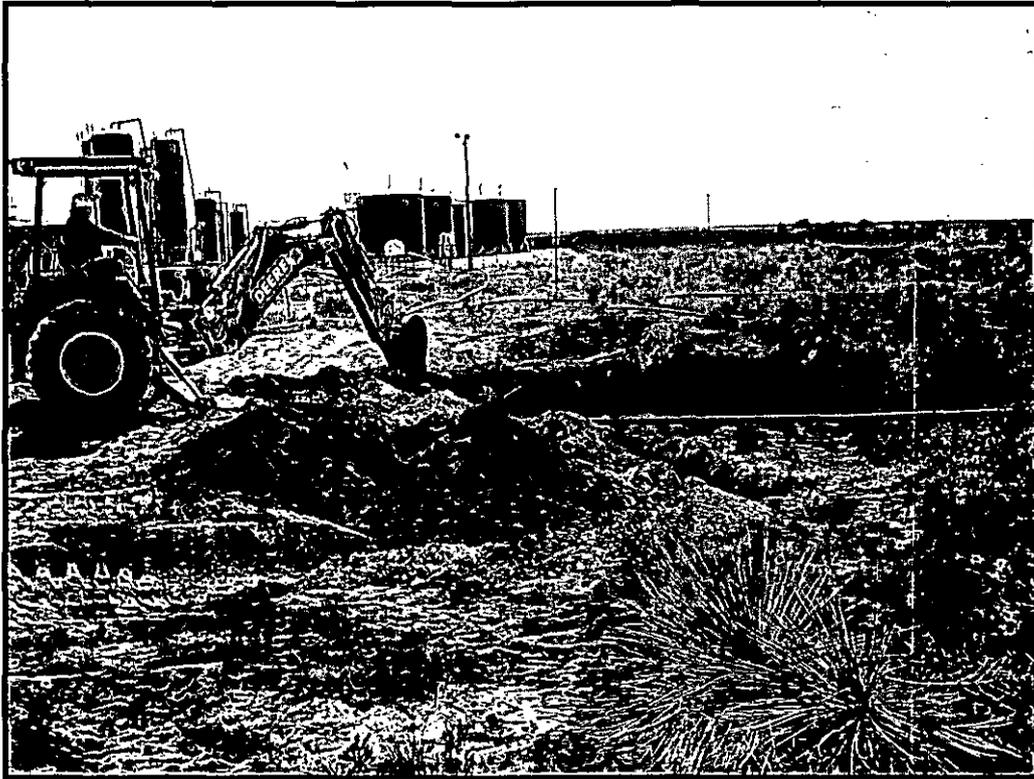
Excavating "Pooling Area" Facing West

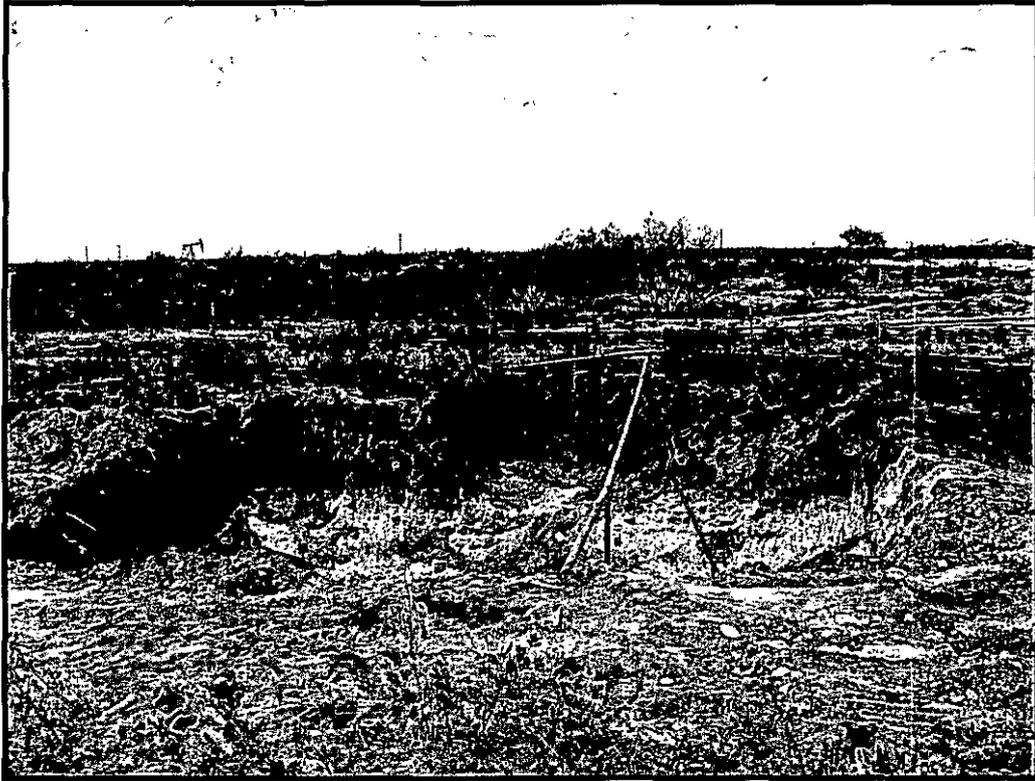
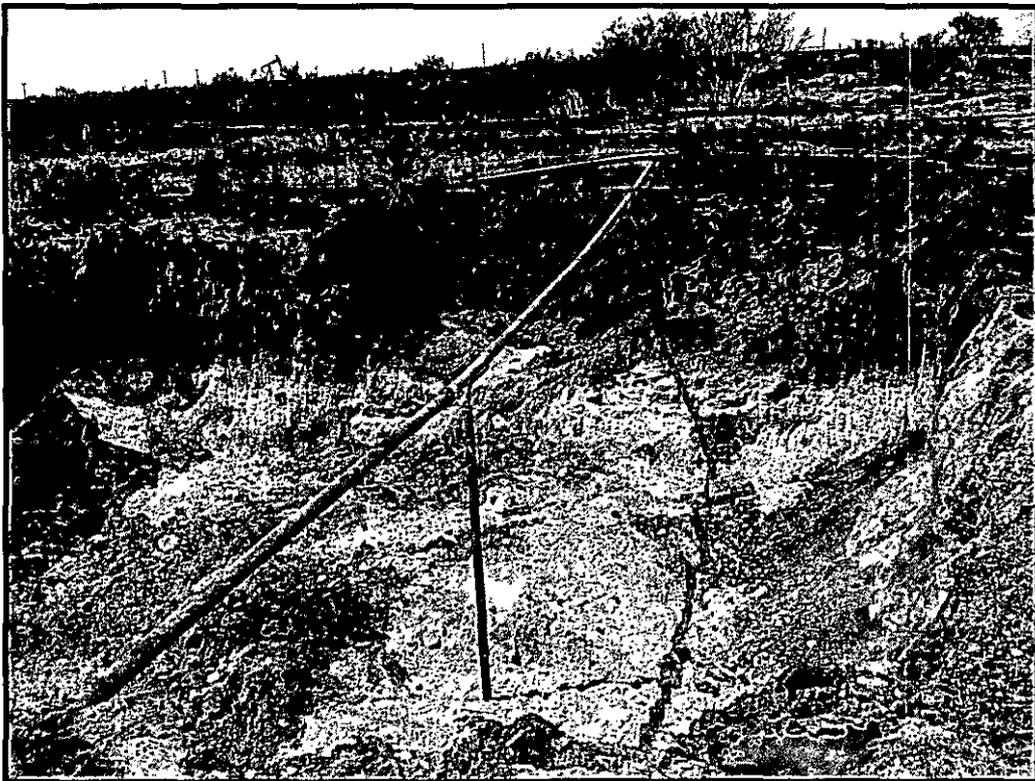
"Pooling Area" Excavated to 7' bgl Facing North

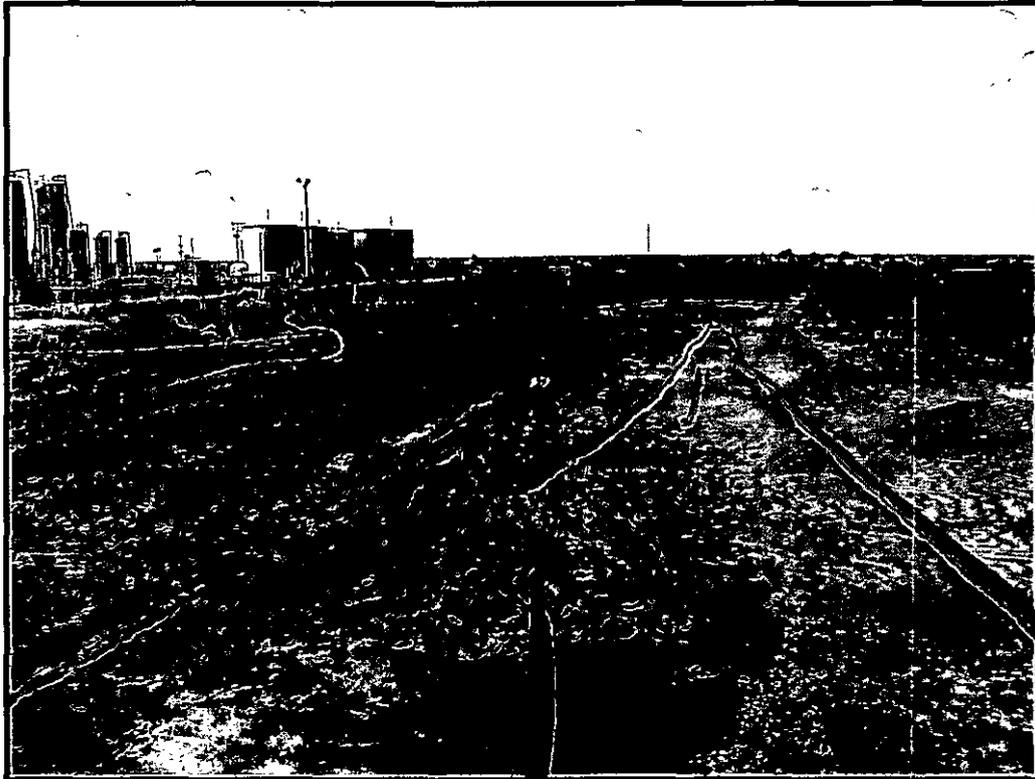
Excavated Area Facing West

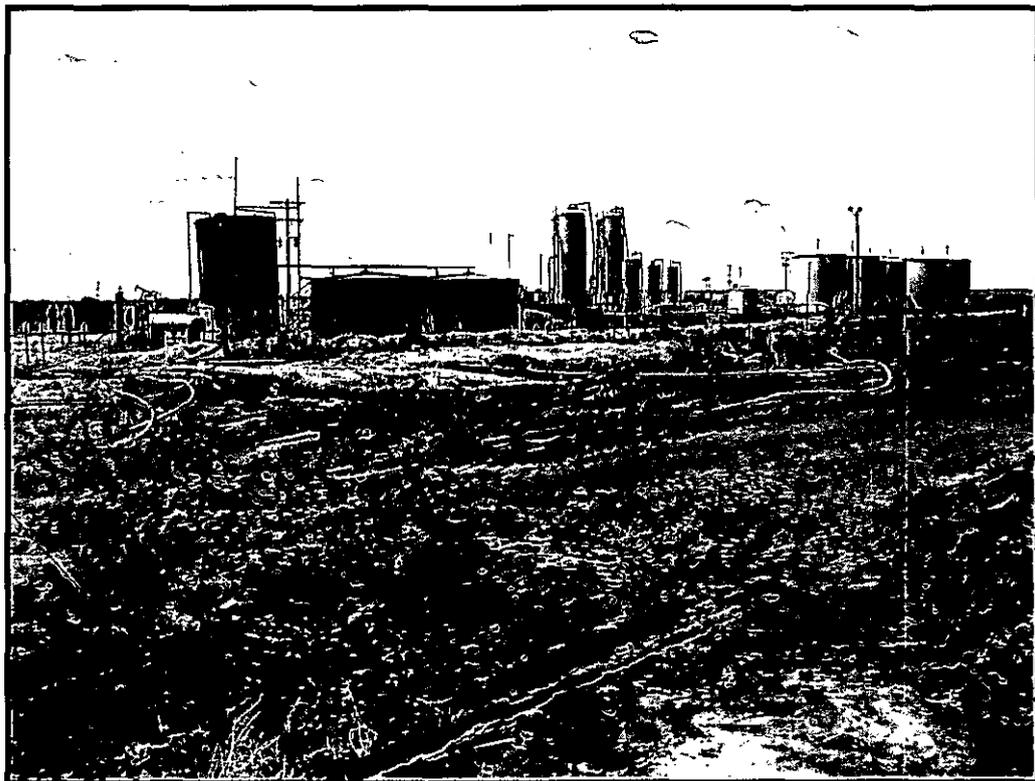
Excavated Area Facing SW

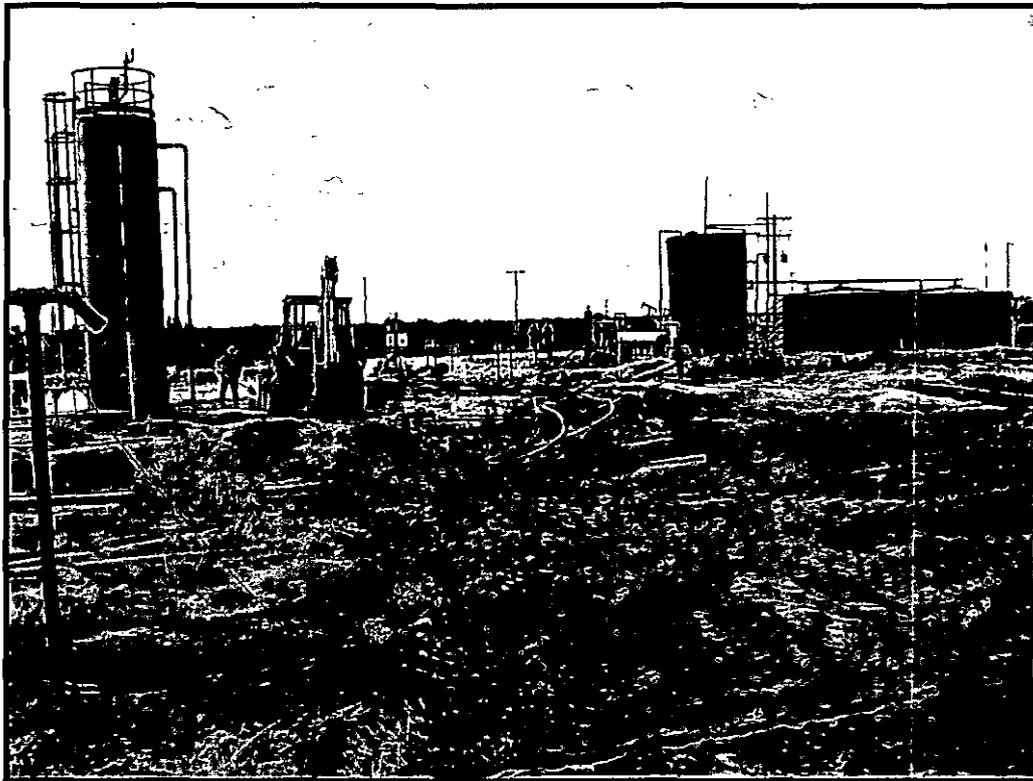
Excavated Area Facing South

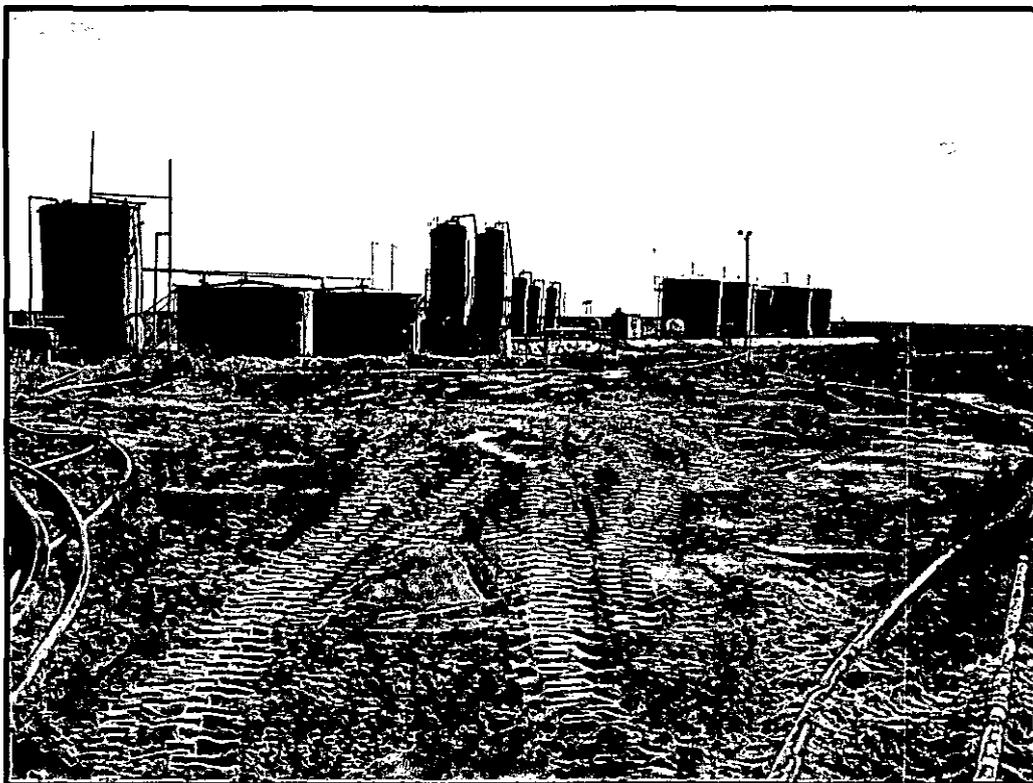
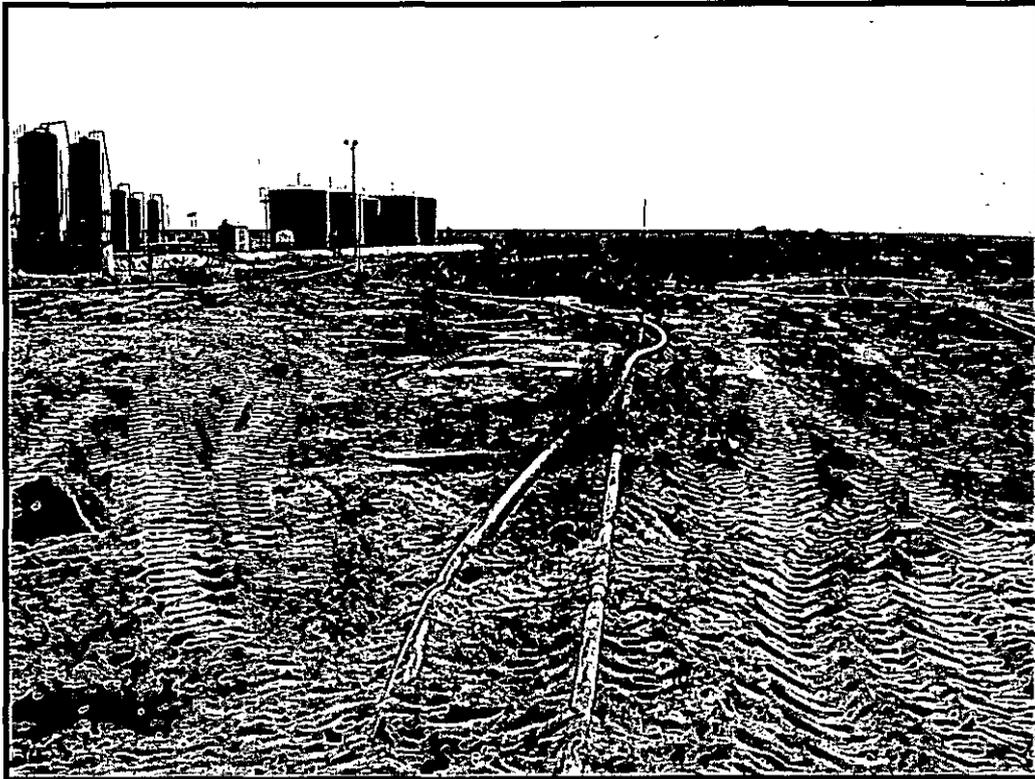
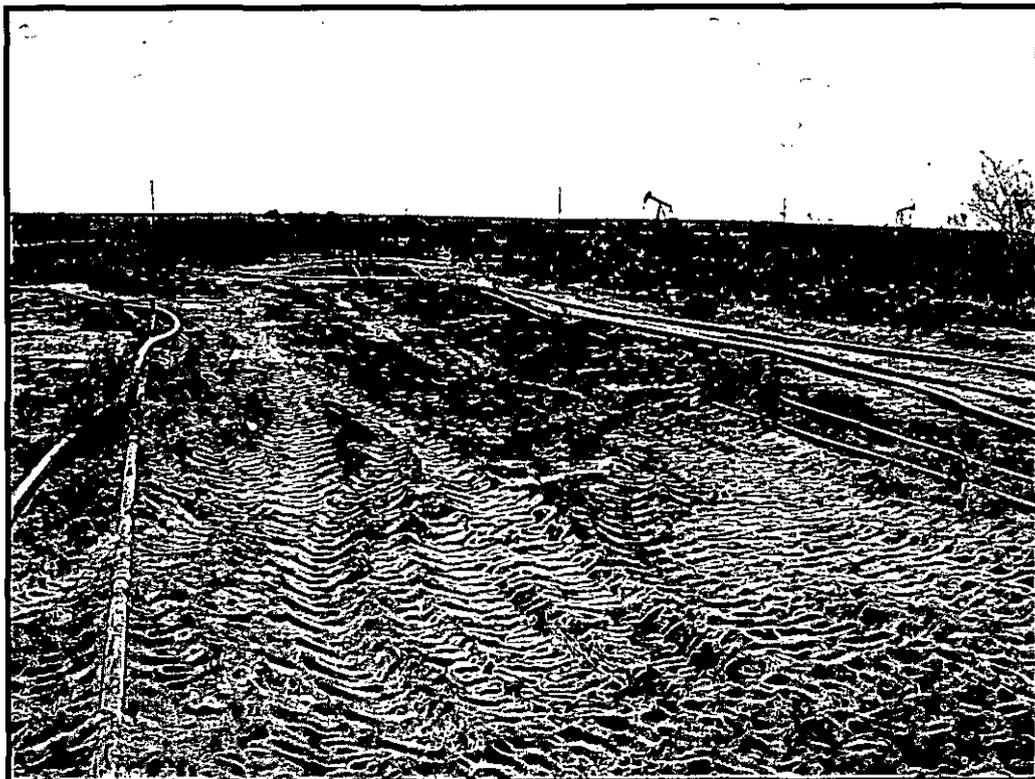
Backfilled Excavation Facing SW

Backfilled Excavation Facing West

Backfilled Excavation Facing NW

On July 6-7, 2009, SESI was onsite with EPI. A total of 378 yards of contaminated soil was transported to Sundance Services, a New Mexico Oil Conservation Division (NMOCD) approved facility for disposal. The pooling area was then backfilled to 3' bgl with a total of 112 yards of caliche, then from 3' bgl to surface with 238 yards of topsoil. The excavated overspray areas were also backfilled with topsoil and contoured to grade.
