Update Report
Environmental Remediation
Sampling Investigation
Dig & Haul Operations

Doral Energy Operating
Amoco #3 Tank Battery
Environmental Remediation
(Historic Minor Spill Inside Tank Battery)

Lease:
Amoco #3 Tank Battery
Location 660 FSL & 660FWL of Sec 26 -T7S-R31E
Coordinates: N 33.67234 W-103.75095
API #30-005-20634
Chaves County, NM

October 3rd, 2011

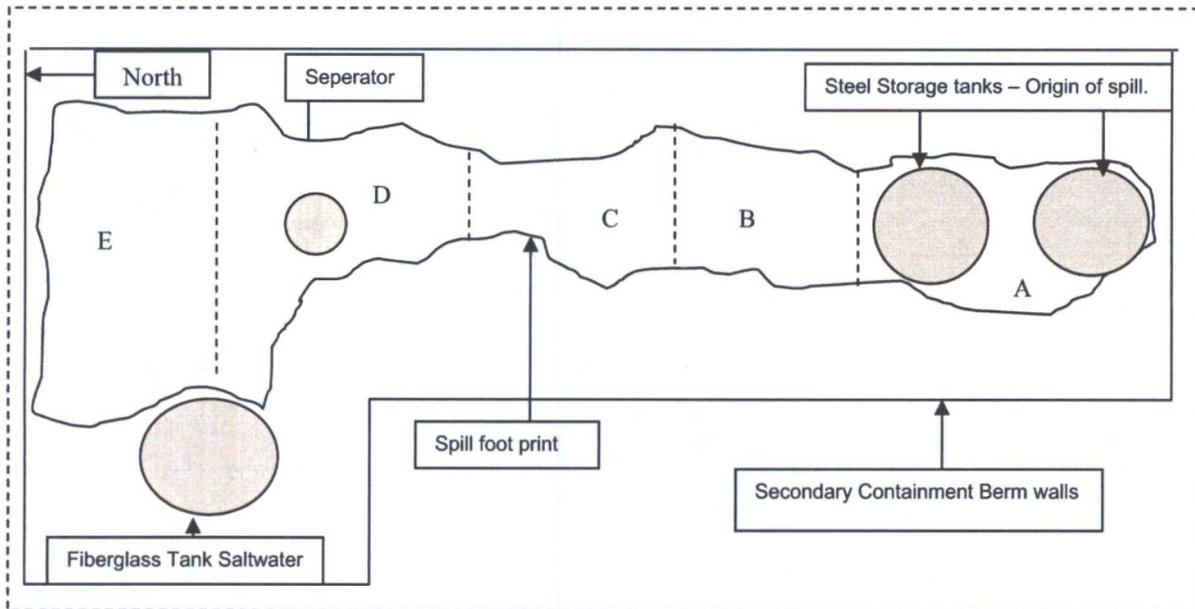
The sampling grid area consisted of five sections within the tank battery berm:

Contaminated Area Delineated: Soil borings with field and laboratory analysis indicated the oil/saltwater spill to be an approximate averaged area of 95ft X 20ftX1.5ft depth.
