Reference: 1RP-2781

**Executive Summary
Chaparral Energy, LLC
Yates State No. 2
Spill Remediation Report**

Chaparral Yates State No. 2

**Remediation and Site Restoration Protocol
Chaparral Energy Co. LLC.
Yates State #2
1RP-2781**

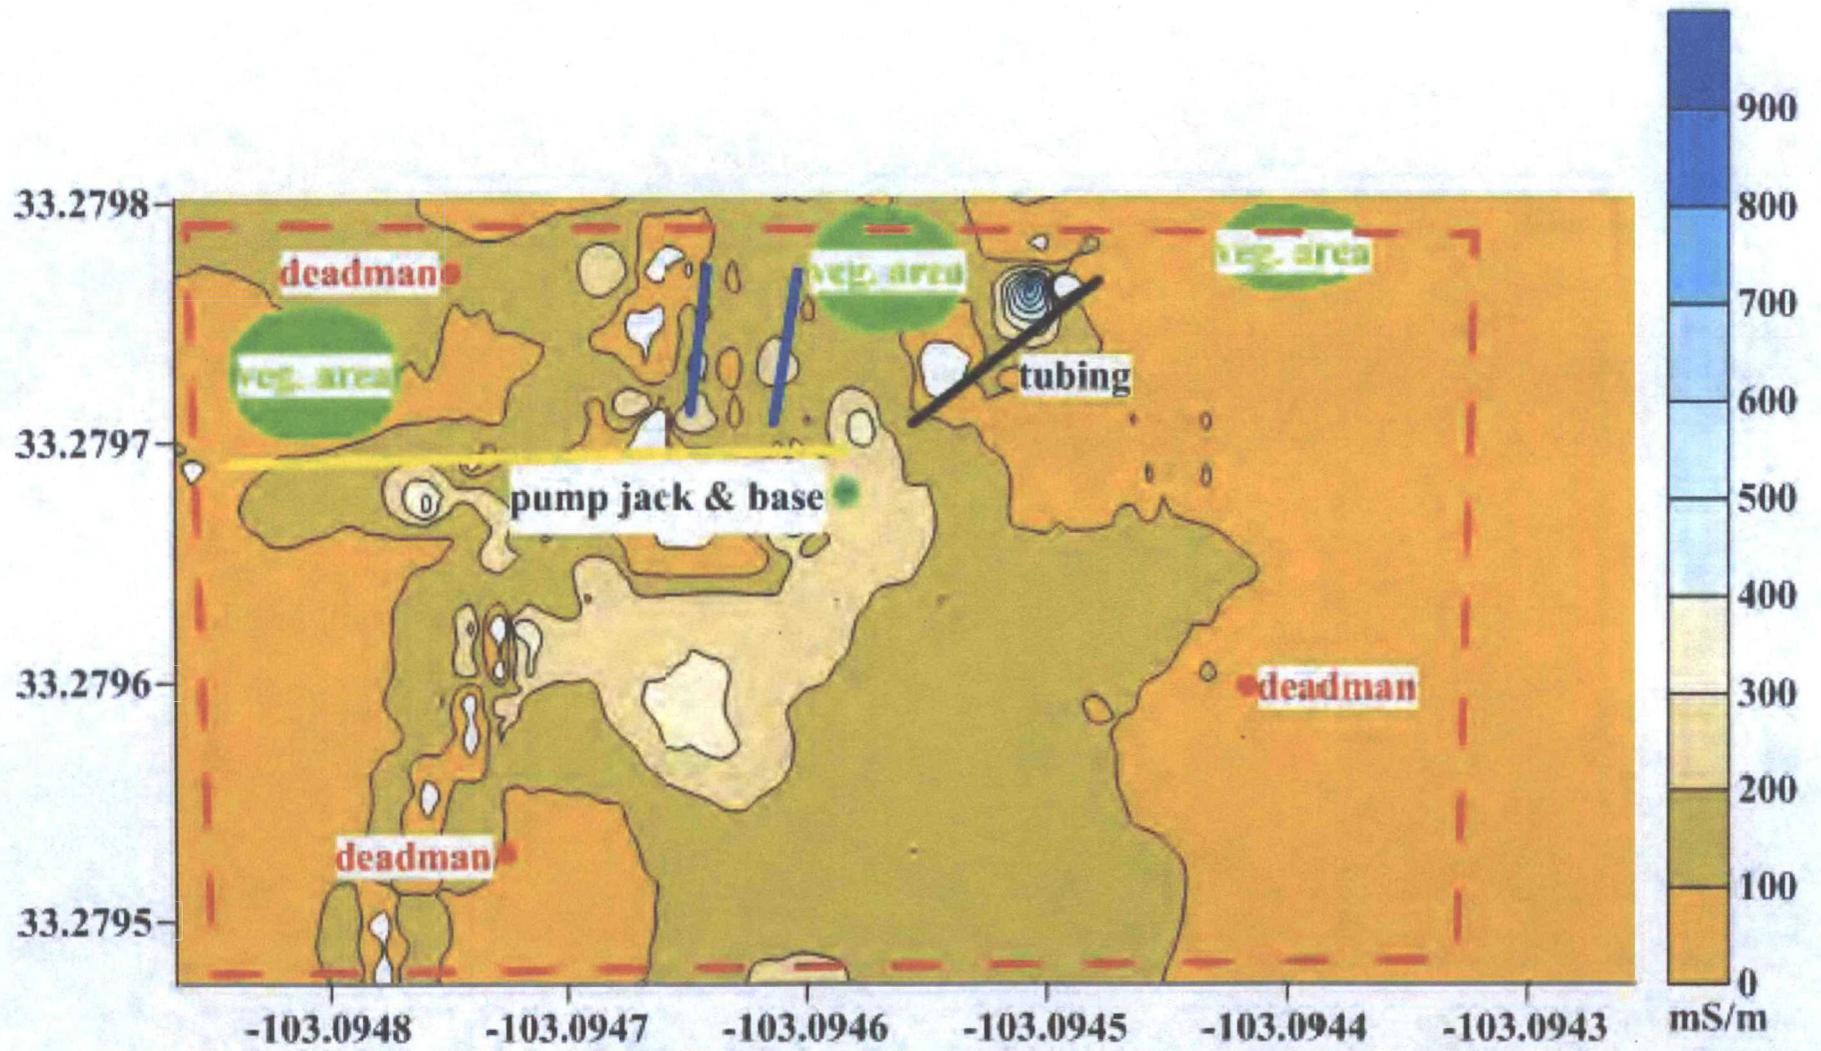
Chaparral Energy LLC.
Yates State #2
API#30-025-30255
UL/H Sec-16 - T12S - R38E
2310' FNL & 330' FEL
GPS Lat & Lon WGS84
N33.2796459383444 / W103.09452468313
Depth to GW: 8' > 20'
2-1-12 EM38 Survey Vertical

Whole Earth Environmental ran an EM38 survey in the vertical mode (0>5') and then advanced a series of three bores and found the majority of the contamination to be superficial, however the area immediately adjacent to the wellhead had elevated chlorides to a total depth of 10' below ground surface.

5.1 The area impacted by the produce water and oil spill will be excavated to depth of 4' below ground surface, and set a geo-textile liner at the bottom of the excavation. Using the dimensions from the previously run EM-38 Survey, the excavated dimensions should be approximately 20' x 60'. The excavated materials will be transported to Gandy / Marley facility near Caprock, NM and be replaced with fresh caliche.
