**Release Report/ C-141**

**Val Verde/ Blanco D  
Turbine**

Release Notification and Corrective Action

**Response/Remediation Plan  
Enterprise Field Services, LLC  
Blanco Plant D-Turbine Lube Oil Release Site  
Unit Letter O Section 11 Township 29 North  
Range 11 West**

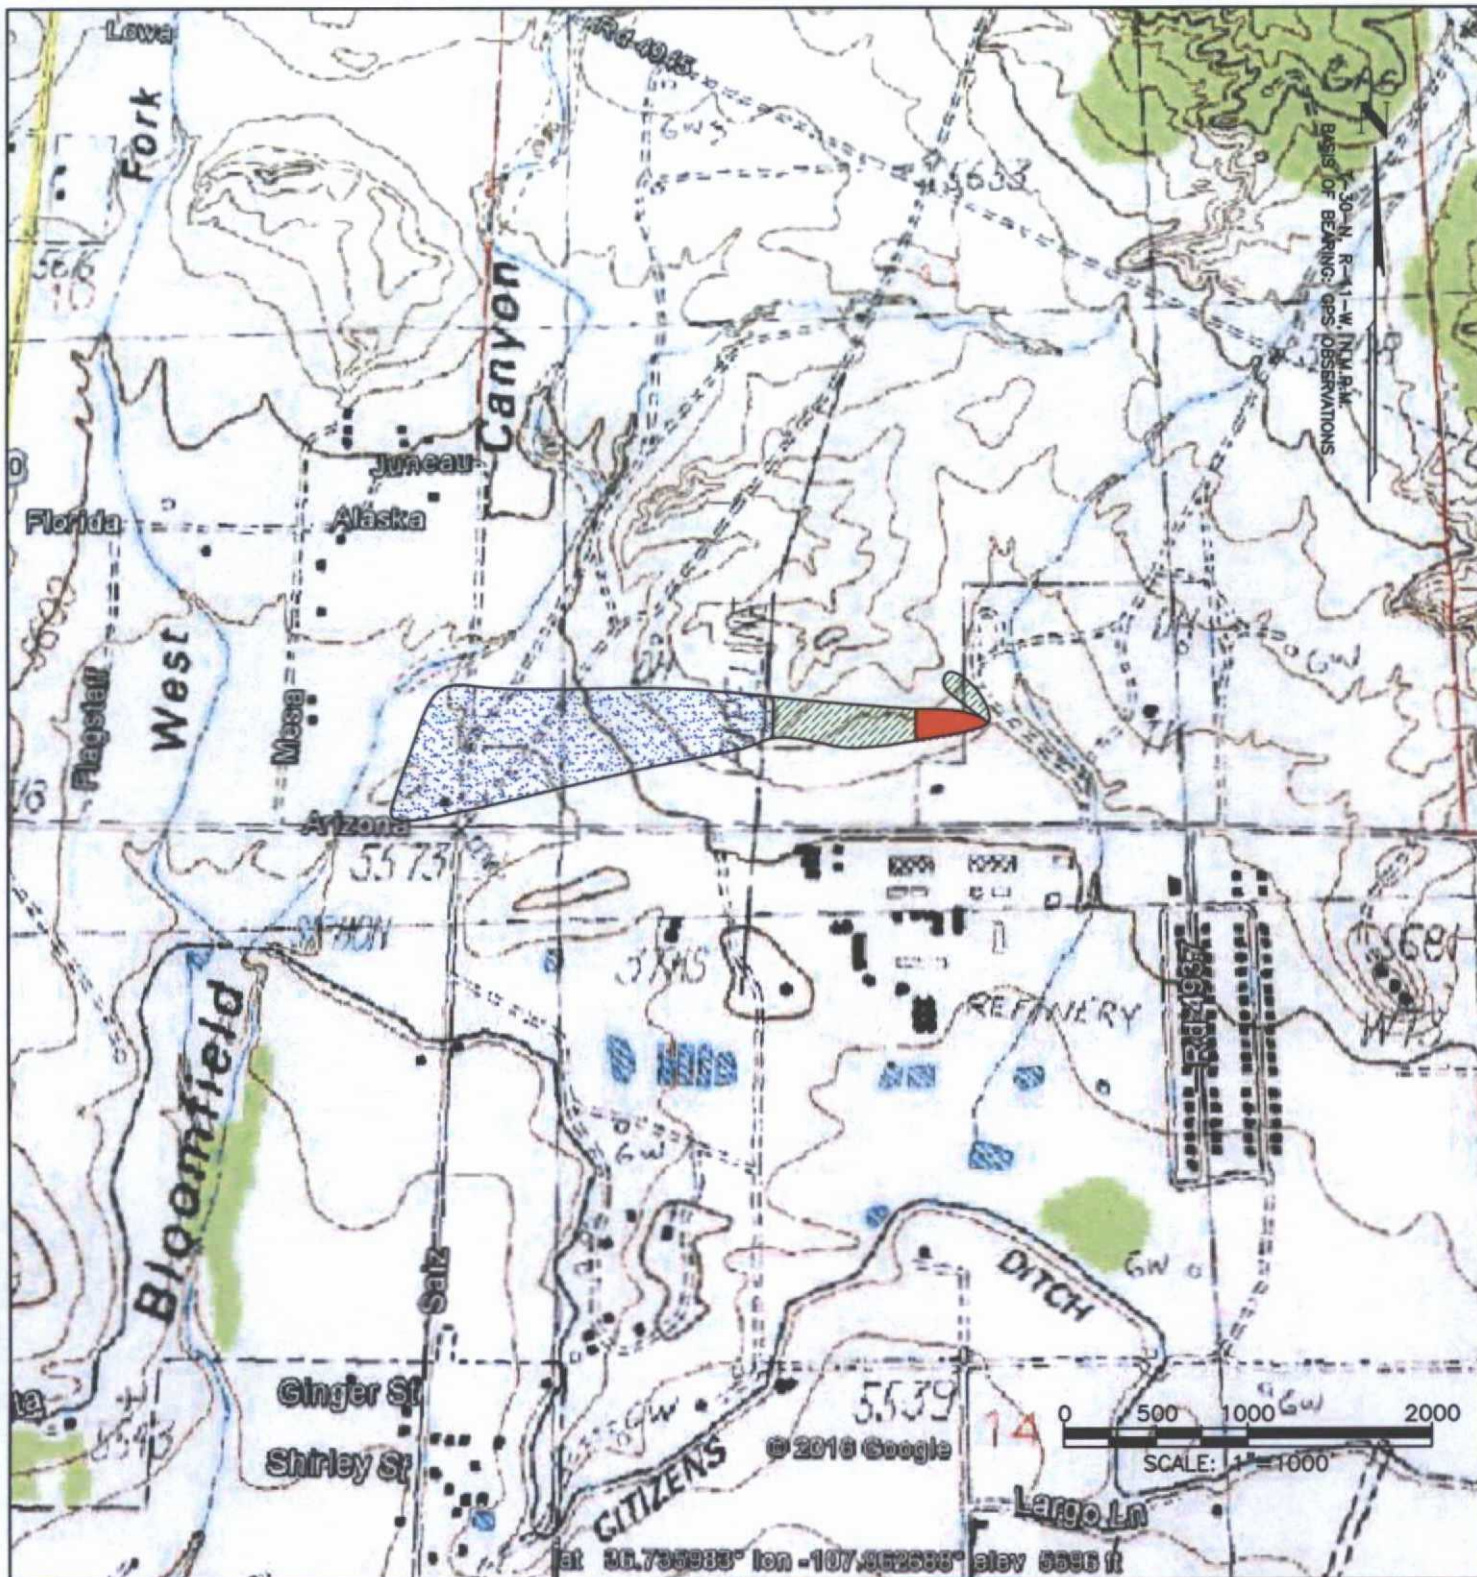
### FIGURE 1: VICINITY MAP

- SATURATED ZONE
- OVERSPRAY ZONE
- MIST ZONE

ENTERPRISE PRODUCTS, LLC  
BLANCO PLANT D TURBINE LUBRICATION OIL RELEASE  
BLOOMFIELD, NEW MEXICO

Enterprise Field Services, LLC (Enterprise) is submitting this response/remediation plan to the Bureau of Land Management (BLM) to mitigate a release of lubrication oil associated with a turbine vent pipe located at Enterprise Products Operating, LLC Blanco Plant D facility (the Site). The initial release occurred on May 3, 2016. A subsequent release occurred on May 4, 2016. The release site is located in Unit Letter K Section 23 Township 26 North Range 6 West. The GPS coordinates for these releases are 36.734617, -107.960433. The attached Vicinity Map (Figure 1) illustrates the location of the release and downwind impacts.

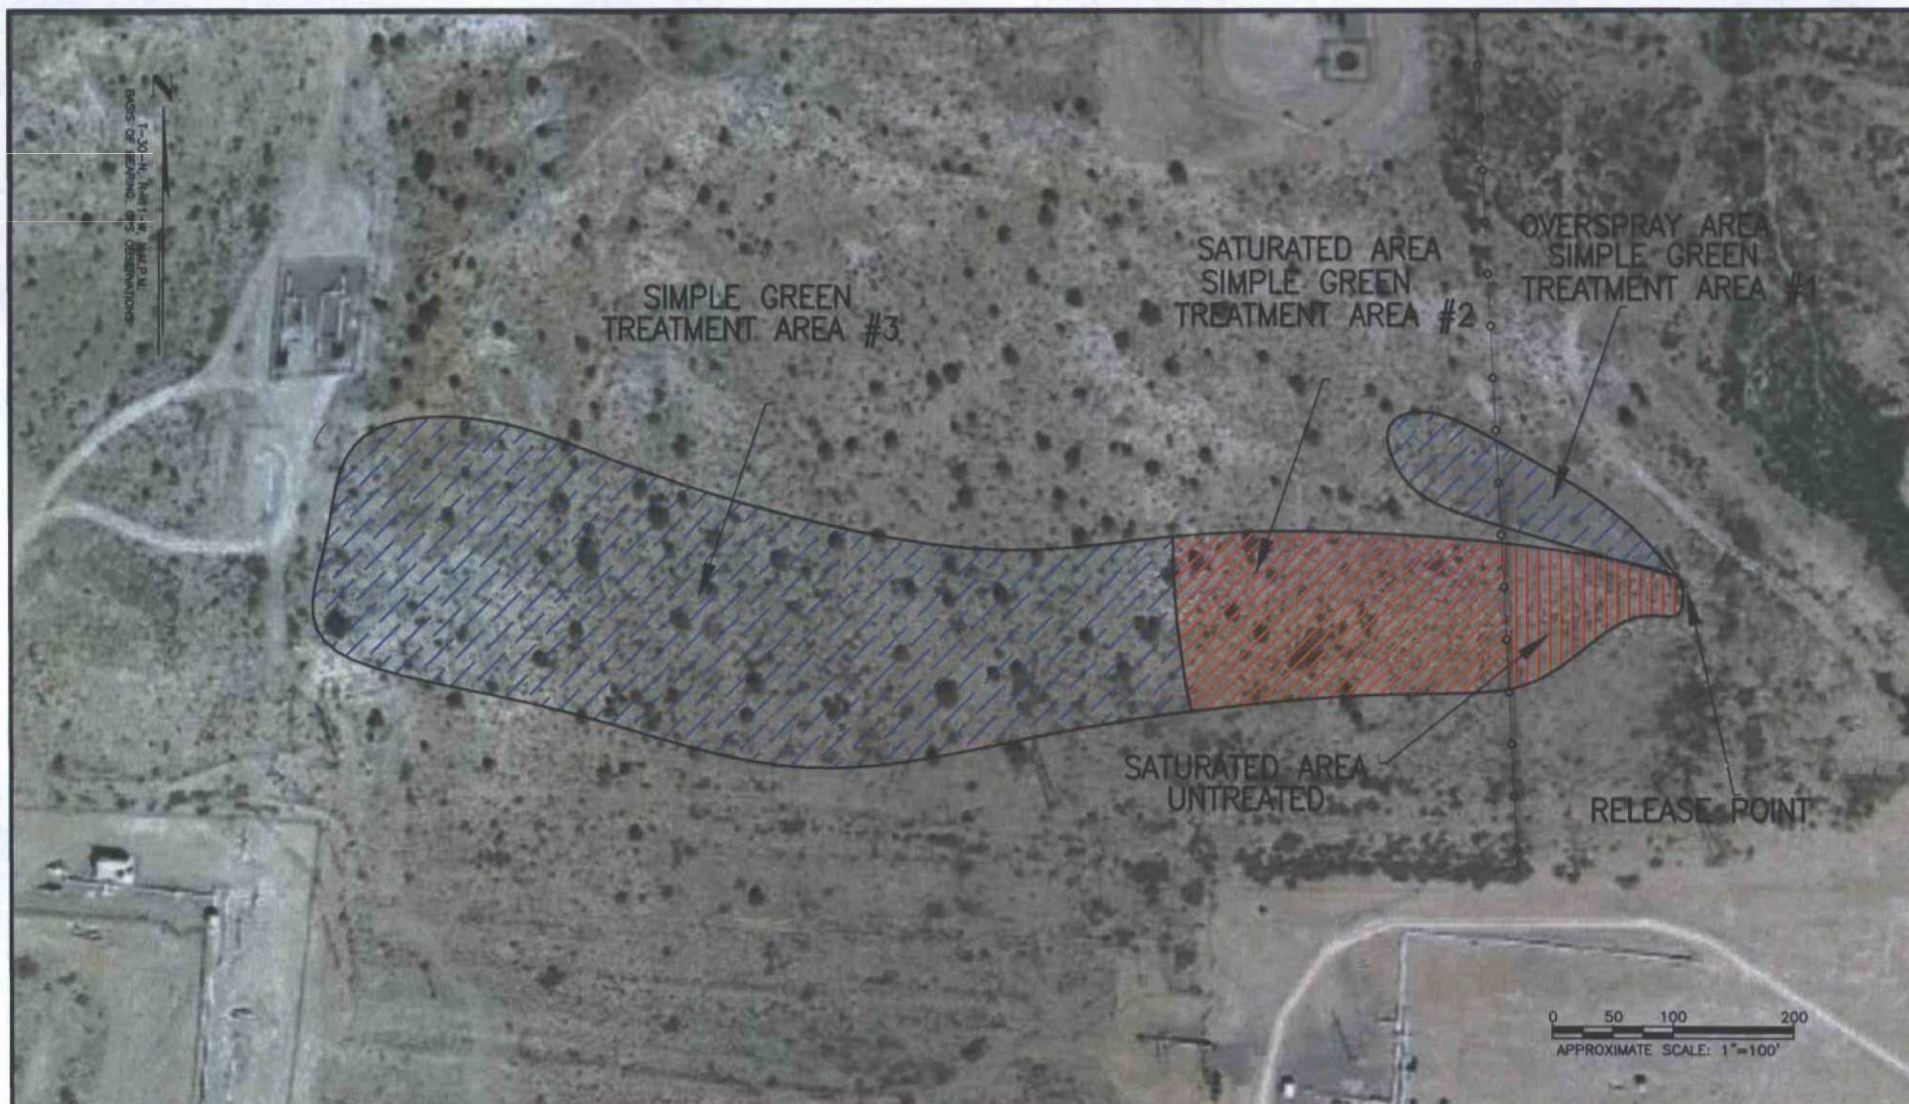
**FIGURE 2: SITE MAP**  
 ENTERPRISE PRODUCTS, LLC  
 BLANCO PLANT D TURBINE LUBRICATION OIL RELEASE  
 BLOOMFIELD, NEW MEXICO

- SATURATED ZONE
- SATURATED ZONE/UNTREATED
- OVERSPRAY ZONE

Describe Area Affected and Cleanup Action: An area of approximate 408 feet long by 140 feet wide was saturated with lubrication oil. An overspray area of approximately 700 feet long and 150 feet wide was impacted. An area of approximately 0.5 miles long by 200 feet wide was misted with the lubrication oil. Residents located to west of the facility were impacted. Mobile homes and vehicles were impacted with a mist of lubrication oil. Enterprise provided cleaning services for impacted property owner's vehicles. Seventeen vehicles were cleaned by Donny's Power Wash Company. Enterprise has developed a remediation plan which has been approved by BLM and NMOCD. Enterprise will implement this plan as soon as all contractors are available and a job plan safety analysis has been completed. A third party corrective action report will be included with the "Final." C-141.
