Re: Remedial Action Report
Jay Management Company, LLC
Satellite No. 1 Tank Battery
Bagley North Field - Lea County, New Mexico
Reference No.: IRP-3691

AREA MAP
REMEDIATION ACTION REPORT
 JAY MANAGEMENT COMPANY, LLC
 SATELLITE NO. 1 TANK BATTERY
 BAGLEY NORTH FIELD - LEA COUNTY, NEW MEXICO

RELEASE AREA MAP

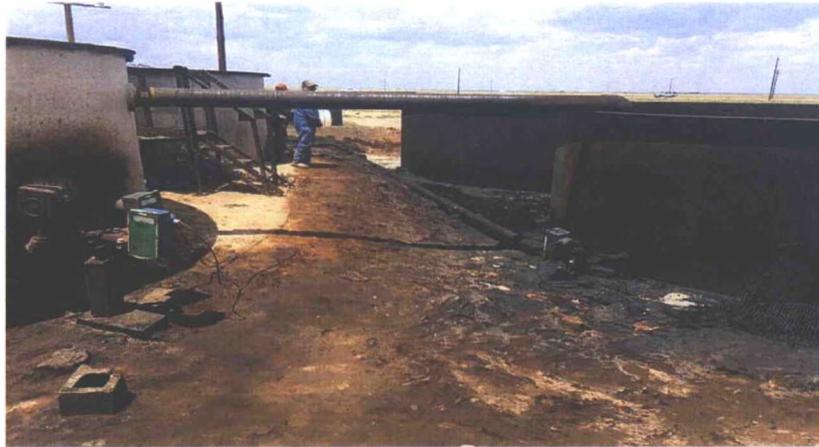
Photograph No. 1

View of the tank battery before remedail activities.

Note: hydrocarbon staining on surface.

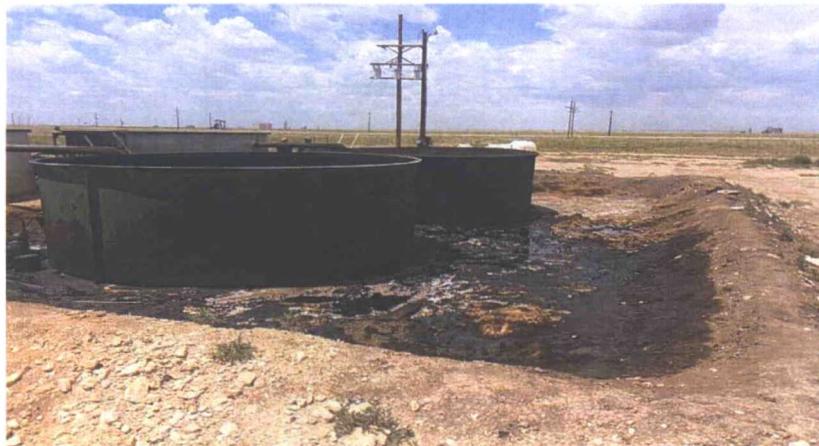
Photograph No. 2

View of the tank battery before remedail activities.

Note: hydrocarbon staining on surface.

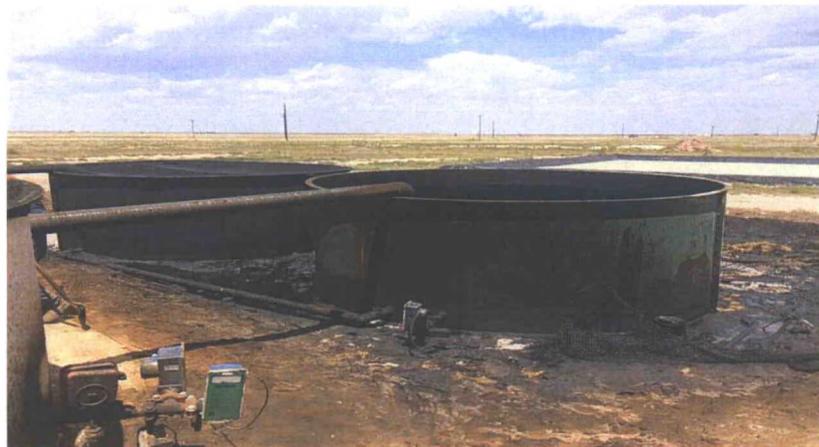
Photograph No. 3

View of the tank battery before remedail activities.

Note: hydrocarbon staining on surface.
