CONOCOPHILLIPS COMPANY

REMEDIATION CLOSURE REPORT

MCA 4-B HEADER RELEASE AREA

NMOCD #1RP-11-10-2652
EPI REF: 150029

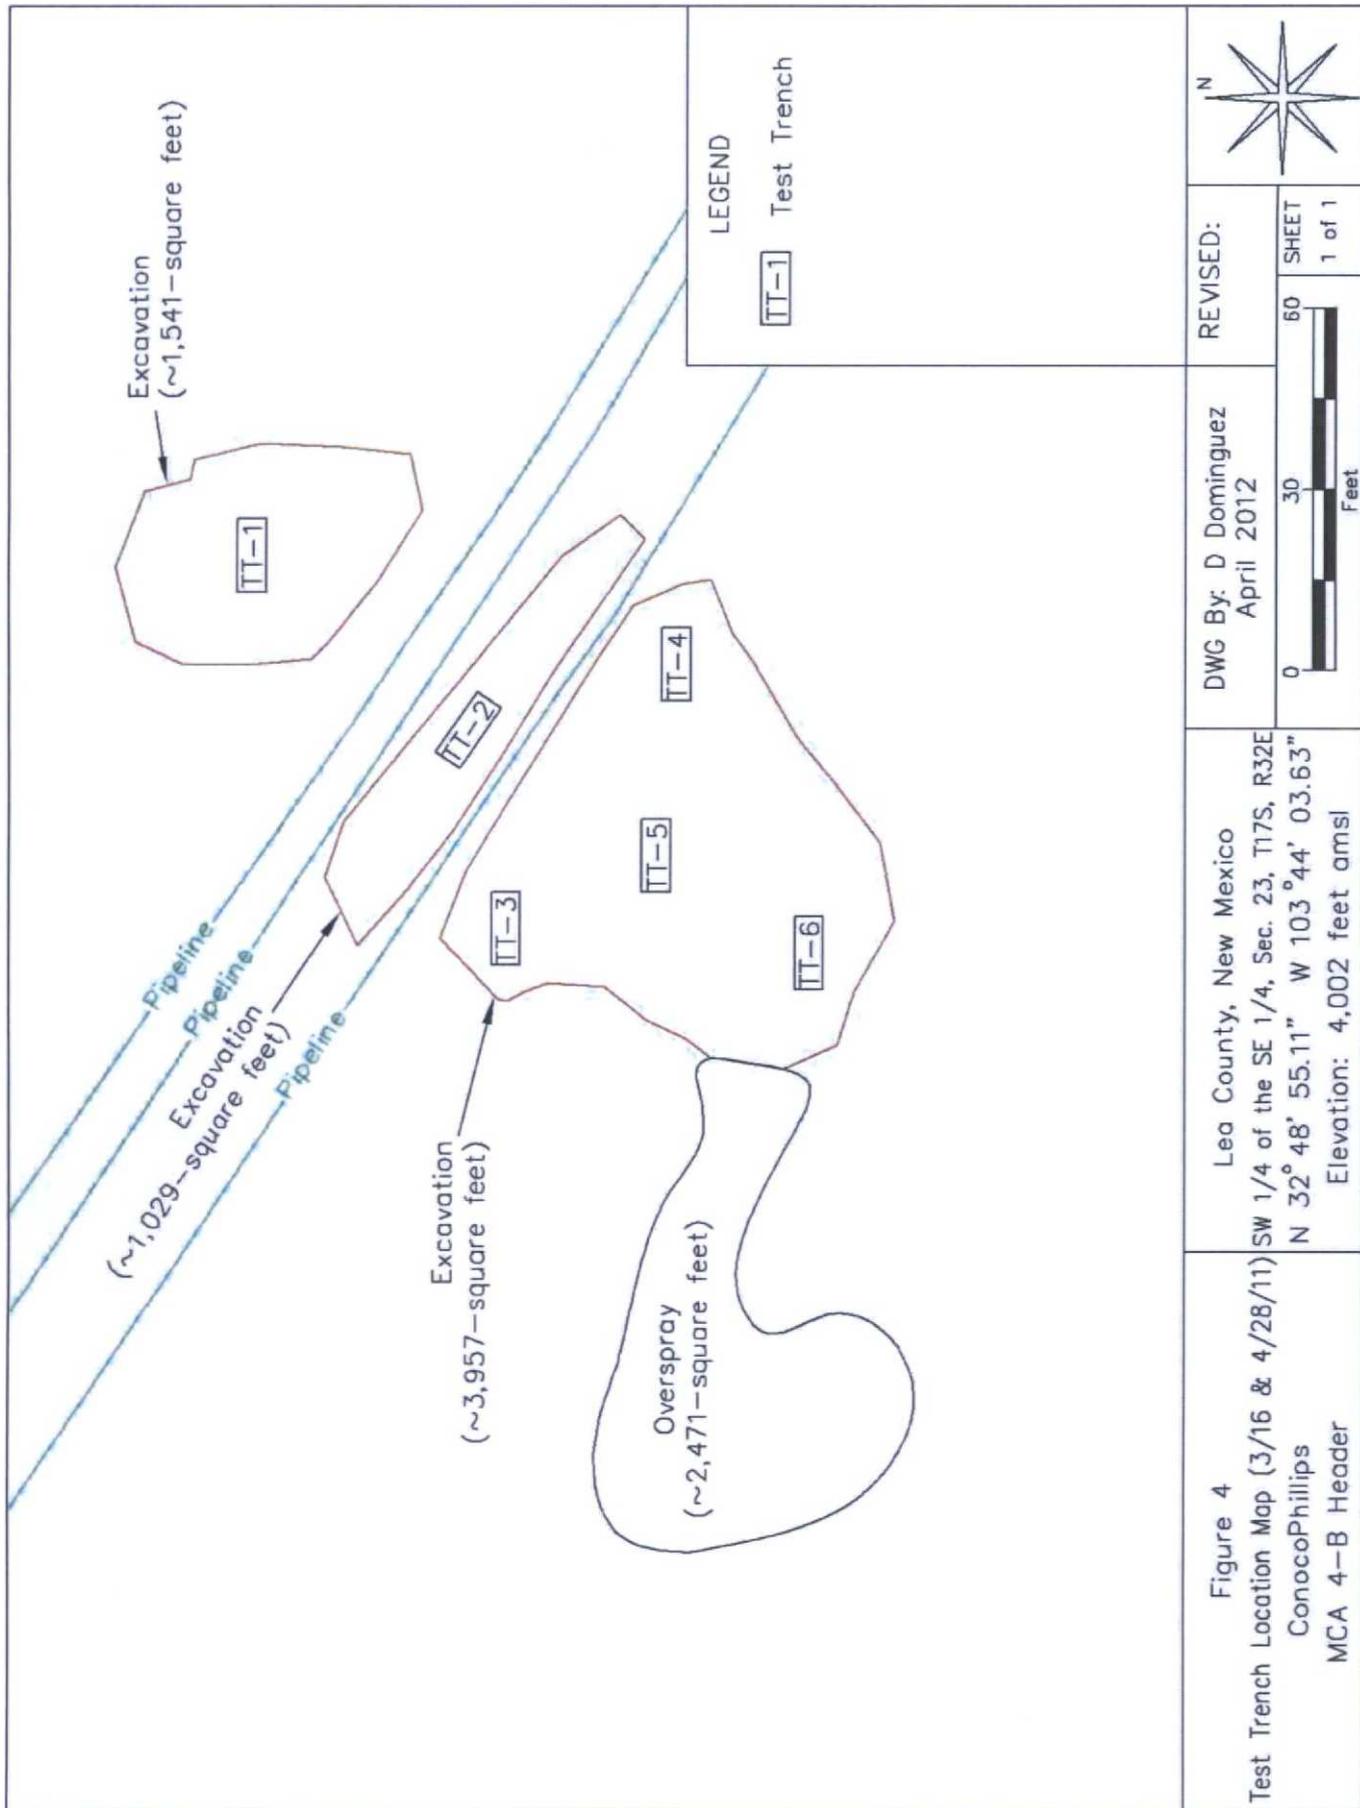
Figure 4

Test Trench Location Map (3/16 & 4/28/11)
 ConocoPhillips
 MCA 4-B Header

On March 4, 2011 EPI mobilized labor and equipment to the Site. From March 4-18, 2011 EPI excavated and transported approximately 518-cubic yards of petroleum contaminated soil to Controlled Recovery, Incorporated (CRI) for disposal. As the release area was on sandy soil located in a depression surrounded by sand dunes, removal of petroleum contaminated soil as directed by BLM representative was a precautionary measure for limiting vertical and horizontal migration of contaminants. In an effort to delineate vertical depth and horizon limits of impacted material, six (6) test trenches were excavated on March 16, 2011. Fourteen (14) soil samples were collected from the six (6) test trenches, three (3) sidewalls and one (1) original sand hill. Soil samples were collected at various depths, field tested and remitted to an independent laboratory for analyses of TPH and chloride concentrations (Ref. *Figure 4* for location and *Table 3* for analytical results).

NMOCD Goals of 100 mg/Kg. However, all six (6) soil samples analyzed for chloride concentrations were elevated above NMOCD Goals of 250 mg/Kg (Ref. *Figure 4* for locations and *Table 3* for analytical results).

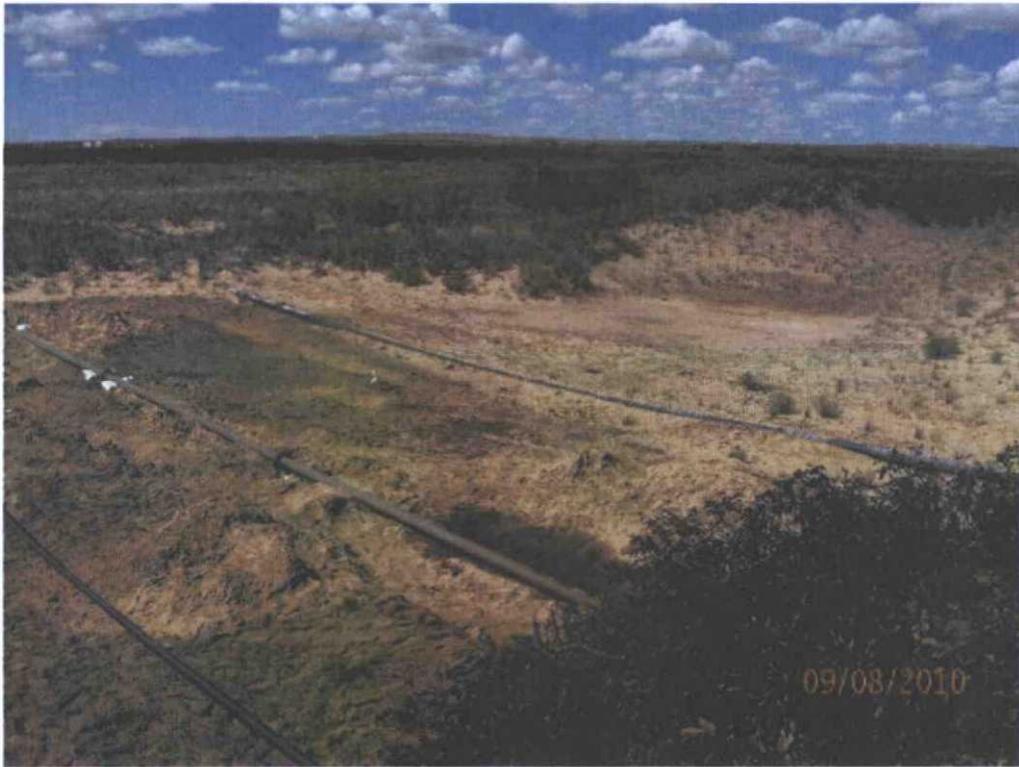
Photograph No. 1 – Looking westerly at original Release Area

Initial release occurred on July 13, 2010 at 10:00 am when approximately 16.3-barrels of petroleum product (16.3 barrels - oil and 0.0 barrels - water) covering a release area of ±9,180 square feet (s.f.) were released when a compression fitting separated on a four (4) inch diameter asbestos cement surface flow line. A vacuum truck deployed to the release area recovered 12-barrels of crude oil.

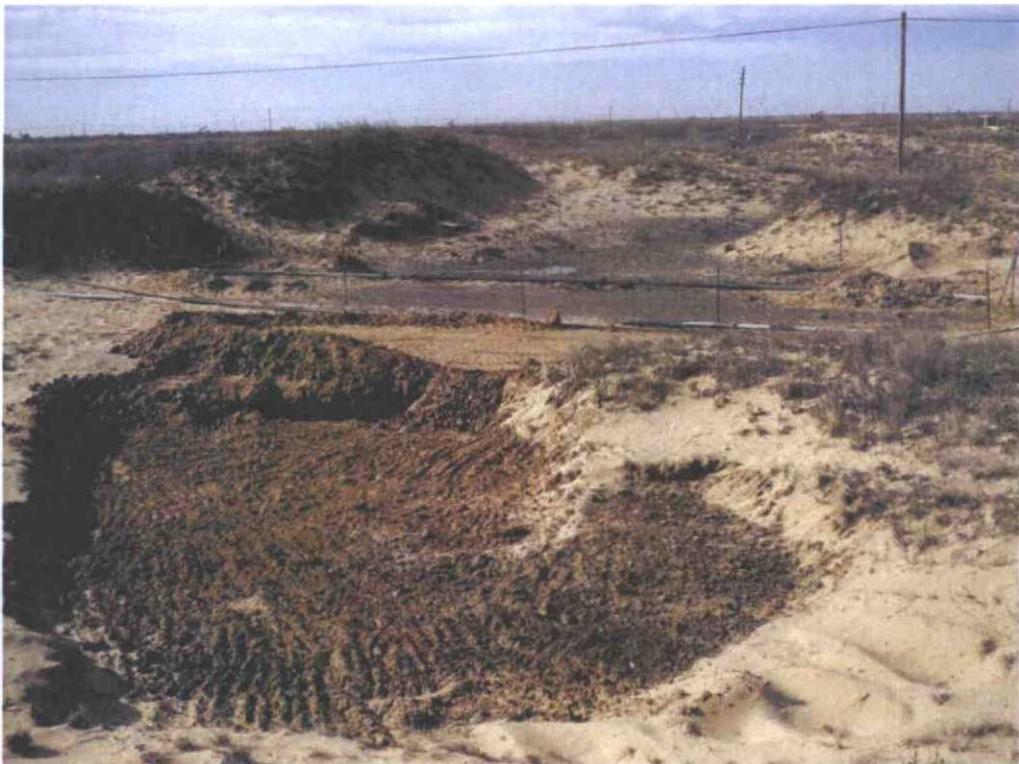
Photograph No. 2 – Looking southwesterly at Second Release Area

A secondary release occurred on February 6, 2011 at an unknown time and volume from the same four (4) inch diameter asbestos cement surface flow line covering a release area of ±7,500 square feet. Approximately 60-barrels of free standing petroleum products were recovered (48 barrels – oil and 12 barrels – water). On February 7, 2011 an additional 35 barrels of fluids were recovered and transported to Sundance Services, Inc., for disposal. On February 10, 2011 a vacuum truck collected an additional 66-barrels of solids and transported to Sundance Services for disposal.

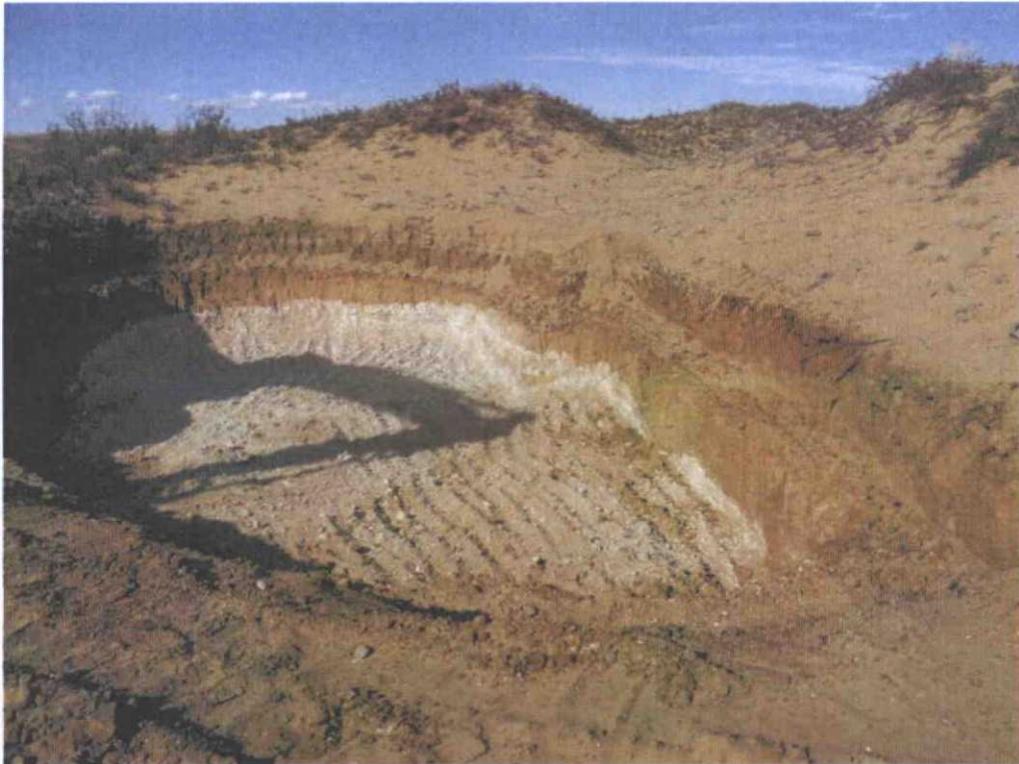
Photograph No. 3 – Looking westerly at North Excavation

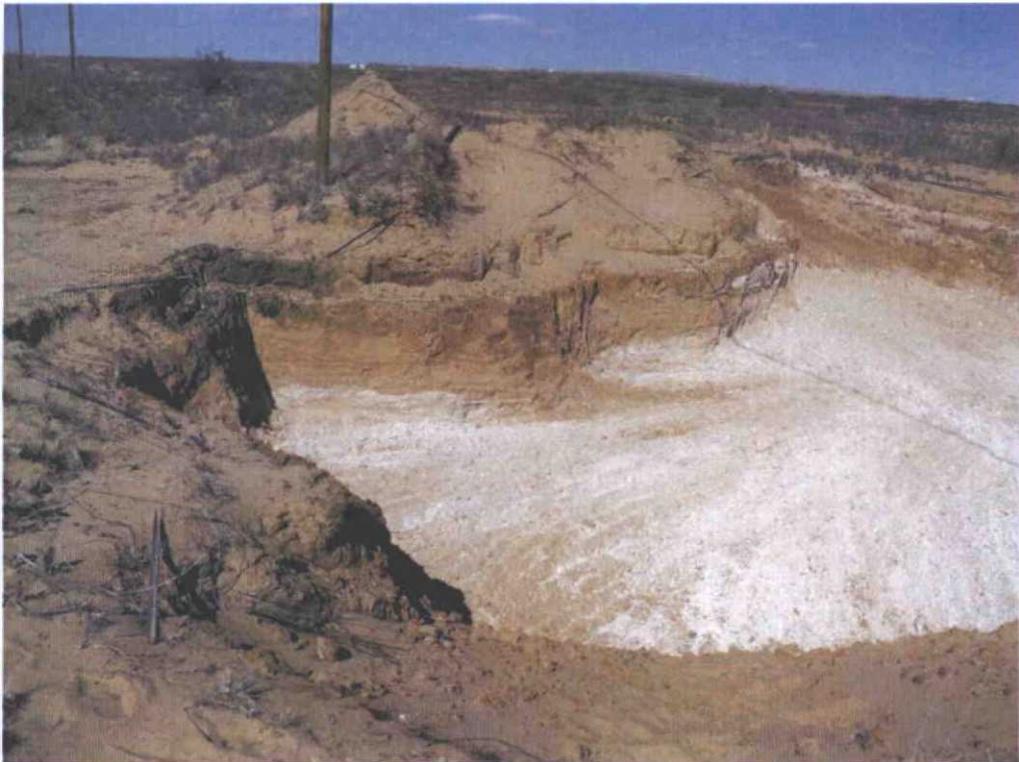
Photograph No. 4 – Looking westerly at South Excavation

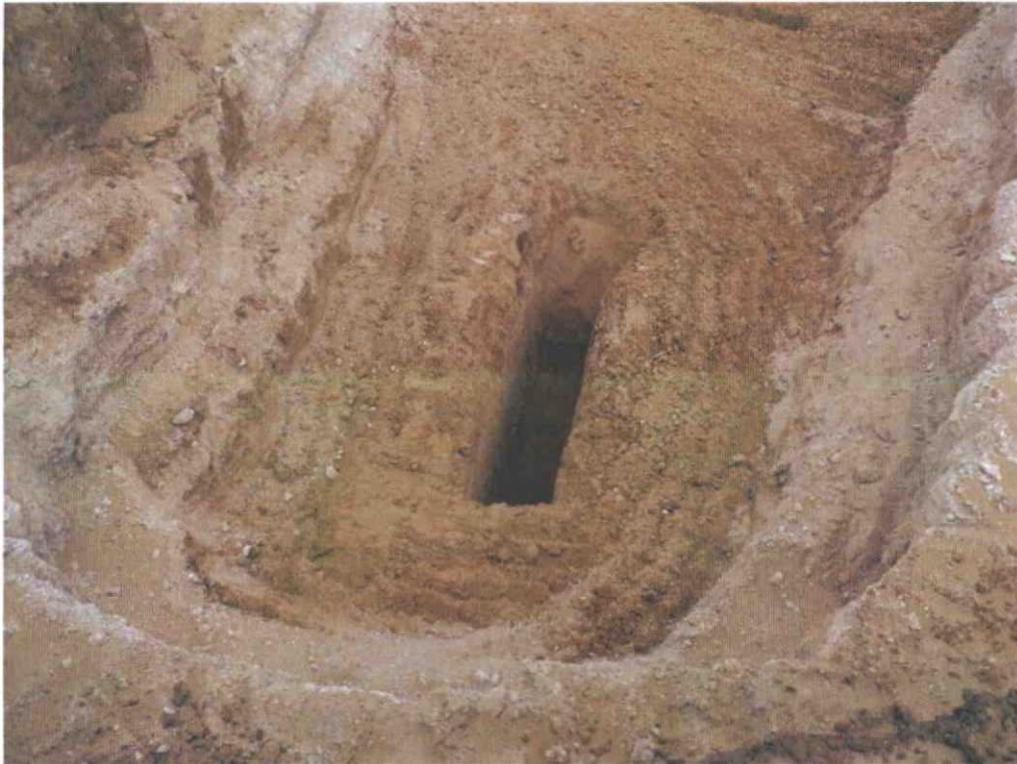
Photograph No. 5 – Looking at Trackhoe Test Trench in South excavation

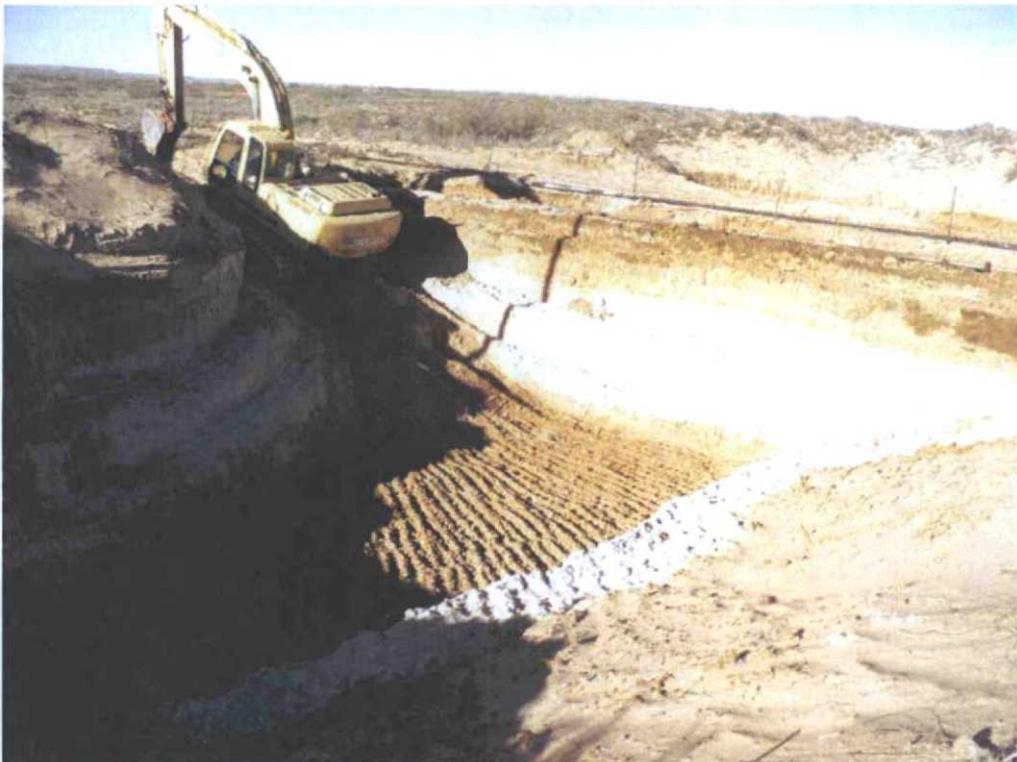
Photograph No. 6 – Looking westerly at finished bottom of South excavation awaiting clay barrier

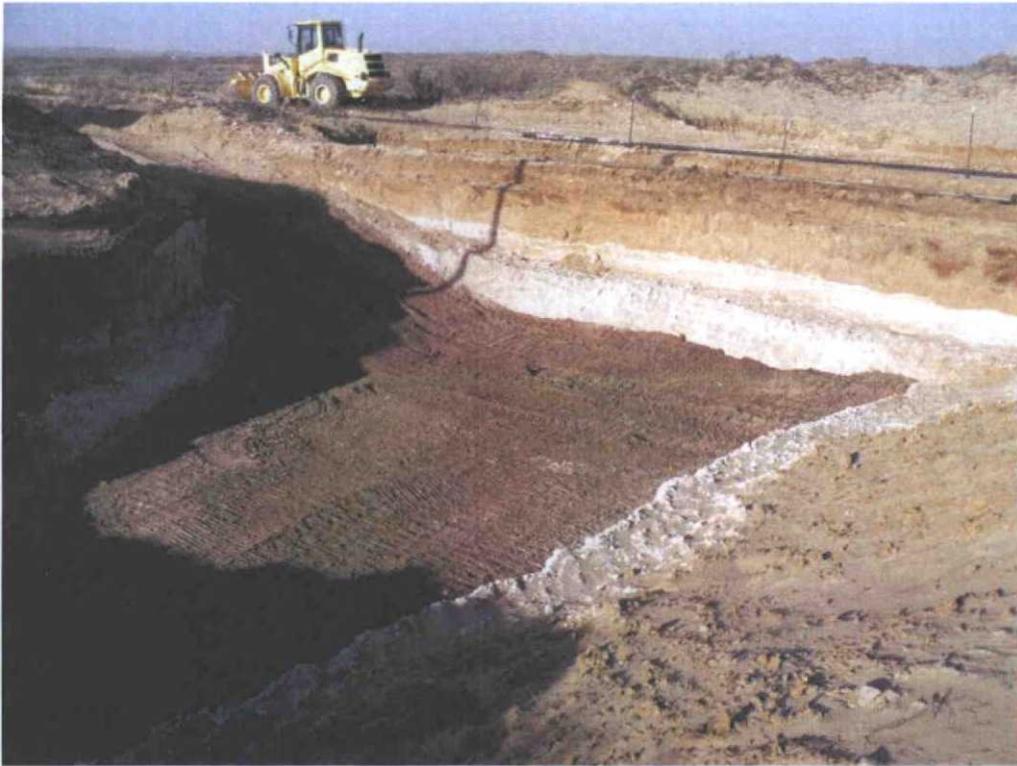
Photograph No. 7 – Looking westerly at two (2) feet thick clay barrier

After consultation with representatives of ConocoPhillips, BLM and NMOCD, it was concluded soil borings were the practical means of determining depth of impacted material. From November 29 through December 14, 2011, the south end of the excavation was prepared for soil boring activities. Bottom of excavation was leveled using in-situ material and compacted with a trackhoe. Approximately 134 cubic yards of imported clay (Wallach Concrete, Eunice, New Mexico) was used to build a minimum two (2) feet thick barrier over the bottom of the

excavation. Compaction was achieved via use of the trackhoe steel tracks. Once the clay barrier was in place and compacted, the excavation was backfilled with caliche to within five (5) feet of original ground surface. During this activity approximately 497 cubic yards of imported caliche were used. To aid in achieving density suitable for supporting a drill rig, the caliche was watered and rolled by the trackhoe. Similarly, ingress/egress road and turnaround areas were improved for accessibility of the drilling rig.

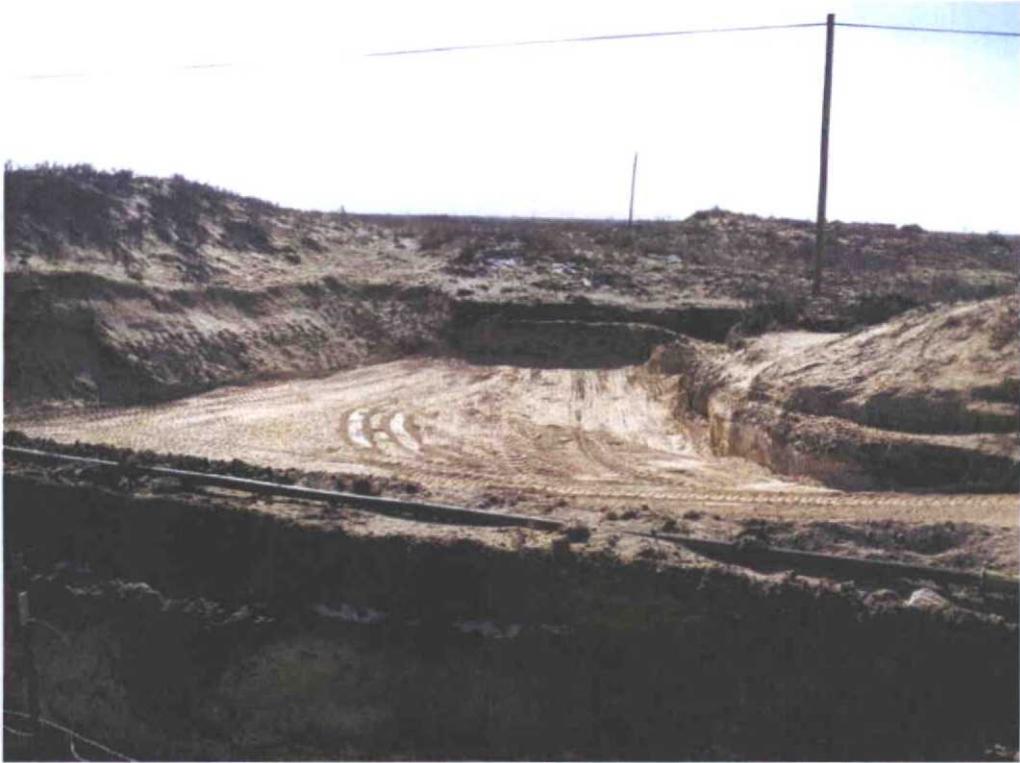
Photograph No. 8 – Looking southerly at finished sub-surface grade in preparation for advancement of soil borings

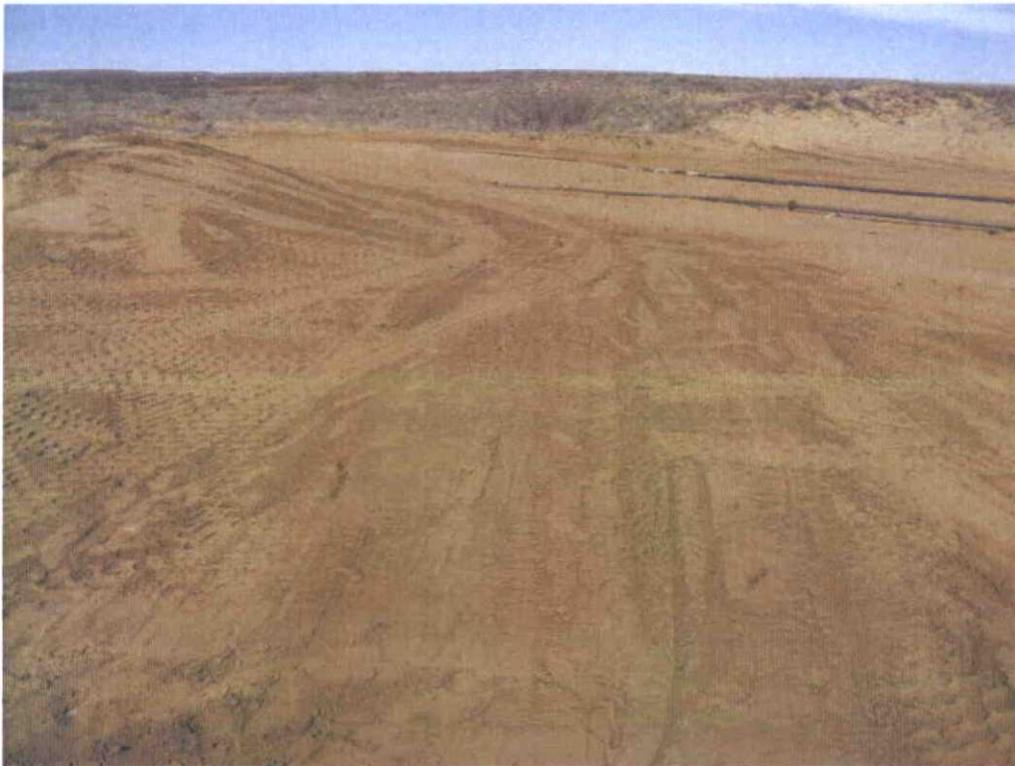
Photograph No. 9 – Looking westerly at finished backfill operations

From January 3-12, 2012 efforts concentrated on backfilling the southerly excavation to within ten (10) horizontal feet of an earthen bridge supporting the flow lines. Approximately 1,658 cubic yards of sandy loam material was transported from the Caviness pit located on SH#529 to the project site. Material was stockpiled near the ingress/egress road and transported via front end loaders to the excavation site. Upon near completion of backfill operations, a roust-a-bout crew arrived on the job site on January 16, 2012 and rerouted the asbestos cement flow line into an existing steel one. Once the by-pass project was completed, excavation activities commenced on the interstice between the earthen bridge and backfilled section of the southerly excavation. Excavation was terminated horizontally at three (3) feet from the flow lines and vertically at a depth coincidental with the bottom of the southerly excavation.

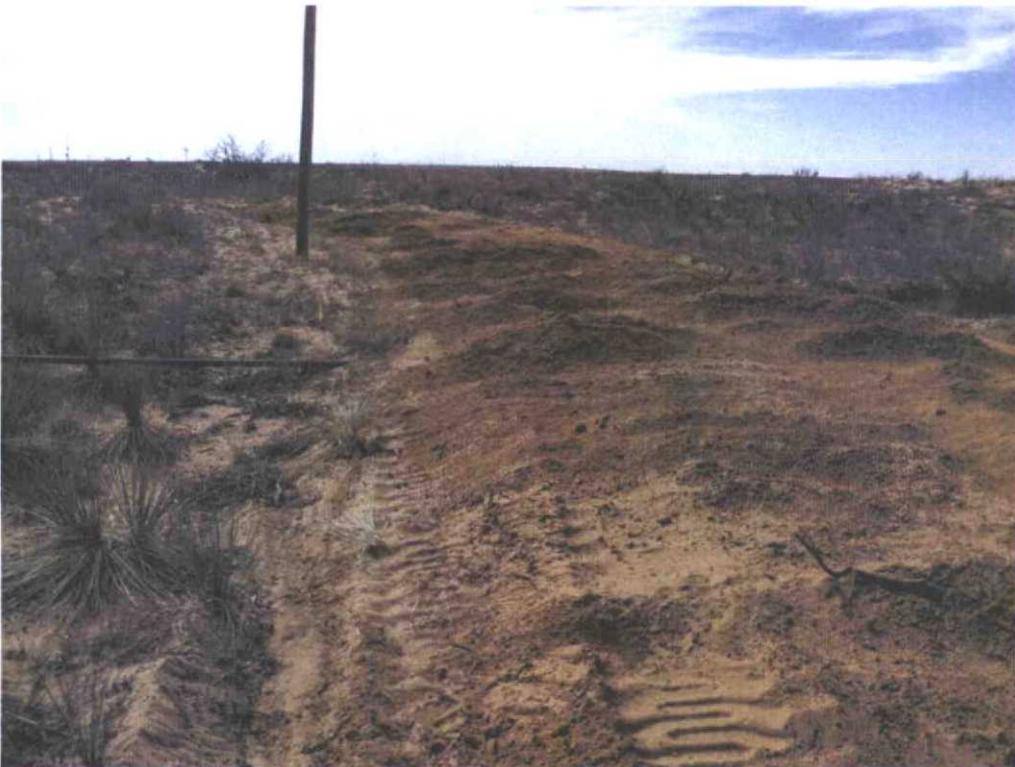
Photograph No. 10 – Looking southwesterly at loamy sand material used in reclamation of excavation Ingress/Egress road

backfilled with sandy loam material terminating with existing surface elevation. Disturbed areas will be disced and deep drill seeded with a seed blend approved by the BLM.
