**KEY ENERGY SERVICES, LLC**

# Bronco Services

**Key Brine Water Station  
Section 15 of Township 21 South, Range 37 East,  
Lea County, New Mexico**

## Closure Report

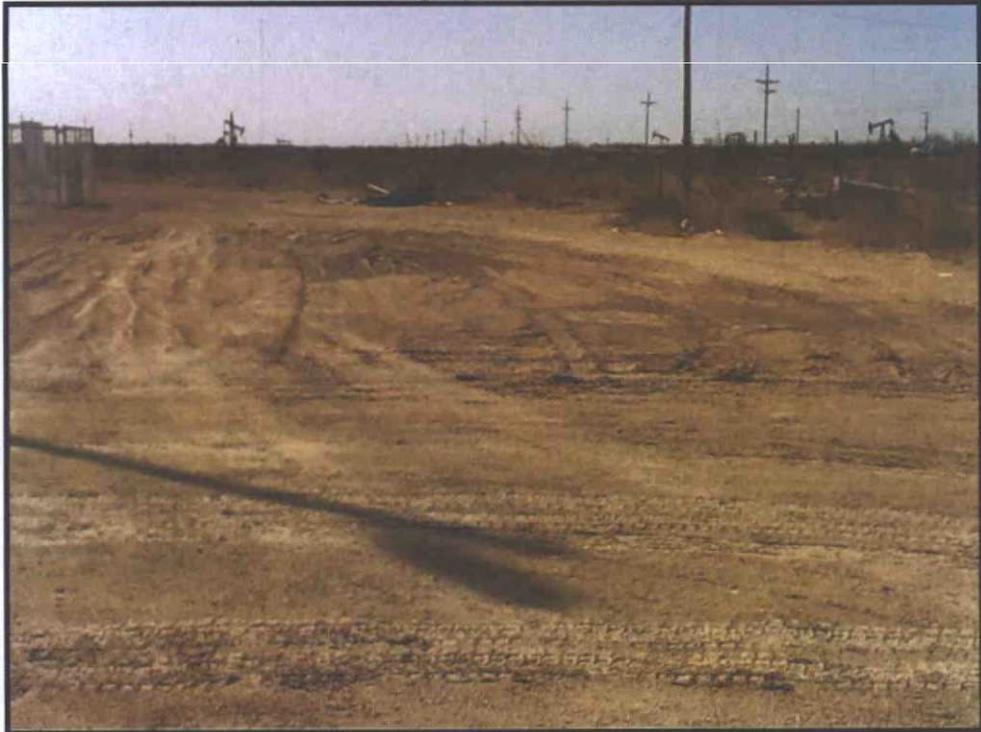
Site before excavation looking south

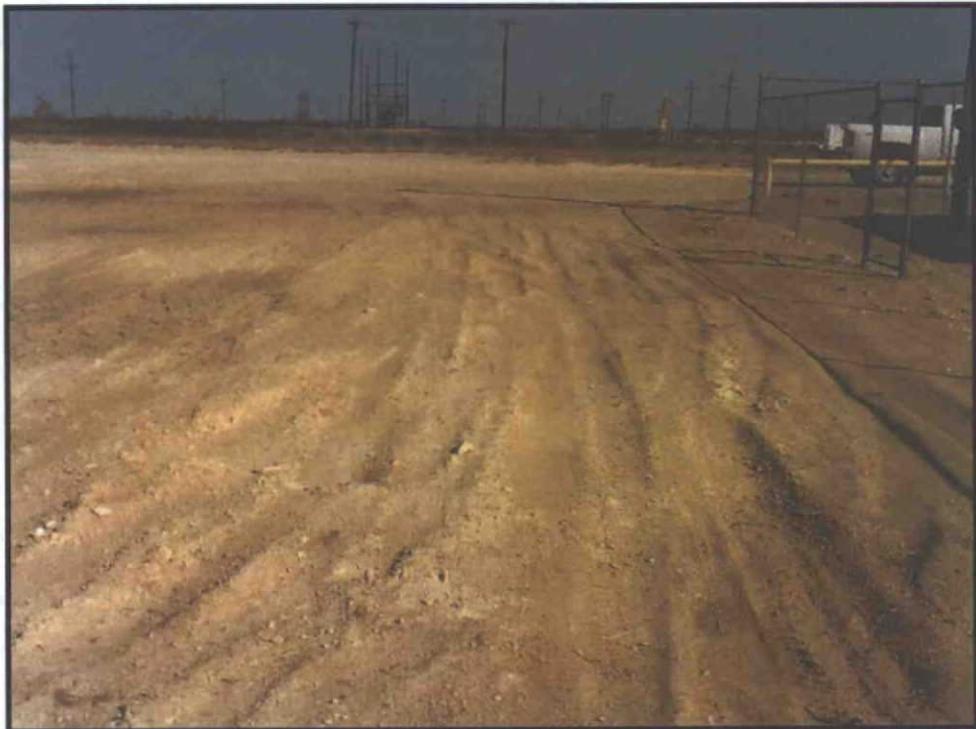
Site before excavation looking north

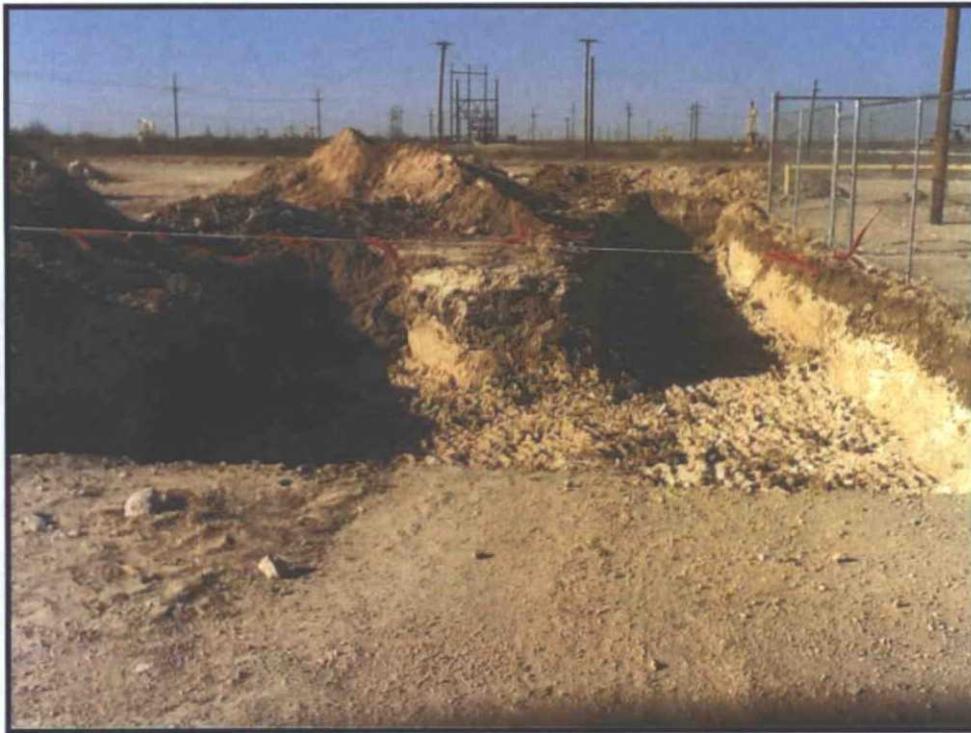
Site excavation looking north

On March 1-5, SESI was onsite with Bryan's Oilfield Service to begin remediation of the affected area. The northwest corner fence line of the facility was excavated to a depth of 4' below ground surface (bgs).

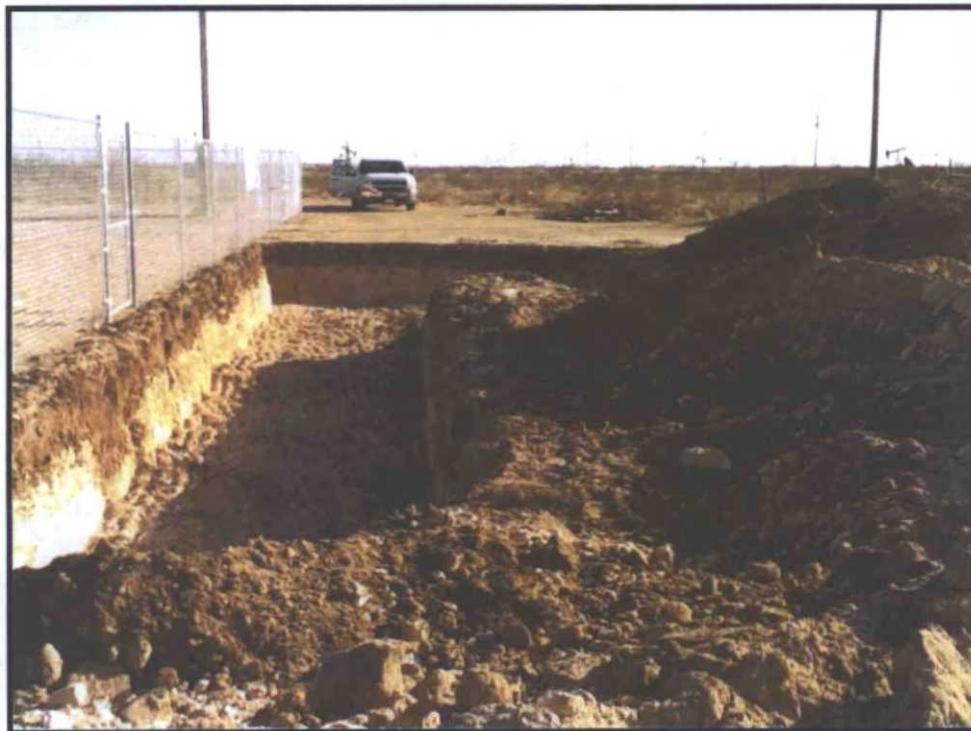
Site excavation looking south

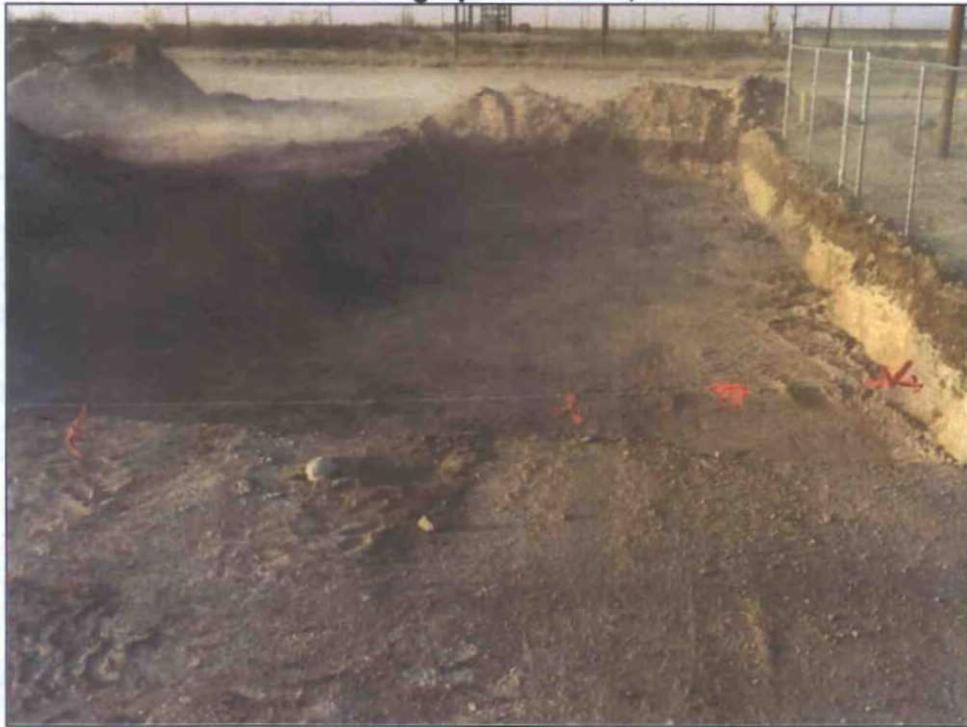
Excavation facing north

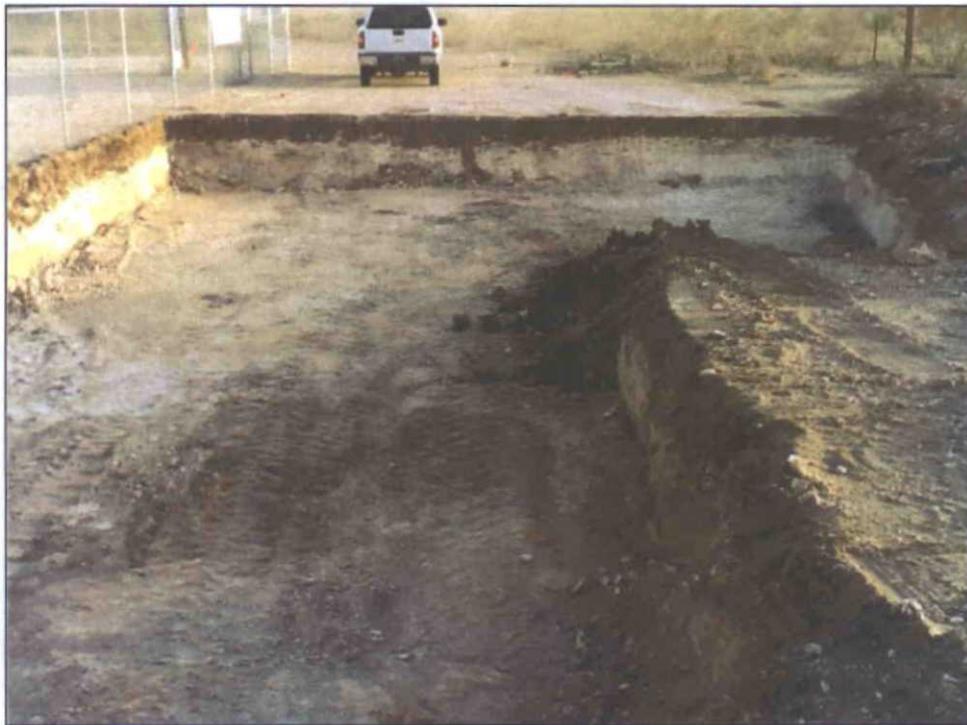
Excavation facing South

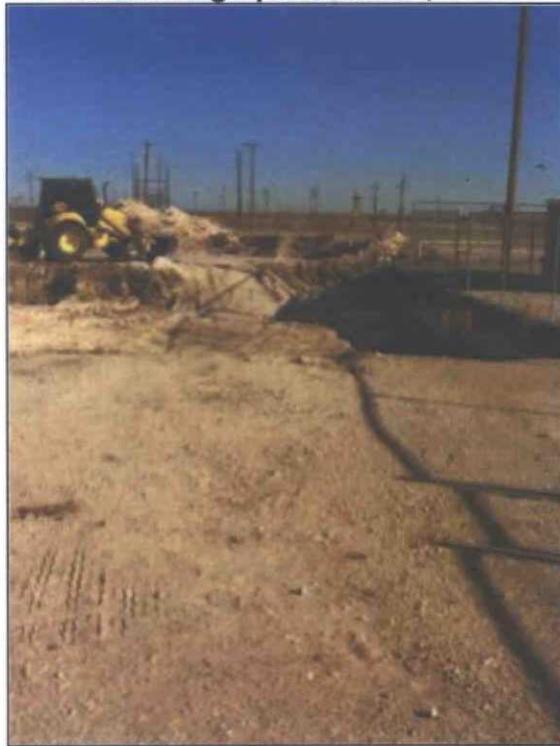
East end of excavation facing North

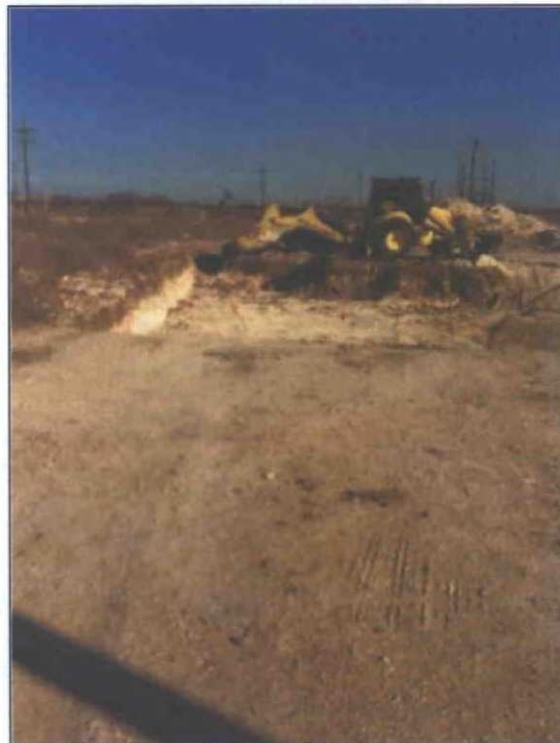
West end of excavation facing North

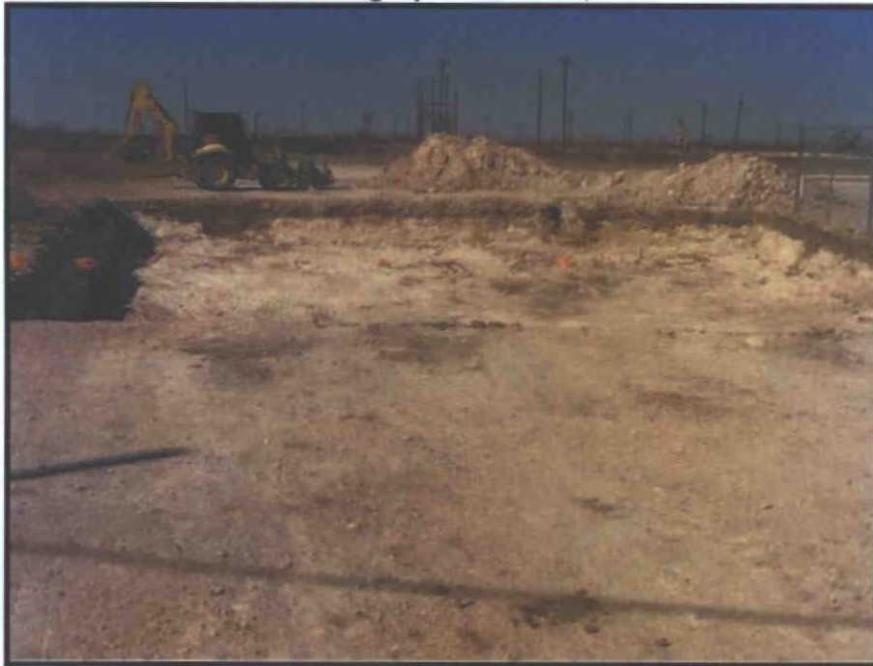
Excavation facing north

A total of five (5) grab samples were retrieved from the bottom of the excavation. All samples were properly preserved and transported under Chain of Custody to Cardinal Laboratories of Hobbs, New Mexico for analysis. The samples were analyzed for Chlorides (EPA Method 4500-Cl<sup>-</sup> B).

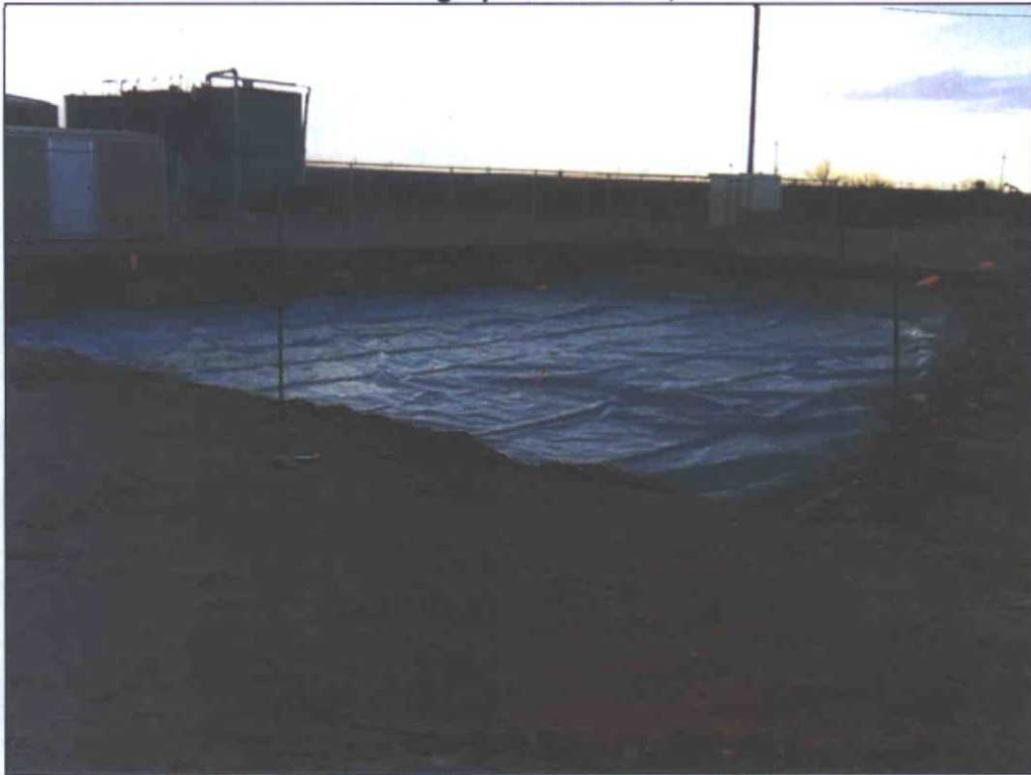
20 mil liner bottom hole of excavation facing southeast

On March 21-26, the floor of the excavation was padded and domed with one (1) foot of clean topsoil. Akome, Inc. was onsite to install the 20-mil reinforced geo-membrane liner. Upon completion, the area was padded with an additional one (1) foot of clean topsoil then backfilled with like soils and contoured to grade.

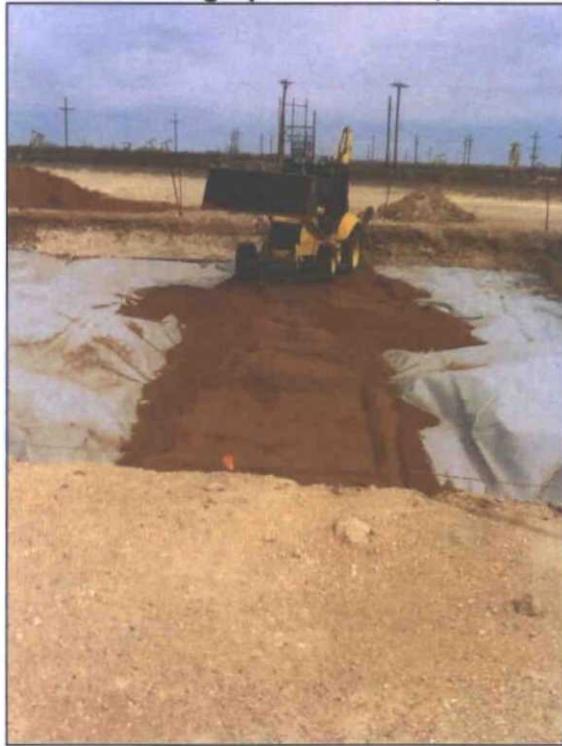
Topsoil process

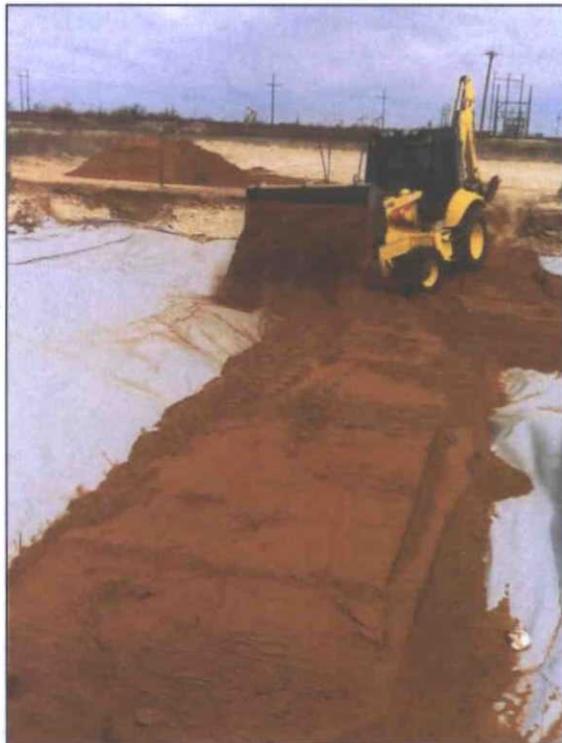
Topsoil on liner facing North

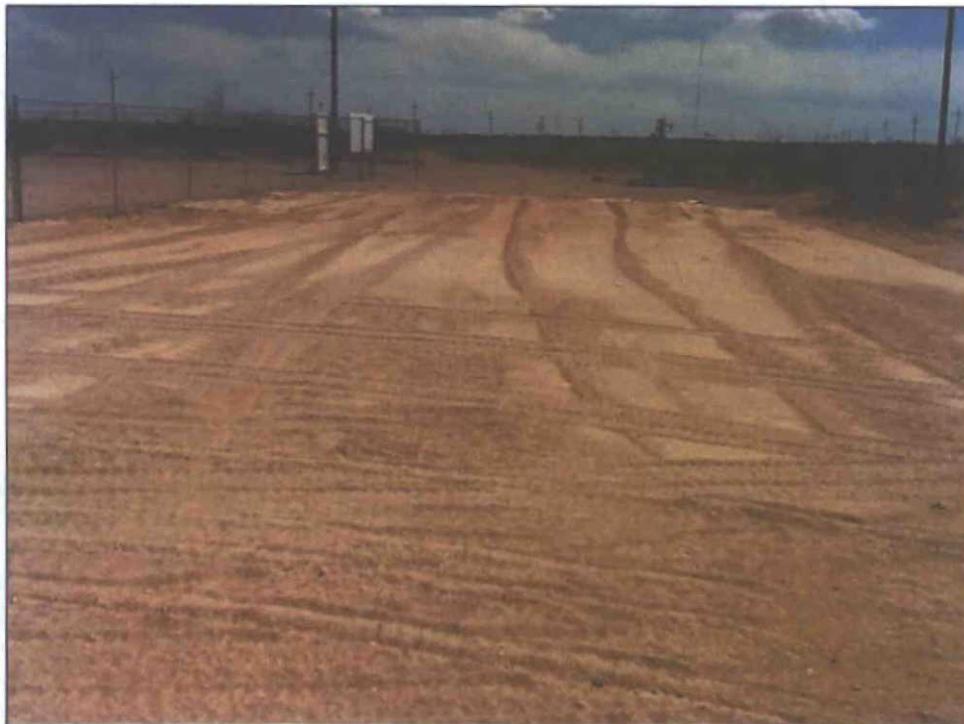
Spill area after liner installation and backfill process

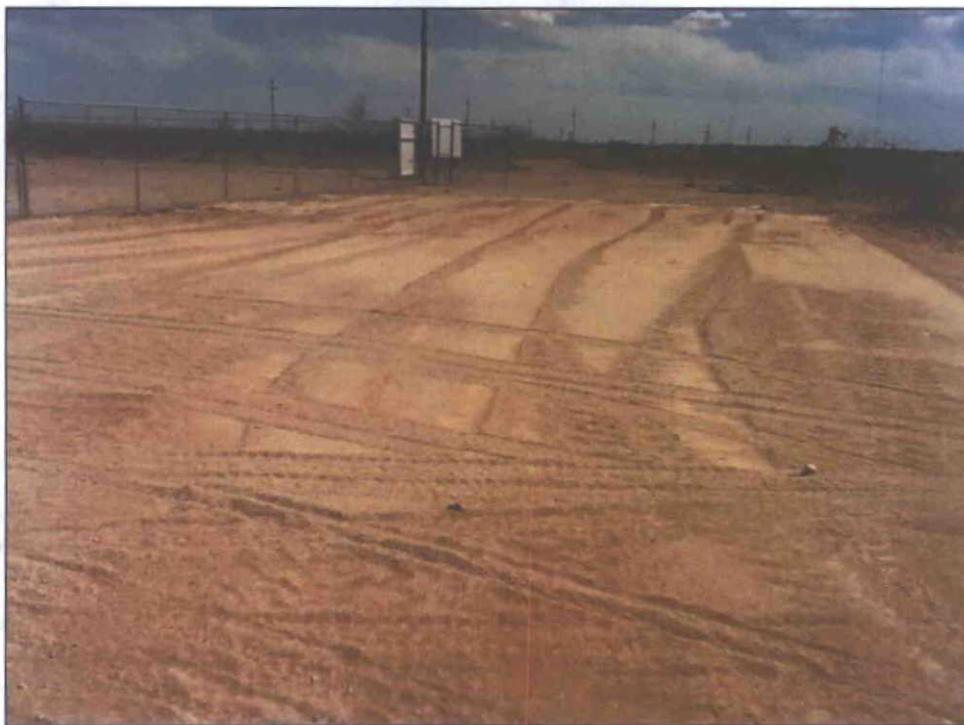
Completion of site facing South
