**KEY ENERGY SERVICES, LLC**

**Bronco Oilfield Service**

**Key Brine Water Station Closure Report**

**Section 15 of Township 21 South, Range 37 East,  
Lea County, New Mexico**

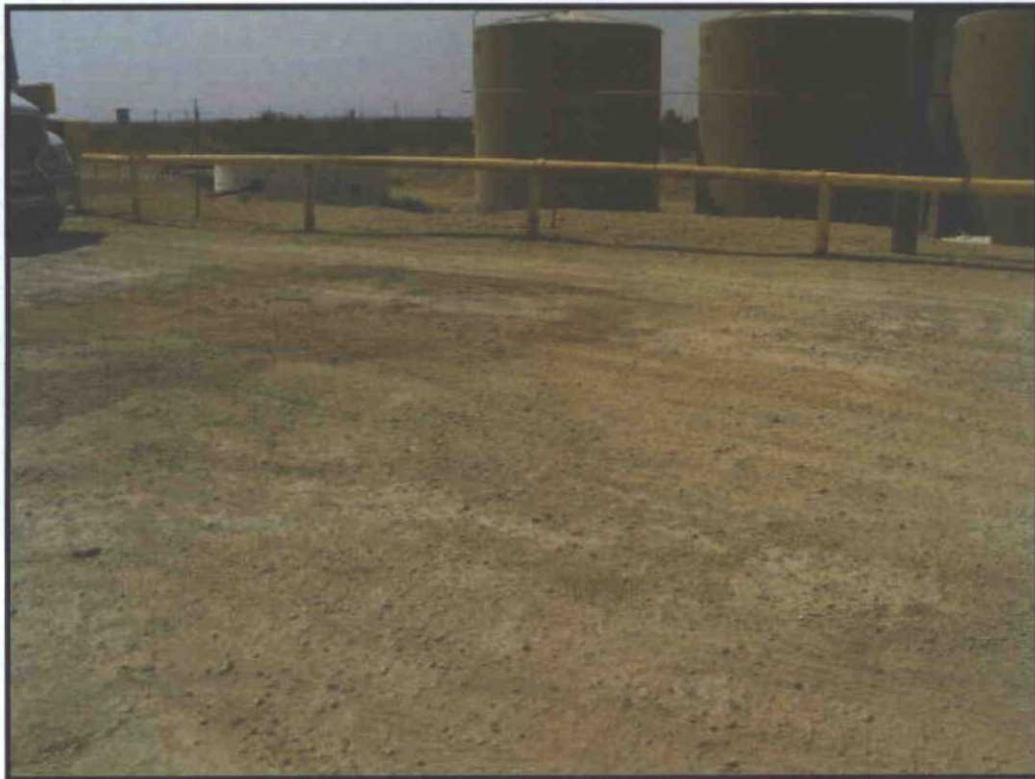
Evandor flowback release on location pad

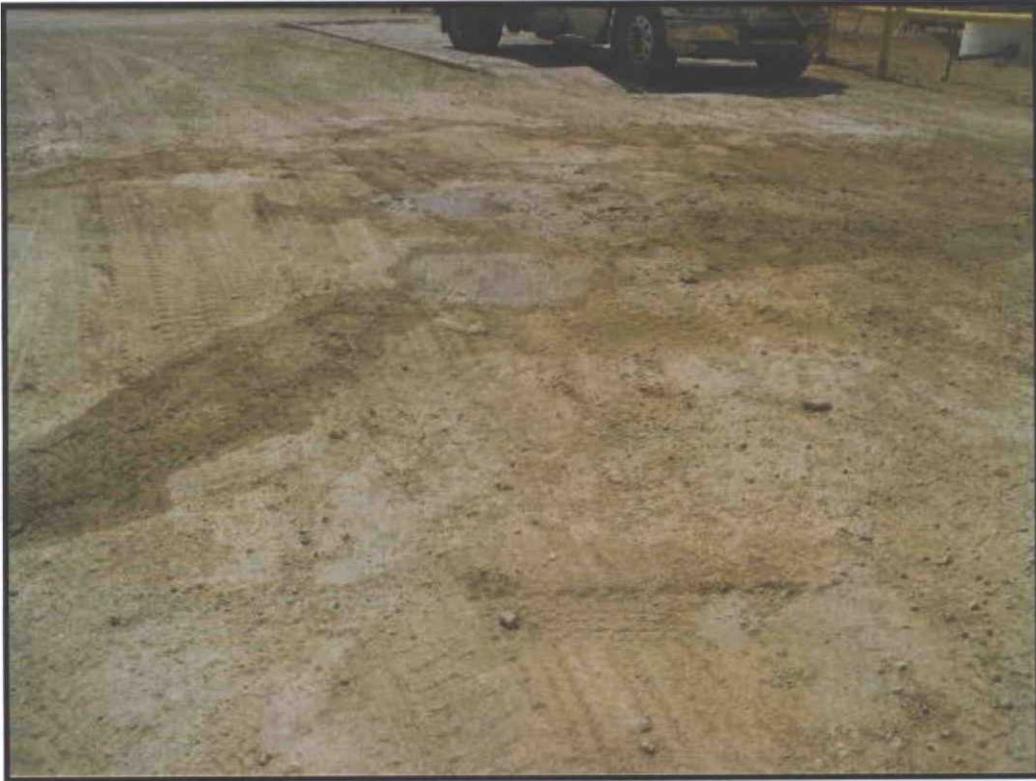
Evandor flowback release facing southeast

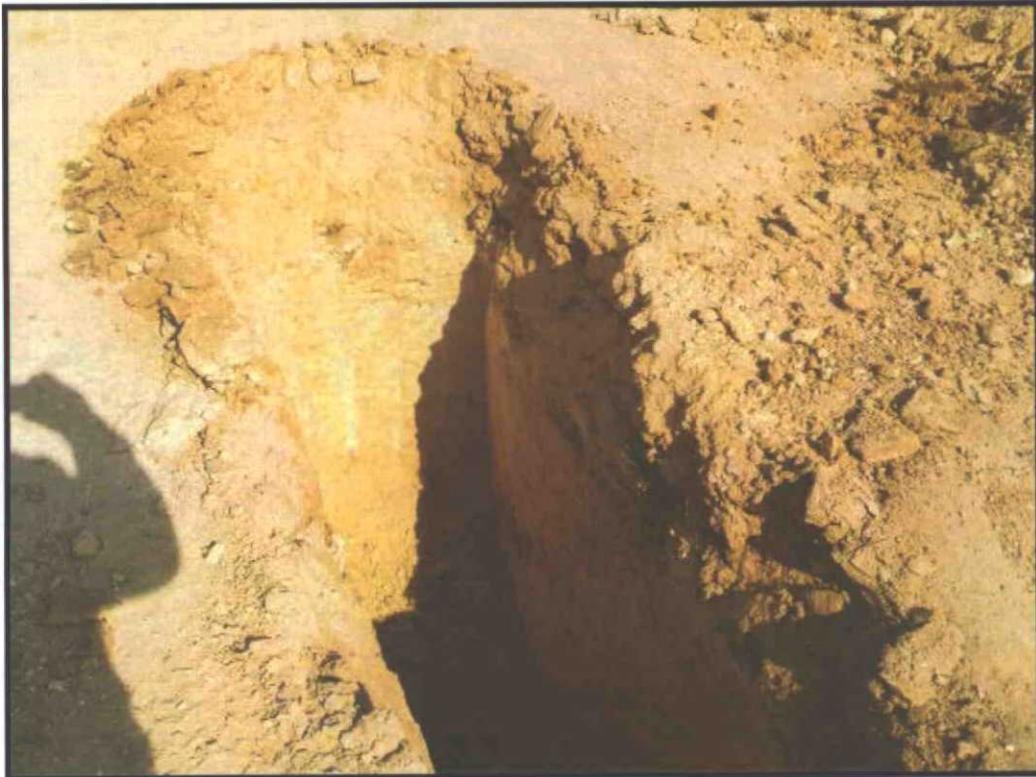
Lab ID	Sample ID	Cl <sup>-</sup> (mg/kg)
Analysis Date:		06/08/11
H101174-01	TT#1 1' bgs	5,680
H101174-02	TT#1 3' bgs	1,180
H101174-03	TT#1 5' bgs	256
H101174-04	TT#2 1' bgs	3,280
H101174-05	TT#2 3' bgs	1,170

Test Trench #1 5'bgs

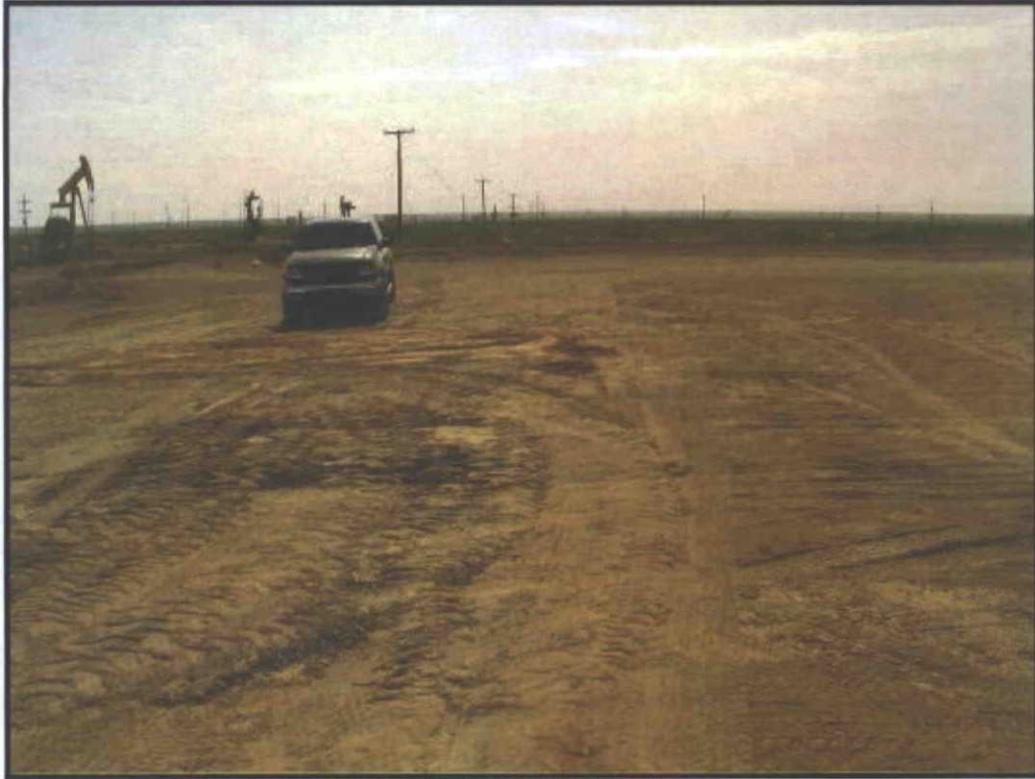
Test Trench #1 backfilled facing east

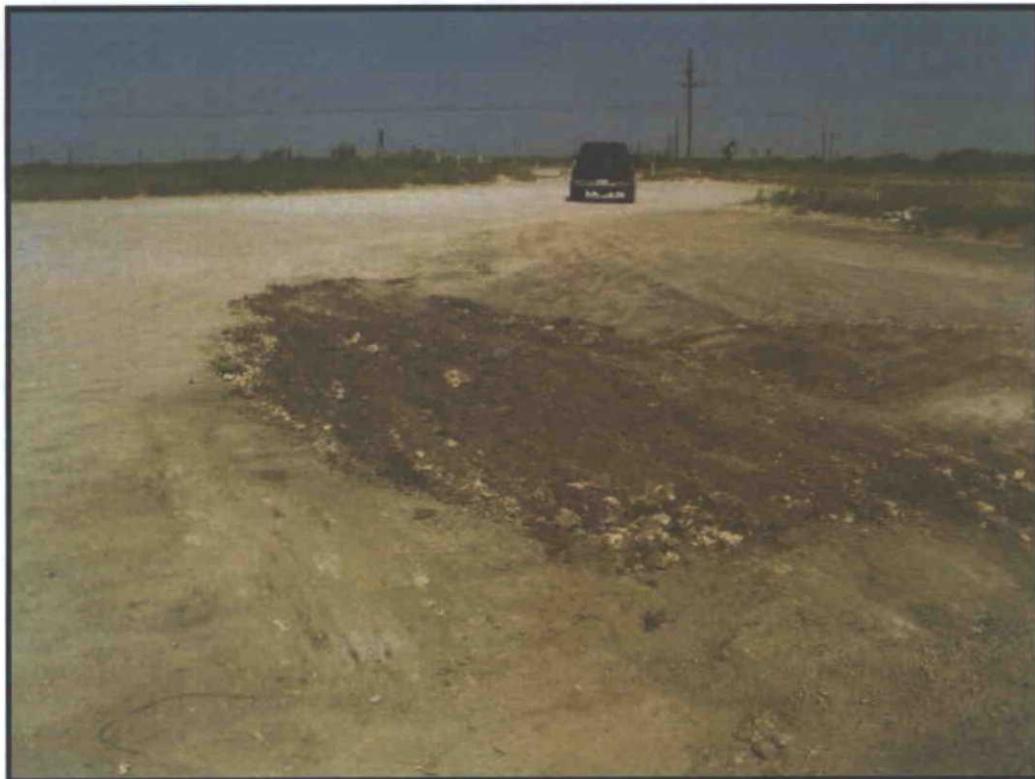
Test Trench #2 Backfilled facing west

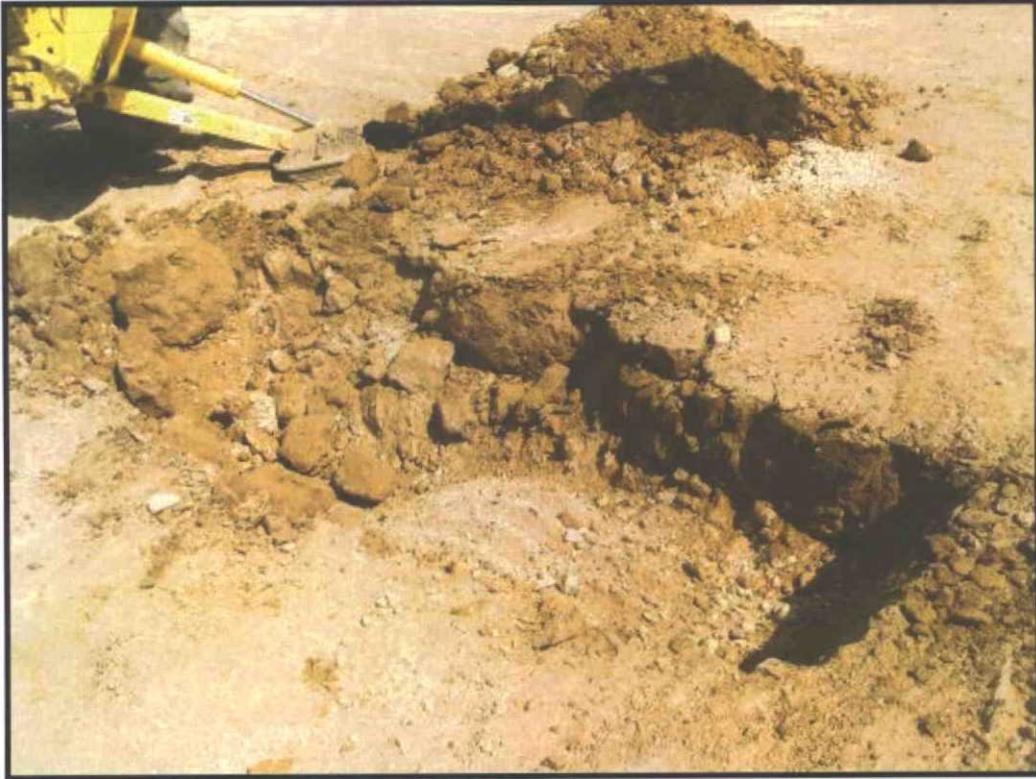
Test Trench #2 3' bgs

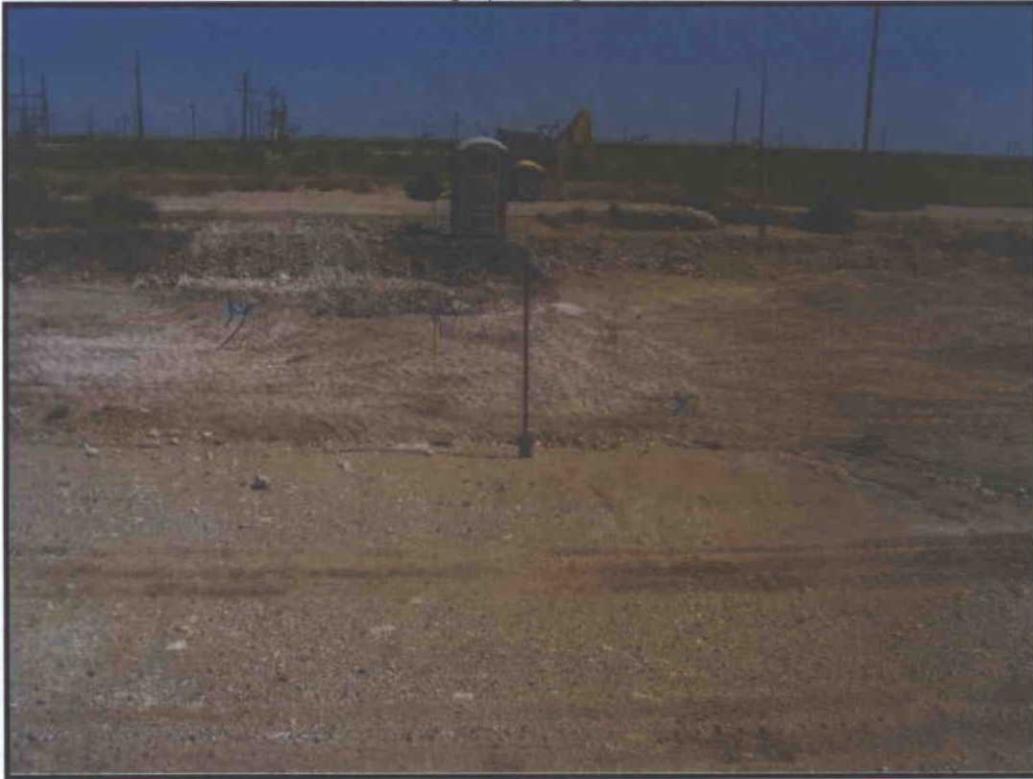
East of excavation facing west

On August 1, 2011, SESI was onsite to obtain soil samples from bottom floor of excavated area. The entire area was excavated to a depth of 3' bgs. A total of ten (10) grab samples were retrieved from the bottom of the excavation. All samples were properly preserved and transported under Chain of Custody to Cardinal Laboratories of Hobbs, New Mexico for analysis. The samples were analyzed for Chlorides (EPA Method 4500-Cl<sup>-</sup> B).

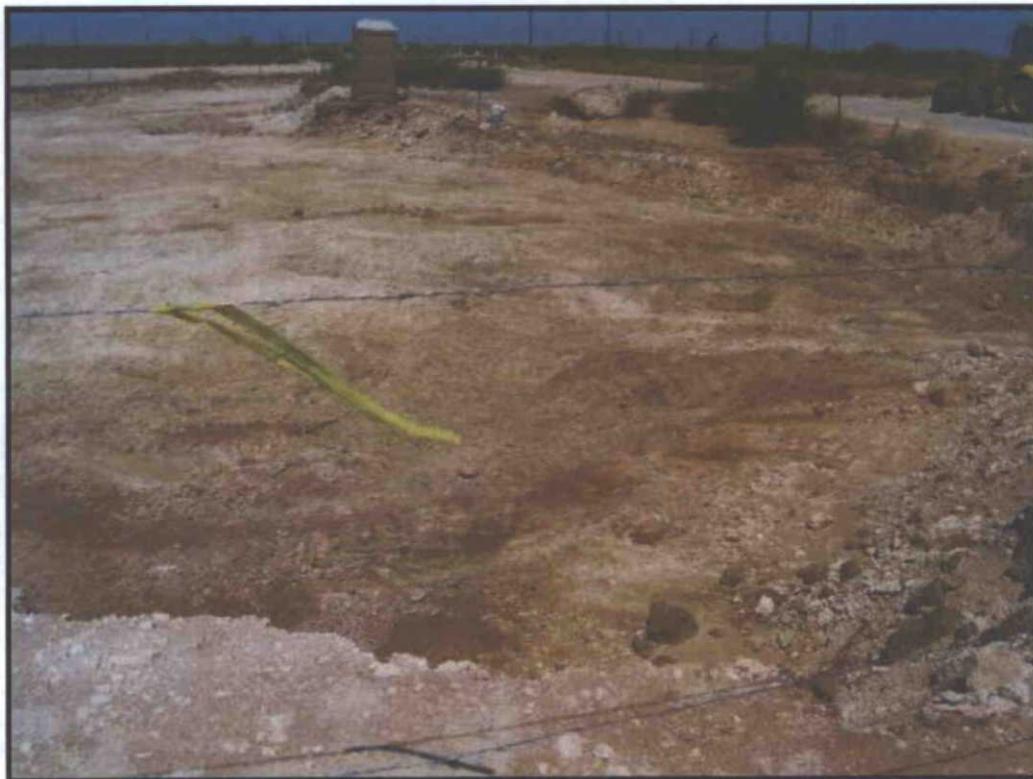
Bottom Hole

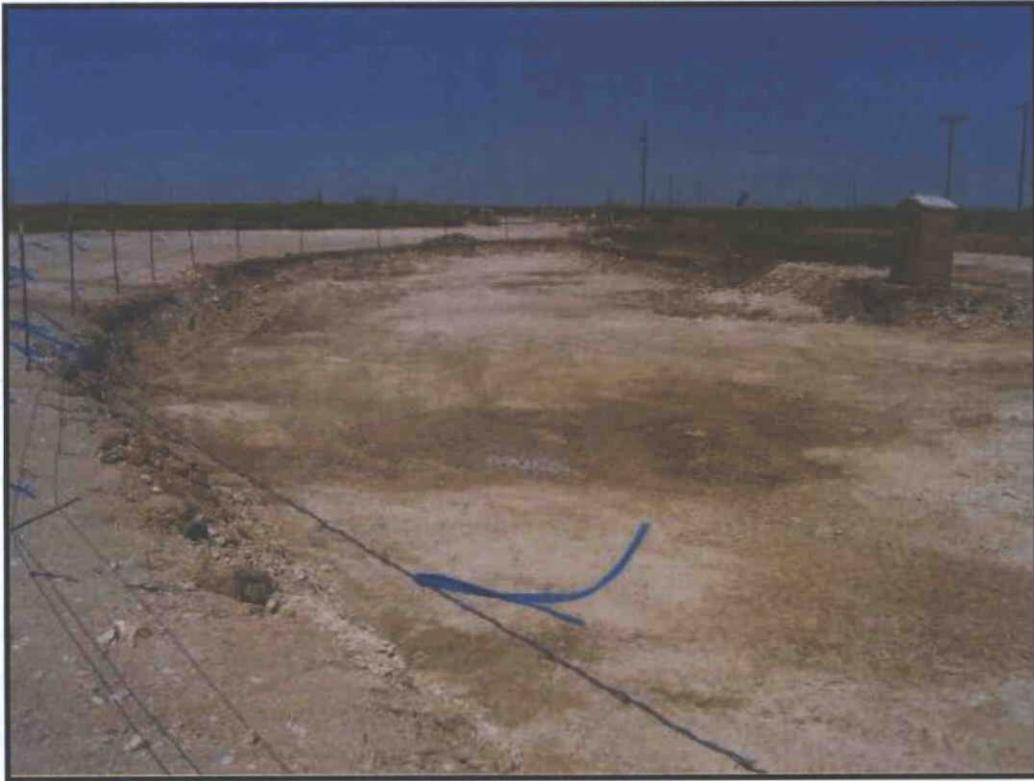
Middle of excavation

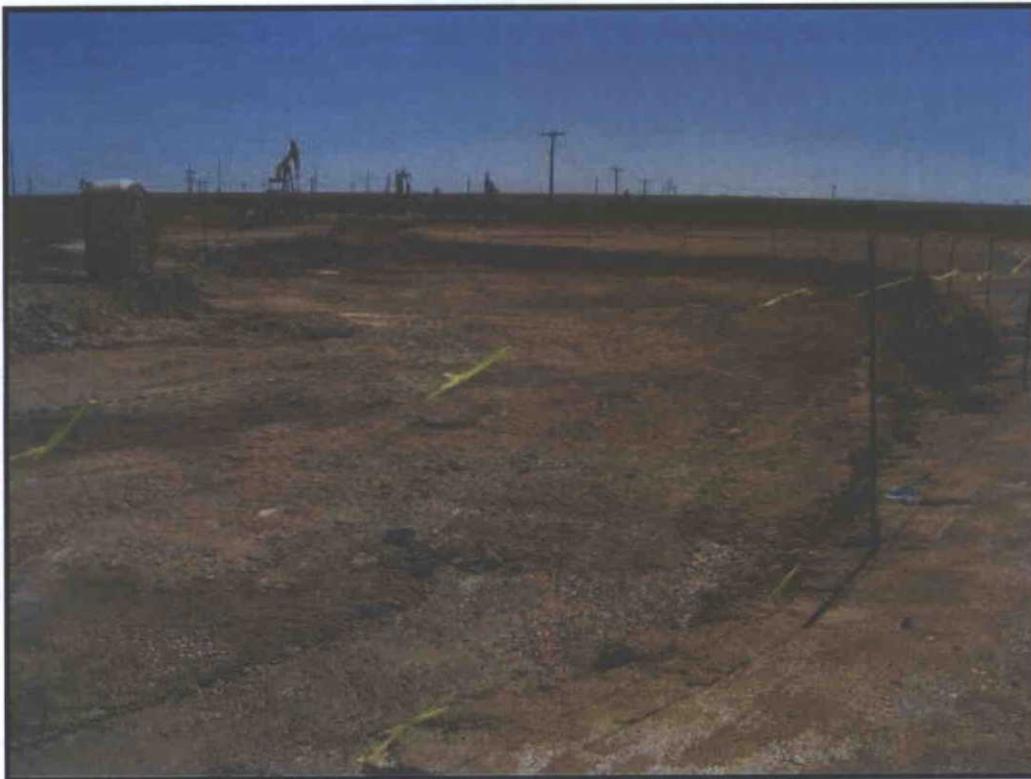
Middle of excavation facing North

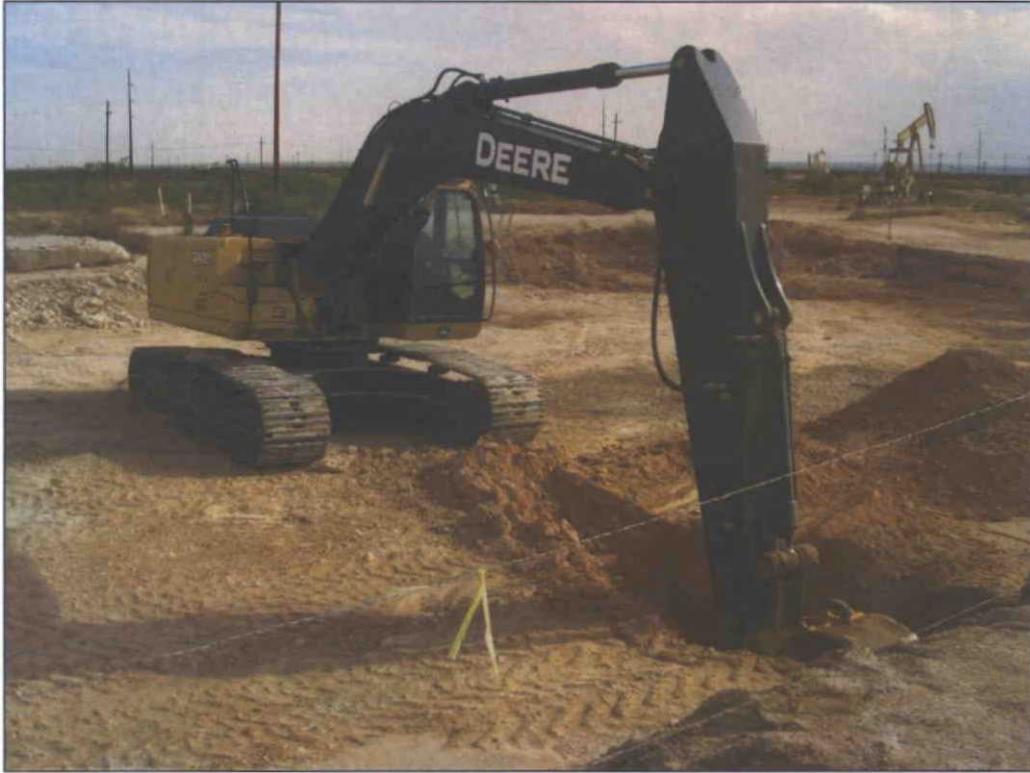
Excavating Test Trench

As per New Mexico Oil Conservation Division (NMOCD) request, Mr. Leking, (NMOCD representative) advised to continue excavating SP-5 area until chloride concentration is below 250 mg/kg. On August 23, 2011, a test trench was installed to a depth of 10' bgs due to the backhoe refusal not able to break through hard caliche layer; the results concluded 464 mg/kg. On September 23, 2011, a trackhoe was utilized to break the hard caliche layer in the existing test trench. A sample was obtained at a depth of 15' bgs; the results concluded 304 mg/kg, slightly above the NMOCD's recommendation. On November 11, 2011, a trackhoe was onsite to excavate additional 2' bgs. The sample was properly preserved and transported under Chain of Custody to Cardinal Laboratories of Hobbs, New Mexico for analysis and analyzed for Chlorides (EPA Method 4500-Cl<sup>-</sup> B). The result of the analysis was 224 mg/kg; therefore vertical extent was determined at a depth of 17' bgs.

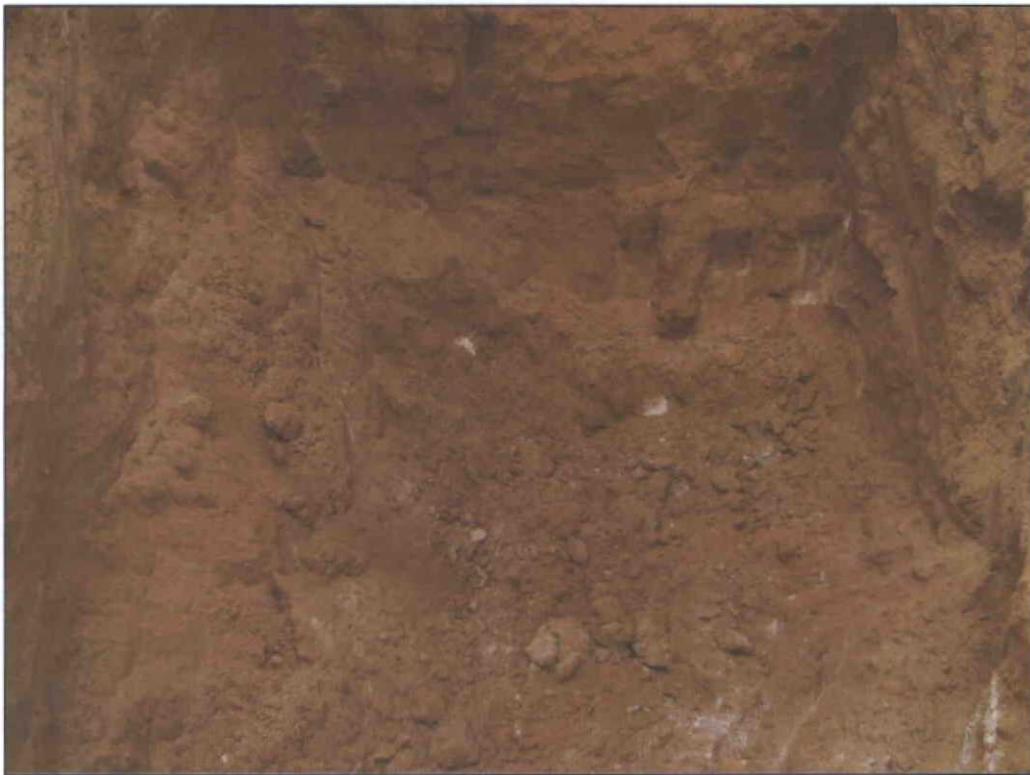
Bottom of test trench 17' below ground surface

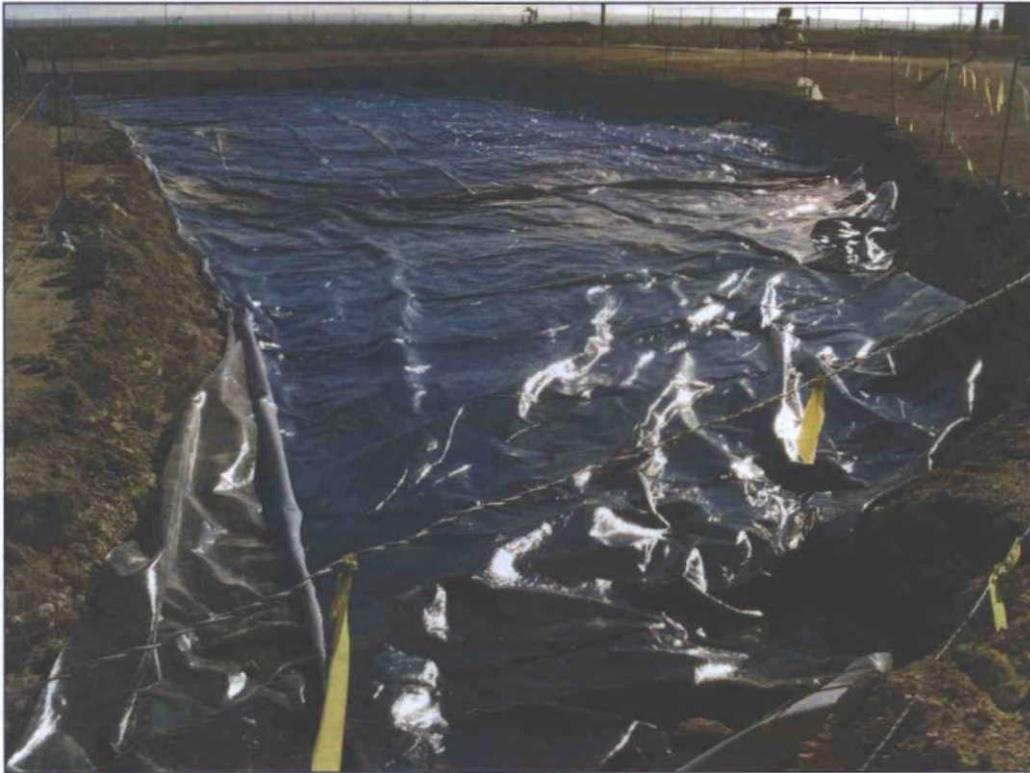
Liner facing East

On November 28, 2011 through December 2, 2011 the floor of the excavation was padded and domed with one (1) foot of clean topsoil. Akome, Inc. was onsite to install the 20-mil reinforced geo-membrane liner. Upon completion, the area was padded with an additional one (1) foot of clean topsoil then backfilled with like soils and contoured to grade.

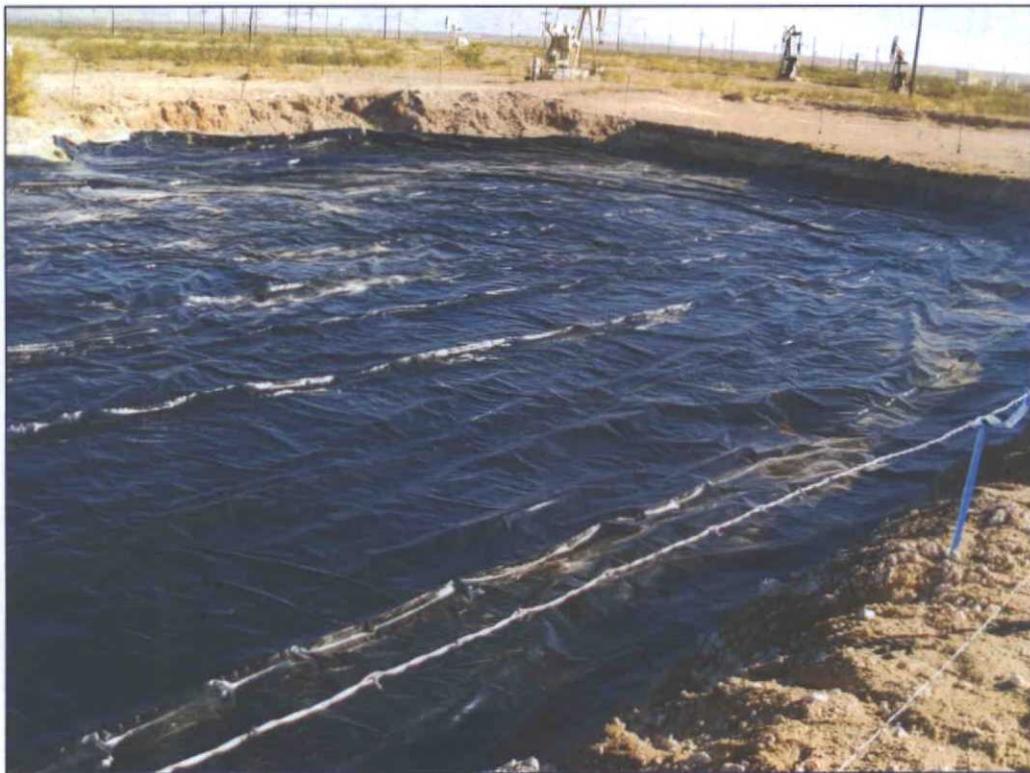
Liner facing northeast

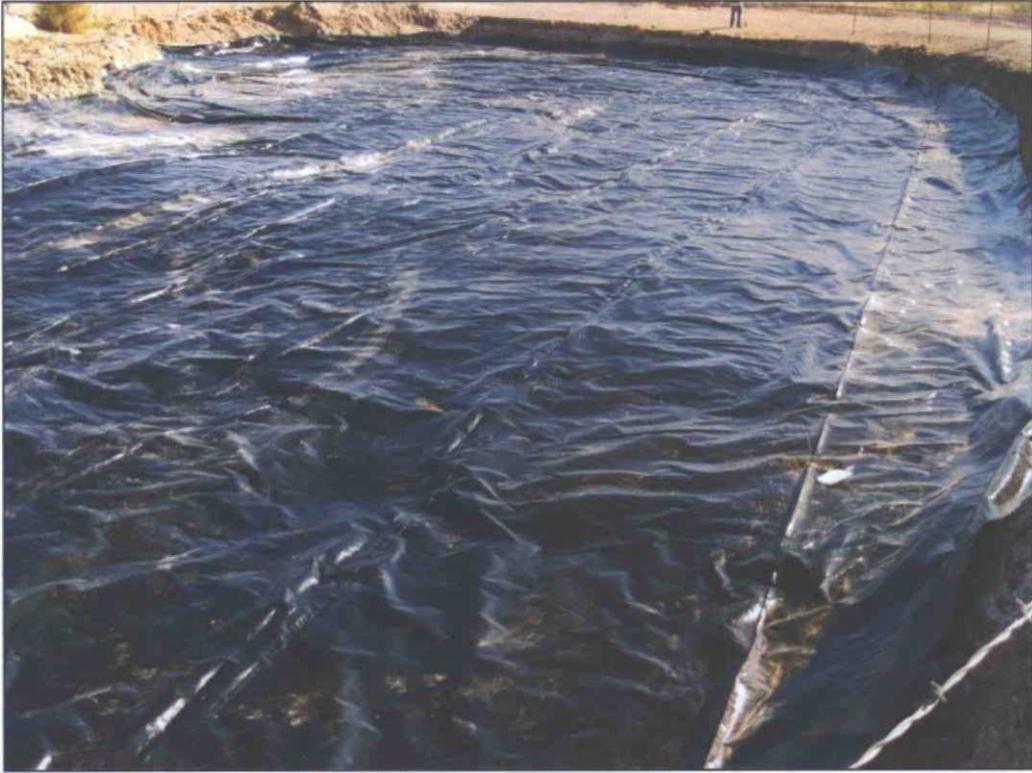
Middle of excavation with liner

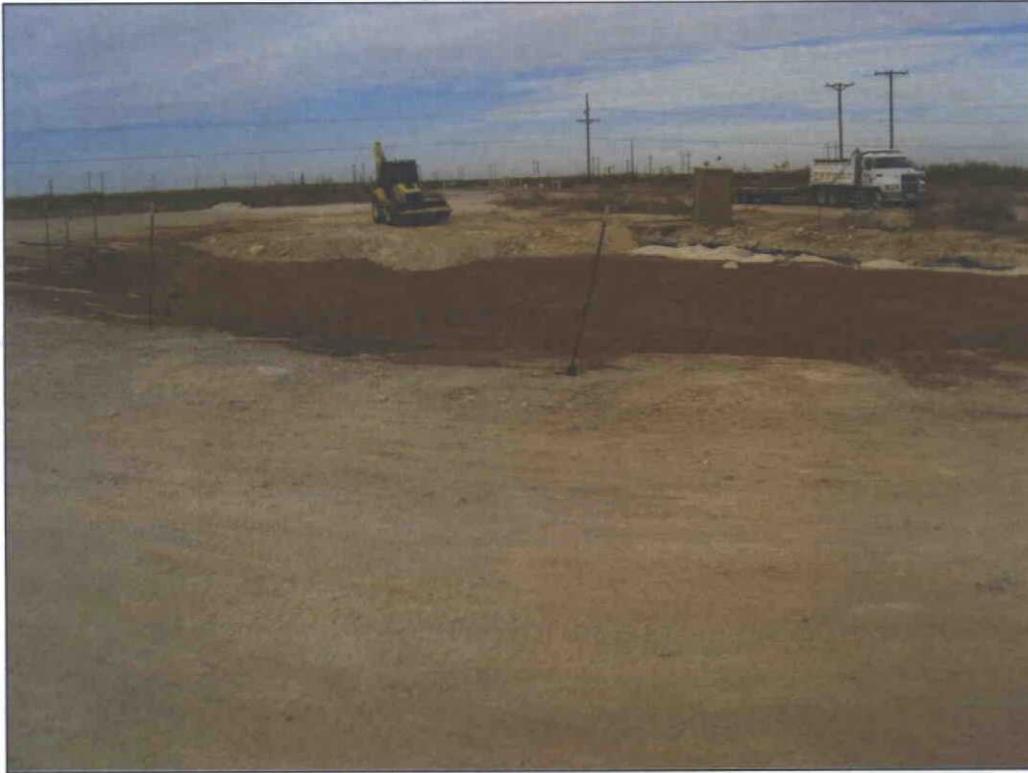
Backfilling area facing northwest

On November 28-30, 2011 SESI was onsite with Bryan's Oilfield Service to begin backfilling the excavation.

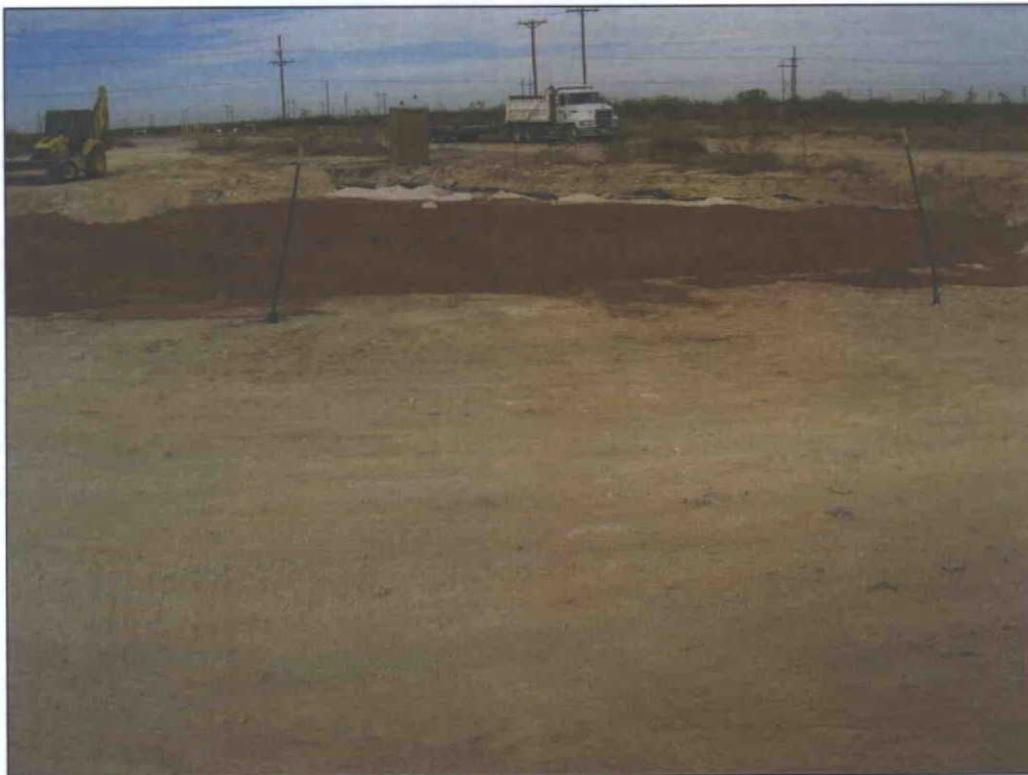
Backfill topsoil and caliche mix

On December 2, 2011, SESI was onsite with Bryan's Oil field Service. A total of 2,094 cu. yards of backfill material were hauled in.

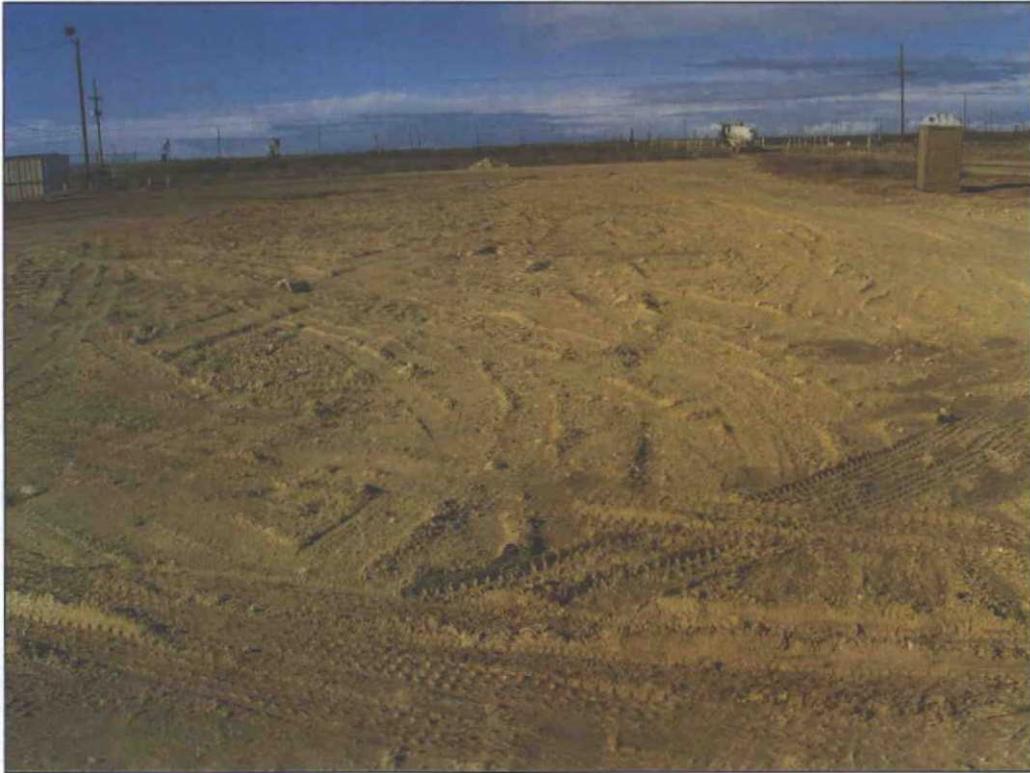
Backfilled surface area facing west

Remedial actions at this site have all been performed with the approval of, and in accordance with all NMOCD requirements. The area will be reseeded in the spring as per landowner's specifications.

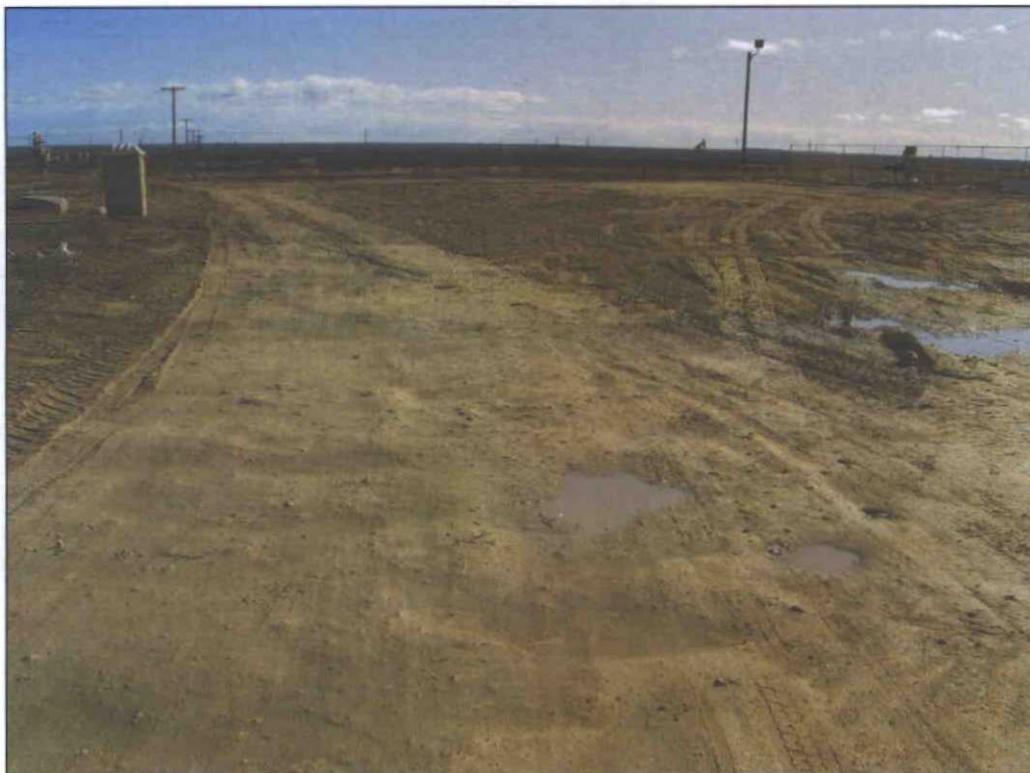
Surface facing east
