REMEDIATION SUMMARY & RISK-BASED SITE CLOSURE PROPOSAL

FASKEN OIL AND RANCH, Ltd.

DENTON SWD #3

Lea County, New Mexico

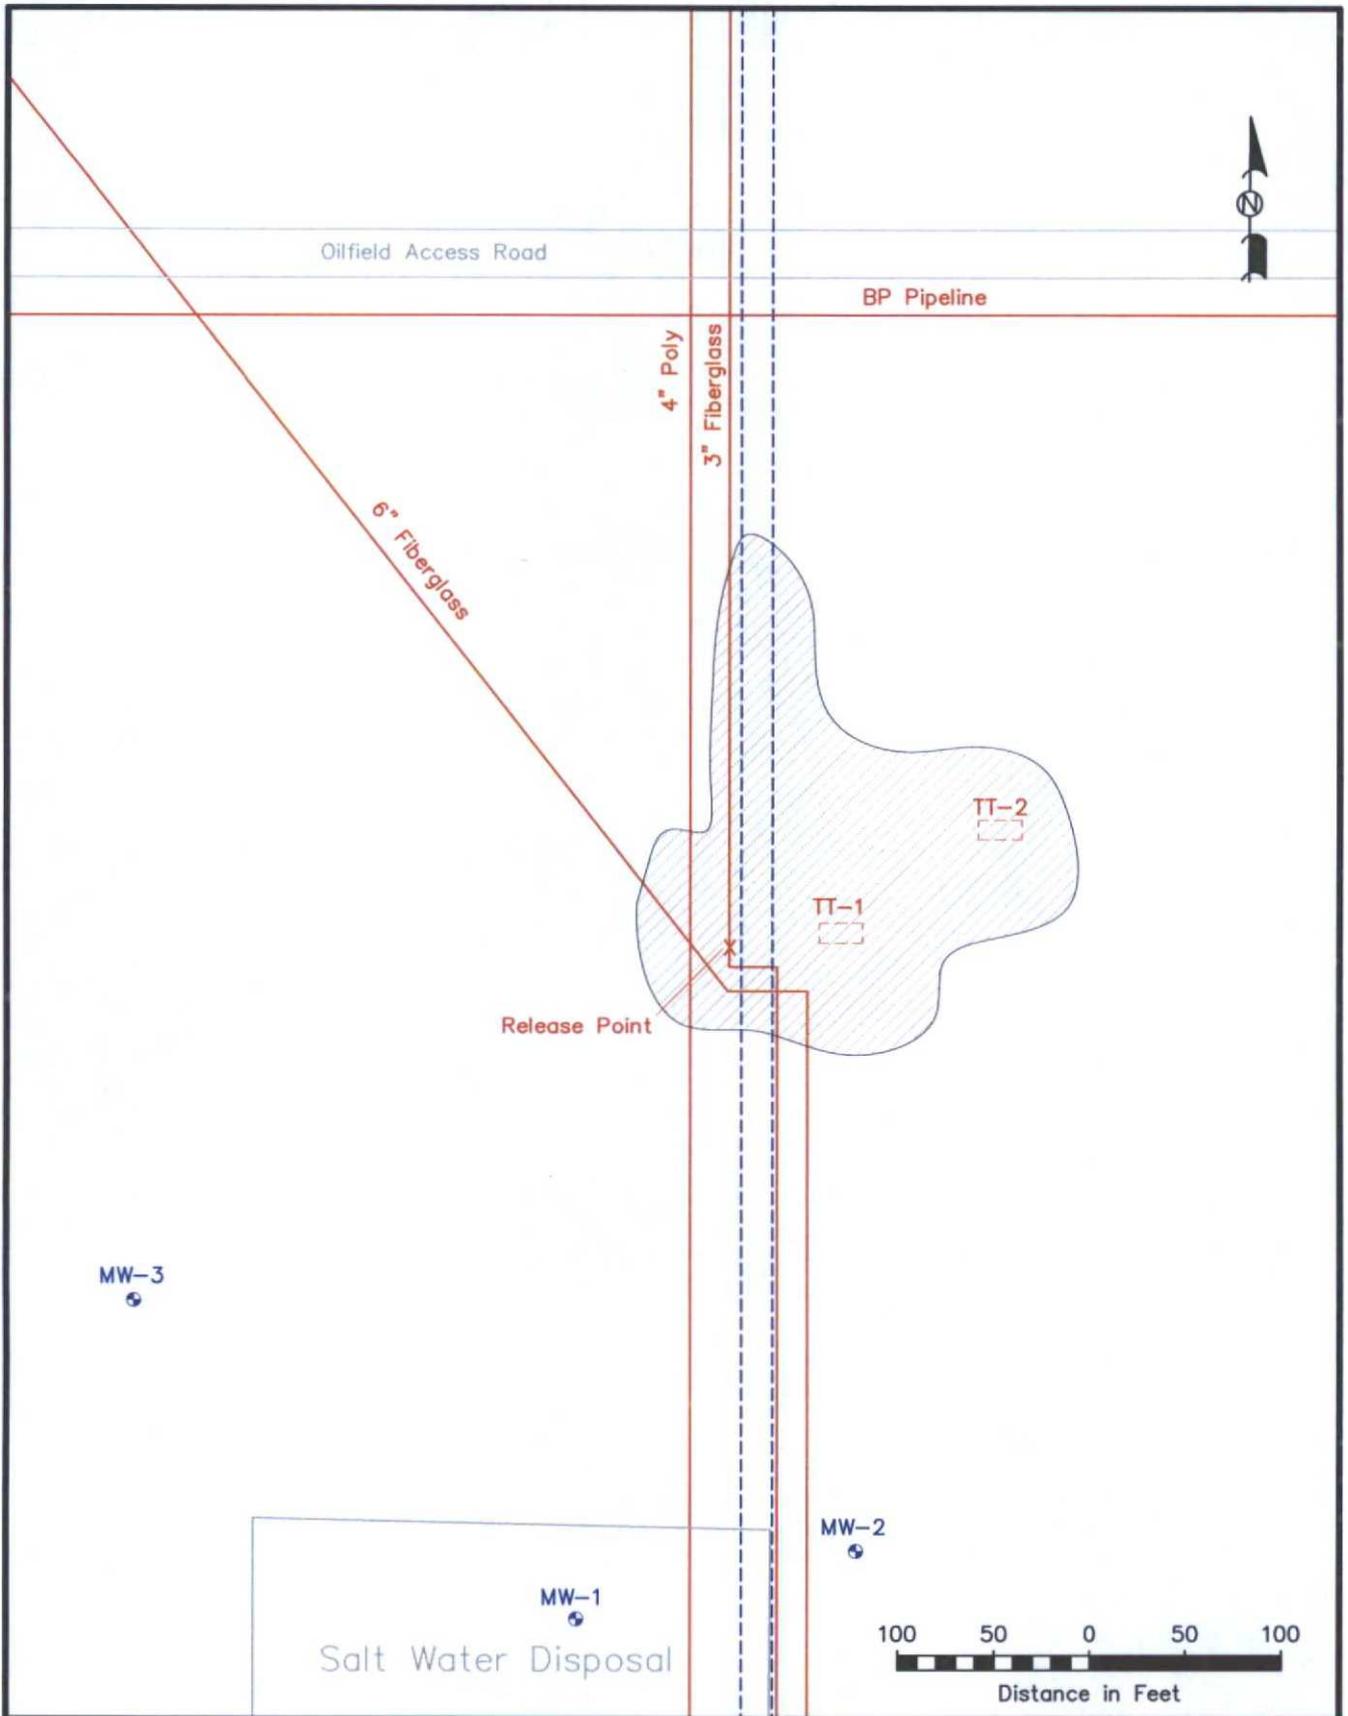
Figure 2
 Site & Sample Location Map
 Fasken Oil and Ranch Ltd.
 Denton SWD #3
 Lea County, NM

On May 13, 2013, Basin responded to the release site. A series of test trenches (TT-1 and TT-2) were advanced in an effort to determine the vertical and horizontal extent of soil impact. TT-1 was advanced south western portion of the release flowpath within an inferred pooling area. TT-1 was advanced to approximately three and one-half feet (3.5') bgs. During the advancement of the test trench, (2) soil samples (TT-1 @ Surface and TT-1 @ 3.5') were collected and submitted to the laboratory for analysis of BTEX, TPH and chloride concentrations. Laboratory analytical results indicated BTEX concentrations were less than the laboratory method detection limit (MDL) for each of the submitted soil samples. TPH concentrations ranged from 23.6 mg/kg for soil sample TT-1 @ Surface to less than the laboratory MDL for soil sample TT-1 @ 3.5'. Chloride concentrations ranged from 6,400 mg/kg for soil sample TT-1 @ Surface to 3,960 mg/kg for soil sample TT-1 @ 3.5'. Further advancement of TT-1 was impracticable due to the presence of an impenetrable rock layer encountered at three and one-half feet (3.5') bgs.

TT-2 was advanced approximately ninety-five feet (95') to the northeast of TT-1 within an inferred pooling area. TT-2 was advanced to approximately two feet (2') bgs. During the advancement of the test trench, (2) soil samples (TT-2 @ Surface and TT-2 @ 2) were collected and submitted to the laboratory for analysis of BTEX, TPH and chloride concentrations. Laboratory analytical results indicated BTEX and TPH concentrations were less than the appropriate laboratory MDL for each of the submitted soil samples. Chloride concentrations ranged from 64.0 mg/kg for soil sample TT-2 @ Surface to 3,000 mg/kg for soil sample TT-1 @ 3.5'. Further advancement of TT-2 was impracticable due to the presence of an impenetrable rock layer at two feet (2') bgs.

- The floor of the excavation will be advanced to the hard rock layer commonly encountered between two feet (2') to five feet (5') bgs. The excavation sidewalls will be advanced until laboratory analytical results from confirmation soil samples indicate concentrations of BTEX, TPH and chloride are below NMOCD Regulatory Standards. Confirmation soil samples will be collected at approximately fifty foot (50') intervals from the excavation floor and sidewalls. Collected soil samples will be submitted to Cardinal Laboratories for analysis of BTEX, TPH, and chlorides using EPA methods SW-846 8021b, SW-846 8015M, and 4500 Cl-B, respectively. Excavation will continue until laboratory analytical results indicate BTEX concentrations are less than 50 mg/Kg, TPH concentrations are less than 1,000 mg/Kg, and chloride concentrations are less than 500 mg/Kg.

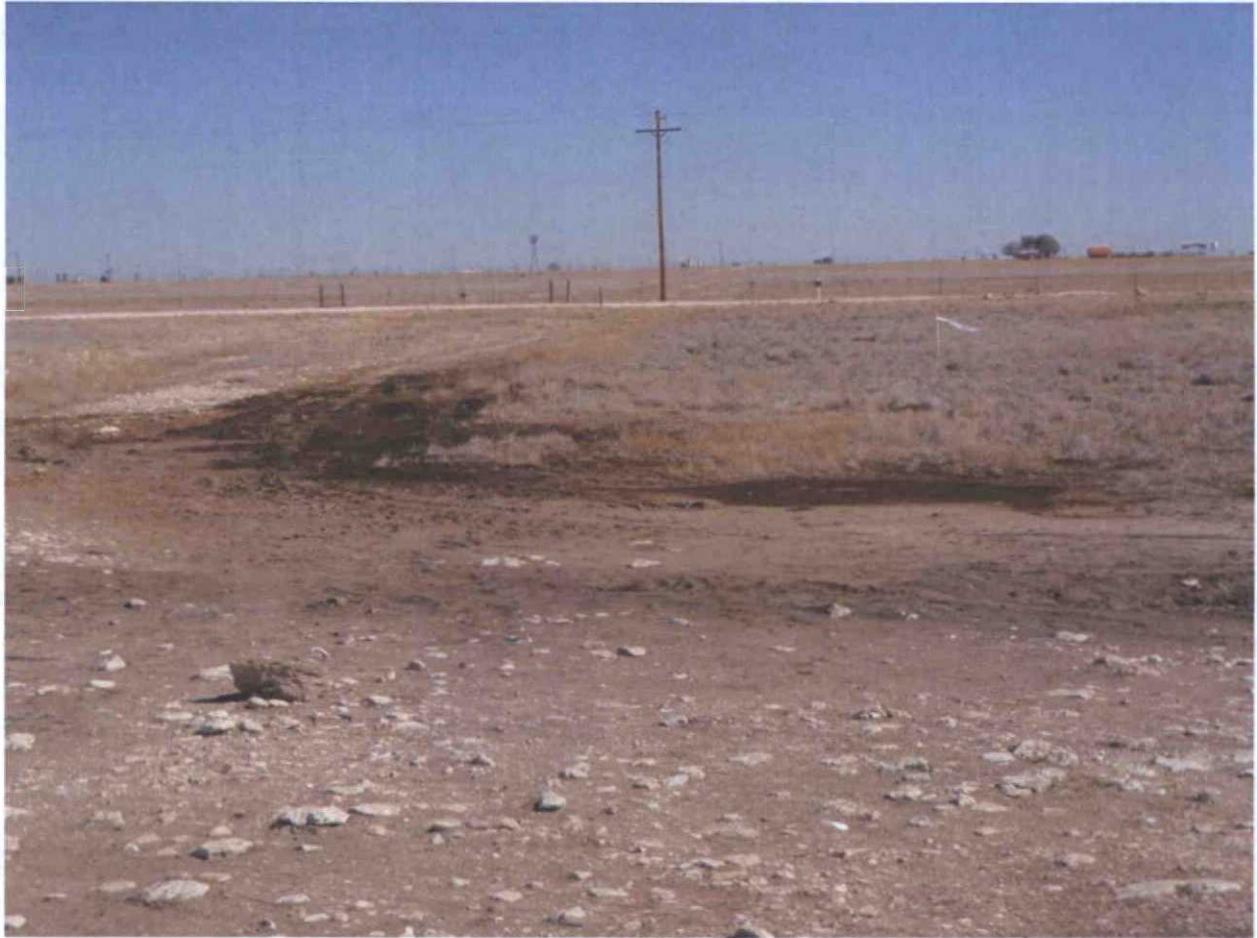
On April 29, 2013, Fasken discovered a release had occurred at the Denton SWD #3. The release was attributed to the failure of a four inch (4") vietaulic clamp. The pump shut down immediately due to low pressure. The site was dug out, and the clamp was replaced. The "Release Notification and Corrective Action" (Form C-141) indicated approximately twenty (20) barrels of produced water were released. The release impacted an area of pasture measuring approximately one hundred feet (100') in length and seventy-five (75') in width.

Photograph of the release at the Denton SWD #3 Environmental Remediation Site.
