Reference: Tomcat 21 Spill Remediation Plan

Executive Summary Devon Tomcat 21 Remediation Project

**Remediation Protocol
Devon Energy Tomcat 21
Brine Release**

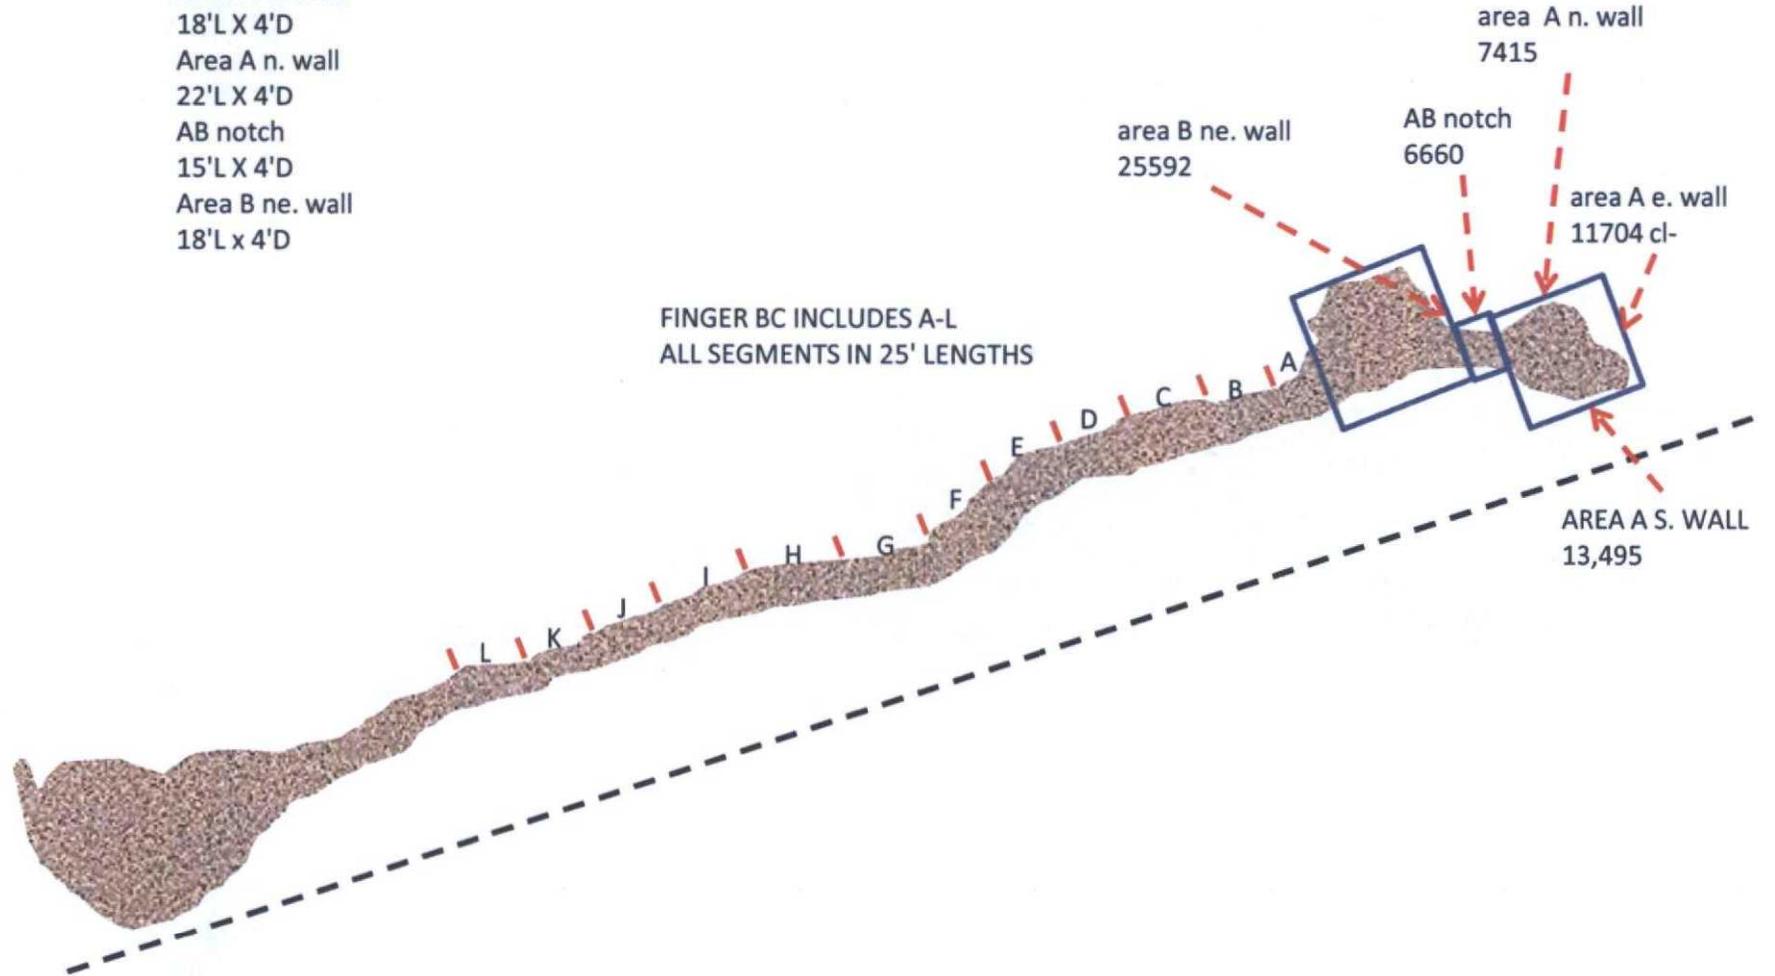
DEVON TOM CAT FED 21 COM #1 LEAK #1
AREA A & B CL- FIELD TITRATIONS RESULTS

AREA A
22'L X 18'W X 4'D
Area A e. wall
18'L X 4'D
Area A n. wall
22'L X 4'D
AB notch
15'L X 4'D
Area B ne. wall
18'L x 4'D
