**Soil Abatement Completion Report
Scharb 9 Tank Battery 2
API Well Number 30-025-28195
Unit F, Section 9, Township 19S, Range 35E
Lea County, New Mexico**

Project No. 12009-0003

SOIL ABATEMENT COMPLETION REPORT
SCHARB 9 TANK BATTERY 2
API WELL NUMBER 30-025-28195
UNIT F, SECTION 9, TOWNSHIP 19S, RANGE 35E
LEA COUNTY, NEW MEXICO

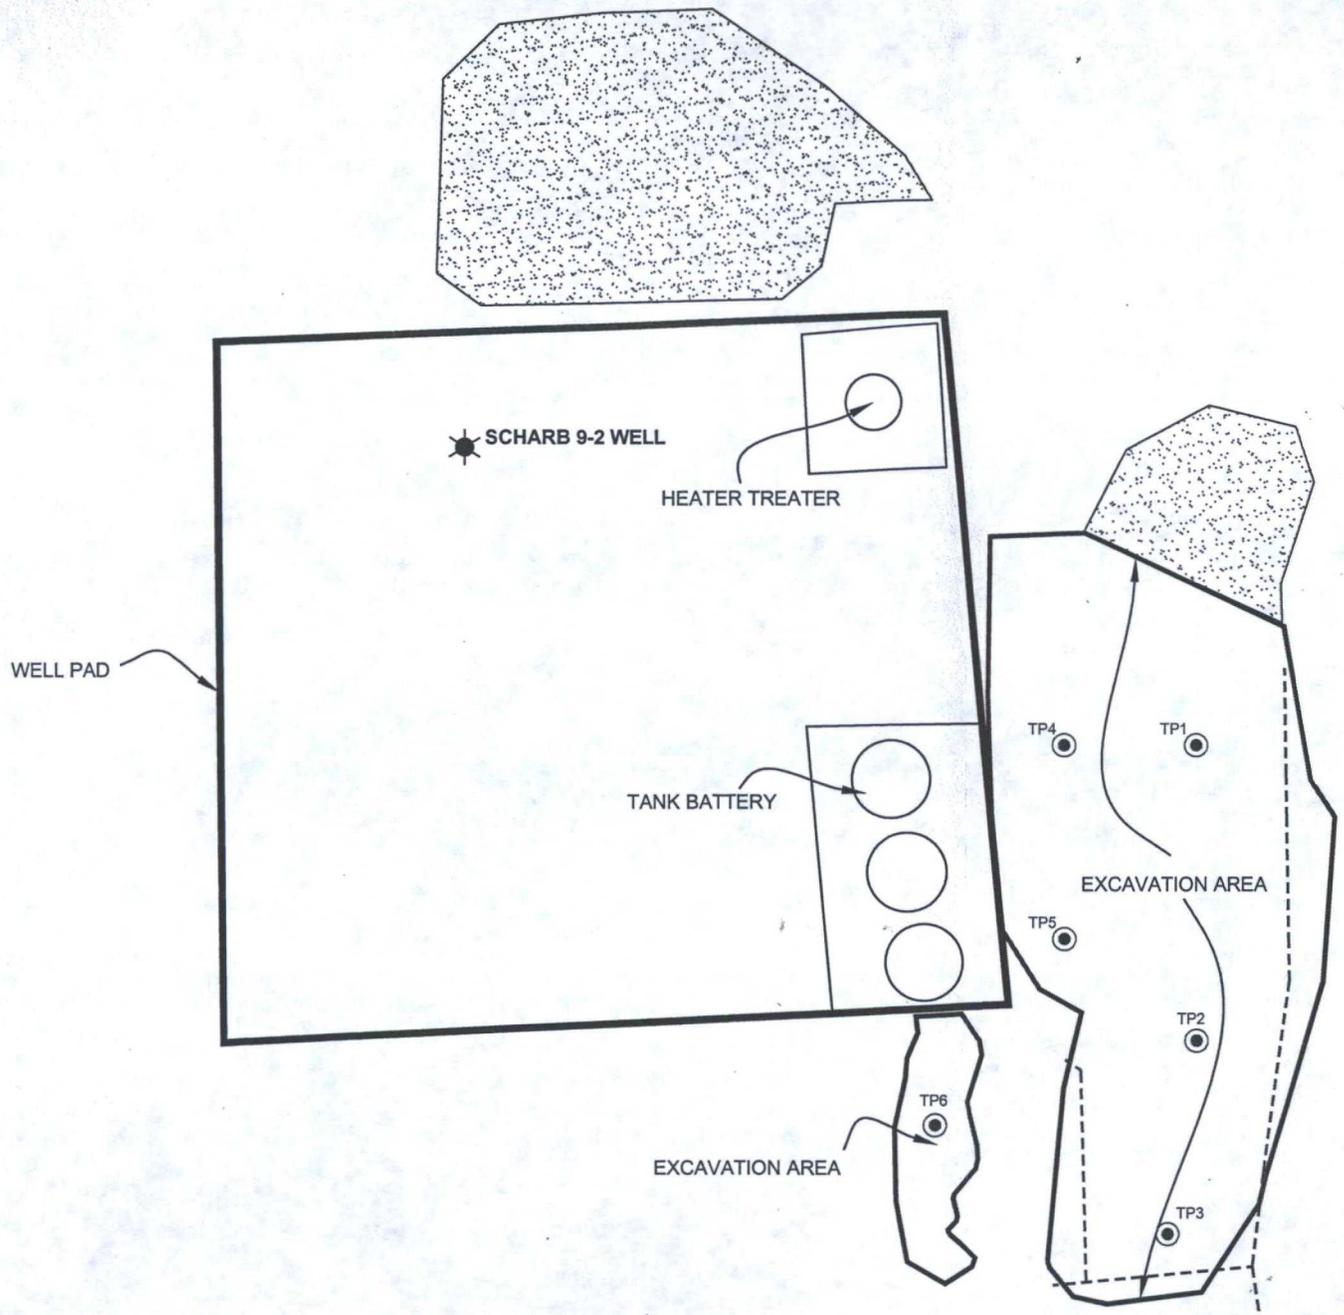
FIGURE
2

- PIPELINE
- ★ OIL/GAS PRODUCTION WELL LOCATION
- STOCKPILED SOIL
- TP1 TEST FIT LOCATIONS (RIO SERVICES, 2010)
- APPROXIMATE EXCAVATION AREA BOUNDARIES

SITE PLAN AND SAMPLE LOCATION MAP

Based on the field-screened chloride concentration data summarized in **Table 1**, Rio excavated the upper 4 feet of soil in the larger excavation area to the east of the new tank battery location. Rio also excavated the upper 2 feet of soil in the smaller excavation area south of the new tank battery. These excavated soils were stockpiled on site pending OCD approval of the excavation activities. The proposed abatement plan was to remove the upper 4 feet of impacted soil and to line the excavation with a composite geotextile and high-density polyethylene (HDPE) liner, backfill, and seed. OCD denied the proposed abatement plan on December 17, 2010. SKA and Linn representatives met with the OCD on January 18, 2011 and discussed a revised abatement plan that involved excavation of the upper 10 feet of impacted soil, placement of a compacted clay liner, backfilling, replacement of topsoil, and seeding. The OCD approved the revised abatement plan on February 9, 2011.

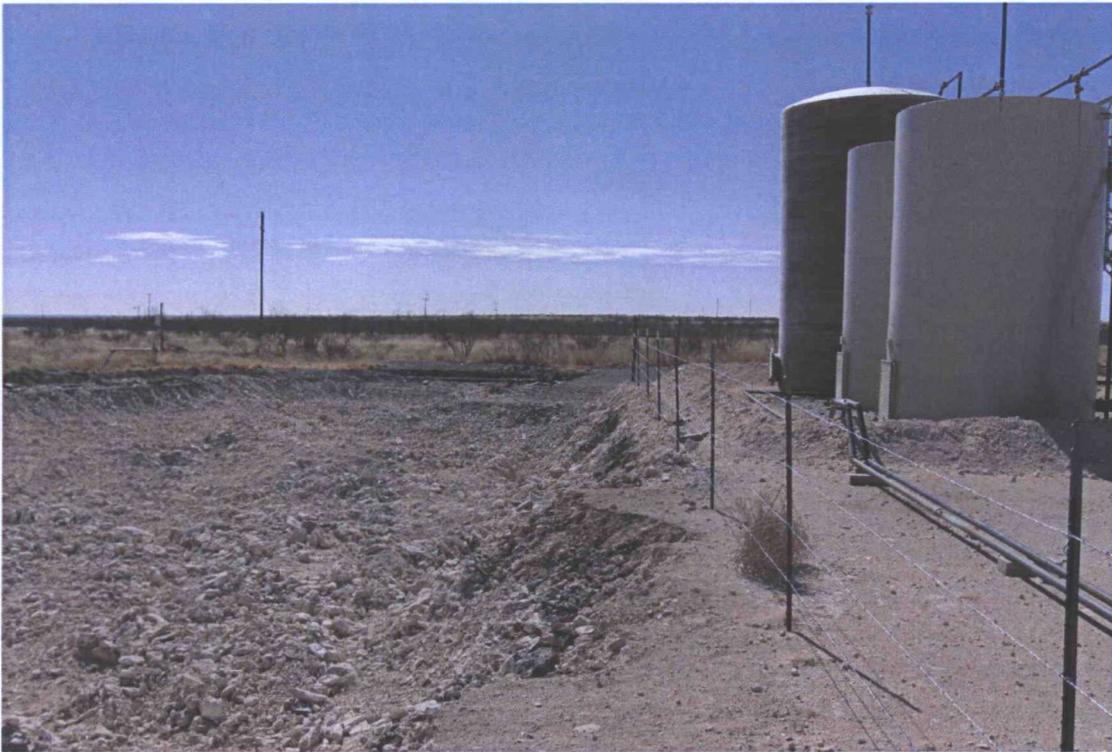
Photo No. 1: A view to the south showing the preliminary excavation and the re-built tank battery to the right.

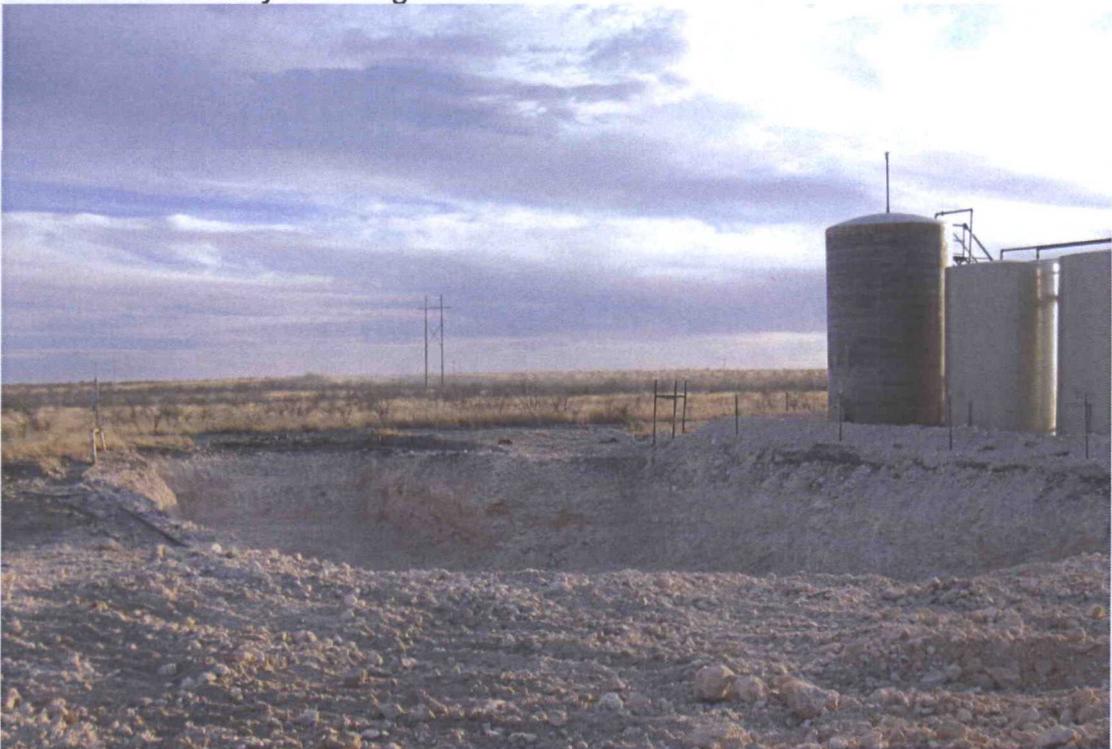
Photo No. 2: View to the south showing the completed excavation and the re-built tank battery to the right.

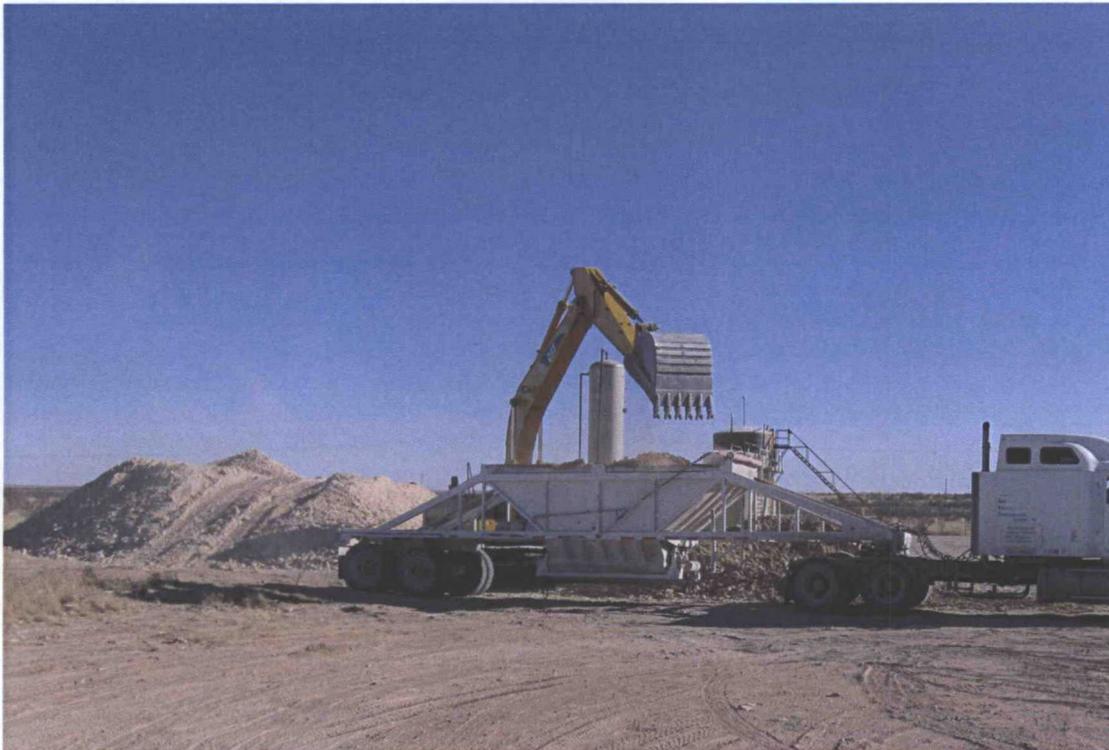
Photo No. 3: View to the northwest showing the chloride-contaminated soil being loaded for off-site disposal.

SKA implemented the approved abatement plan and collected composite soil samples of the soil stockpile. These samples exhibited chloride concentrations of less than 1,000 mg/kg so the soil was eligible for landfarming. The stockpiled soil was hauled and disposed at the Lazy Ace Land Farm, near Eunice, New Mexico. SKA continued the excavation to an ultimate depth of 10 ft-bgs. Additional excavated soil was also disposed of at the Lazy Ace Land Farm. Photographs of the soil abatement activities are provided in **Appendix 5**.

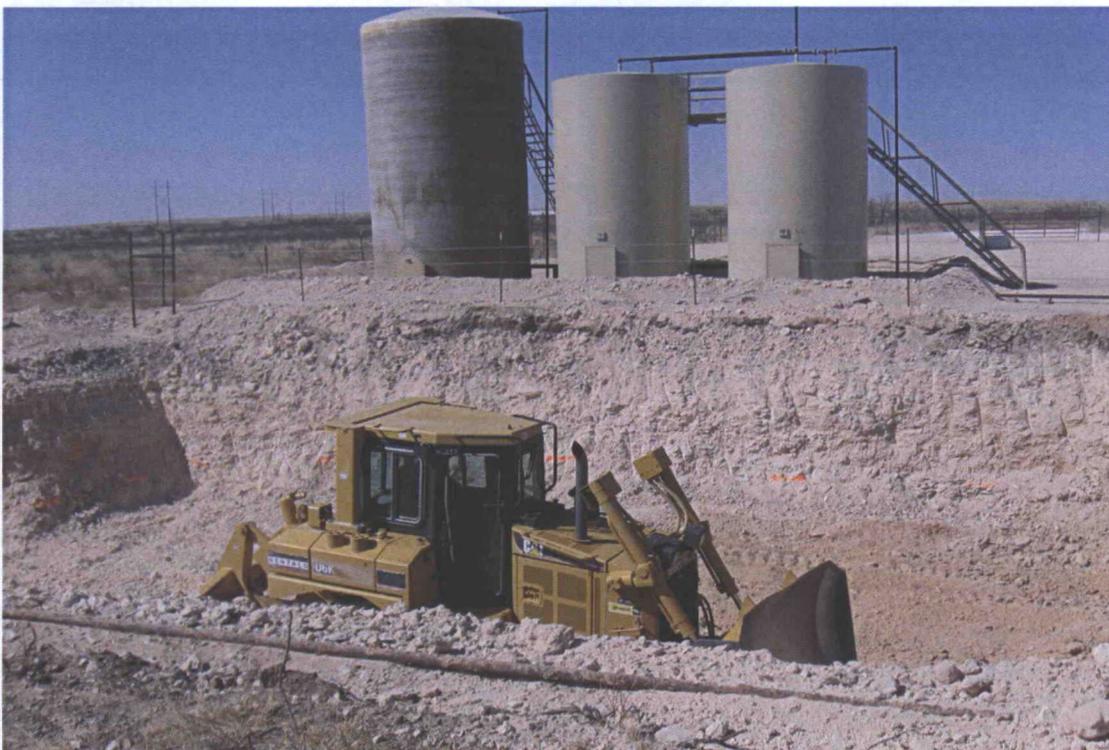
Photo No. 4: View to the west showing the excavation bottom being compacted by the dozer before placement of the clay liner. Note the orange clay liner fill marks on the excavation walls.

The excavation was backfilled to a depth of 8 ft-bgs with clay obtained from the Lazy Ace Land Farm. The clay was graded and machine compacted with a trackhoe. The excavation was further backfilled up to 2 ft-bgs using native caliche obtained from the landowner's on site pit. The upper two feet of the excavation was backfilled using topsoil obtained from the Lazy Ace Land Farm and approved by the landowner. After backfilling, the excavated area and other adjacent disturbed areas were reseeded.

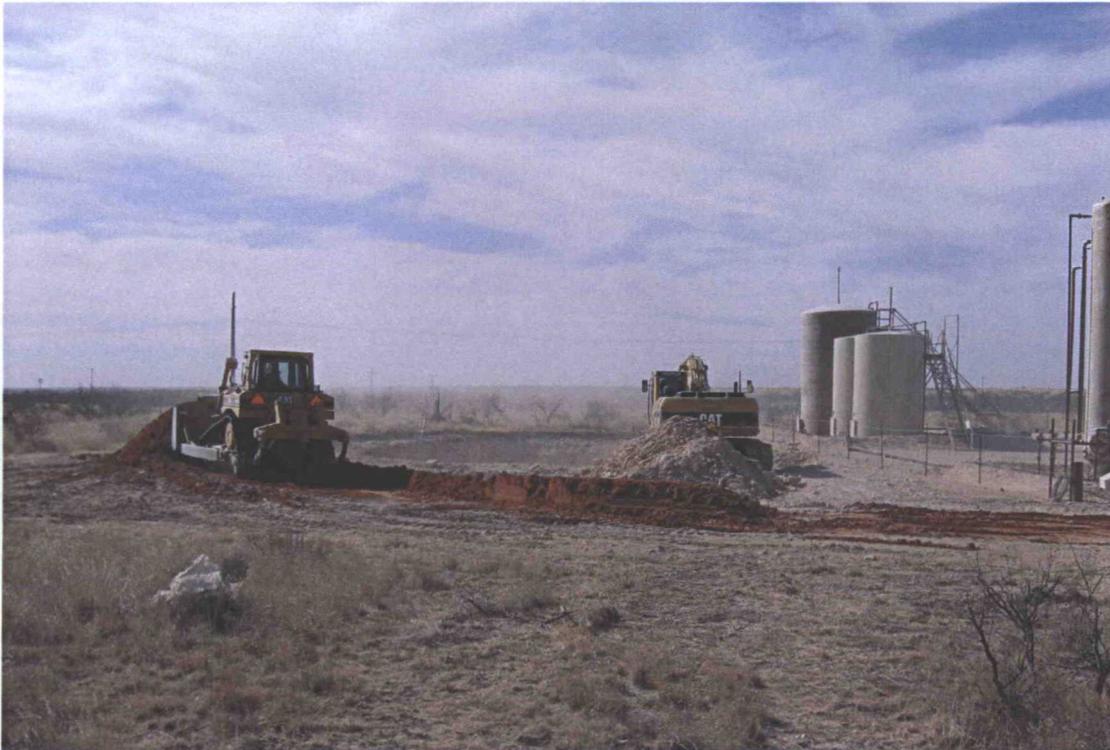
Photo No. 5: View to the south of red clay liner material being pushed into the excavation by the dozer.

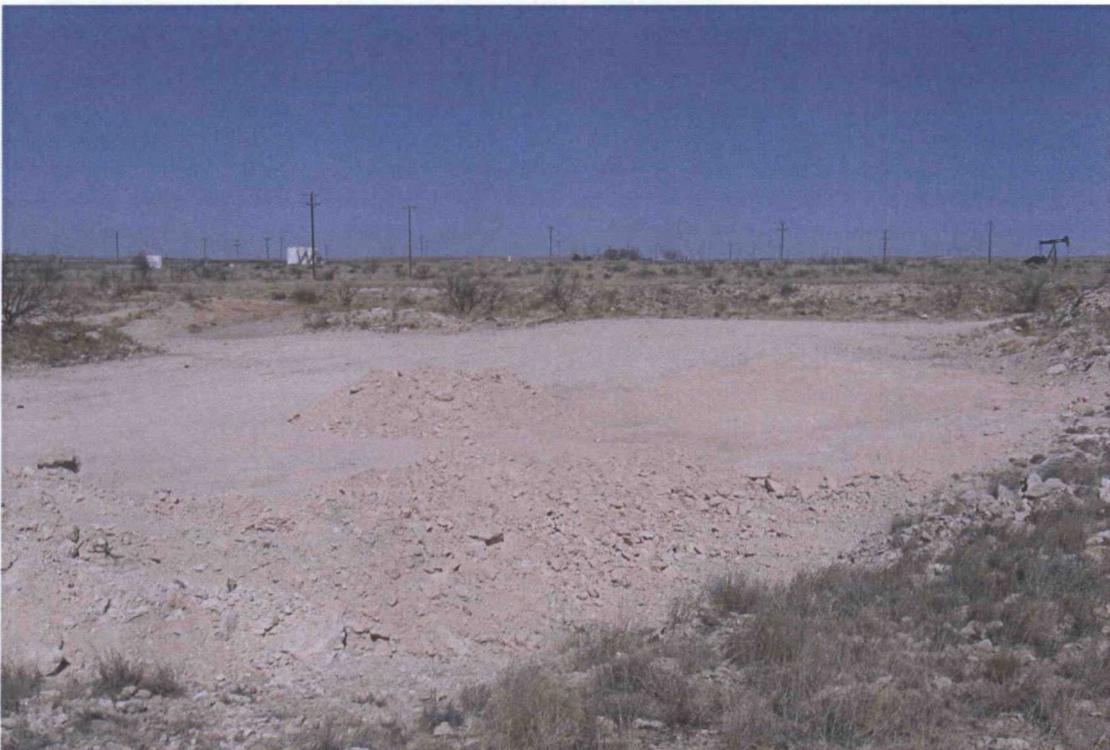
Photo No. 6: View to the southeast showing the excavation backfilled with caliche.

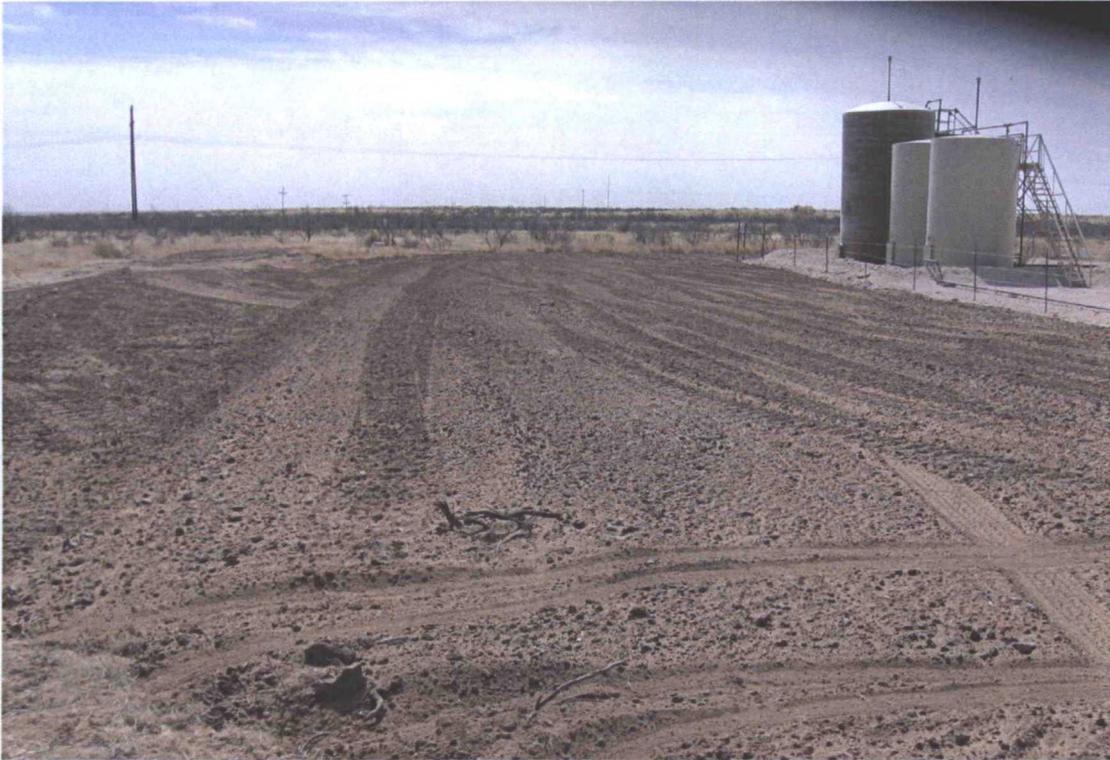
Photo No. 7: View to the south showing the restored site with topsoil.

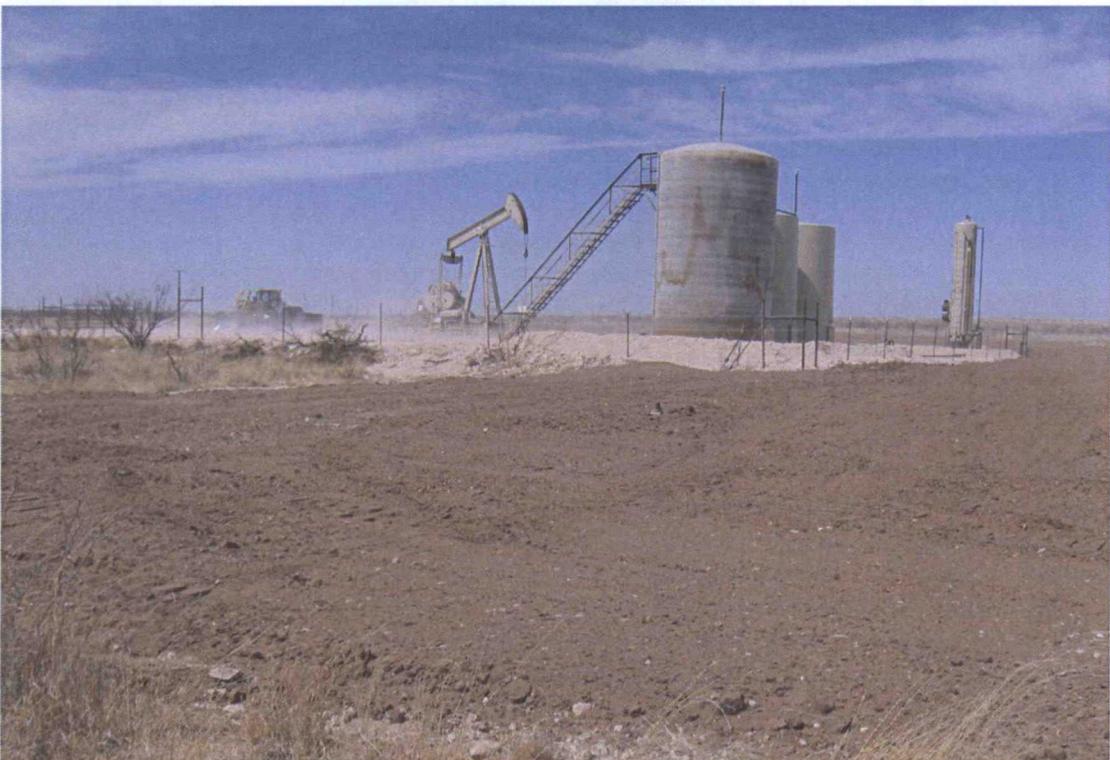
Photo No. 8: View to the northwest of the restored site with topsoil.
