**Re: Soil Abatement Completion Report
Scharb 9 Battery 2
API Well Number 30-025-28195
Unit F, Section 9, Township 19S, Range 35E
Lea County, New Mexico**

**Soil Abatement Completion Report
Scharb 9 Tank Battery 2
API Well Number 30-025-28195
Unit F, Section 9, Township 19S, Range 35E
Lea County, New Mexico**

Project No. 12009-0003

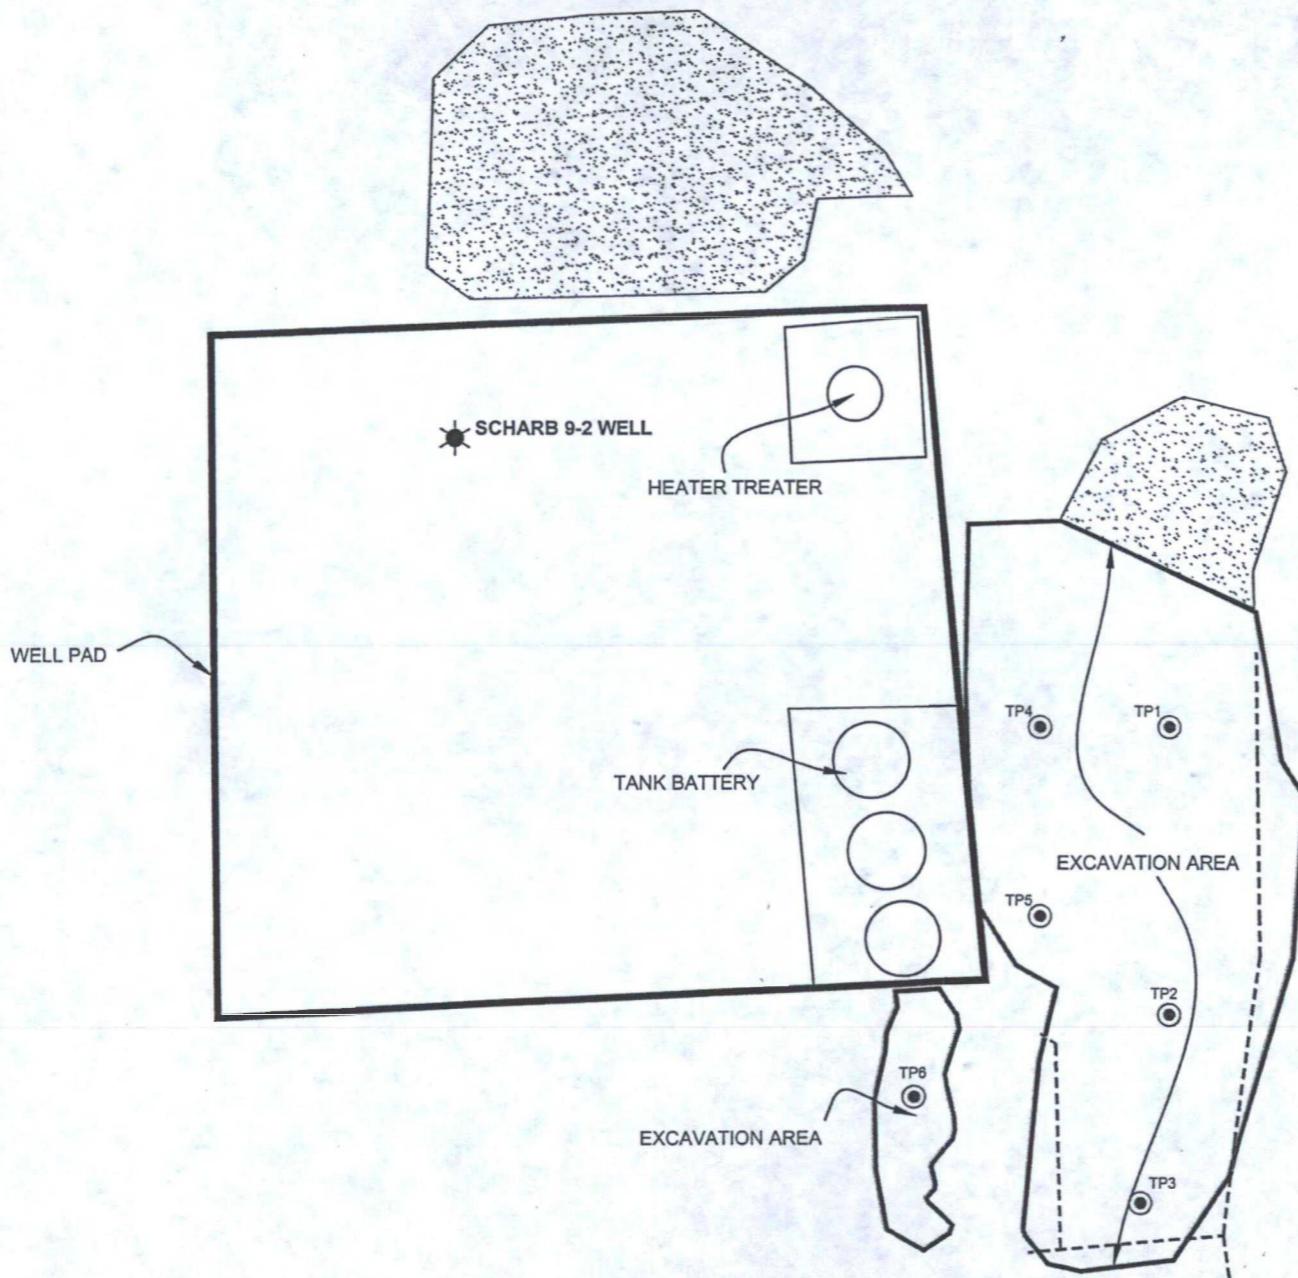
FIGURE
2

SITE PLAN AND SAMPLE LOCATION MAP

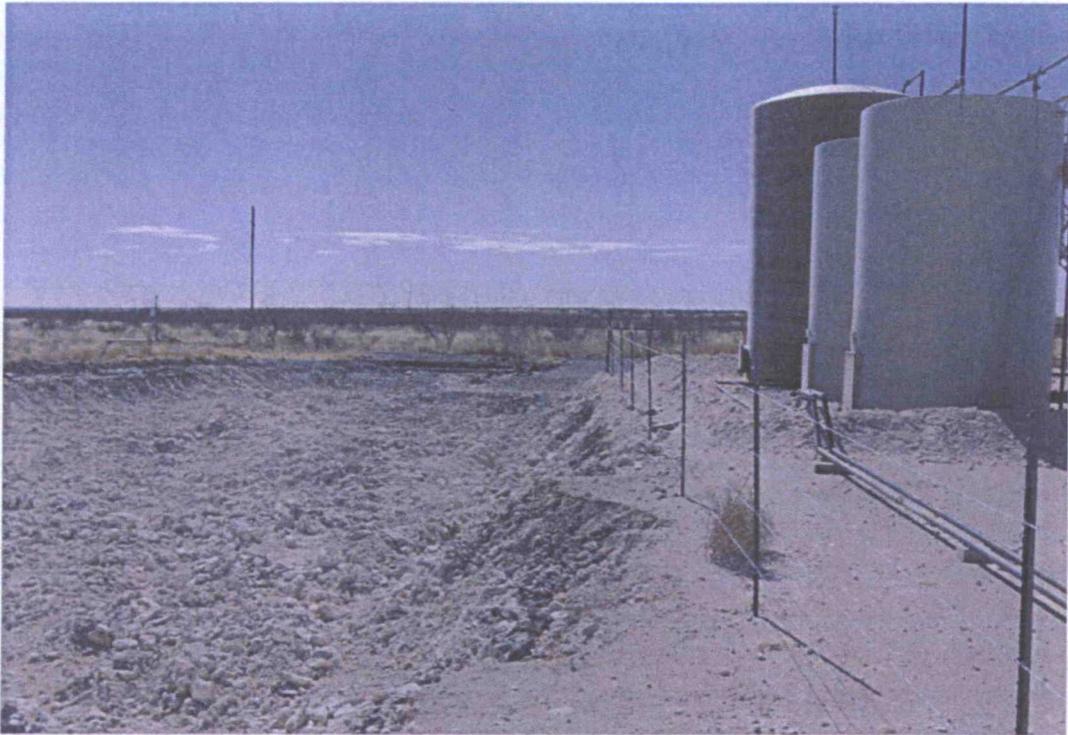
Photo No. 1: A view to the south showing the preliminary excavation and the re-built tank battery to the right.

Based on the field-screened chloride concentration data summarized in **Table 1**, Rio excavated the upper 4 feet of soil in the larger excavation area to the east of the new tank battery location. Rio also excavated the upper 2 feet of soil in the smaller excavation area south of the new tank battery. These excavated soils were stockpiled on site pending OCD approval of the excavation activities. The proposed abatement plan was to remove the upper 4 feet of impacted soil and to line the excavation with a composite geotextile and high-density polyethylene (HDPE) liner, backfill, and seed. OCD denied the proposed abatement plan on December 17, 2010. SKA and Linn representatives met with the OCD on January 18, 2011 and discussed a revised abatement plan that involved excavation of the upper 10 feet of impacted soil, placement of a compacted clay liner, backfilling, replacement of topsoil, and seeding. The OCD approved the revised abatement plan on February 9, 2011.

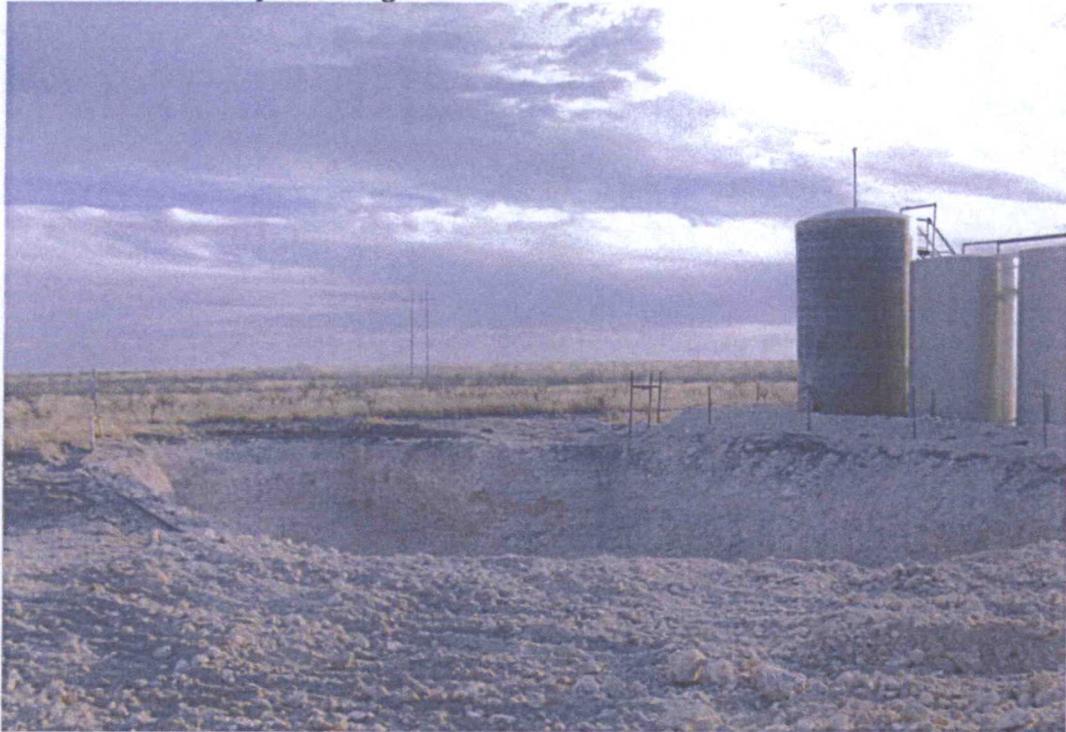
Photo No. 2: View to the south showing the completed excavation and the re-built tank battery to the right.

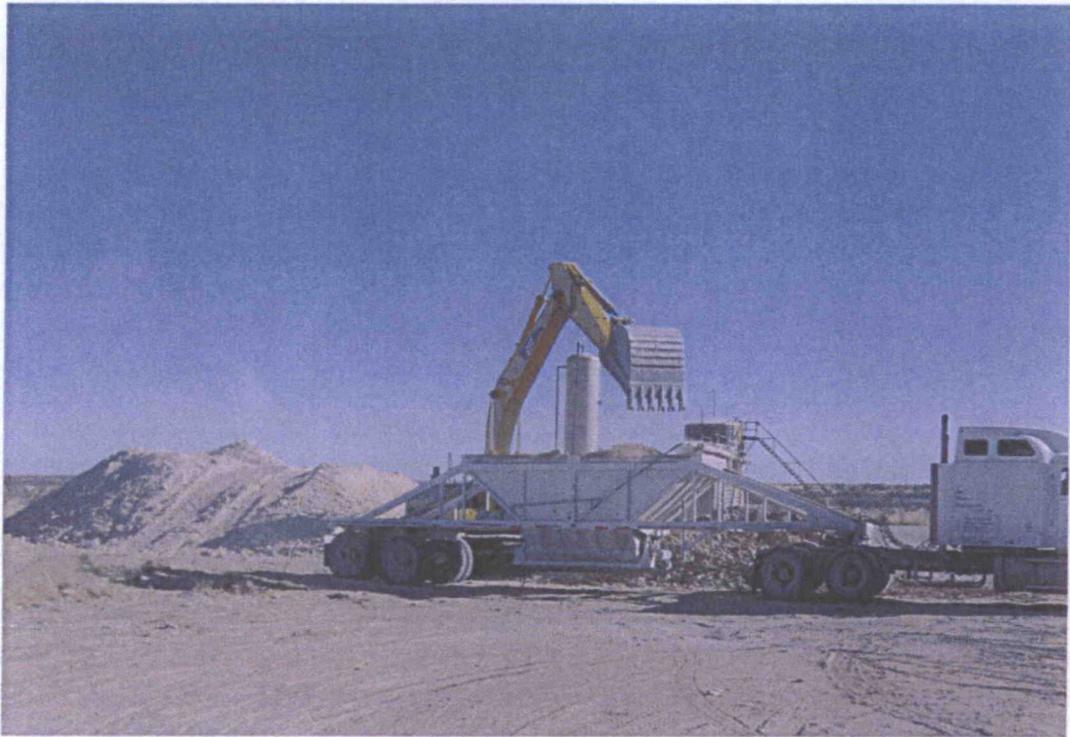
Photo No. 3: View to the northwest showing the chloride-contaminated soil being loaded for off-site disposal.

SKA implemented the approved abatement plan and collected composite soil samples of the soil stockpile. These samples exhibited chloride concentrations of less than 1,000 mg/kg so the soil was eligible for landfarming. The stockpiled soil was hauled and disposed at the Lazy Ace Land Farm, near Eunice, New Mexico. SKA continued the excavation to an ultimate depth of 10 ft-bgs. Additional excavated soil was also disposed of at the Lazy Ace Land Farm. Photographs of the soil abatement activities are provided in **Appendix 5**.

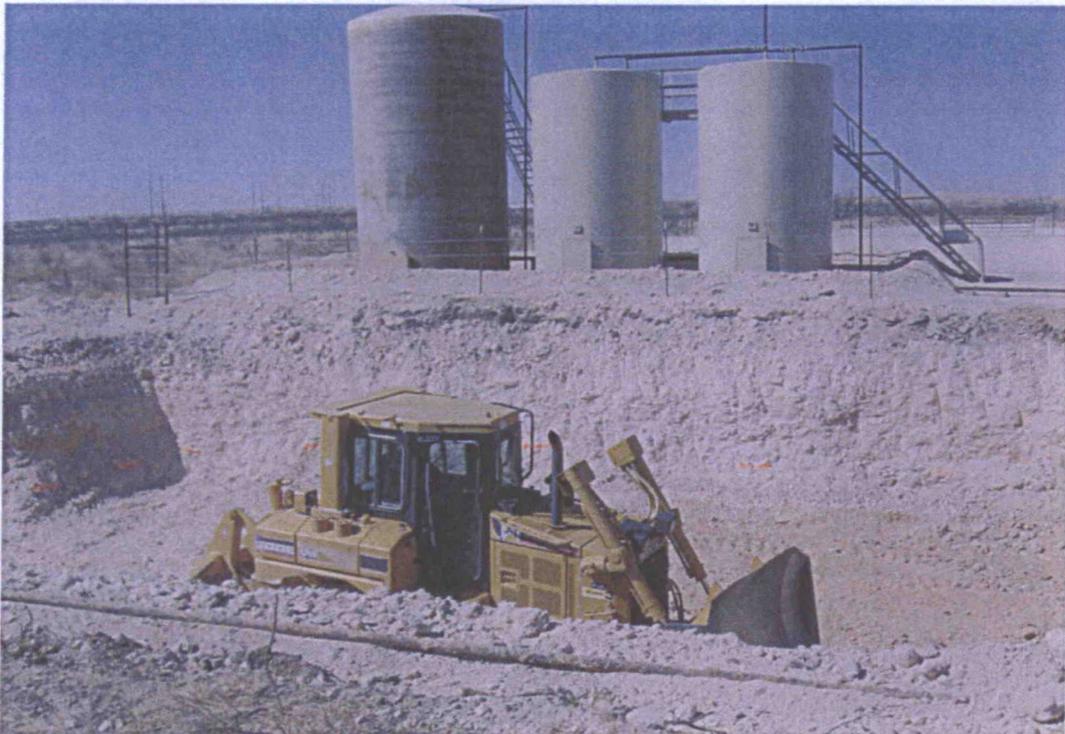
Photo No. 4: View to the west showing the excavation bottom being compacted by the dozer before placement of the clay liner. Note the orange clay liner fill marks on the excavation walls.

The excavation was backfilled to a depth of 8 ft-bgs with clay obtained from the Lazy Ace Land Farm. The clay was graded and machine compacted with a trackhoe. The excavation was further backfilled up to 2 ft-bgs using native caliche obtained from the landowner's on site pit. The upper two feet of the excavation was backfilled using topsoil obtained from the Lazy Ace Land Farm and approved by the landowner. After backfilling, the excavated area and other adjacent disturbed areas were reseeded.

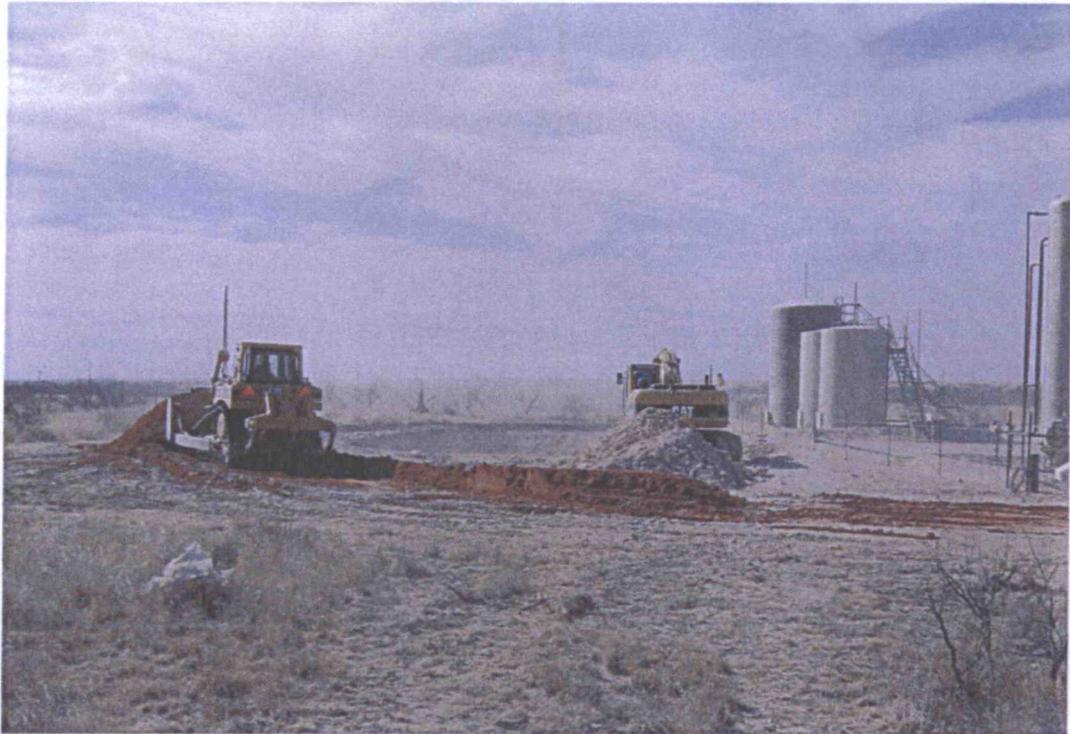
Photo No. 5: View to the south of red clay liner material being pushed into the excavation by the dozer.

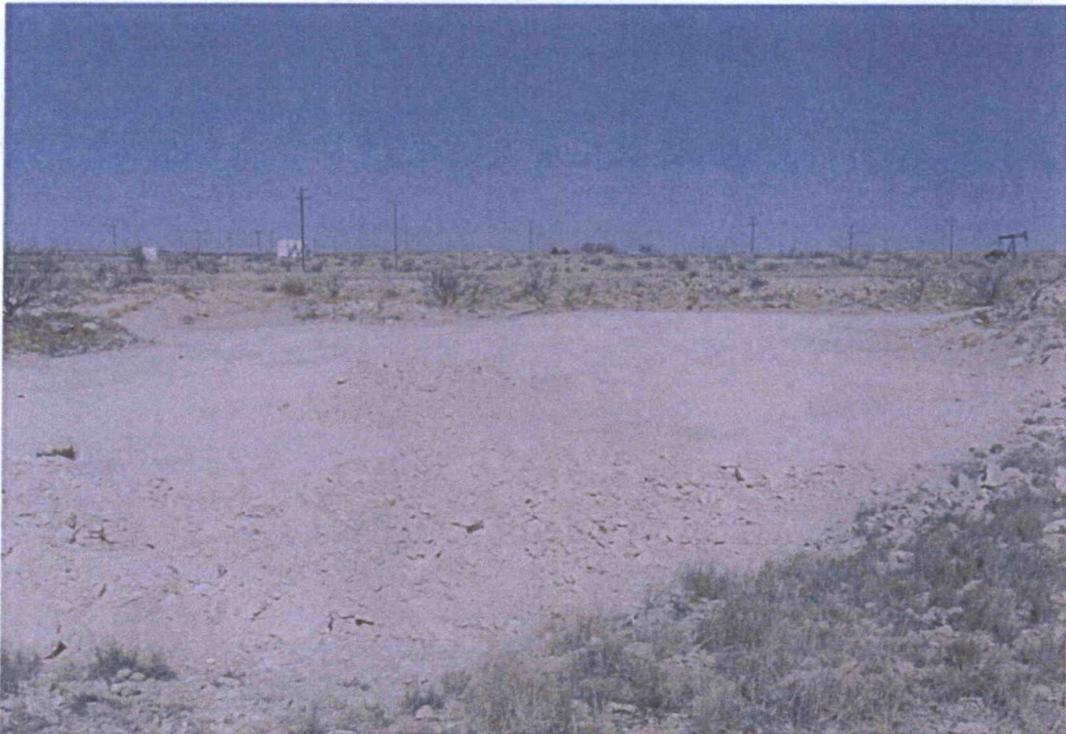
Photo No. 6: View to the southeast showing the excavation backfilled with caliche.

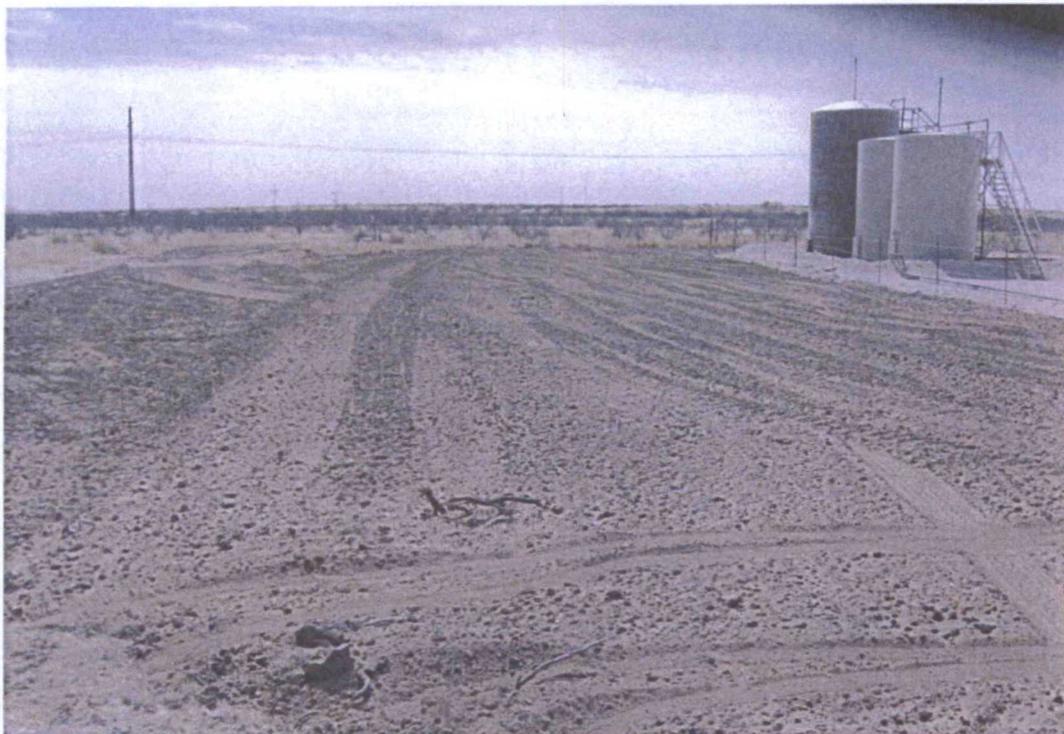
Photo No. 7: View to the south showing the restored site with topsoil.

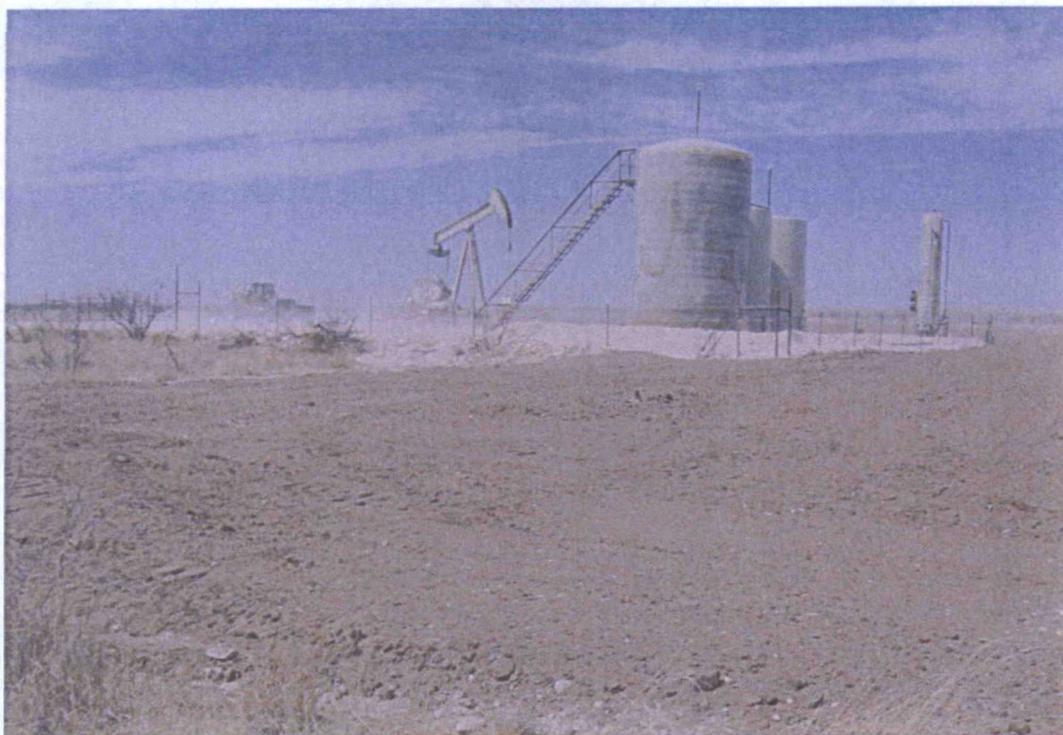
Photo No. 8: View to the northwest of the restored site with topsoil.
