## MCA UNIT 2 - F PRODUCTION HEADER LEAK (04-13-05)

### ENVIRONMENTAL SITE INVESTIGATION

OCTOBER 6, 2005

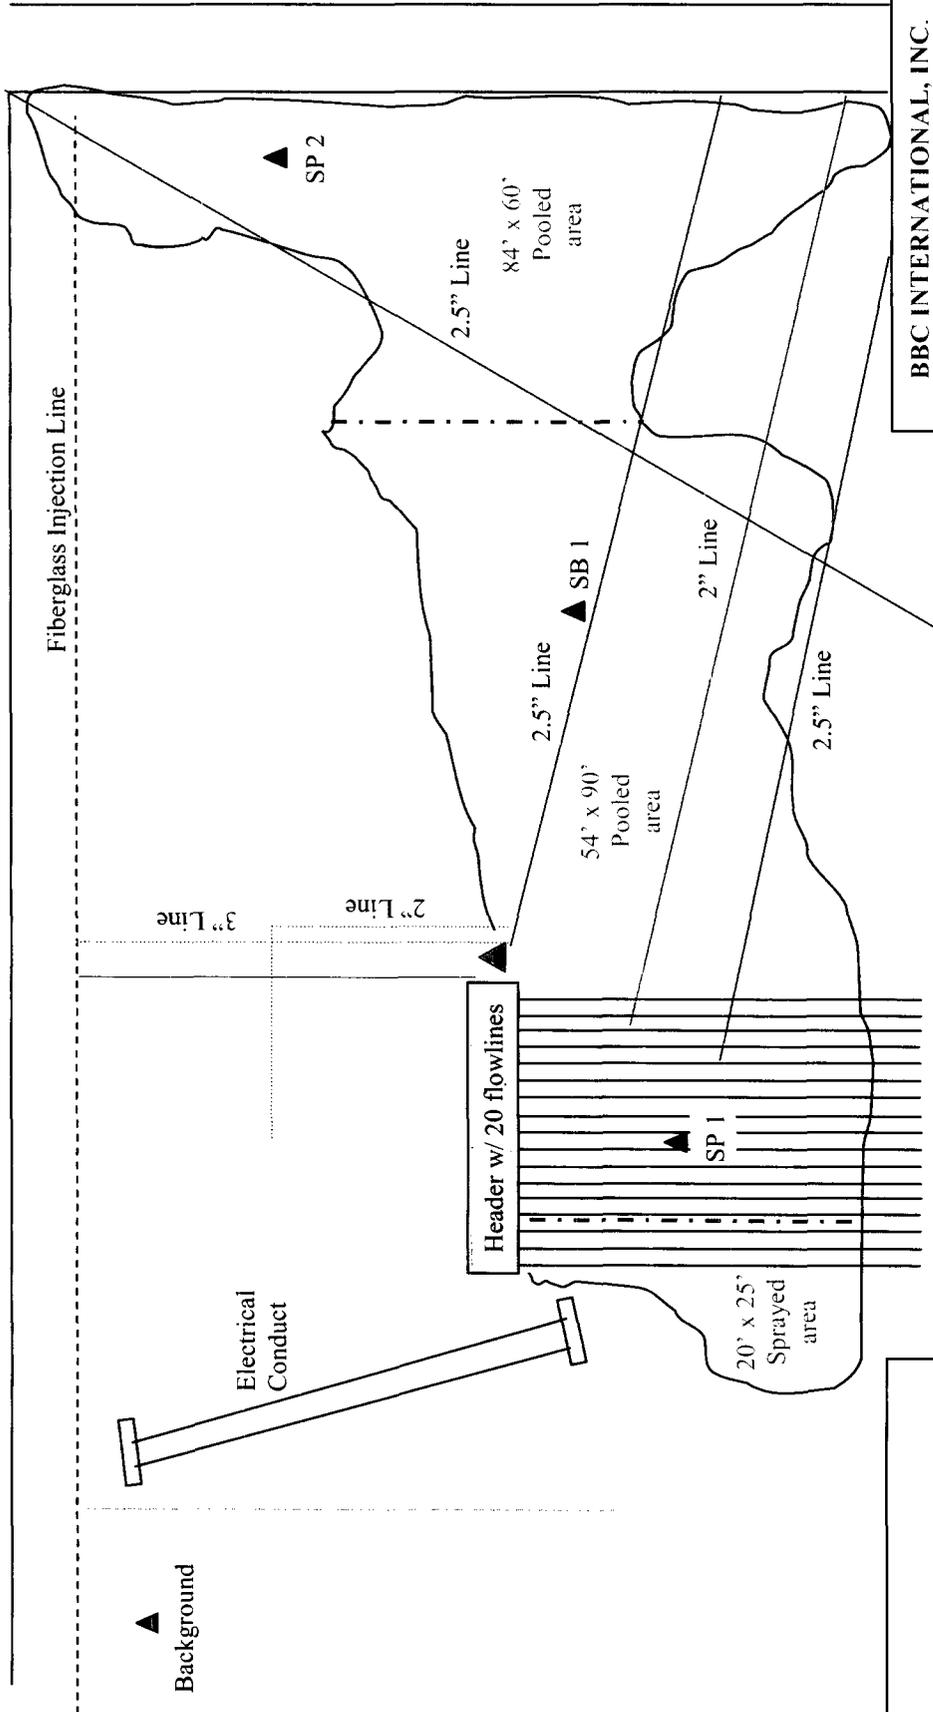
# CONOCOPHILLIPS MCA UNIT 2 – F PRODUCTION HEADER

The leak area measures approximately 54 feet by 90 feet at the center, 84 feet by 60 feet on the west side, with a smaller sprayed area on the east side that measures approximately 20 feet by 25 feet. A sketch of the leak area including the sample points can be reviewed in Appendix II of this report. Site photographs can be viewed in Appendix III of this report. The surface soil is red sand and caliche. There is no water source within 1,000 feet of the site. There is no surface water within 1,000 feet of the site. Based on data from the ground water monitoring well located at the Maljamar Plant, depth to ground water is approximately 90 feet.

On August 31, 2005, BBC personnel conducted an investigation of the site. A soil boring was drilled near the center of the leak area using BBC's tractor mount drilling rig, to a total depth of 10 feet. Four samples were taken from the soil boring; one each at one foot, three feet, five feet, and ten feet. The samples were taken to Cardinal Laboratories for analysis. Laboratory analysis for SB1 @ 1' is: GRO – non-detect, DRO – 937 ppm, Chlorides 768 ppm, Benzene – non-detect, Toluene – non-detect, Ethyl Benzene – non-detect, Total Xylenes – non-detect. Laboratory analysis for SB1 @ 3' is: Chlorides 736 ppm. Laboratory analysis for SB1 @ 5' is: Chlorides 768 ppm. Laboratory analysis for SB1 @ 10' is: GRO – non-detect, DRO – 82.9 ppm, Chlorides 192 ppm, Benzene – non-detect, Toluene – non-detect, Ethyl Benzene – non-detect, Total Xylenes – non-detect. Laboratory analytical results for this sampling event can be reviewed in Appendix I of this report. The location of the soil boring and other sample points can be viewed on the site diagram in Appendix II of this report.

Two near surface samples were also taken; one from the east end of the leak area and one from the west end of the leak area. The samples were taken at a depth of one foot and were taken to Cardinal Laboratories for analysis.
