**Range Operating New Mexico, Inc.
South Culebra Bluff 23 Well #7
Unit J, Sec. 23, T23S, R28E
Eddy County, New Mexico**

Work Plan

October 8, 2009

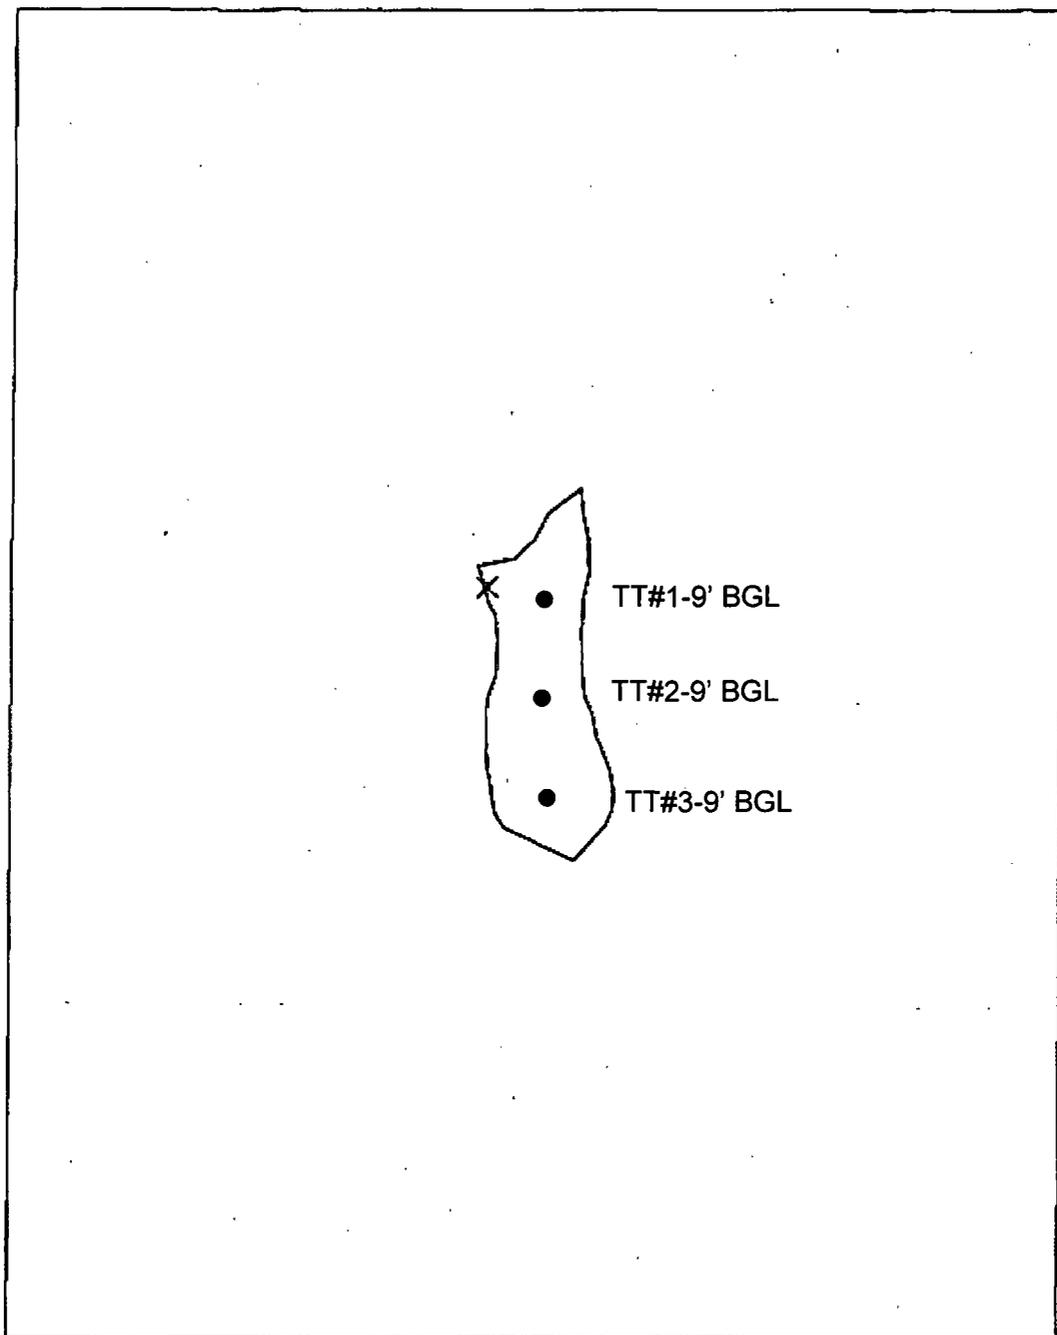
**Figure 2
Site Plan**

On July 9, 2009 SESI was onsite to assess the affected area. The area was mapped using a Trimble Geo XM GPS. SESI observed an excavated area, approximately one (1) foot in depth, located north of the well head.

SESI was onsite with M& J Backhoe Services to attempt to delineate the spill area. A total of three (3) test trenches were installed within the affected area. Chloride samples were collected within each of the three (3) trenches to determine the vertical extent of the contamination.

It is requested that the affected area be excavated to a depth of three (3) feet bgl. The excavated soils will be transported to a New Mexico Oil Conservation Division (NMOCD) approved facility for disposal. A 20 mil reinforced geo-membrane liner will be installed and the area will be backfilled with like soils and contoured to grade. It is also requested that the temporary monitor well be plugged and abandoned.
