**3R-1011**

**Release Report/ General  
Correspondence**

**Enterprise SJ**

## CORRECTIVE ACTION REPORT

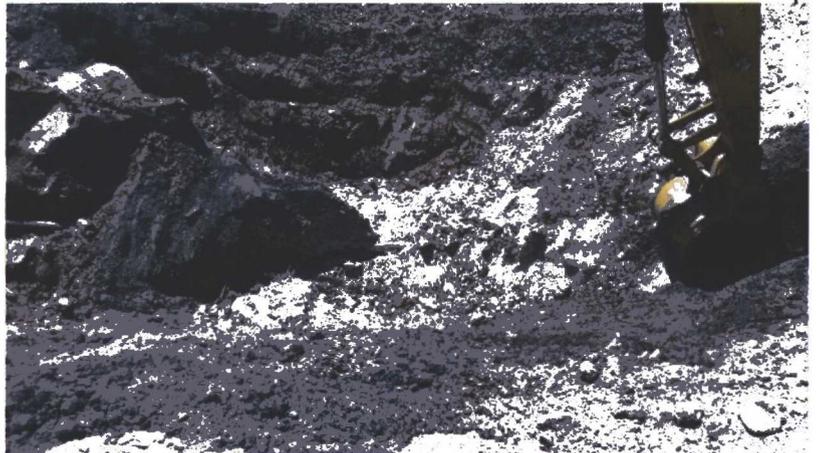
**Photograph 2**

View of in-process corrective action activities, facing south.

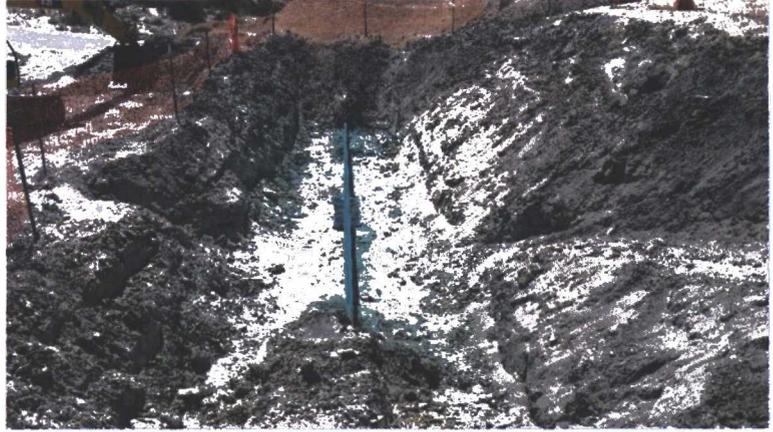
**Photograph 4**

View of the final excavation and repaired pipeline, facing west.

On April 20, 2016, Enterprise personnel discovered evidence of a surface release on the Morris #5 pipeline. The surface expression of the release was characterized by a small blow hole at the ground surface. Beginning on May 31, 2016, Enterprise initiated excavation activities to facilitate the repair of the pipeline and to remediate potential hydrocarbon impact. The pipeline release, which resulted from corrosion of the pipe, was repaired by replacing a 40 foot section of pipe.

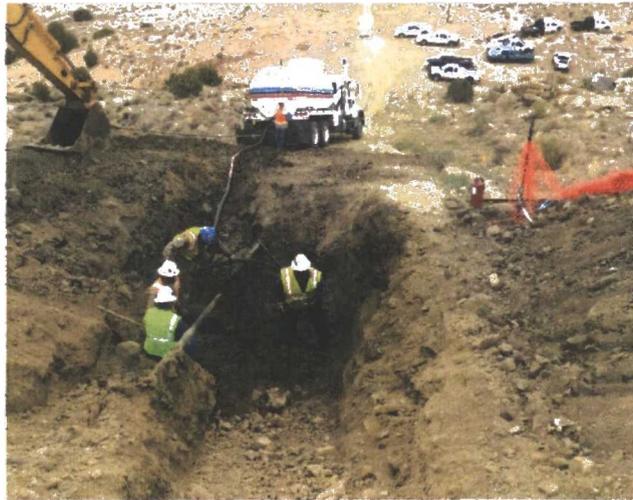
**Photograph 1**

View of the in-process corrective action activities, facing northwest.

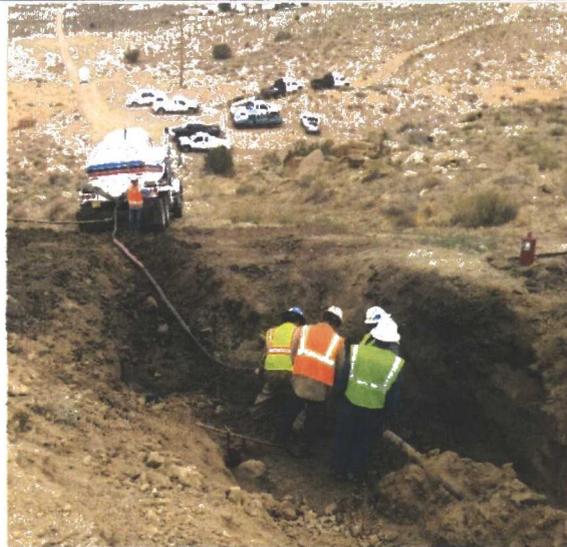
**Photograph 2**

View of the in-process corrective action activities, facing north.

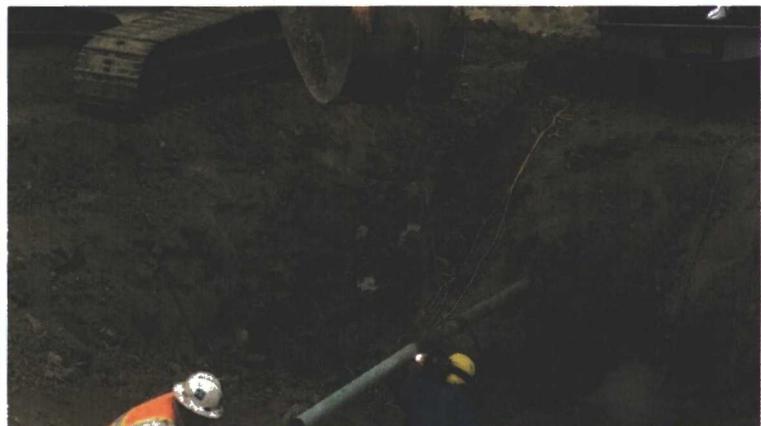
**Photograph 3**

View of repaired pipeline, facing northwest.

On August 8, 2016, Enterprise initiated preparation activities to perform a scheduled hydrostatic pressure test on the LID 696 AID 141 – 3 inch pipeline, which covers a total distance of approximately 26.1 miles, to verify the integrity of the pipeline. The hydrostatic pressure test resulted in one (1) rupture. The resulting pipeline failure was subsequently repaired by replacing a four foot section of pipe. The pipeline was subsequently re-tested with no failures.
