**Jicarilla A Ridge
Compressor Station**

**RE: Request for Site Closure
ConocoPhillips Jicarilla A Ridge Compressor Station
Rio Arriba County, New Mexico**

**RE: Petroleum Hydrocarbon Removal Report
August 2013 to August 2015
Jicarilla A Ridge Compressor Station
Rio Arriba County, New Mexico**

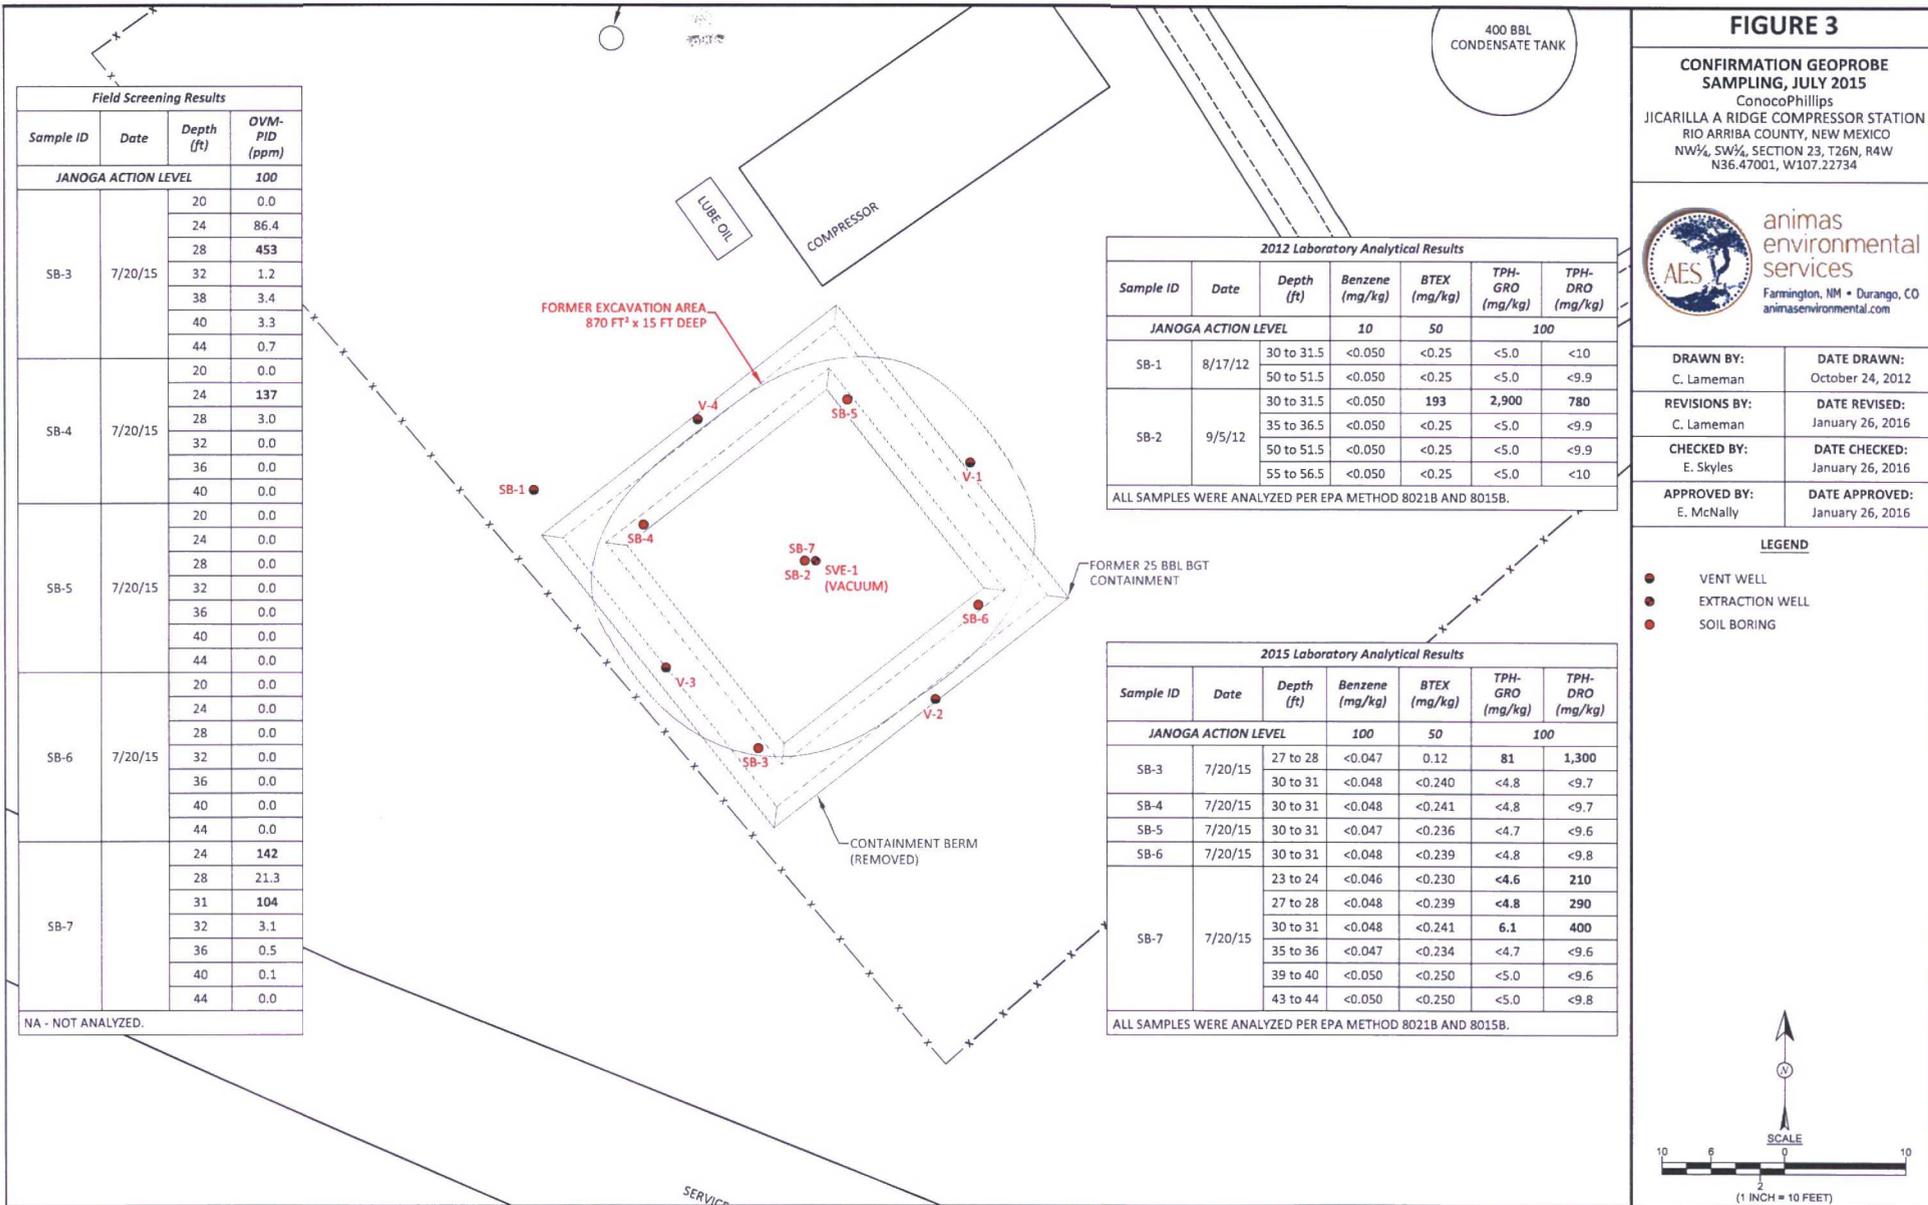
FIGURE 3

On July 20, 2015, post remediation sampling was conducted by AES within the extents of the former excavation (at the center and along the perimeter of excavation). Closure soil samples were collected from five soil borings to determine if soil remediation objectives were met through operation of the SVE system. AES collected 34 soil samples from 5 soil borings which were advanced to a maximum depth of 44 feet bgs utilizing a Geoprobe with a hollow stem assembly. Samples from each boring were collected at similar intervals to 2012 samples within the boring, and all soil samples were field screened for VOCs. Selected soil samples were submitted for confirmation laboratory analysis. Soil sample locations are included on Figure 3.

Field screening readings for VOCs via OVM ranged from 0.0 ppm in SB-3 through SB-7 up to 453 in SB-3. Field sampling results are summarized in Table 1 and presented on Figure 3.

through SB-7 up to 1,381 mg/kg in SB-3. Laboratory analytical results are summarized in Table 2 and included on Figure 3. The laboratory analytical report is attached.

CONFIRMATION GEOPROBE SAMPLING, JULY 2015
 ConocoPhillips
 JICARILLA A RIDGE COMPRESSOR STATION
 RIO ARRIBA COUNTY, NEW MEXICO
 NW¼, SW¼, SECTION 23, T26N, R4W
 N36.47001, W107.22734

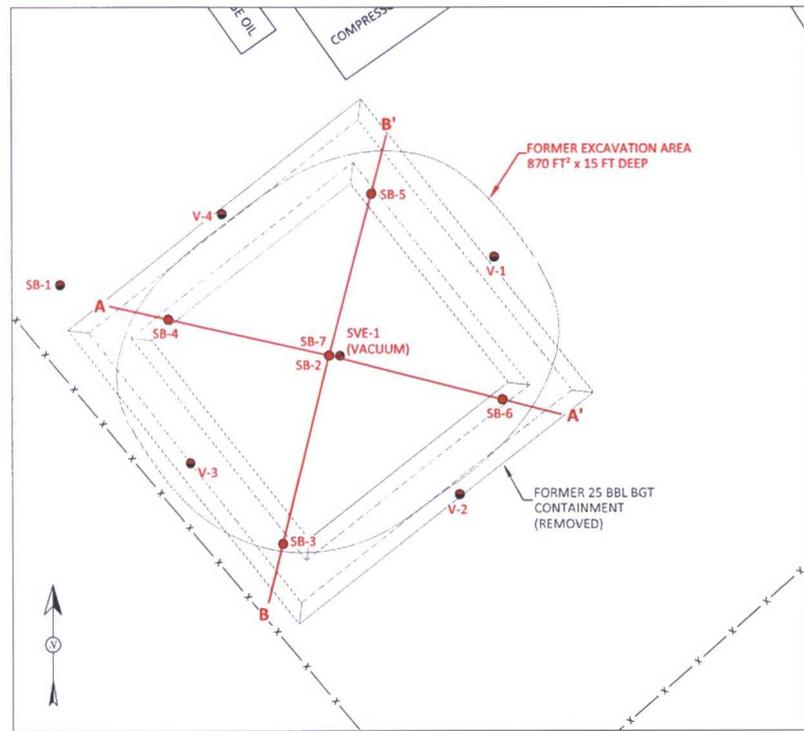
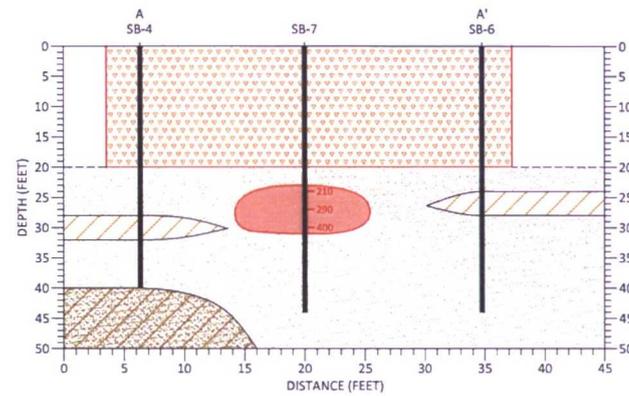
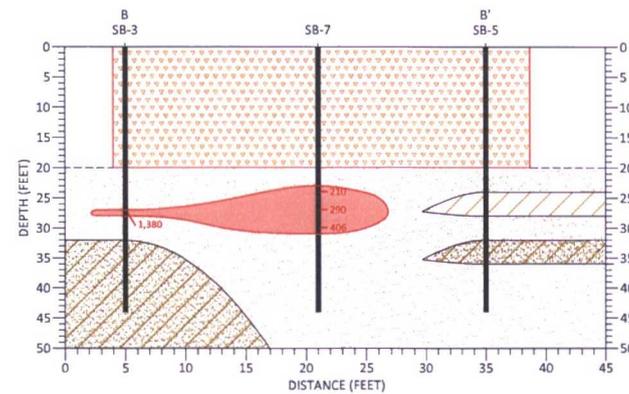
FIGURE 4

Laboratory analytical results reported concentrations of benzene and BTEX below laboratory detection limits or well below JANOGA action levels in all samples analyzed in July 2015. However, total TPH concentrations remained above JANOGA action levels of 100 mg/kg in two zones between two soil borings, SB-3 and SB-7. Soil samples from SB-3 (located on the southwest edge of the previously determined extent of contamination) from 27 to 28 feet bgs are above JANOGA action levels, with 1,380 mg/kg TPH, while deeper soil samples from that boring are below laboratory detection limits. Laboratory results in SB-7 from 23 to 31 feet were above JANOGA action levels, with the highest TPH reported from 30 to 31 feet bgs at 406 mg/kg. All soil samples below this interval were reported below detection limit.

Based on analytical results, the minor residual areas of petroleum hydrocarbon impact total an estimated volume of 80 cubic yards of contaminated soils remaining at the Jicarilla A Ridge Compressor station, compared to 610 cubic yards in 2012 (an 87 percent reduction in the volume of contaminated soils). In comparison to sampling conducted in 2012, there has been a 99.9 percent reduction of benzene, 99.8 percent reduction of BTEX, and 89 percent reduction of TPH concentrations. In addition, 3,218 pounds of hydrocarbons have been removed from the location as a result of the SVE mechanical remediation system. The amount of contaminated soil remaining onsite is estimated to be 13 percent of the original impacted area.

**GEOLOGIC CROSS SECTION AND
TPH RESULTS, JULY 2015**

NOTE: TPH RESULTS WERE ANALYZED PER USEPA METHOD 8015D AND REPORTED AS mg/kg.

Note that groundwater was not encountered within any of the soil borings and was not observed in the excavation. Due to the lack of risk to human health, reduced migration potential, lack of contamination over the majority of the area, and residual volume, no further action is recommended at the Jicarilla A Ridge. Additional options for an alternative remediation plan for this location is to leave the residual contamination *in situ* and return in three years to conduct additional sampling to monitor natural attenuation.
