RE: RE-VEGETATION, RESEEDING AND STABILIZATION REPORT, FORMER SOUTHWEST  
WATER DISPOSAL FACILITY, BLANCO AREA, SAN JUAN COUNTY, NEW MEXICO

# RE-VEGETATION, RESEEDING AND STABILIZATION FORMER SOUTHWEST WATER DISPOSAL FACILITY

NEAR BLANCO, NEW MEXICO  
SE/SW & SW/SE SECTION 32,  
TOWNSHIP 30 NORTH, RANGE 9 WEST  
SAN JUAN COUNTY, NEW MEXICO

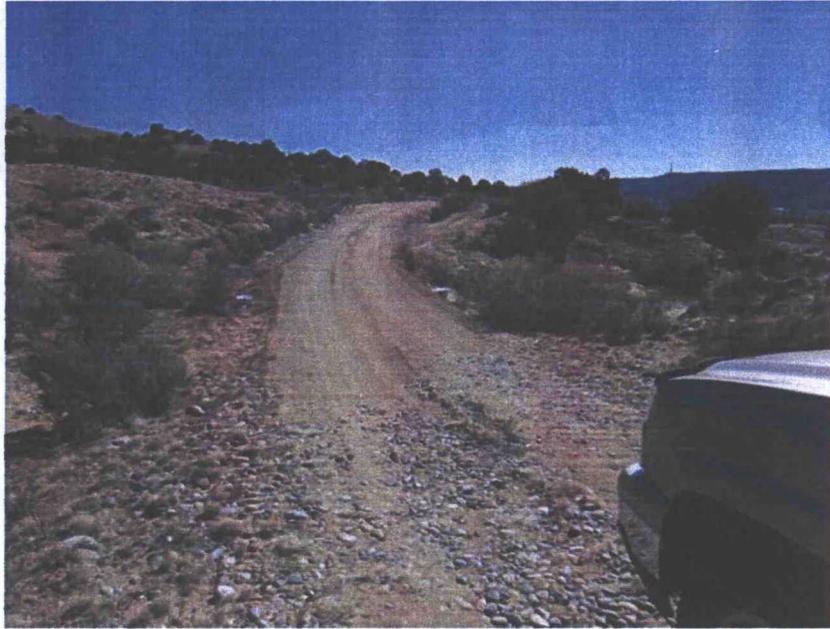
*Photo 1 Entry Road and New Culvert*

The primary dirt subcontractor, La Plata Construction, began reconstruction of the access road April 3, 2014. A 20 foot section of 15" culvert was installed using road base from Four Corners Materials. La Plata Construction finished grading the access road the same day allowing trucks to begin hauling the following Monday. Approximately 2,200 feet of silt fence was constructed along the southern boundary of the work area and the west half of the access road as a storm water BMP to prevent any runoff of materials from the site during construction. La Plata experimented on re-vegetation channel #1 to determine the best equipment and most practical method to implement the designed 2 foot deep 10-15 feet wide re-vegetation channels across the site. To ensure adequate documentation of materials sources and quantities, SMA and La Plata coordinated with the JFJ Land Farm for IEI to track the loads leaving the site as support for La Plata's bills of lading from the truck drivers.

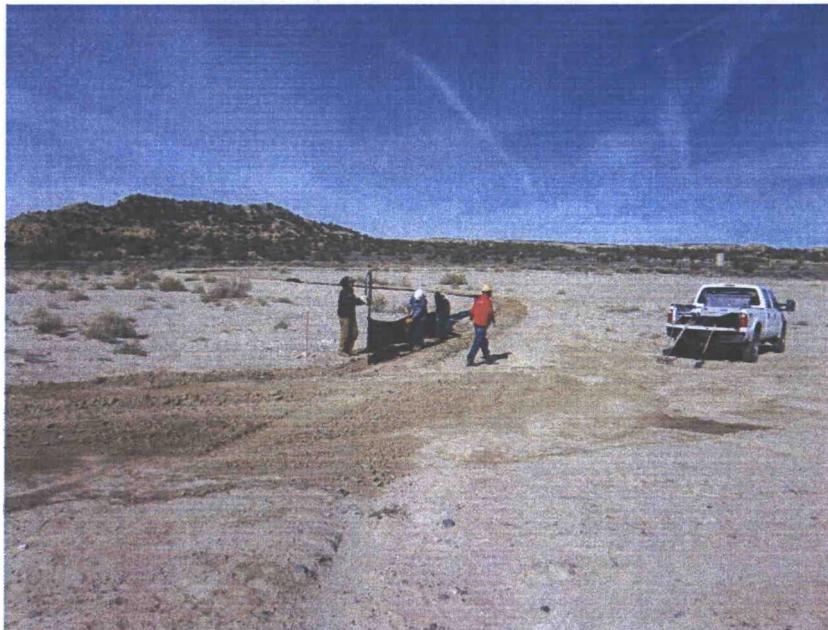
*Photo 2 Silt Fence Construction*

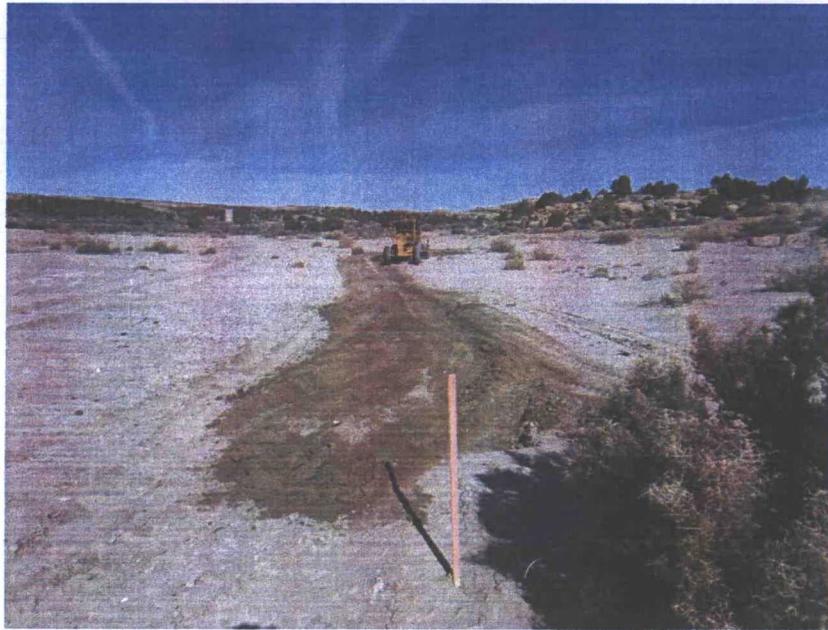
*Photo 3 Re-vegetation Channel #1*

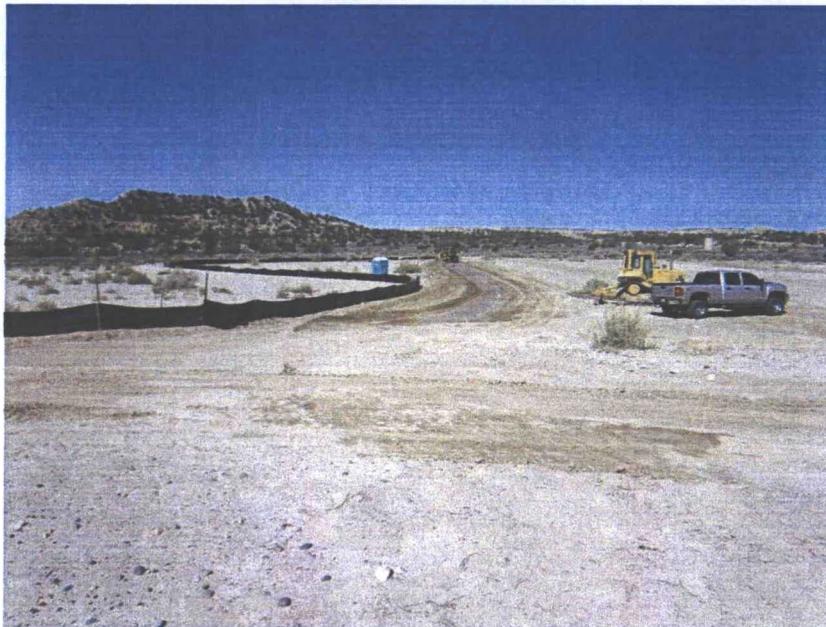
*Photo 4 Re-vegetation Channel #4*

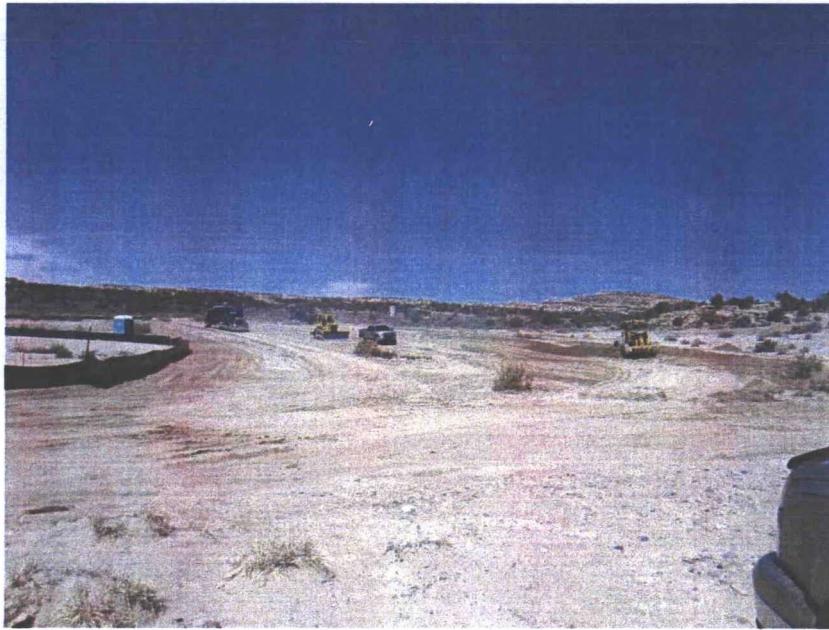
*Photo 5 Soil Cap Application*

La Plata Construction began hauling remediated hydrocarbon contaminated material from the six approved biopiles to the site on April 7, 2014. Two hundred seventy-two loads were hauled to SWWD from JFJ Land Farm totaling 4,658 cubic yards through April 24, 2014. An additional 16 loads of mixed cow and horse manure were hauled to the site from the adjacent landowner with verbal approval from NMOCD representative Brandon Powell, for an approximate total of 150 cubic yards. La Plata cut the five re-vegetation channels shown on Figure #1. The channels were filled with remediated soils and the 2013 cap area (approximately the fenced area) was covered with an additional six inch cap of remediated soils. The five new berms constructed with materials from the re-vegetation channels were also covered. La Plata Construction completed mixing the remediated soils into the cap and cleaning up debris on April 25, 2014.

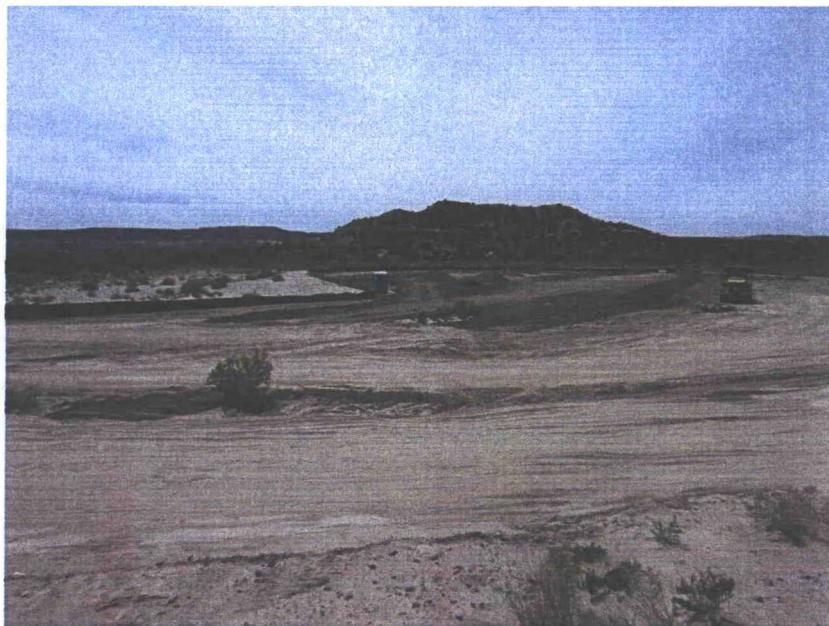
*Photo 6 Work in Progress*

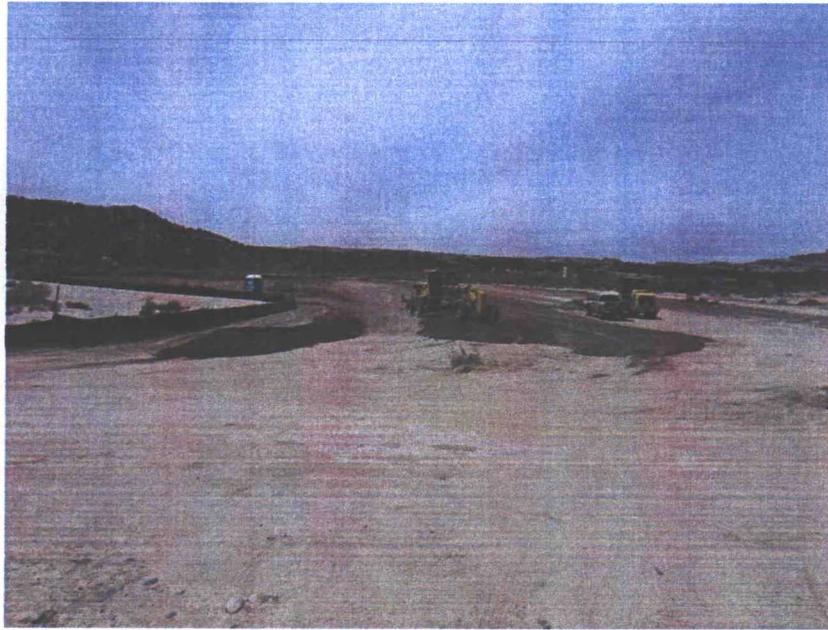
*Photo 7 Grader Spreading and Contouring*

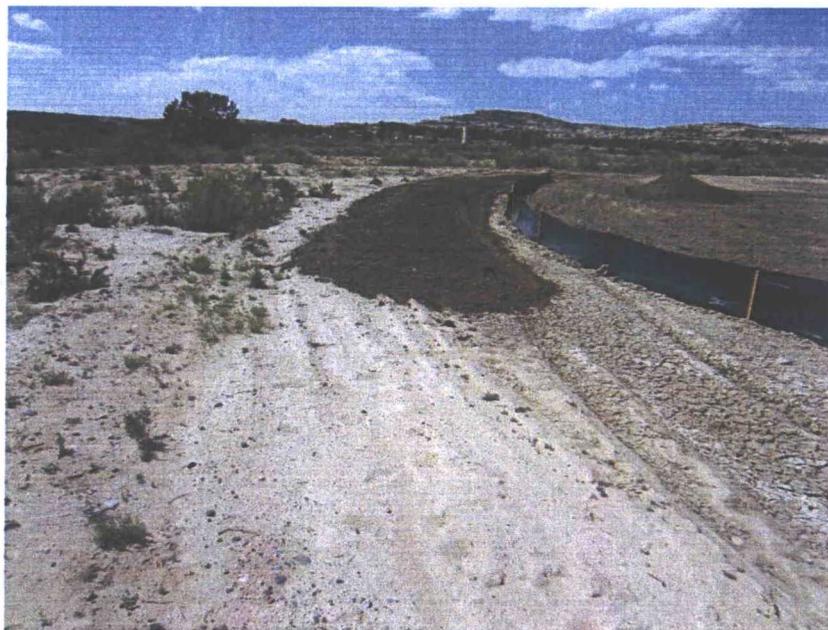
*Photo 8 Soil Cap Below Down Gradient Berm*

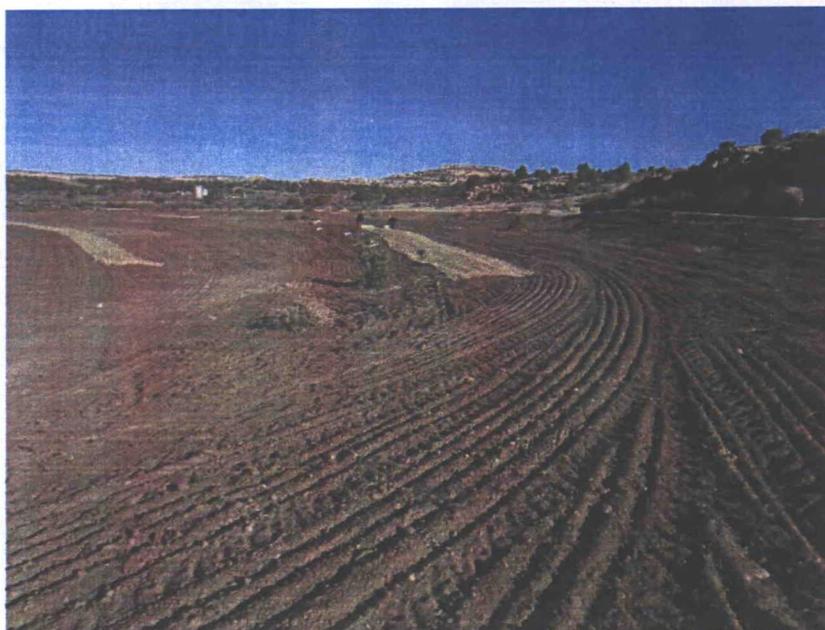
*Photo 9 Erosion Blankets Installation*

Nelson Revegetation was on site April 28, 2014 with their tractor and no-till drill to perform the seeding of the salt tolerant seed mix (Appendix E) developed for the SWWD site. An additional three crew members started installing the biodegradable erosion blankets over vulnerable reseeded areas. Seeding was completed utilizing approximately 3.5 5# bags of seed per acre for heavy coverage. A two-man crew returned to the site on April 29, 2014, to complete the installation of 2200 square feet of erosion blankets. The blankets were installed with wooden stakes as pins. Refer to Appendix F, Photo Gallery.

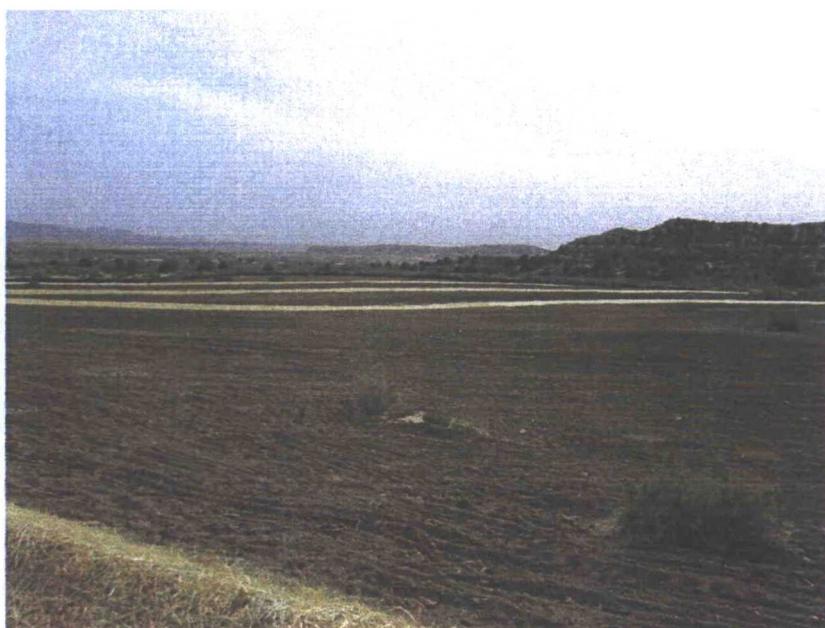
*Photo 10 Reseeded and Blankets Installed*

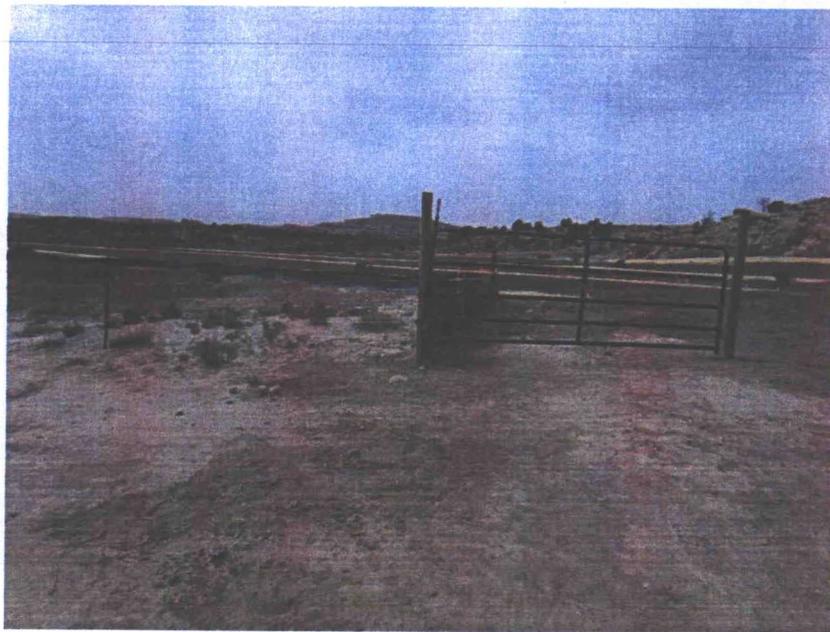
*Photo 11 Three Strand Barbed Wire Fence and Site Gate*

TCP, LLC, a service company, provided a roustabout crew on site May 1, 2014 to construct a three strand barbed wire fence around the seeded area. The crew drove 61 T-posts, dug holes for gate posts, and cemented in the wooden gate posts. On May 2, 5, and 6, 2014, the TCP crew worked on the southern perimeter fence, strung and stretched barbed wire, installed the gate to the seeded area, and installed the lower gate, limiting access to the entryway. The gates were locked and keys conveyed to the NMOCD District Office personnel. Refer to Figure #1 Site Map with Improvements and the Photo Gallery in Appendix F.

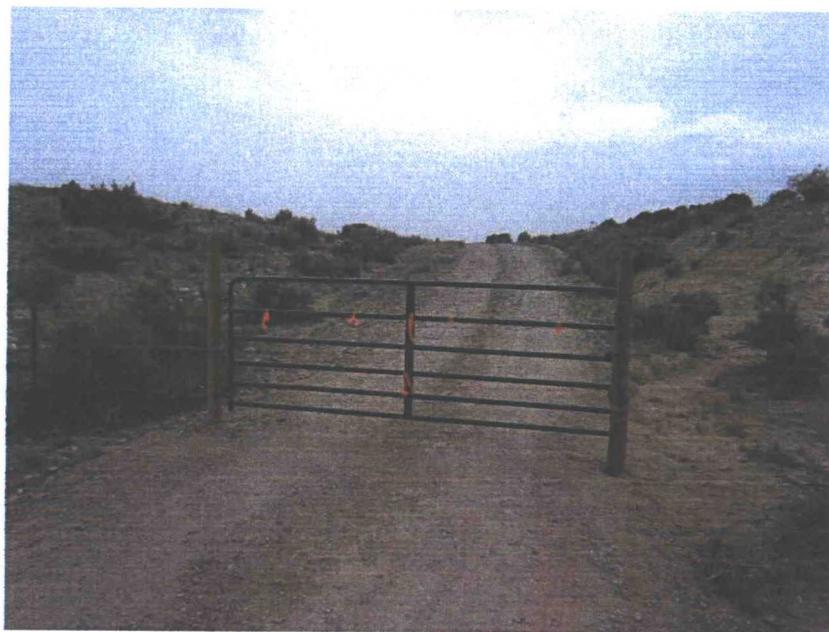
*Photo 12 Entry Gate at Road Culvert*

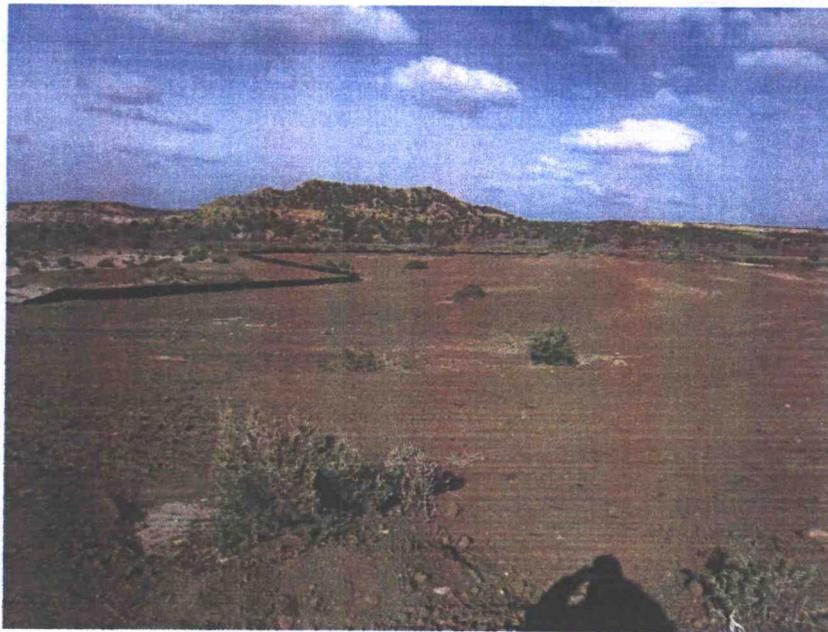
*Photo 13 Looking Across Finished Growth Media Cap*

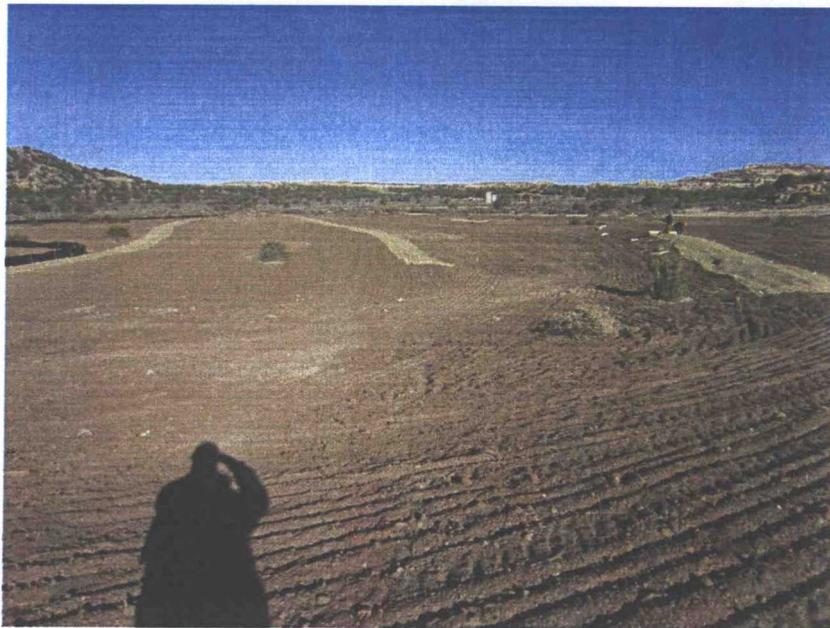
*Photo 14 Across Finished Growth Media Cap*

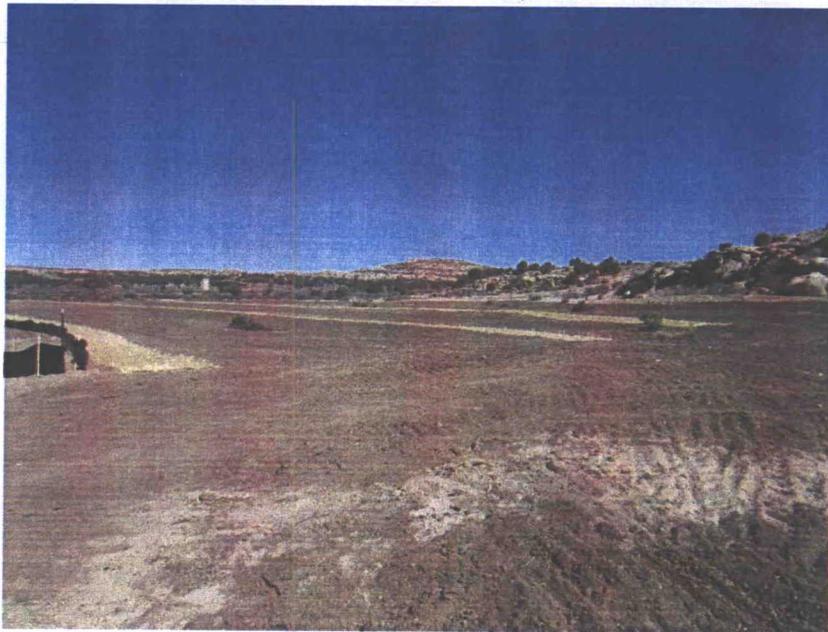
*Photo 15 Across Finished Growth Media Cap*

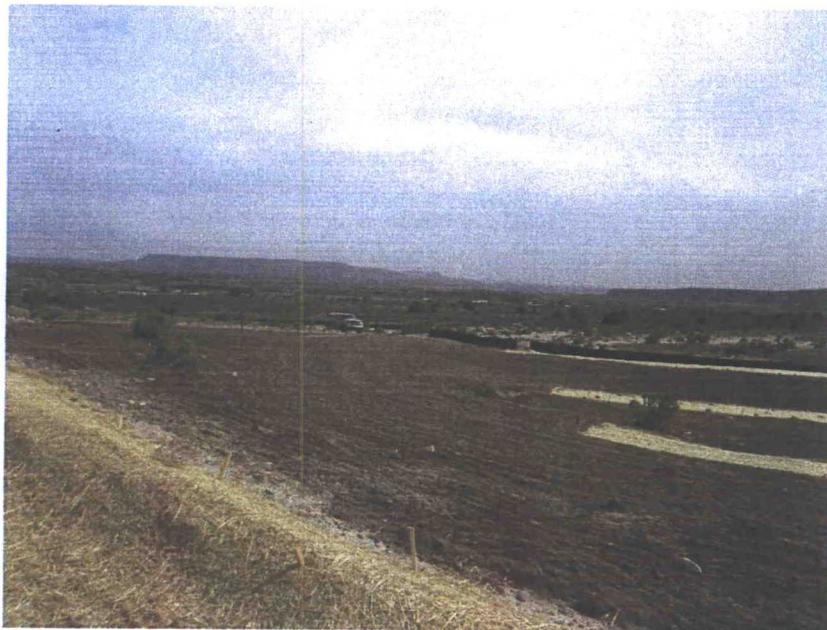
*Photo 16 Waiting for Rain*
