**Williams Four Corners, LLC**

Pit, Below-Grade Tank, or  
Proposed Alternative Method Permit or Closure Plan Application

Williams Four Corners LLC  
Below Grade Tank Closure Report  
Facility Name: 32-8#2 – BGT2 – Used Oil  
API Number: C-144-15943

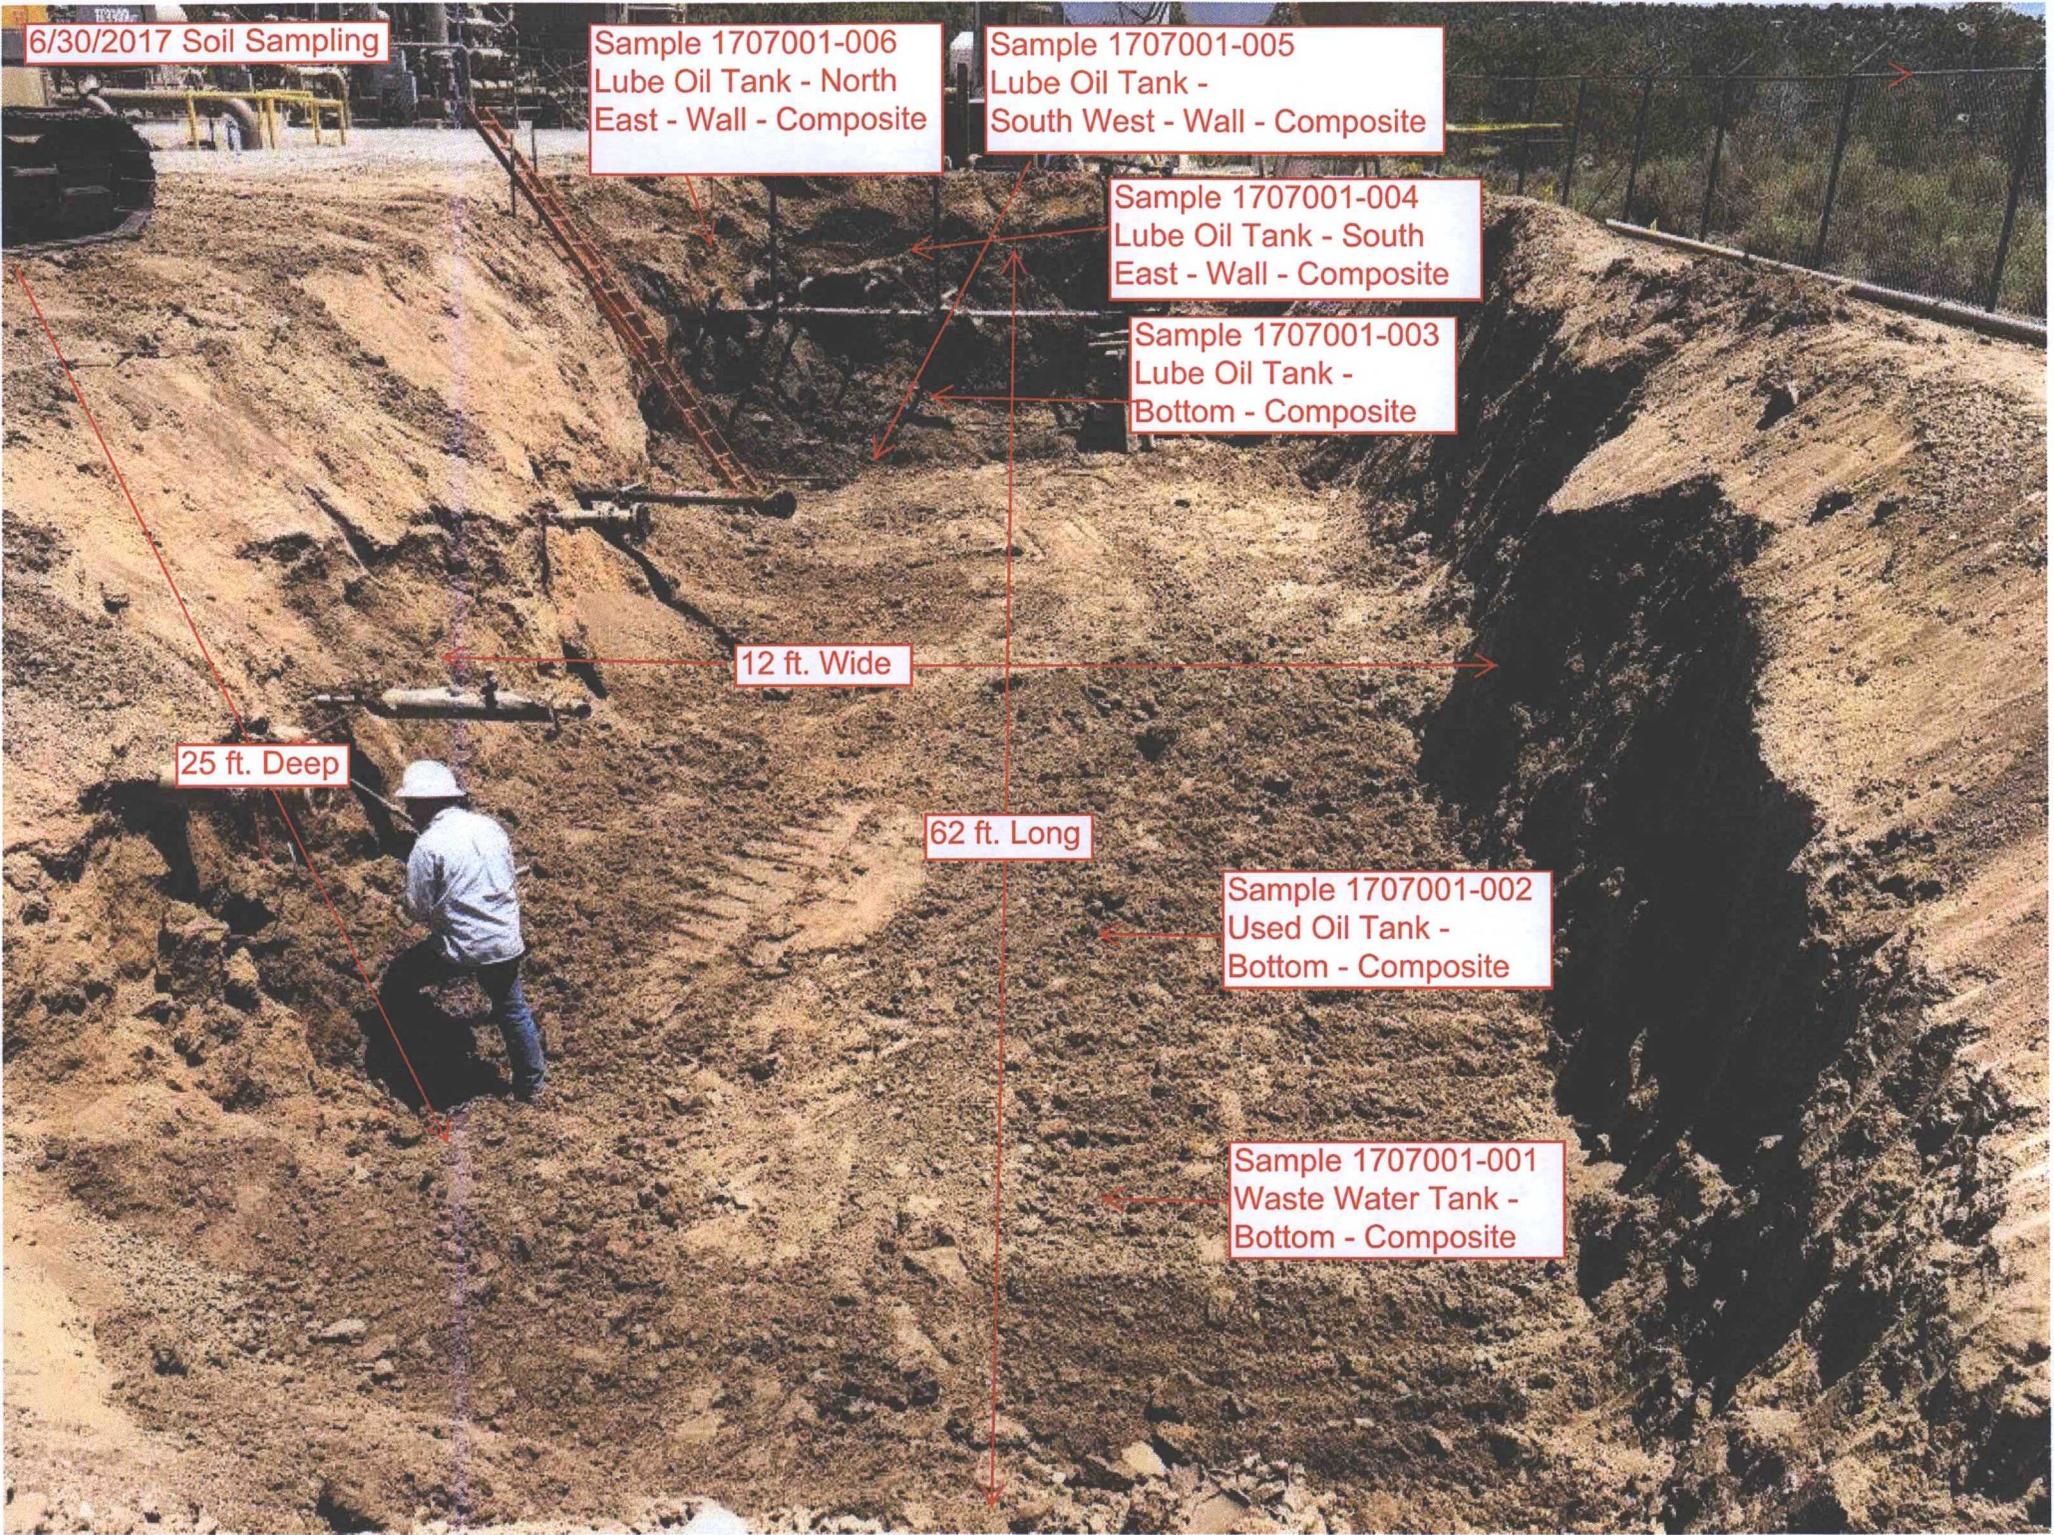
Sample 1707001-002  
Used Oil Tank -  
Bottom - Composite

Sample 1707001-001  
Waste Water Tank -  
Bottom - Composite
