Release Notification

Site Name Navajo Tribal H 13 WTS	Site Type Water Transfer Station
Date Release Discovered 8/7/2018	API# (if applicable) N/A

Navajo Tribal H 13 WTS

Description of Remediation activities:

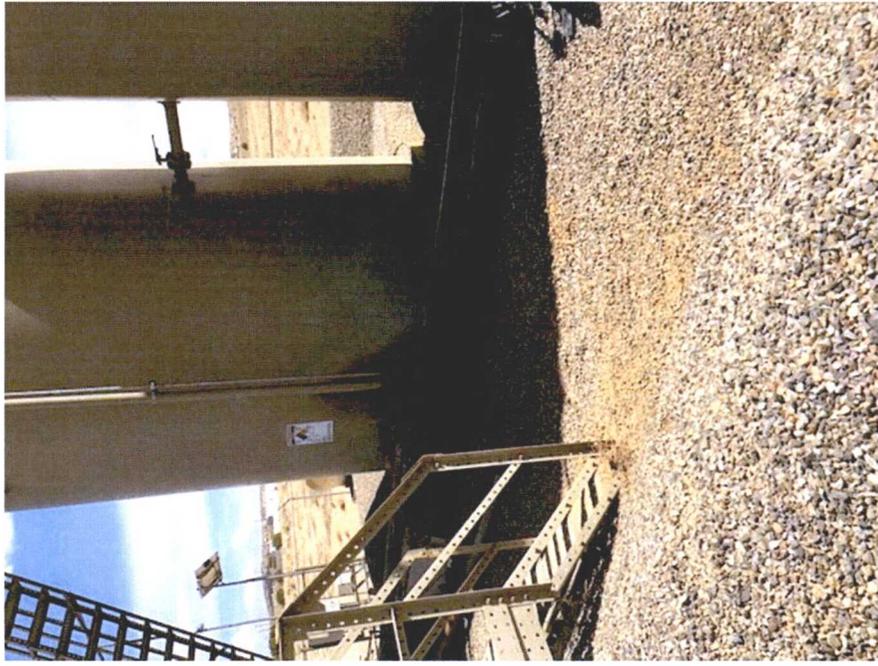
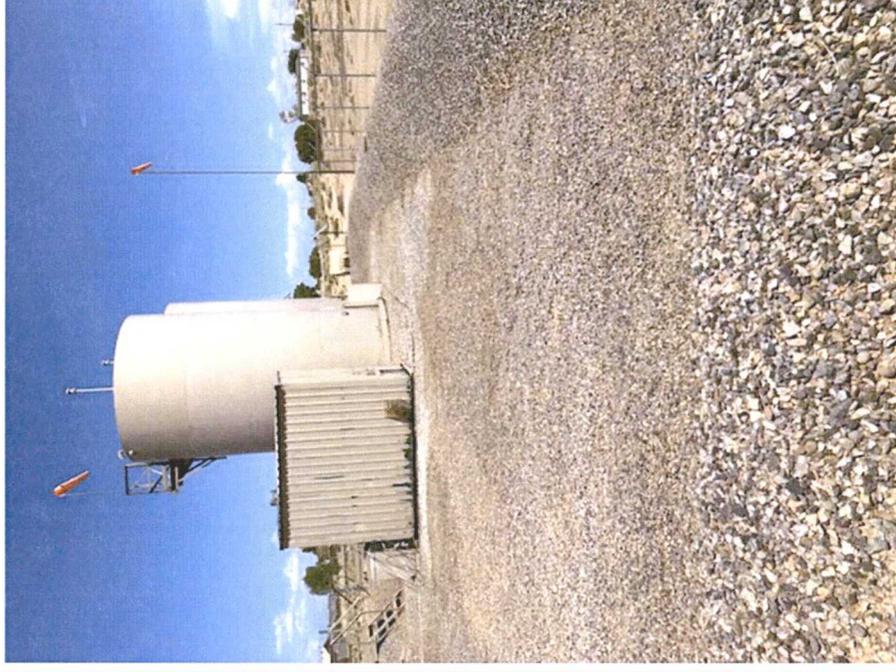
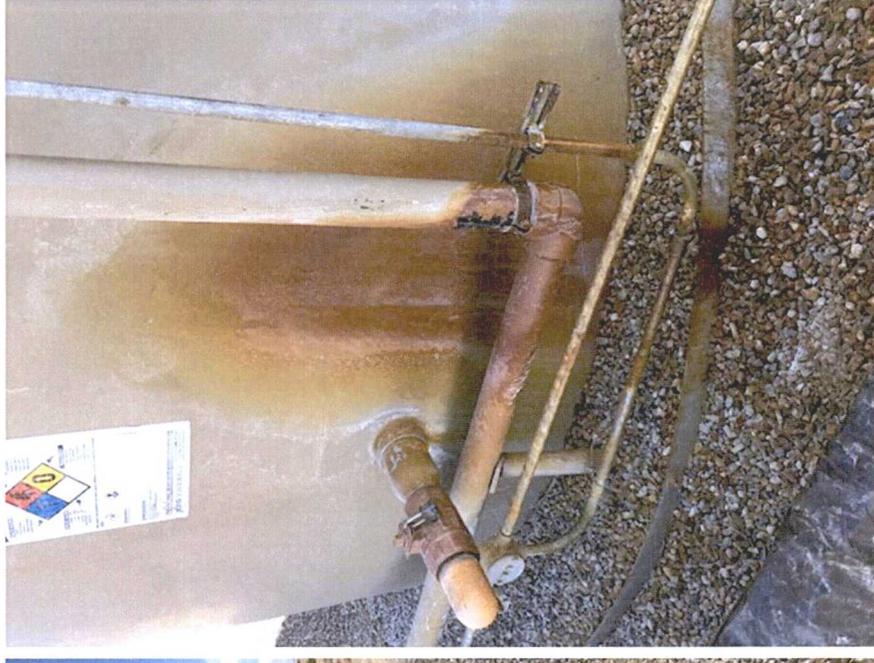
Photographs – Spill Impact

Operator discovered water leaking from the tank valve. He immediately isolated the tank and called to have water tank drained and replaced the valve. Leak in tank valve was due to corrosion.

Hilcorp Energy Company used a vac truck to recover 5bbbls of produced water. The water stayed within the berm. The berm area was lined but contained gravel on the top. Hilcorp hydrovaced the gravel off of the liner and found three holes. The liner was removed and confirmation sampling occurred. Three composite samples were sent to the labs using standard turnaround. Based on the lab analysis, all lab results are below the NMOCD Standards. No further action is required.

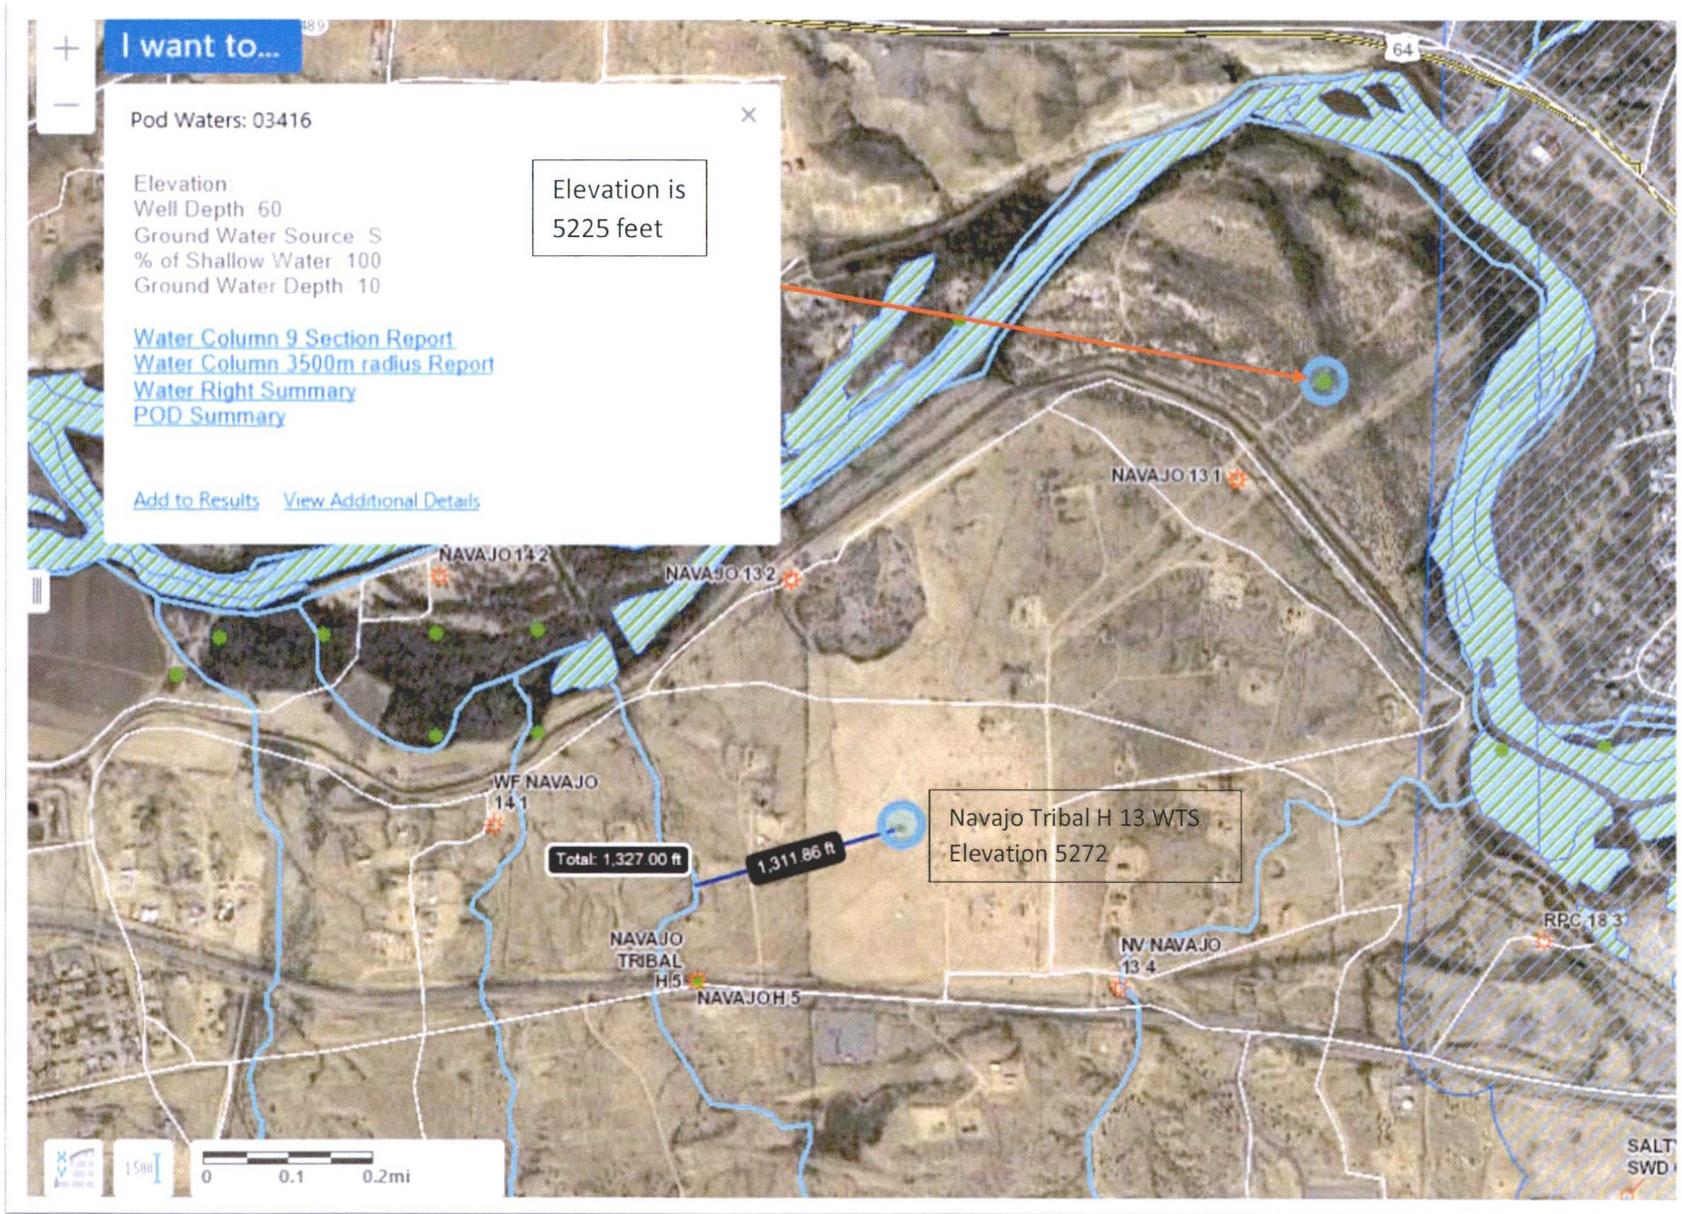
Navajo Tribal H 13 WTS – Ranking 10 due to distance from closest blue water line is >200 feet and Depth to groundwater is >50ft using elevation difference of water well. (5272-5225 = 47 +10ft = 57ft)

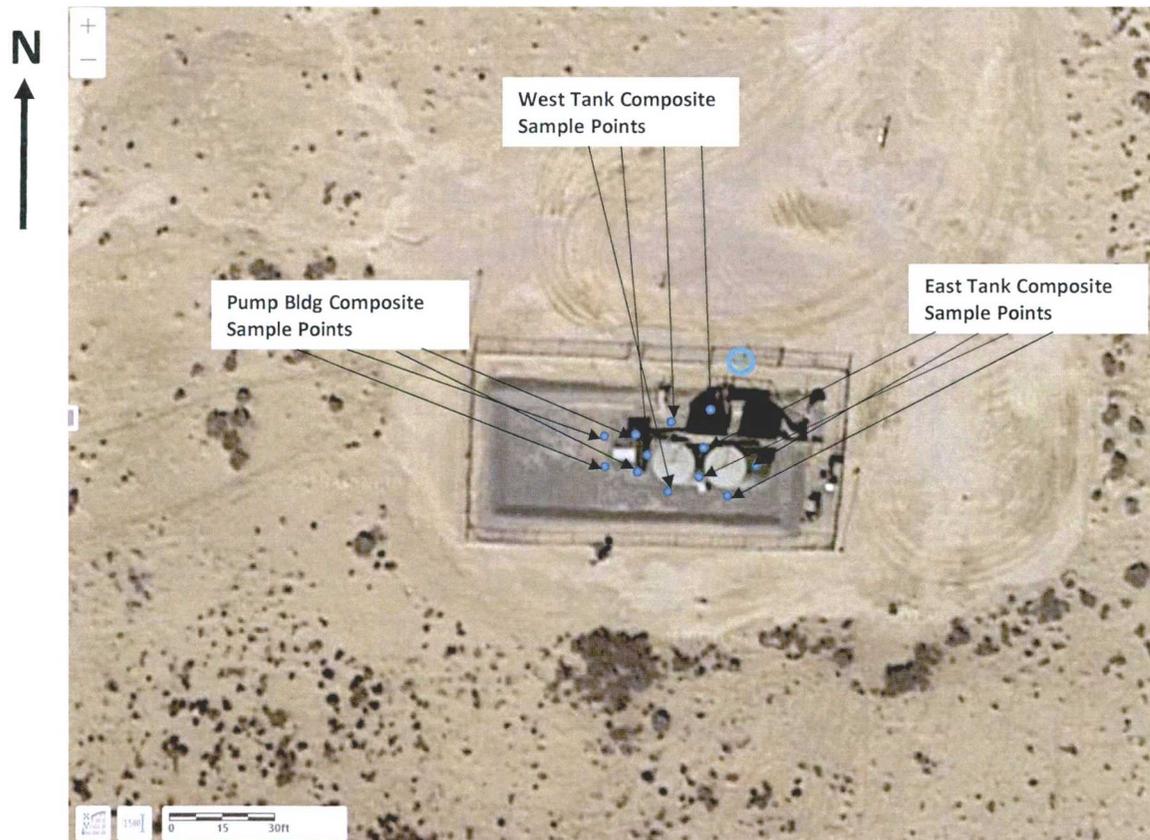
Navajo Tribal H 13 WTS - Site Map with sample points

(all fluids stayed within the berm)

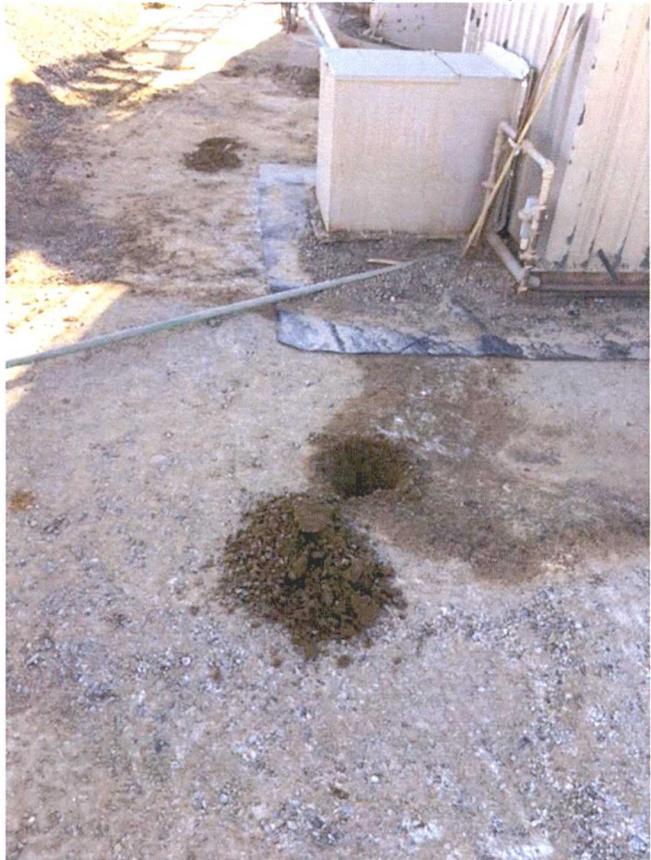
NW & NE of Pump Bld.
Pump Bld Composite Sample

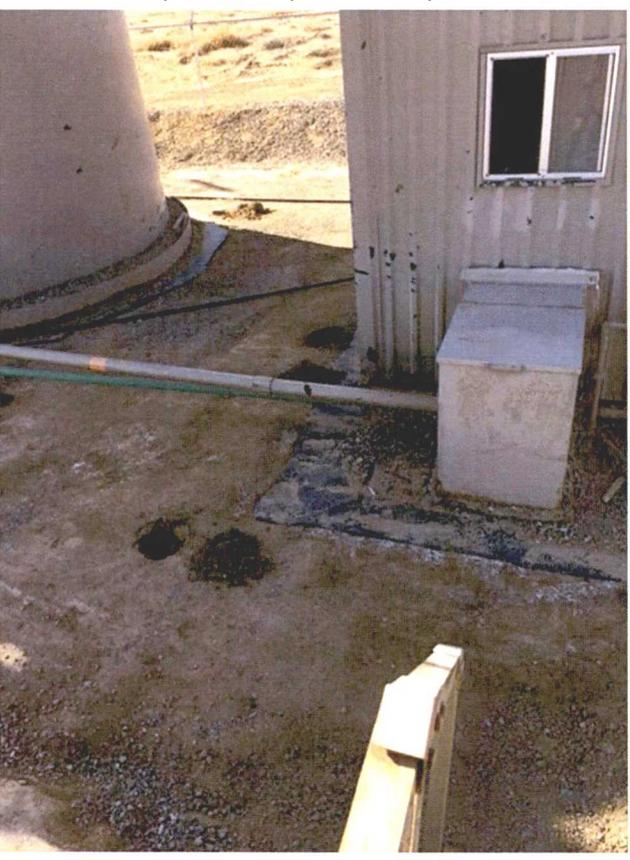
NE & SE of Pump Bld.
Pump Bld Composite Sample

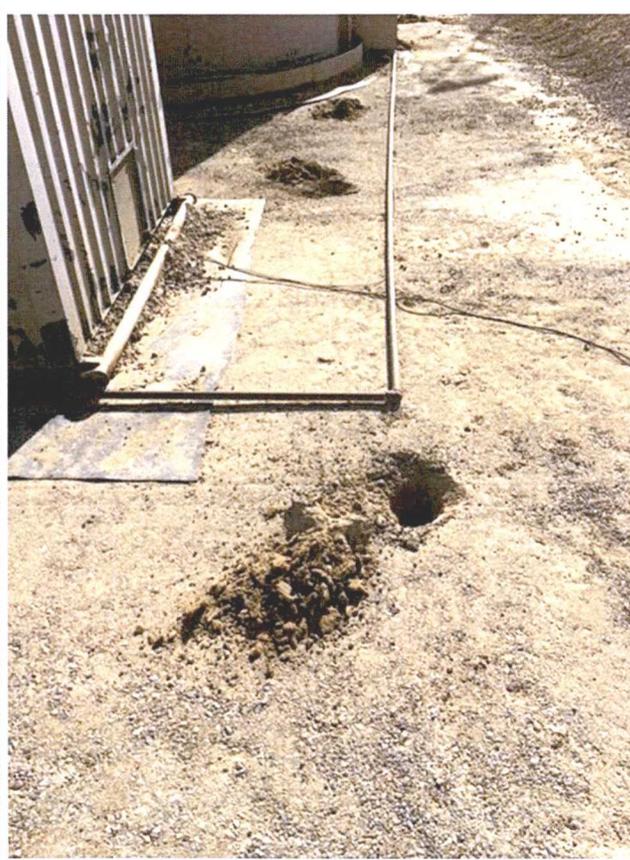
SW & SE of Pump Bld.
Pump Bld Composite Sample

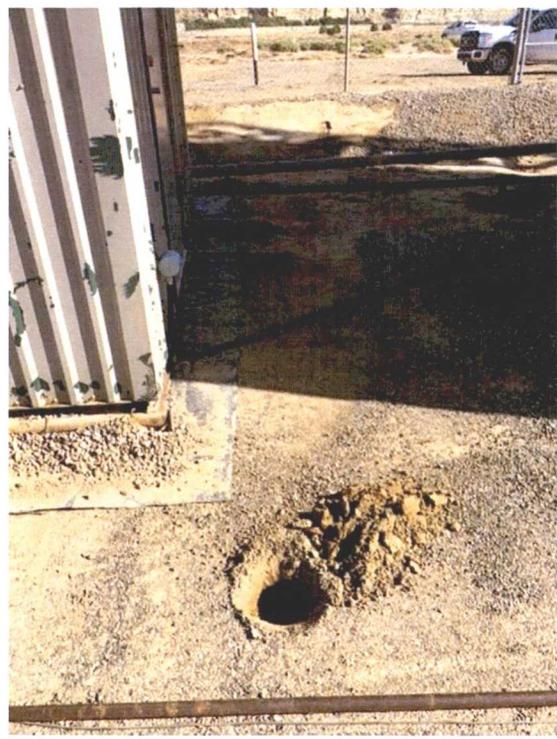
NE & SE of Pump Bld
Composite Sample

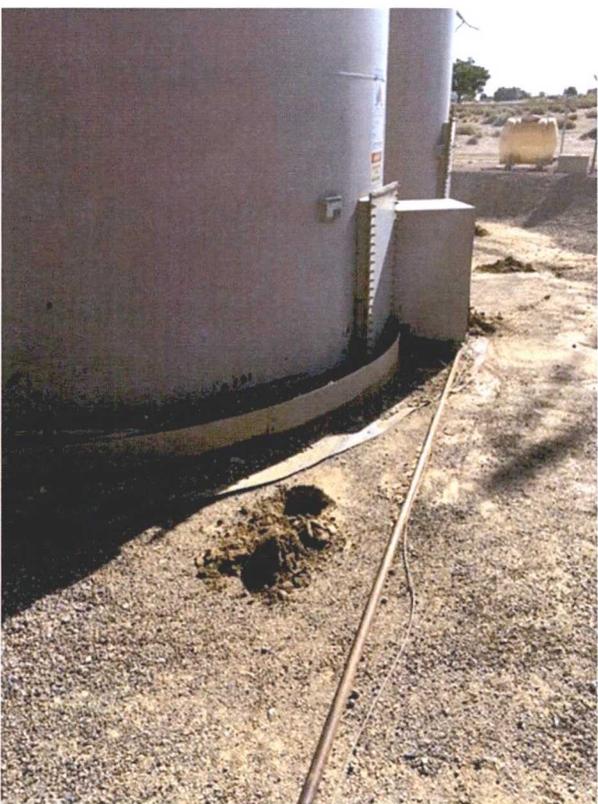
SW of West Tank
Composite Sample

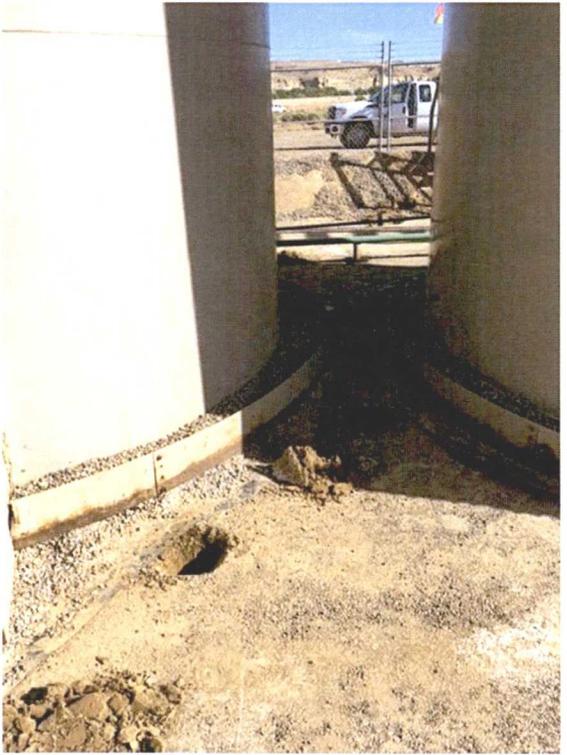
Between E & W Tanks
Part of W & E Tank Composites

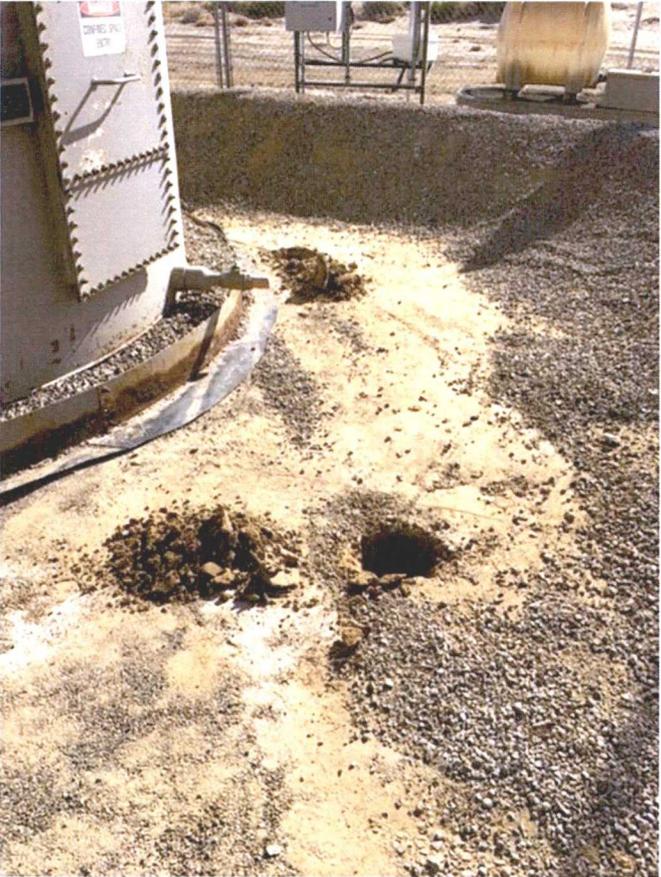
SW & SE of
E Tank Composite

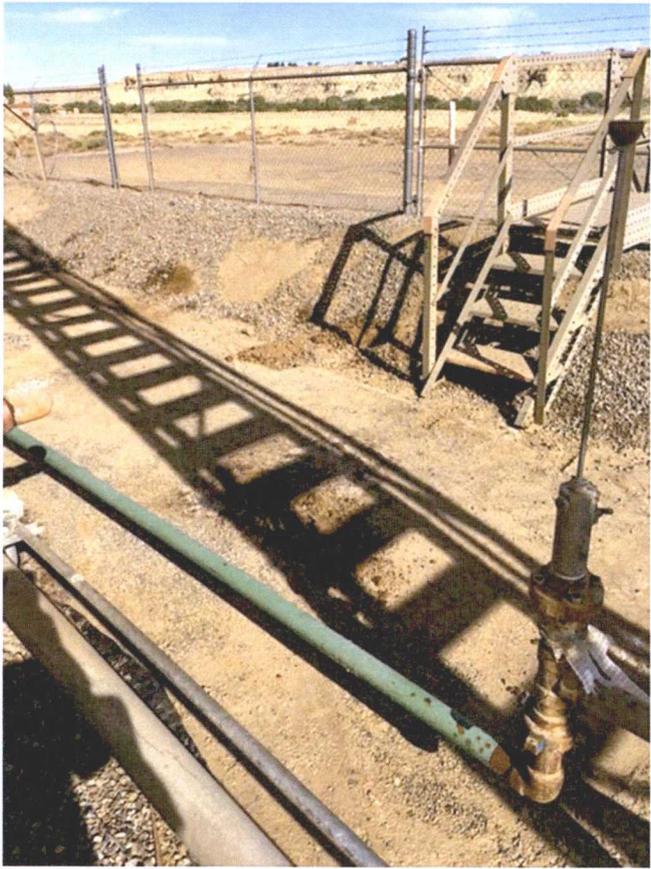
Edge of Berm in front of West Tank
Part of W Tank Composite

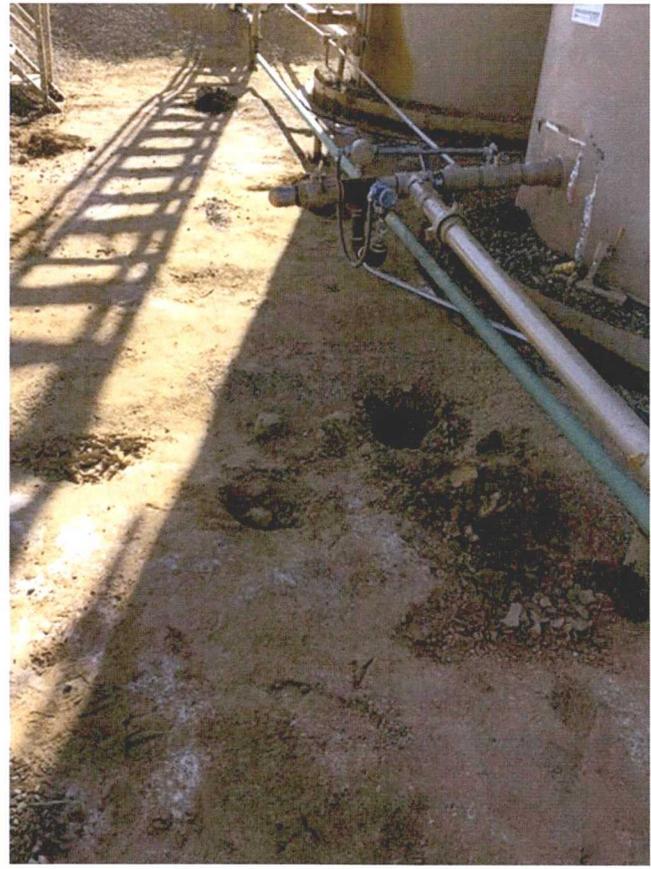
North of W & E Tanks
Part of W & E Tank Composites

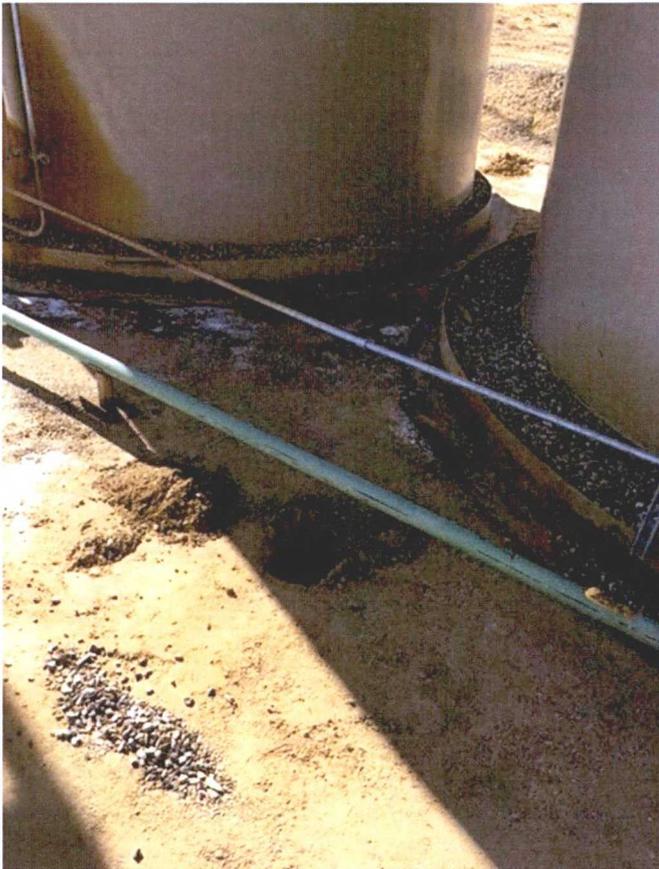
NE Sample Point
of W Tank Composite

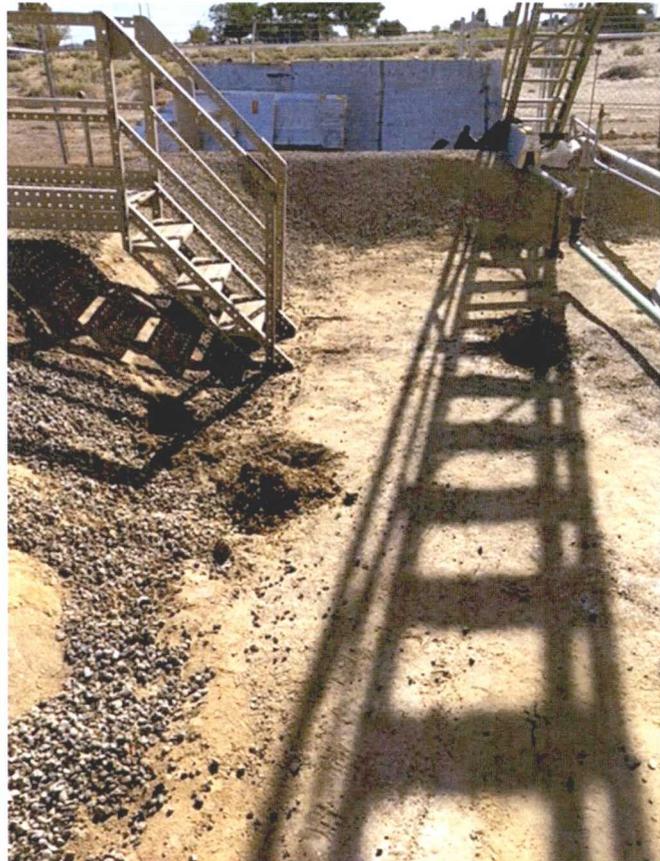
Edge of Berm Sample Point
N of West Tank

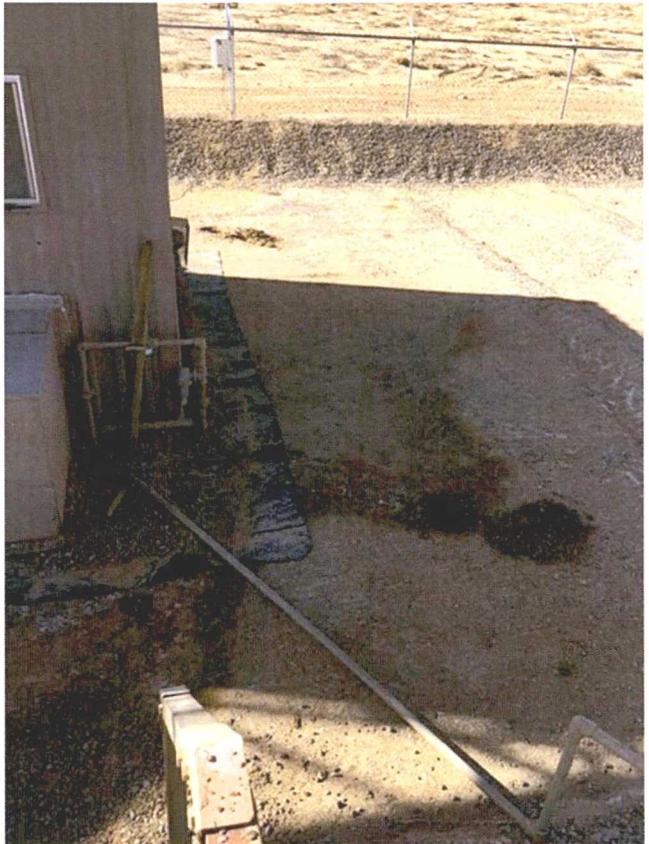
NW Sample Point
Pump Bld Composite of
