Release Notification

CORRECTIVE ACTION REPORT

**Val Verde Plant Amine and Water Release (April 2018)
NE ¼, S14 T29N R11W
San Juan County, New Mexico**

October 9, 2018
Apex Project No. 725040112442

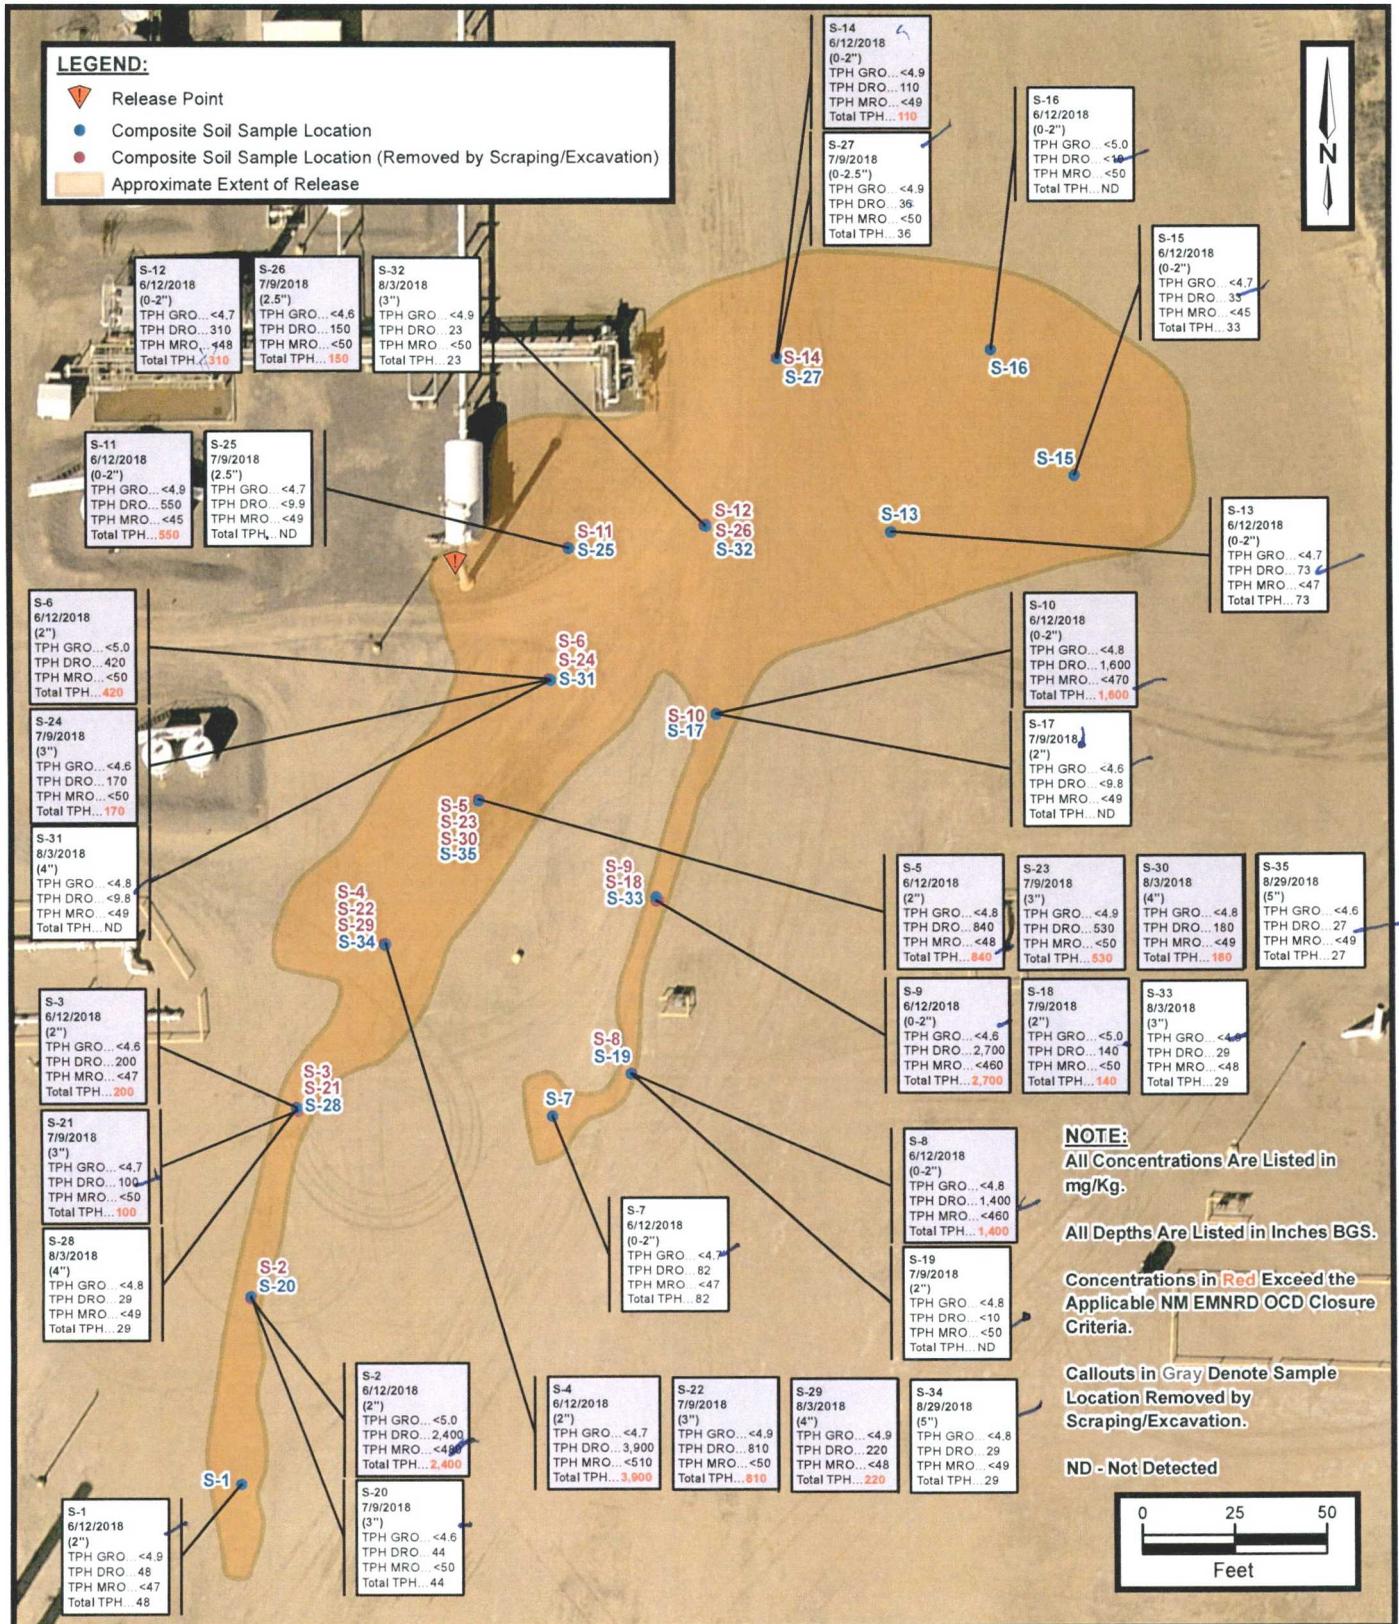
FIGURE 3

Figures 3 indicates the approximate soil sample locations in relation to the flow path (**Appendix A**). Photographic documentation of the field activities is included in **Appendix C**.

Site Map with Soil Analytical Results

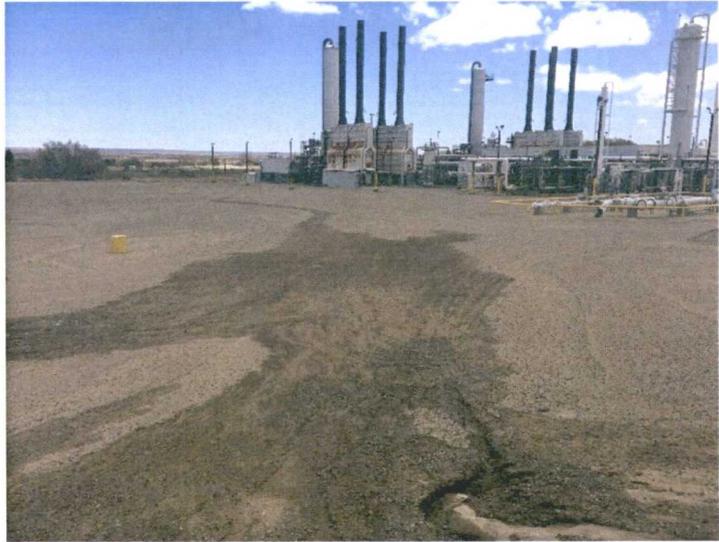
Photograph 1

View of the flow path, facing south-west.

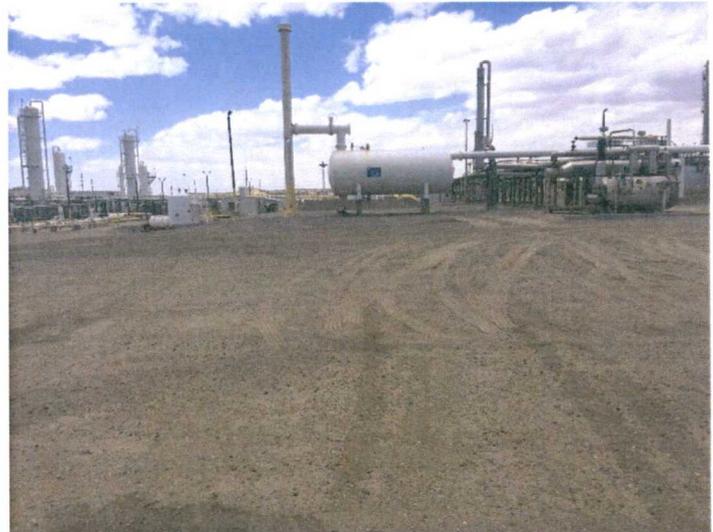
Photograph 2

View of the flow path, facing east.

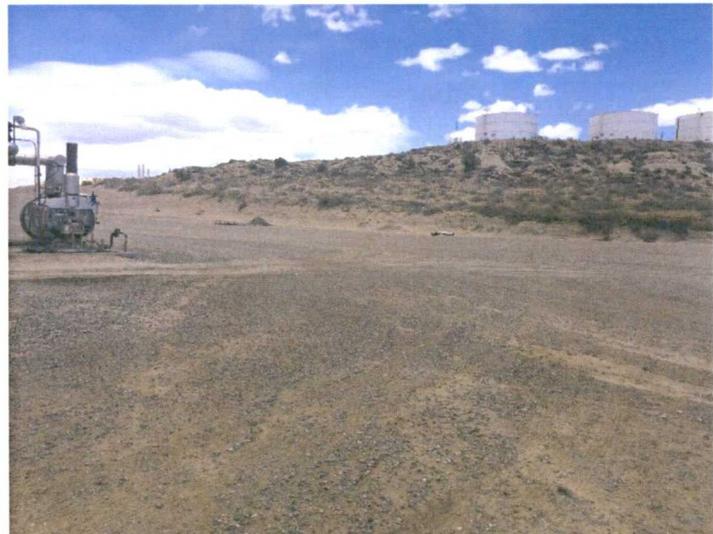
Photograph 3

View of the overspray area, facing northeast.

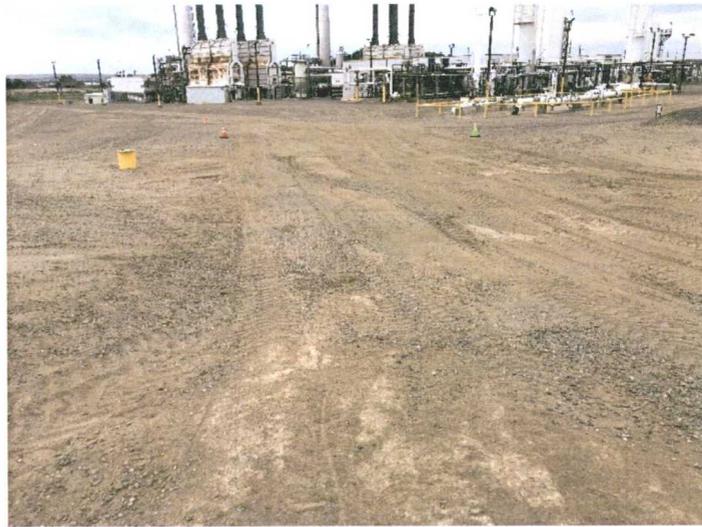
Photograph 4

View of the final scraped/excavated flow path, facing southwest.

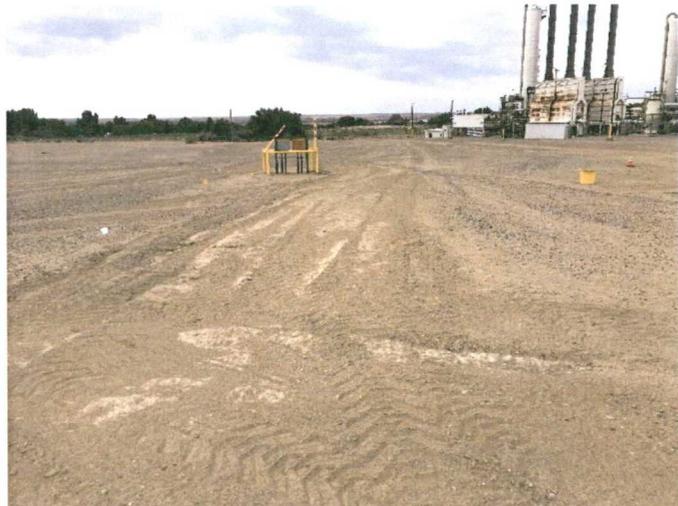
Photograph 5

View of the final scraped/excavated flow path, facing southwest.

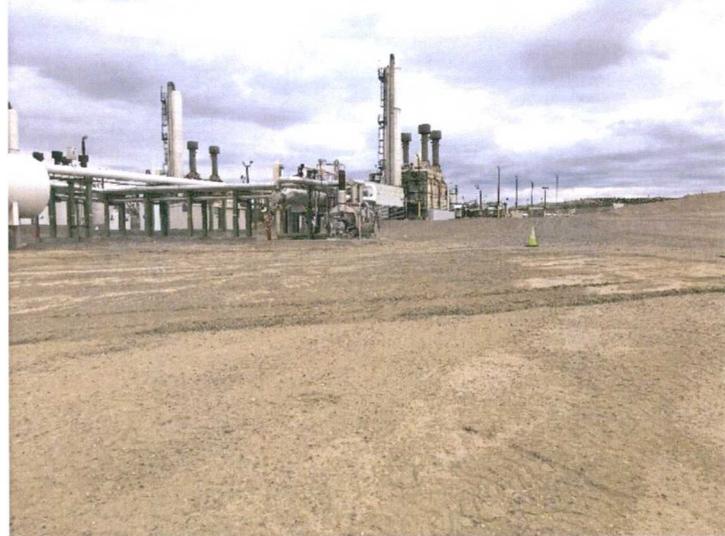
Photograph 6

View of the final scraped/excavated flow path, facing northwest.

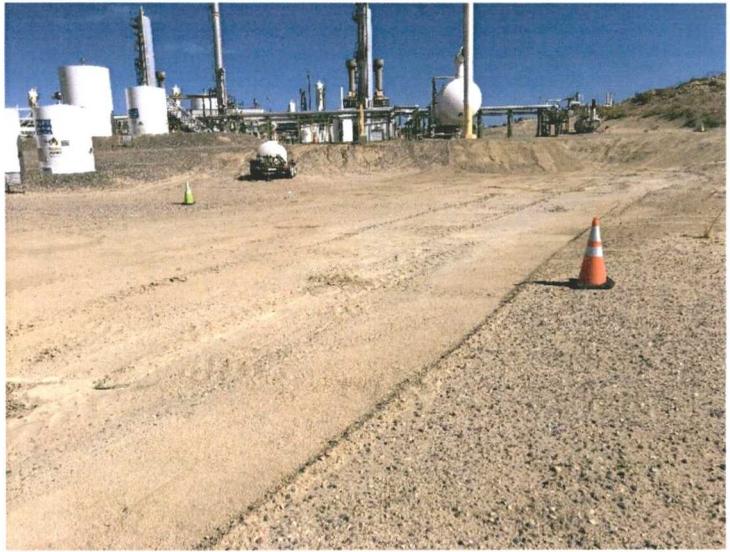
Photograph 7

View of the final scraped/excavated flow path, facing north.
