STAGE 1 ABATEMENT PLAN

**STANDARD #1
SAN JUAN COUNTY, NEW MEXICO**

AP-126 P JEG-1821432884

STAGE 1 ABATEMENT PLAN
STANDARD #1
SAN JUAN COUNTY, NEW MEXICO
Project Number: 017817006

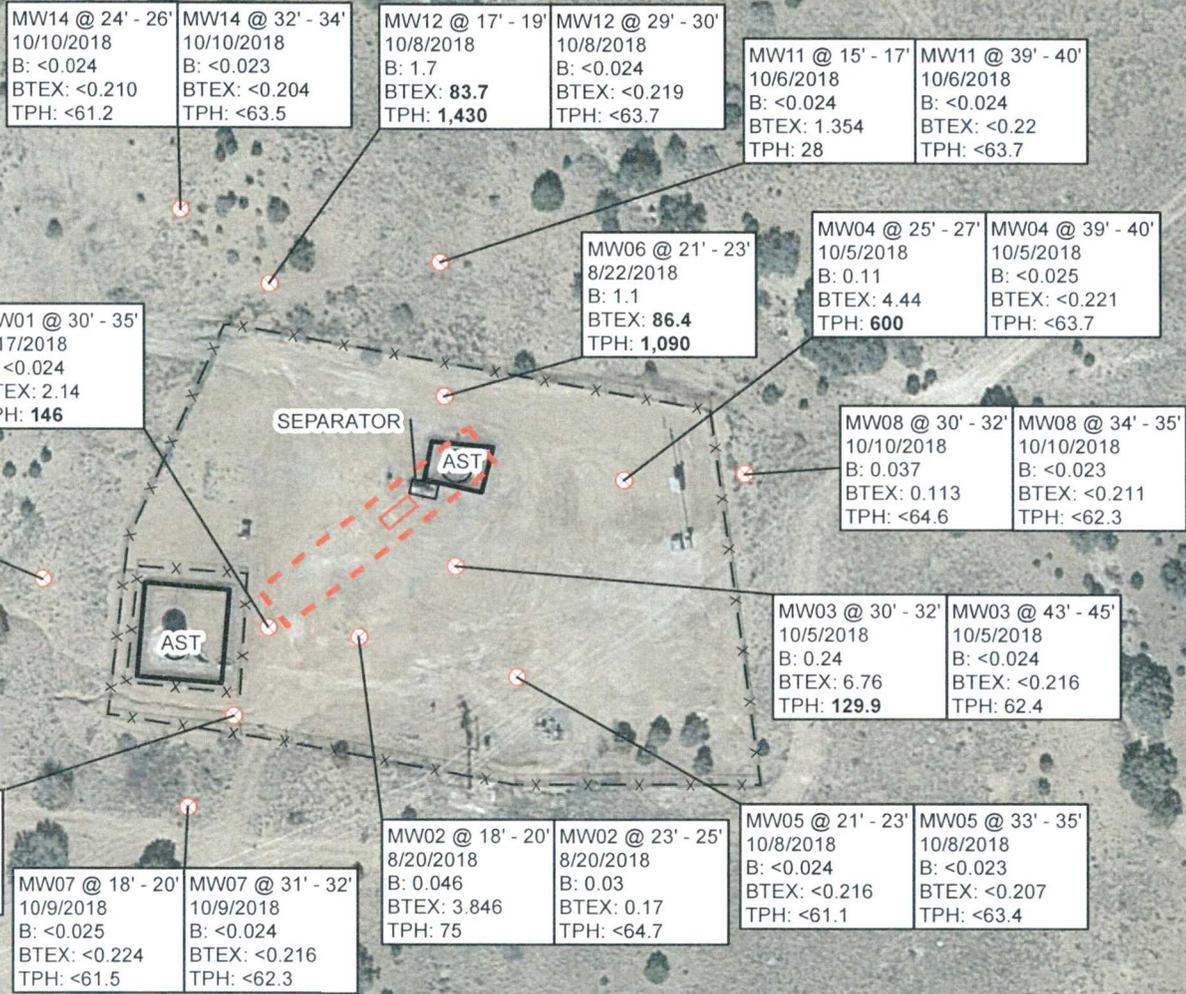
SAMPLE ID @ DEPTH BELOW GROUND SURFACE (FEET)
 SAMPLE DATE
 B: BENZENE IN MILLIGRAMS PER KILOGRAM (mg/kg)
 T: TOLUENE (mg/kg)
 E: ETHYLBENZENE (mg/kg)
 X: TOTAL XYLENES (mg/kg)
 BTEX: TOTAL BTEX (mg/kg)
 TPH: TOTAL PETROLEUM HYDROCARBONS (mg/kg)
BOLD: INDICATES RESULT EXCEEDS THE APPLICABLE STANDARD
 <: INDICATES RESULT IS LESS THAN THE LABORATORY REPORTING LIMIT

A small pothole in the middle of the excavation was excavated to observe fluid conditions (Figure 2). The pothole did not immediately fill in with water, so LTE collected a sample of the claystone beneath the wet clay, crushed it, and submitted it for laboratory analysis of BTEX and TPH. The goal was to document a clean horizon beneath the impact for vertical delineation. Results confirmed the bedrock beneath the water-bearing unit was not impacted by the release (Table 1, soil sample BR-1). The claystone appeared to represent vertical delineation of the release and an aquitard, preventing vertical migration of observed water deeper into the subsurface.

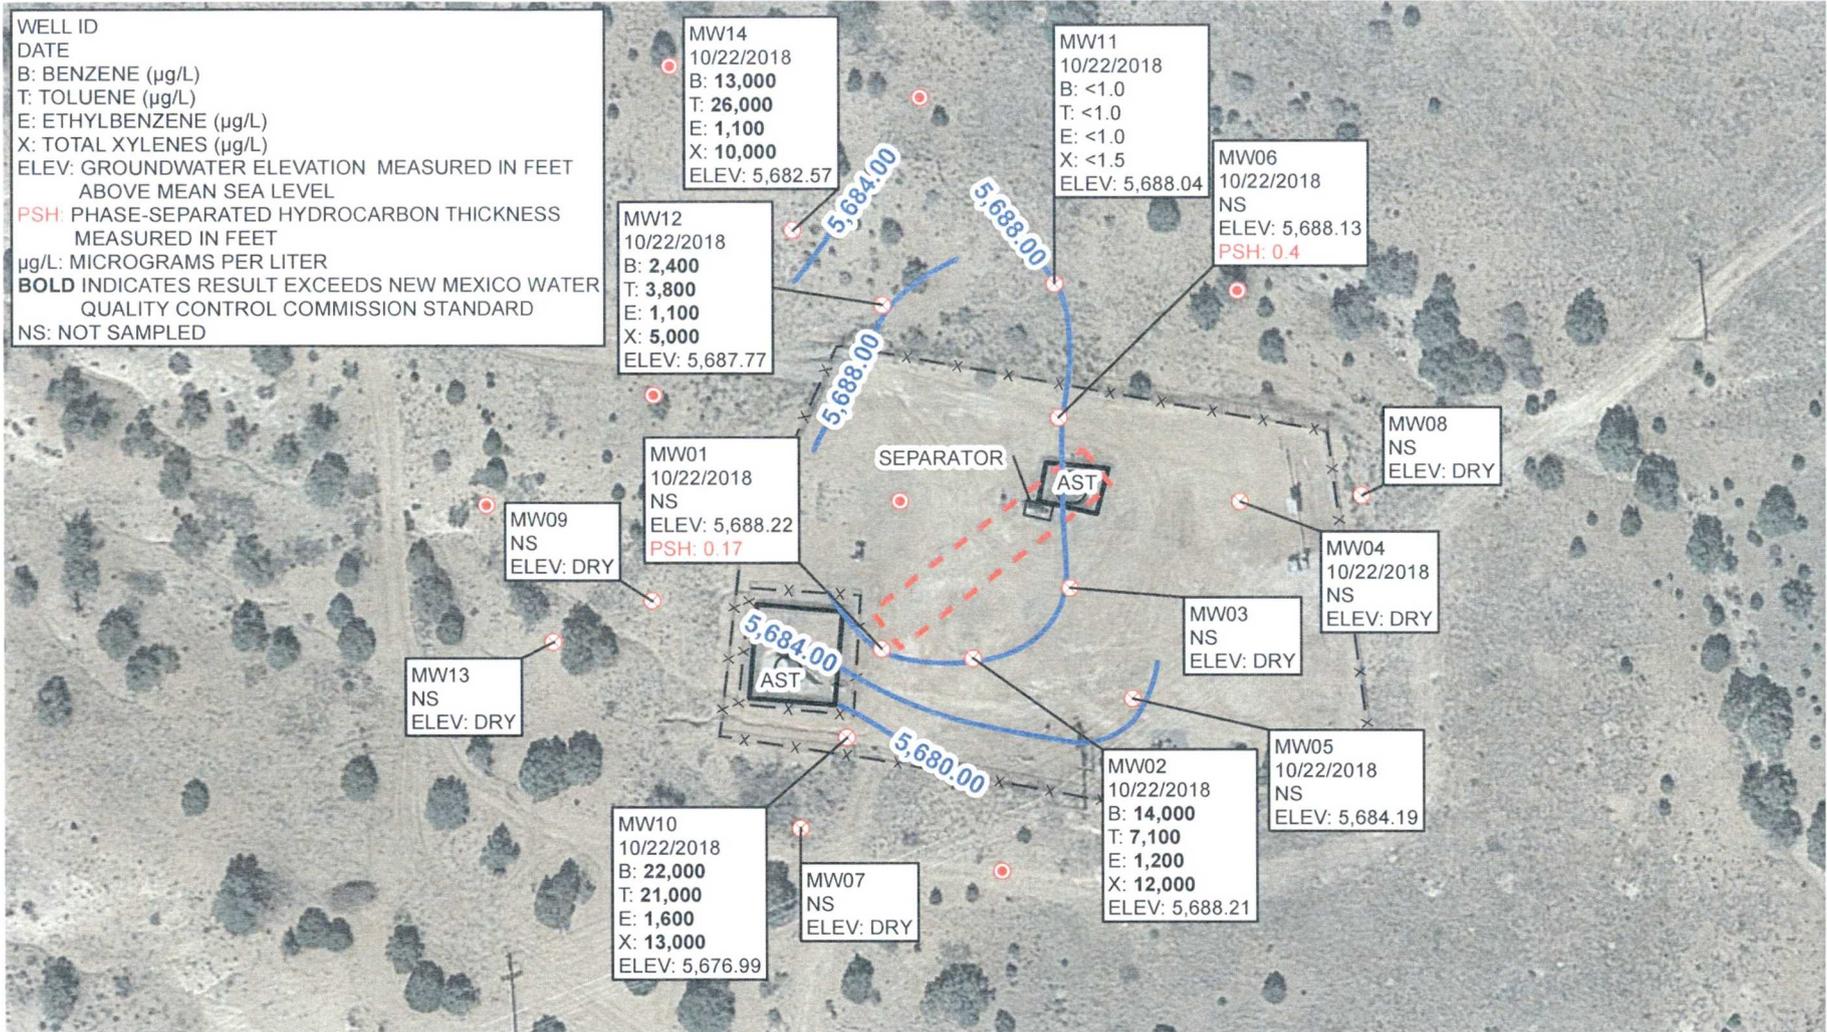
WELL ID
 DATE
 B: BENZENE (µg/L)
 T: TOLUENE (µg/L)
 E: ETHYLBENZENE (µg/L)
 X: TOTAL XYLENES (µg/L)
 ELEV: GROUNDWATER ELEVATION MEASURED IN FEET ABOVE MEAN SEA LEVEL
 PSH: PHASE-SEPARATED HYDROCARBON THICKNESS MEASURED IN FEET
 µg/L: MICROGRAMS PER LITER
BOLD INDICATES RESULT EXCEEDS NEW MEXICO WATER QUALITY CONTROL COMMISSION STANDARD
 NS: NOT SAMPLED

- ⊗ EXISTING INSTALLED MONITORING WELL
- PROPOSED SOIL BORING
- x — x FENCE
- INFERRED GROUNDWATER ELEVATION CONTOUR
CONTOUR INTERVAL = 4.0 FEET
- ⬡ REMEDIATION EXCAVATION EXTENT
- ▭ BERM
- AST: ABOVEGROUND STORAGE TANK

Depth to groundwater ranged from 19.89 feet below top of casing (btoc) (MW11) to 32.26 feet btoc (MW10). During the groundwater sampling event, PSH was observed in monitoring wells MW01 and MW06 with measured thicknesses of 0.17 ft and 0.4 ft, respectively, during the sampling event. Based on topography, initial data, and regional groundwater trends, the generalized groundwater flow direction is to the northwest, towards the Animas River. However, initial data suggests groundwater flow is relatively flat at the well pad, situated on a potentiometric high that falls off in several directions with distance from the well pad (Figure 3). Groundwater at the Site is discontinuous as evidence by lack of groundwater in several monitoring wells. At this time, LTE is unable to determine what controls accumulation of water in the monitoring wells. Water may even accumulate in monitoring wells as a result of the introduction of a borehole conduit in the subsurface. Based on this unknown and the lack of full delineation of soil and groundwater impacts, additional data points are needed to evaluate remediation options.

LTE proposes to install at least seven additional soil borings by sonic drilling at the Site to continue delineation of the identified hydrocarbon subsurface impacts. The soil borings will be logged by an LTE geologist who will inspect the soil for the presence or absence of petroleum hydrocarbon odor and/or staining. The soil will be characterized by visually inspecting the soil samples and field screening the soil headspace using a PID to monitor for the presence of volatile organic vapors. Two soil samples from each soil boring will be submitted for laboratory analysis: the most impacted sample based on field screening techniques and the terminus of the borehole. Soil samples will be submitted for analysis of BTEX by USEPA 8021 and TPH-GRO, TPH-DRO, and TPH-MRO by USEPA Method 8015. If groundwater is encountered, monitoring wells will be constructed by installing screened casing across the groundwater interface and solid casing to surface. Upon completion of additional boreholes, groundwater monitoring wells will be developed and tied into the existing survey data. To develop the wells, depth to water will be measured and ten casing volumes will be purged or until dry. At least 48 hours after development, the new groundwater monitoring wells will be sampled with a disposable bailer after three casing volumes have been purged. Groundwater samples will be submitted for analysis of BTEX by USEPA Method 8260. Proposed borehole locations are depicted on Figure 3. Additional borings and monitoring wells will be installed as needed based on field observations to complete delineation of the identified impacts. Prior to drilling activities, all additional proposed borehole locations will be permitted with the New Mexico Office of the State Engineer (NMOSE).

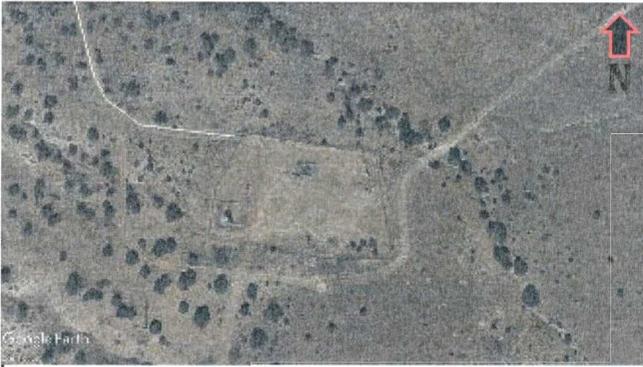
BORING LOG/MONITORING WELL COMPLETION DIAGRAM

Boring/Well Number: MW02		Project: Standard #1	
Date: 8/17/2018 - 8/20/2018		Project Number: 017817006	
Logged By: Eric Carroll		Drilled By: Enviro Drill	
Elevation: 5,795	Detector: PID		Drilling Method: ODEX
Gravel Pack: 10-20 Silica Sand (13'-25')		Seal: Bentonite (10'-13')	Grout: Bentonite/Cement Slurry (0'-10')
Casing Type: Schedule 40 PVC		Diameter: 2"	Length: 15'
		Hole Diameter: 4.5"	Depth to Liquid: -
Screen Type: Schedule 40 PVC		Slot: 0.010"	Diameter: 2"
		Length: 10'	Total Depth: 25'
			Depth to Water: ~20'

Penetration Resistance	Moisture Content	Vapor (ppm)	HC Staining?	Sample #	Depth (ft. bgs.)	Sample Run	Recovery	Soil/Rock Type	Lithology/Remarks	Well Completion
	Dry	0.0	N		0					
					1					
					2					
	Moist	0.0	N		3	1	80%	SM	Silty sand, some clay <15%, trace gravel < 5%, reddish brown, compact No stain/odor	
					4					
	Moist	1.4	N		5			SM	SAA	
					6					
	Dry	0.0	N		7					
					8	2	30%	SP	Coarse sand and gravel, trace fines < 5%, cobbles > 1" diameter, dark brown, very dense No stain/odor	
50					9					
	Dry	0.0	N		10			SP	SAA, No stain/odor	
					11					
	Moist	0.0	N		12			SP	Coarse sand some gravel < 15% , dark brown, loose No stain/odor	
					13	3	90%			
					14					
30					15			SP	SAA	
	Moist	0.0	N

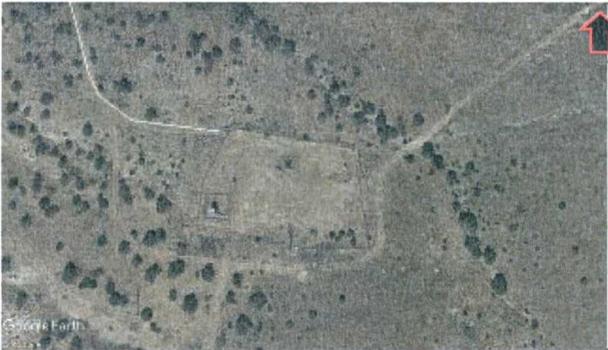
G WELL COMPLETION DIAGRAM

Boring/Well Number: MW03		Project: Standard #1	
Date: 8/20/2018-8/23/2018, 10/5/2018		Project Number: 017817006	
Logged By: Eric Carroll, Josh Adams		Drilled By: Cascade Drilling	
Elevation: 5,795	Detector: PID	Drilling Method: Sonic	Sampling Method: Continuous
Gravel Pack: 10-20 Silica Sand (20'-30')		Seal: Bentonite (17'-20')	Grout: Bentonite/Grout (0'-17')
Casing Type: Schedule 40 PVC		Diameter: 2" Length: 20'	Hole Diameter: 10" Depth to Liquid:
Screen Type: Schedule 40 PVC Slot: 0.010"		Diameter: 2" Length: 10'	Total Depth: 45' (set @ 30") Depth to Water: dry

Penetration Resistance	Moisture Content	Vapor (ppm)	HC Staining?	Sample #	Depth (ft. bgs.)	Sample Run	Recovery	Soil/Rock Type	Lithology/Remarks	Well Completion
		0	N		0			SP	Poorly graded sand, some fines <15%, reddish brown, compact No stain/odor	Flush Mount
	Dry				1					
					2		10	CL		
	Dry	0	N		3	1	0		Sandy clay, trace gravel, reddish brown, No stain/odor	
20					4					
					5			CL	SAA No stain/odor	
					6					
					7					
					8	2				
					9				Refusal of hollow stem at 8', switch to ODEX	
	Moist	5.30	N		10		40		Sandy gravel, cobbles, dark brown, loose, No stain/odor	
	Dry	28.7	N		11	10'-13'		SP-SM	Poorly graded sand with silt and gravel, light brown	
	Dry	42.0	N		12	10'-13'		SP-SM	Poorly graded sand with silt and gravel	
	Moist	34.9	N		13	13'-15'		SW	Well graded sand with gravel, brown	
	Moist	31.9	N		14			SP-SM	Poorly graded sand with silt, dark brown/grey	
					15

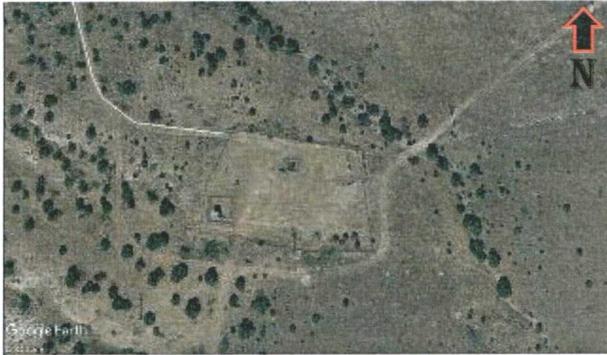
BORING LOG/MONITORING WELL COMPLETION DIAGRAM

Boring/Well Number: MW04	Project: Standard #1
Date: 10/5/2018	Project Number: 017817006
Logged By: Josh Adams, Mary Mrdjenovich	Drilled By: Cascade Drilling

Penetration Resistance	Moisture Content	Vapor (ppm)	HC Staining?	Sample #	Depth (ft. bgs.)	Sample Run	Recovery	Soil/Rock Type	Lithology/Remarks	Well Completion
	Dry	2.4	N		0	0'-5'		SM	Silty sand, light brown	Stick up
					1	0'-5'		SM	SAA, brown	
	Moist	2.4	N		2	0'-5'		CL	Lean clay with sand, brown	
		1.5	N		3	0'-5'				
					4	0'-5'		CH	Sandy fat clay with leeches and gravel	
	Dry	1.2	N		5	5'-10'		CH	SAA	
		1.0	N		6	5'-10'		CH	SAA	
	Dry	1.4	N		7	5'-10'				
					8	5'-10'		CH	SAA	
	Dry	0.9	N		9	5'-10'		SP-SM	Poorly graded sand with silt and gravel, brown	
	Damp	0.9	N		10	5'-10'				
					11	10'-13'		SP-SM	SAA	
	Moist	3.3	N		12	10'-13'				
		5.4	N		13	10'-13'		SP-SM	SAA	
	Dry	5.4	N		14	13'-15'		SP-SM	SAA	
	Moist	7.7	N		15	13'-15'		SP-SM	SAA

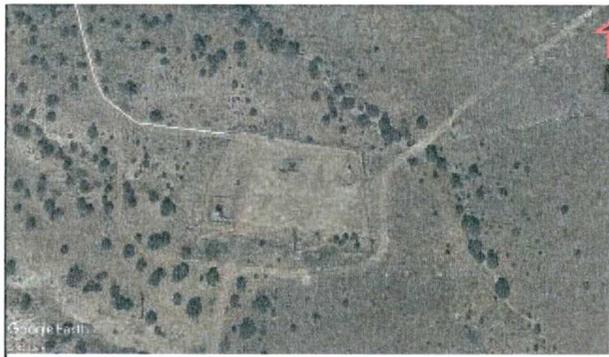
BORING LOG/MONITORING WELL COMPLETION DIAGRAM

Boring/Well Number: MW07	Project: Standard #1
Date: 10/9/2018	Project Number: 017817006
Logged By: Josh Adams	Drilled By: Cascade Drilling
Elevation: 5795	Detector: PID
Drilling Method: Sonic	Sampling Method: Continuous
Gravel Pack: 10-20 Silica Sand (9'-22')	Seal: Bentonite (7'-9')
Casing Type: Schedule 40 PVC	Grout: Cement Slurry (0'-7')
Screen Type: Schedule 40 PVC	Slot: 0.010"
Diameter: 2"	Length: 13'
Diameter: 2"	Length: 10'
Hole Diameter: 10"	Depth to Liquid: 18'
Total Depth: 35'	Depth to Water: dry

Penetration Resistance	Moisture Content	Vapor (ppm)	HC Staining?	Sample #	Depth (ft. bgs.)	Sample Run	Recovery	Soil/Rock Type	Lithology/Remarks	Well Completion
					0					Stick up
					1					
					2			SM	0-5' Removed with hand auger to clear hole. Silty Sand, light brown	
					3					
					4					
	Dry	1.3	N		5	5'-10'		SM	Silty sand, light brown/tan No stain/odor	
					6					
	Dry	2.4	N		7	5'-10'		SP-SM	Poorly graded sand with silt, gravel and cobbles	
					8					
	Dry	4.5	N		9	5'-10'		SP-SM		
					10				SAA	
	Dry	2.6	N		11	10'-11'		SP-SM		
					12				SAA	
	Dry	10.4	N		13	11'-12.5'		SP-SM		
					14				SAA	
	Dry	11.7	N		15	12.5'-15'		SP-SM		
									SAA

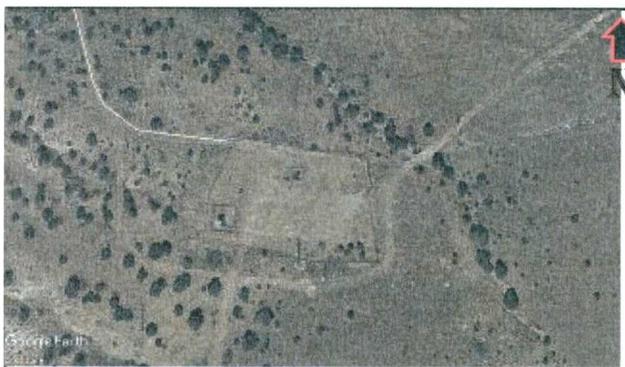
BORING LOG/MONITORING WELL COMPLETION DIAGRAM

Boring/Well Number: MW08		Project: Standard #1	
Date: 10/10/2018		Project Number: 017817006	
Logged By: Josh Adams		Drilled By: Cascade Drilling	
Drilling Method: Sonic		Sampling Method: Continuous	
Gravel Pack: 10-20 Silica Sand (12'-25')		Seal: Bentonite (9'-12')	
Casing Type: Schedule 40 PVC		Grout: Bentonite Gel (0'-9')	
Diameter: 2"	Length: 15'	Hole Diameter: 10"	Depth to Liquid:
Screen Type: Schedule 40 PVC	Slot: 0.010"	Diameter: 2"	Length: 10'
		Total Depth: 35'	Depth to Water: dry

Penetration Resistance	Moisture Content	Vapor (ppm)	HC Staining?	Sample #	Depth (ft. bgs.)	Sample Run	Recovery	Soil/Rock Type	Lithology/Remarks	Well Completion
					0					Stick up
					1					
	Dry	0.6	N		2			SM	Removed by hand, Silty sand, brown	
					3					
					4					
	Dry	1.5	N		5	5'-10'		SM	Silty sand, tan/cream	
					6					
	Dry	2.5	N		7	5'-10'		SP-SM	Poorly graded sand with silt, gravel and cobbles	
					8					
	Dry	2.5	N		9	5'-10'		SP-SM		
					10				SAA	
	Dry	2.0	N		11	10'-15'		SP-SM		
					12				SAA	
	Dry	4.2	N		13	10'-15'		SP-SM		
					14				SAA	
	Dry	4.0	N		15	10'-15'		SP-SM		
									SAA

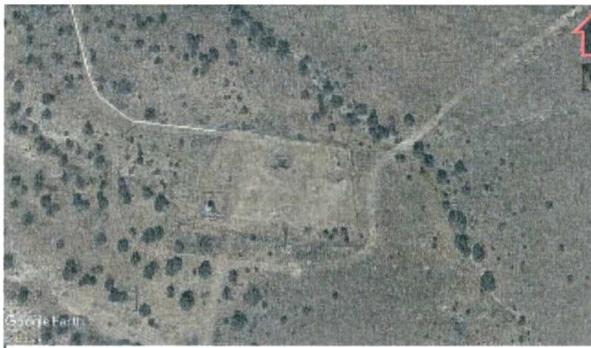
BORING LOG/MONITORING WELL COMPLETION DIAGRAM

Boring/Well Number: MW09		Project: Standard #1	
Date: 10/6/2018		Project Number: 017817006	
Logged By: Mary Mrdjenovich		Drilled By: Cascade Drilling	
Drilling Method: Sonic		Sampling Method: Continuous	
Seal: Bentonite (10'-12')		Grout: Bentonite Gel (0'-10')	
Casing Type: Schedule 40 PVC		Diameter: 2"	Length: 15'
Screen Type: Schedule 40 PVC		Diameter: 2"	Length: 10'
Slot: 0.010"		Total Depth: 35'	Depth to Liquid: dry

Penetration Resistance	Moisture Content	Vapor (ppm)	HC Staining?	Sample #	Depth (ft. bgs.)	Sample Run	Recovery	Soil/Rock Type	Lithology/Remarks	Well Completion
	Dry	5.4	N		0	0'-5'		SM	Silty Sand, brown	Stick up
	Dry	8.8	N		1	0'-5'		SM	SAA, with gravel	
					2		100%			
	Dry	12.50	N		3	0'-5'		CL	Sandy lean clay with gravel, light brown, leeches	
					4					
	Dry	5.0	N		5	5'-6'	100%	CL	SAA	
	Dry	5.3	N		6	6'-10'		GM	Silty sand gravel, light grayish-brown	
					7					
					8		60%			
	Dry	7.6	N		9	6'-10'		GM	SAA, grayish-brown	
					10					
	Dry	14.1	N		11	10'-13'		GM	SAA	
					12		100%			
	Moist	282.2	Y, gray yellow		13	13'-20'		CH	Fat clay, dark grayish-brown, Hc odor	
					14					
					15

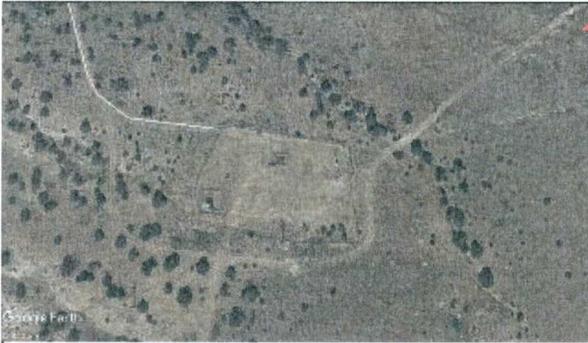
BORING LOG/MONITORING WELL COMPLETION DIAGRAM

Boring/Well Number: MW10	Project: Standard #1
Date: 10/4/2018	Project Number: 017817006
Logged By: Josh Adams	Drilled By: Cascade Drilling

Penetration Resistance	Moisture Content	Vapor (ppm)	HC Staining?	Sample #	Depth (ft. bgs.)	Sample Run	Recovery	Soil/Rock Type	Lithology/Remarks	Well Completion
	Dry		N		0	0'-5'		SM-SP	Poorly graded sand with silt, light brown	Stick up
					1					
	Dry	2.5	N		2	0'-5'	100%	SM	Silty sand, light brown, plastic fines	
					3					
	Dry	1.8	N		5	5'-15'		SM	SAA	
					6					
	Moist	2.0	N		7	5'-15'		ML	Silt with sand, gravel and organics, light brown	
					8					
	Dry	6.1	N		9	5'-15'	100%	ML	SAA, with gravel and cobbles	
					10					
	Dry	7.5	N		11	5'-15'		SP-SM	Poorly graded sand with gravel	
					12					
	Dry	7.0	N		13	5'-15'		SP-SM	SAA	
					14					
					15

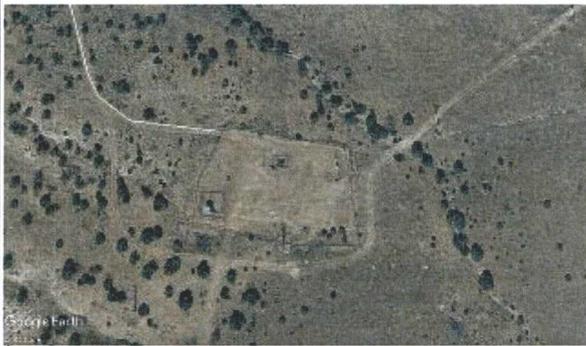
BORING LOG/MONITORING WELL COMPLETION DIAGRAM

Boring/Well Number: MW11	Project: Standard #1
Date: 10/8/2018	Project Number: 017817006
Logged By: Mary Mrdjenovich	Drilled By: Cascade Drilling

Penetration Resistance	Moisture Content	Vapor (ppm)	HC Staining?	Sample #	Depth (ft. bgs.)	Sample Run	Recovery	Soil/Rock Type	Lithology/Remarks	Well Completion
	Dry	1.4	N		0	0'-5'		SM	Silty sand with gravel, light brown, trace leeches	Stick up
					1					
	Dry	0.9	N		2	0'-5'	100%	SM	SAA	
					3					
	Dry	0.2	N		5	5'-8'		GM	Silty sand gravel, light brwn	
					6		100%			
	Damp	0.1	N		7	5'-8'		GM	SAA, brown	
	Damp	1.5	N		8	8'-15'		GM	SAA	
					9					
	Moist	2.3	N		10	8'-15'		GM	SAA	
					11					
	Moist	4.7	N		12	8'-15'	100%	GM	SAA	
					13					
	Moist	3.2	N		14	8'-15'		GM	SAA, dark brown, slight Hc odor	
					15

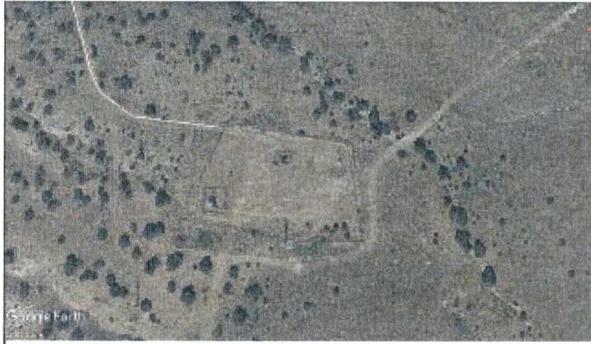
BORING LOG/MONITORING WELL COMPLETION DIAGRAM

Boring/Well Number: MW12	Project: Standard #1
Date: 10/8/2018	Project Number: 017817006
Logged By: Josh Adams	Drilled By: Cascade Drilling

Penetration Resistance	Moisture Content	Vapor (ppm)	HC Staining?	Sample #	Depth (ft. bgs.)	Sample Run	Recovery	Soil/Rock Type	Lithology/Remarks	Well Completion
					0					Stick up
					1				No Recovery 0'-2'	
	Dry	1.4	N		2	2'-5'		SM	Silty sand, brown	
					3		100%			
	Dry	2.0	N		4	2'-5'		SM	SAA	
	Dry	8.4	N		5	5'-11'		SP-SM	Poorly graded sand with silt and gravel	
					6					
	Dry	9.6	N		7	5'-11'		SP-SM	SAA	
					8		100%			
	Dry	6.1	N		9	5'-11'		SP-SM	SAA	
					10					
	Dry	19.2	N		11	11'-14'		SP-SM	SAA	
					12					
	Moist	7.2	N		13	11'-14'	100%	SP-SM	SAA	
	Moist	15.5	N		14	14'-15'	100%	SW-SM	Well graded sand with silt and gravel	
					15

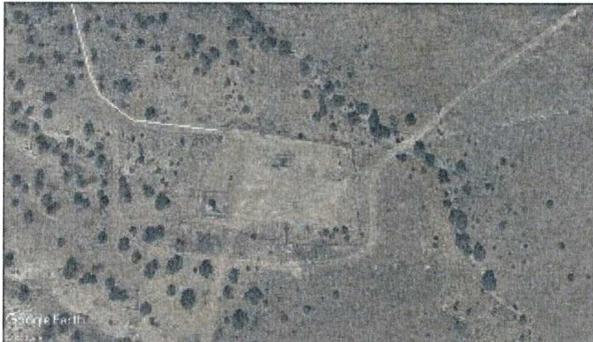
BORING LOG/MONITORING WELL COMPLETION DIAGRAM

Boring/Well Number: MW13	Project: Standard #1
Date: 10/10/2018	Project Number: 017817006
Logged By: Josh Adams	Drilled By: Cascade Drilling

Penetration Resistance	Moisture Content	Vapor (ppm)	HC Staining?	Sample #	Depth (ft. bgs.)	Sample Run	Recovery	Soil/Rock Type	Lithology/Remarks	Well Completion
	Dry	1	N		0	0'-6'		SM	Silty sand, brownish-red	Stick up
					1					
	Dry	2.3	N		2	0'-6'	100%	SM	SAA	
					3					
	Dry	1.9	N		4	0'-6'		SM	SAA, with some pebbles	
					5					
	Dry	9.6	N	MW13 @ 6'-8'	6	6'-9'		SM	SAA	
					7		100%			
	Dry	7.7	N		8	6'-9'		SP-SM	Poorly graded sand with silt, gravel and cobbles, brown	
					9	9'-16'		SP-SM	SAA	
					10					
	Dry	3.4	N		11	9'-16'		SP-SM	SAA	
					12		100%			
	Moist	4.4	N		13	9'-16'		SP-SM	SAA	
					14					
					15
