Release Notification

CORRECTIVE ACTION REPORT

**Baca Gas Com A #1A CH
NW 1/4, S28 T26N R10W
San Juan County, New Mexico**

July 24, 2018
Apex Project No. 725040112424

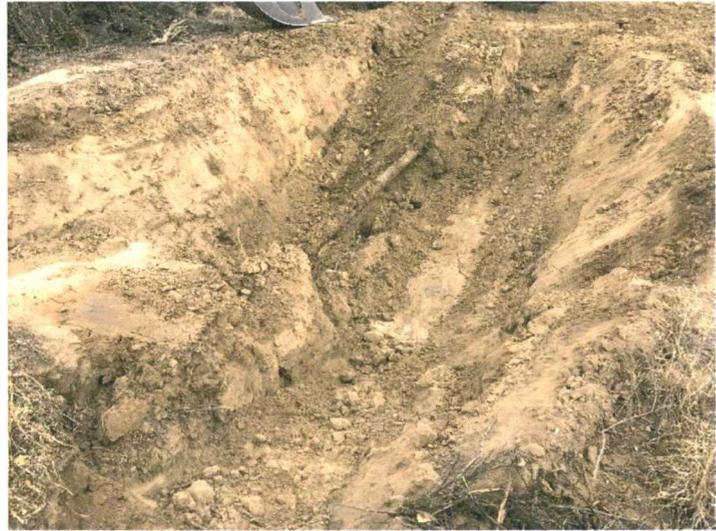
Photograph 1

View of the source area and in-process excavation activities, facing southeast.

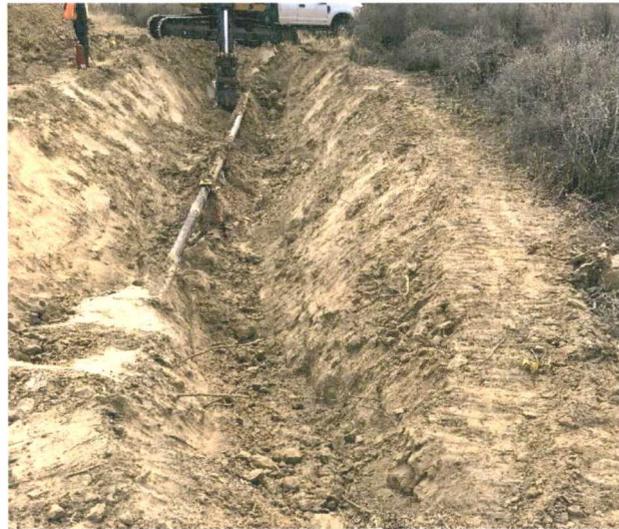
Photograph 2

View of the in-process excavation activities, facing south.

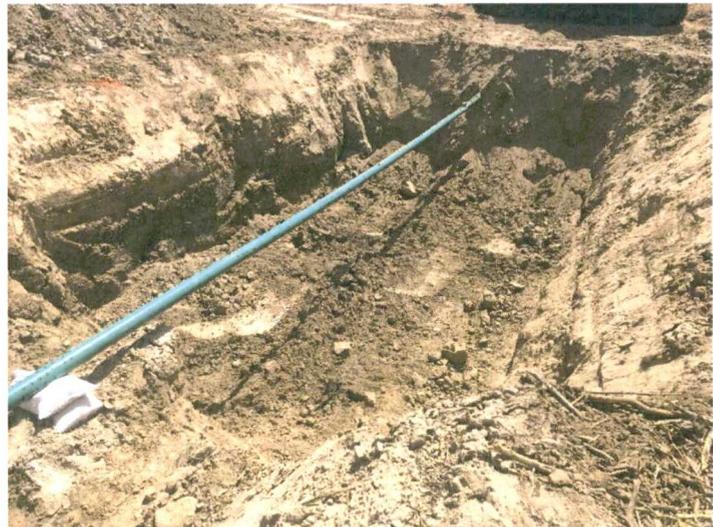
Photograph 3

View of the in-process excavation activities, facing southeast.

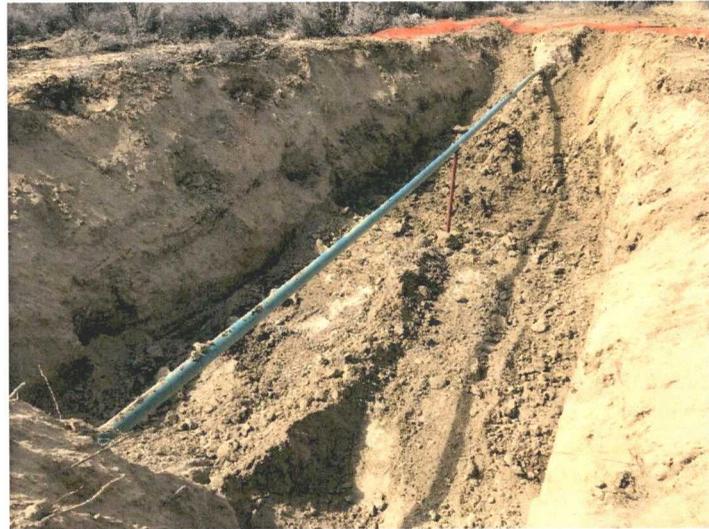
Photograph 4

View of the in-process excavation activities, facing northwest.

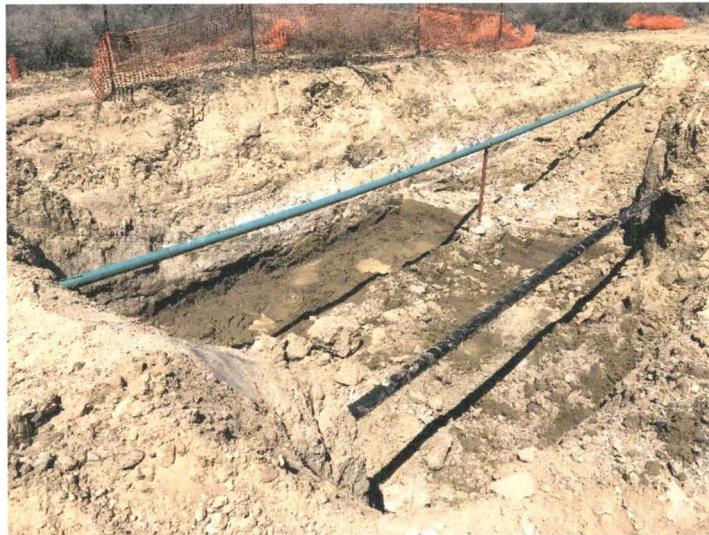
Photograph 5

The final excavation measured approximately 50 feet long by 23 feet wide at the maximum extents. The maximum depth of the excavation measured approximately 10.5 feet bgs.

View of the final excavation, facing northwest.

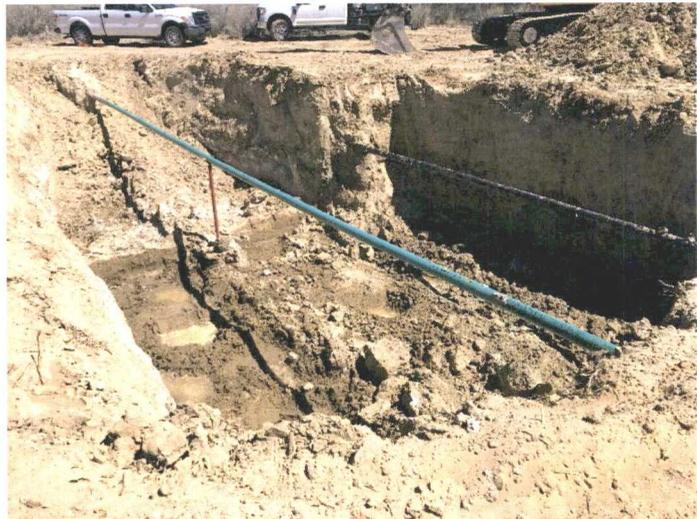
Photograph 6

View of the final excavation, facing northeast.
