**Cause of Release:** On January 28, 2018, a water/glycol solution was ejected from the Train 5 Glycol Reboiler onto the ground surface. An estimated 5-10 barrels of water/glycol solution was released. Remediation activities were completed on March 15, 2108. The contaminant mass was removed by mechanical excavation. The final excavation dimensions measured approximately 60 feet long by 50 feet wide by 0.5 feet deep. Approximately 32 cubic yards of hydrocarbon impacted soil were excavated and stockpile on a plastic liner with other hydrocarbon impacted material associated with other remediation projects at the facility. The excavated soil was transported to a New Mexico Oil Conservation Division approved land farm facility in September 2018. A third party investigation report is included with this "Final." C-141.

## CORRECTIVE ACTION REPORT

**Val Verde Plant Glycol Release (January 2018)  
NE ¼, S14 T29N R11W  
San Juan County, New Mexico**

September 26, 2018  
Apex Project No. 725040112393

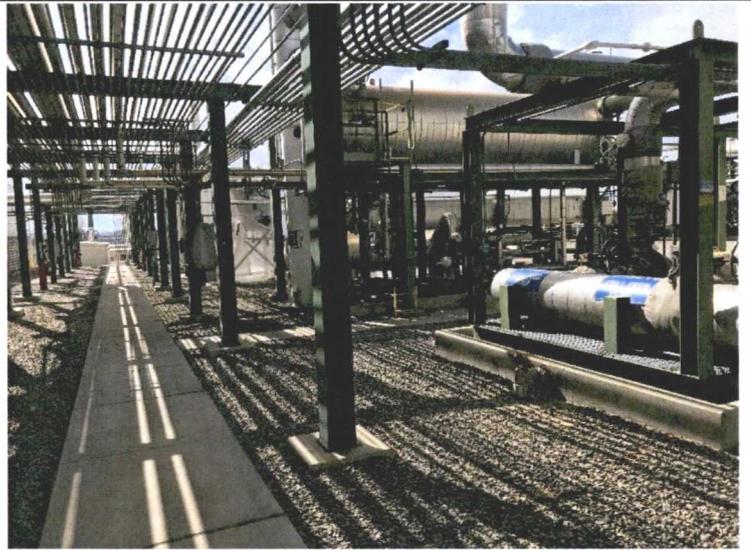
**Photograph 1**

View of the release area, facing southwest.

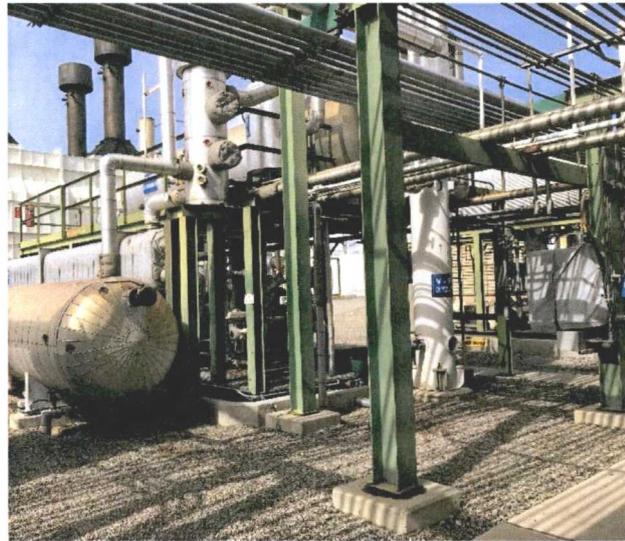
**Photograph 2**

View of the release area, facing northwest.

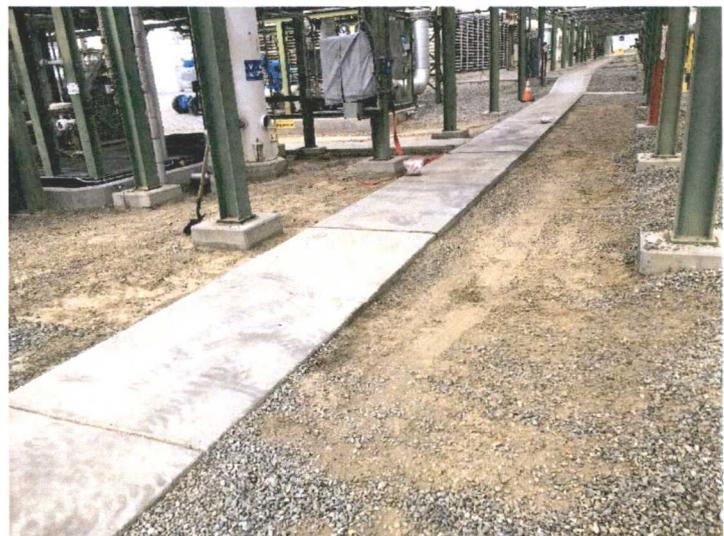
**Photograph 3**

View of the excavated area, facing northeast.

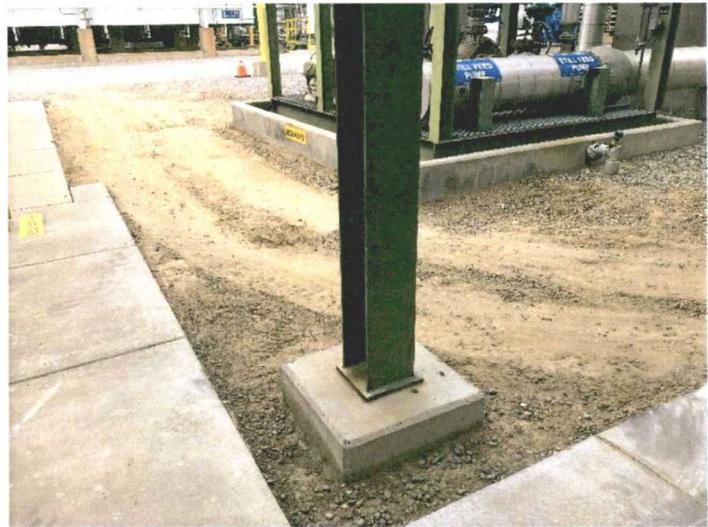
**Photograph 4**

View of the excavated area, facing west.

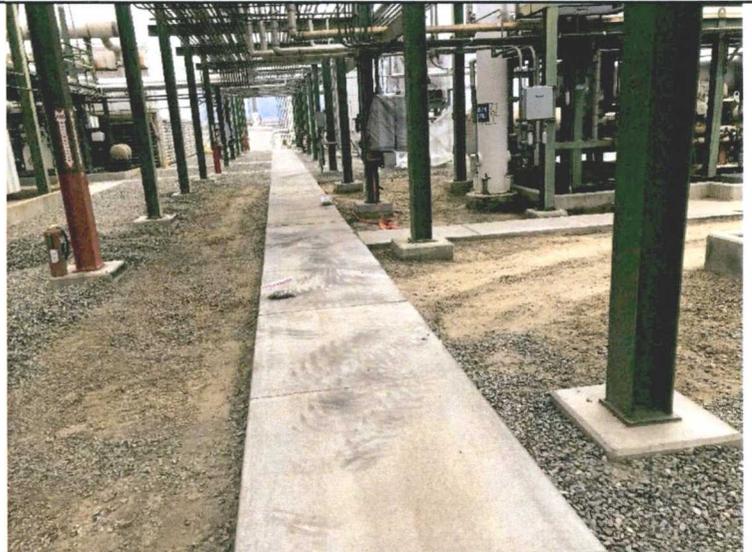
**Photograph 5**

View of the excavated area, facing south.
