## Release Notification

Site Name: Mudge B 012R	Site Type: Natural Gas Production Well Pad
Date Release Discovered: September 21, 2018	API#: 30-045-10792

# **Remediation Plan**

## BP Remediation Plan Mudge B 12R

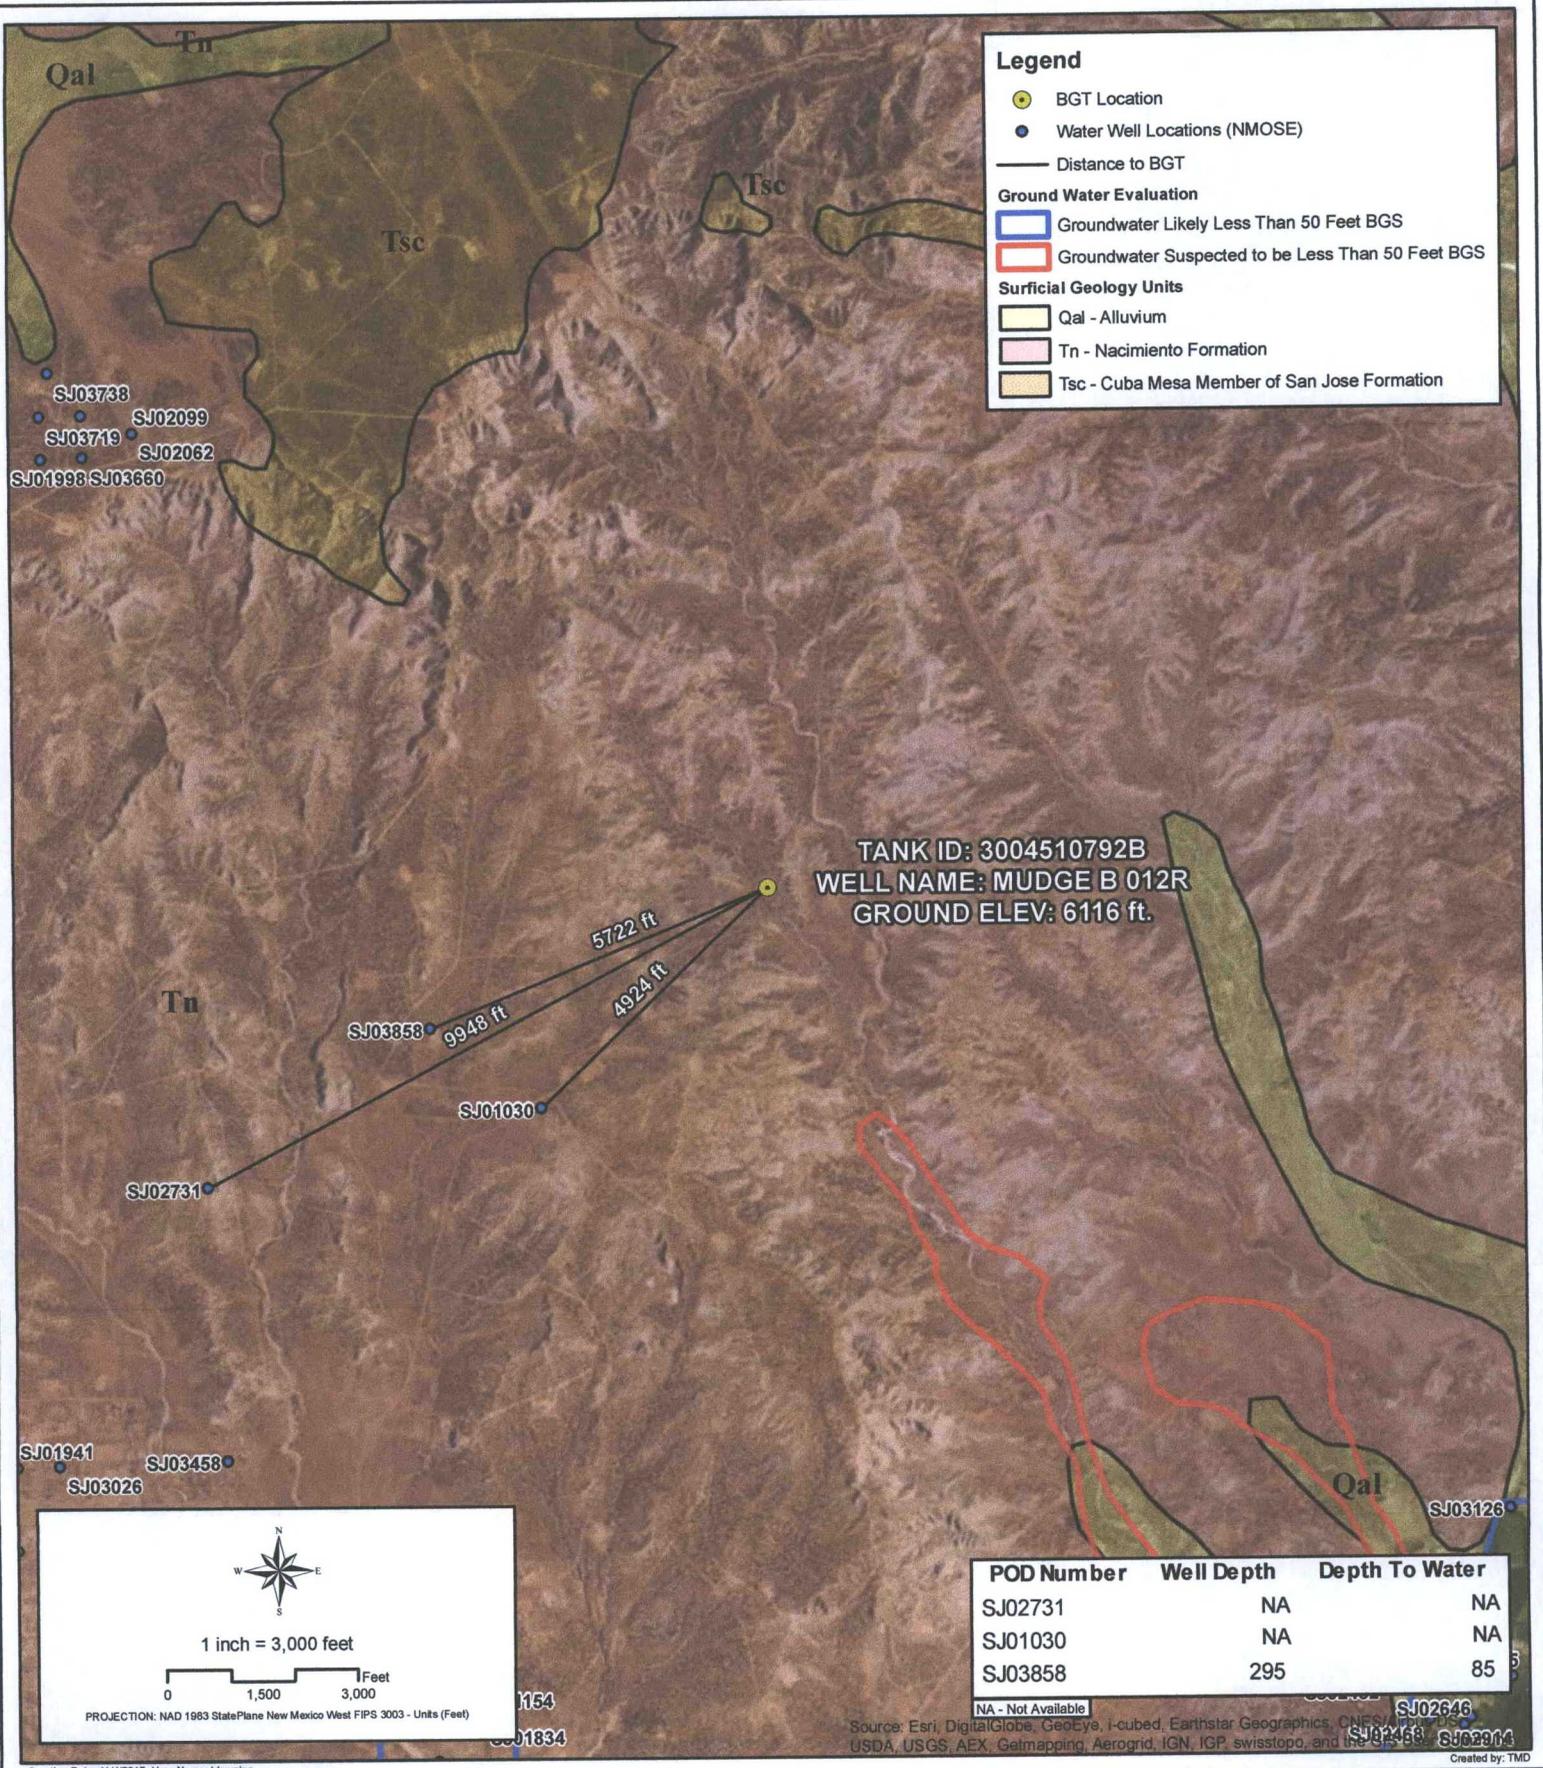
**FIGURE**  
**1**

**GROUNDWATER AND WATER WELL PROXIMITY**  
**WELL NAME: MUDGE B 012R**  
 API NUMBER: 3004510792 TANK ID: 3004510792B  
 SECTION 17, TOWNSHIP 31.0N, RANGE 11W, P.M. NM23

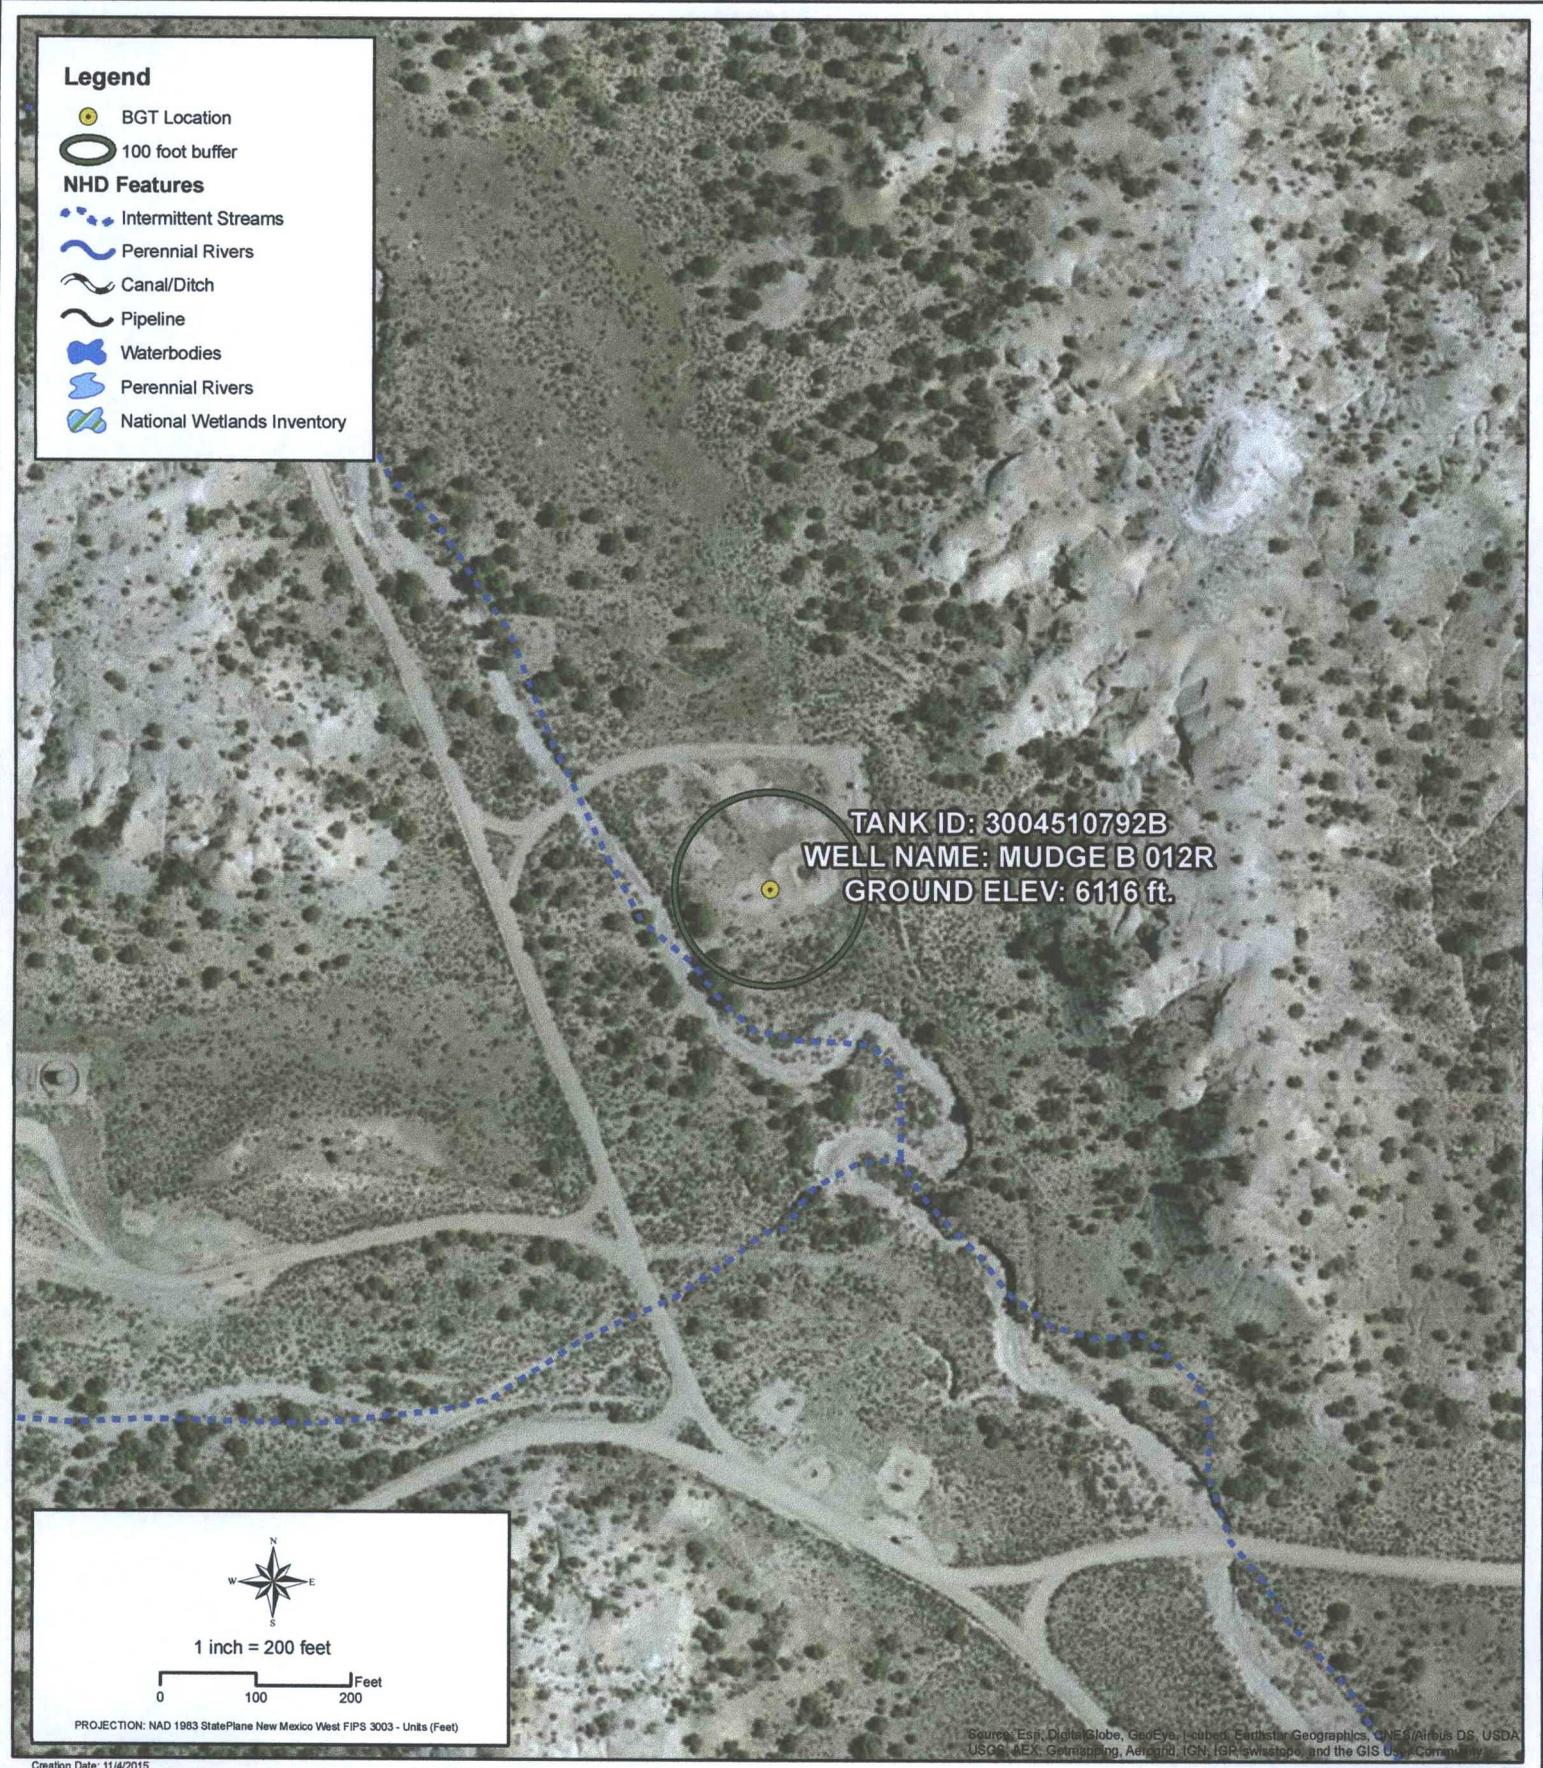
**FIGURE**  
**3**

**PROXIMITY TO WATERCOURSES AND WETLANDS**  
**WELL NAME: MUDGE B 012R**  
 API NUMBER: 3004510792 TANK ID: 3004510792B  
 SECTION 17, TOWNSHIP 31.0N, RANGE 11W, P.M. NM23

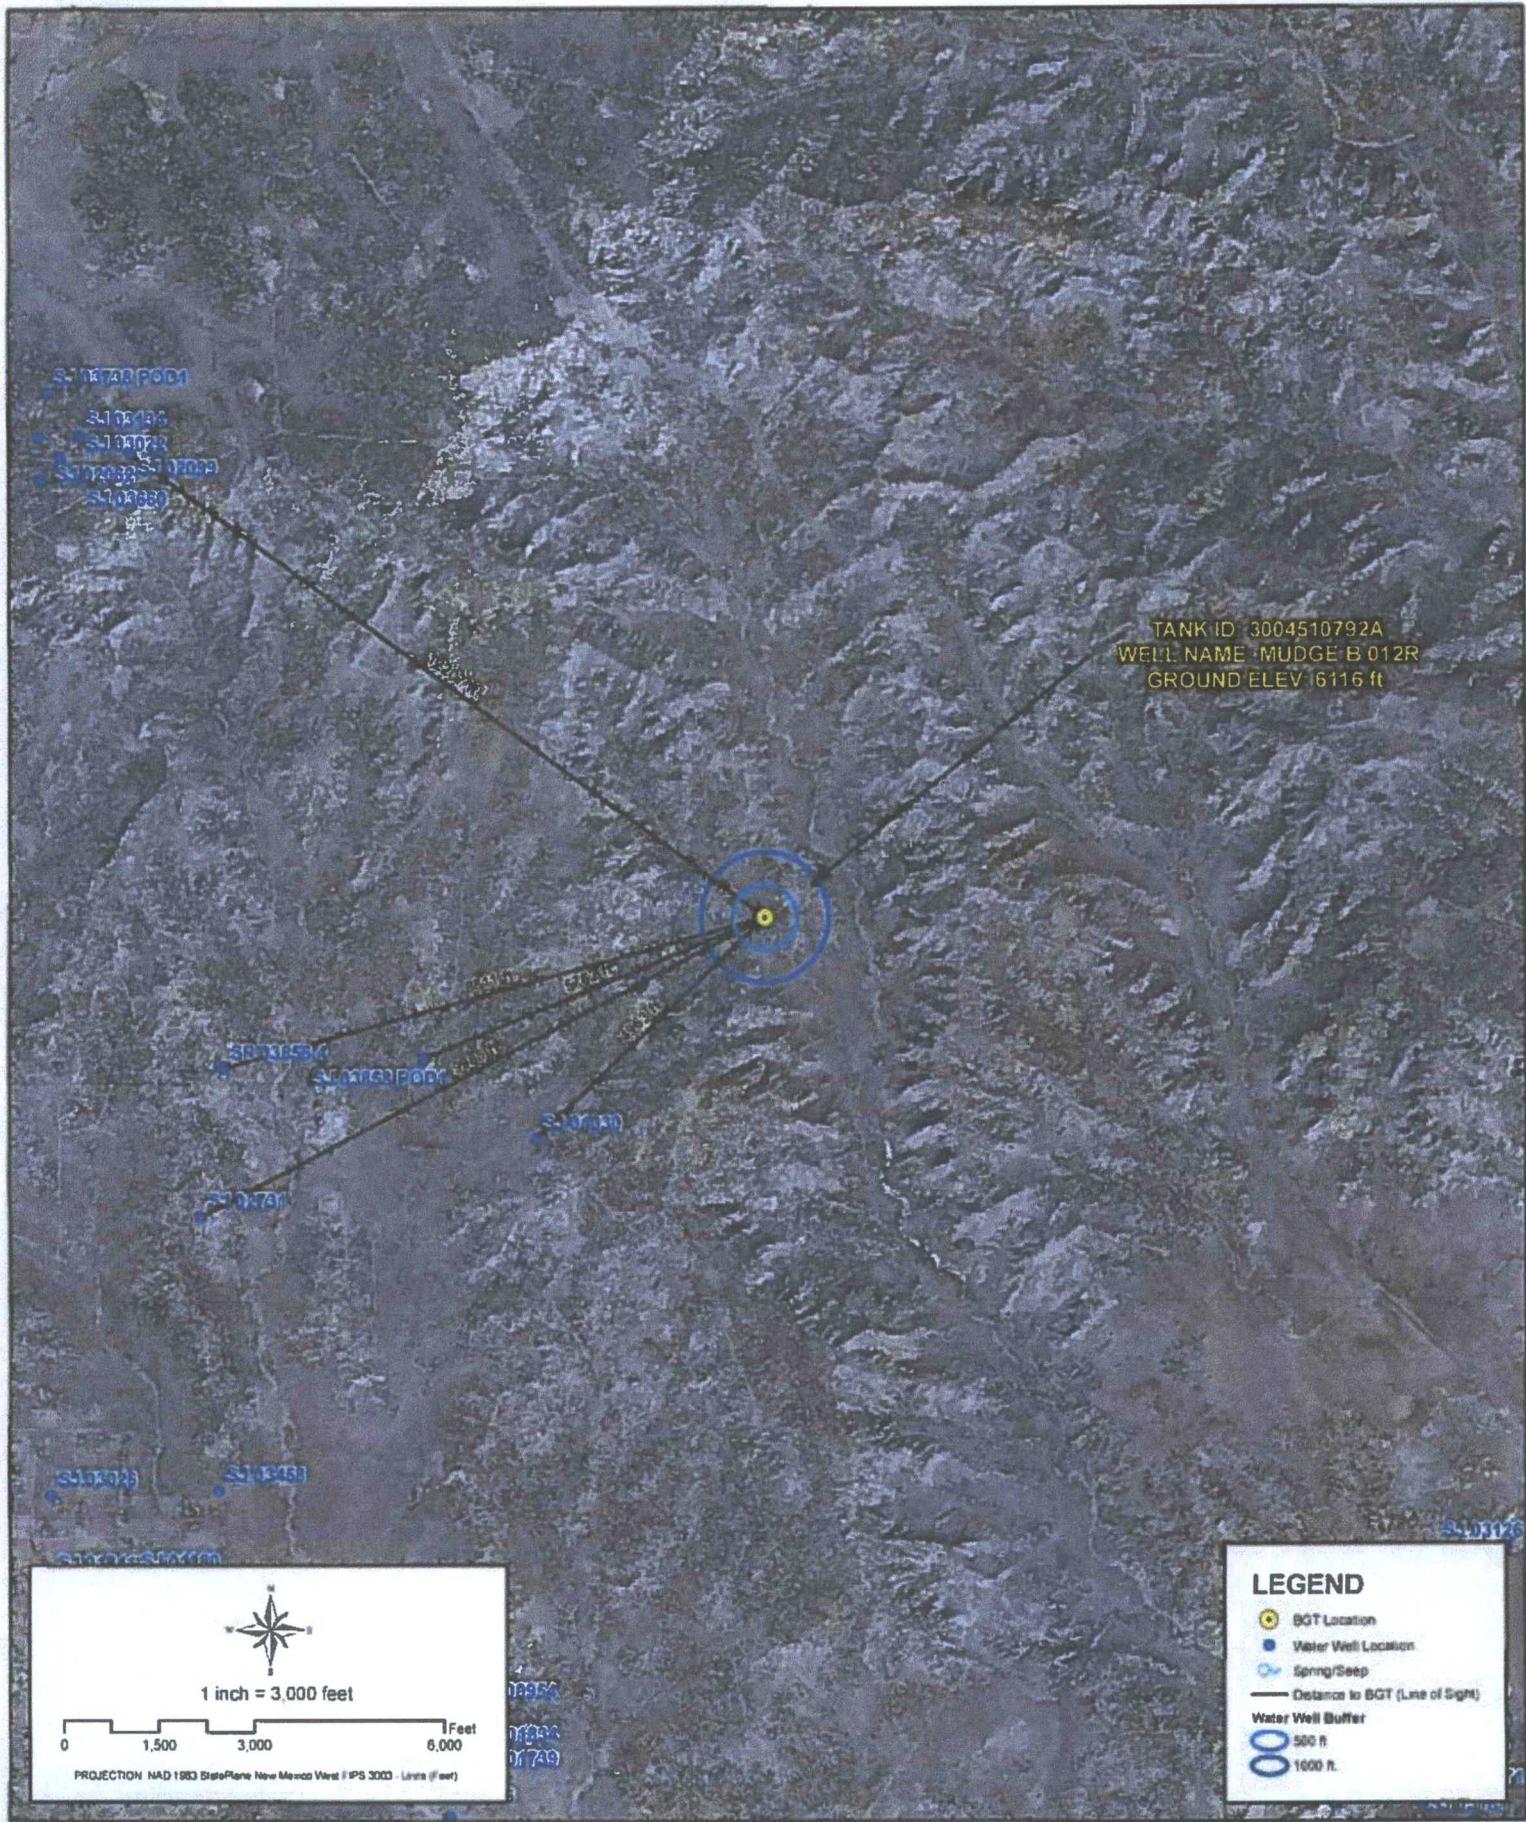
**FIGURE**  
**4**

**PROXIMITY TO WATER WELLS**  
**WELL NAME: MUDGE B 012R**  
 API NUMBER: 3004510792 TANK ID: 3004510792A  
 SECTION 17, TOWNSHIP 31.0N, RANGE 11W, P.M. NM23
