RE: Closure Report  
Dynegy Midstream Services North 24-Inch Release Site (Ref. # 210004)  
SE ¼ of the SE ¼, Sec. 15, T21S, R37E  
Lea County, New Mexico

Figure 1  
 Area Map  
 Dynegy Midstream Services  
 North 24"

Figure 2  
 Site and Well Location Map  
 Dynege Midstream Services  
 North 24"

Figure 5  
 Sample Location Map  
 Dynege Midstream Services  
 North 24"

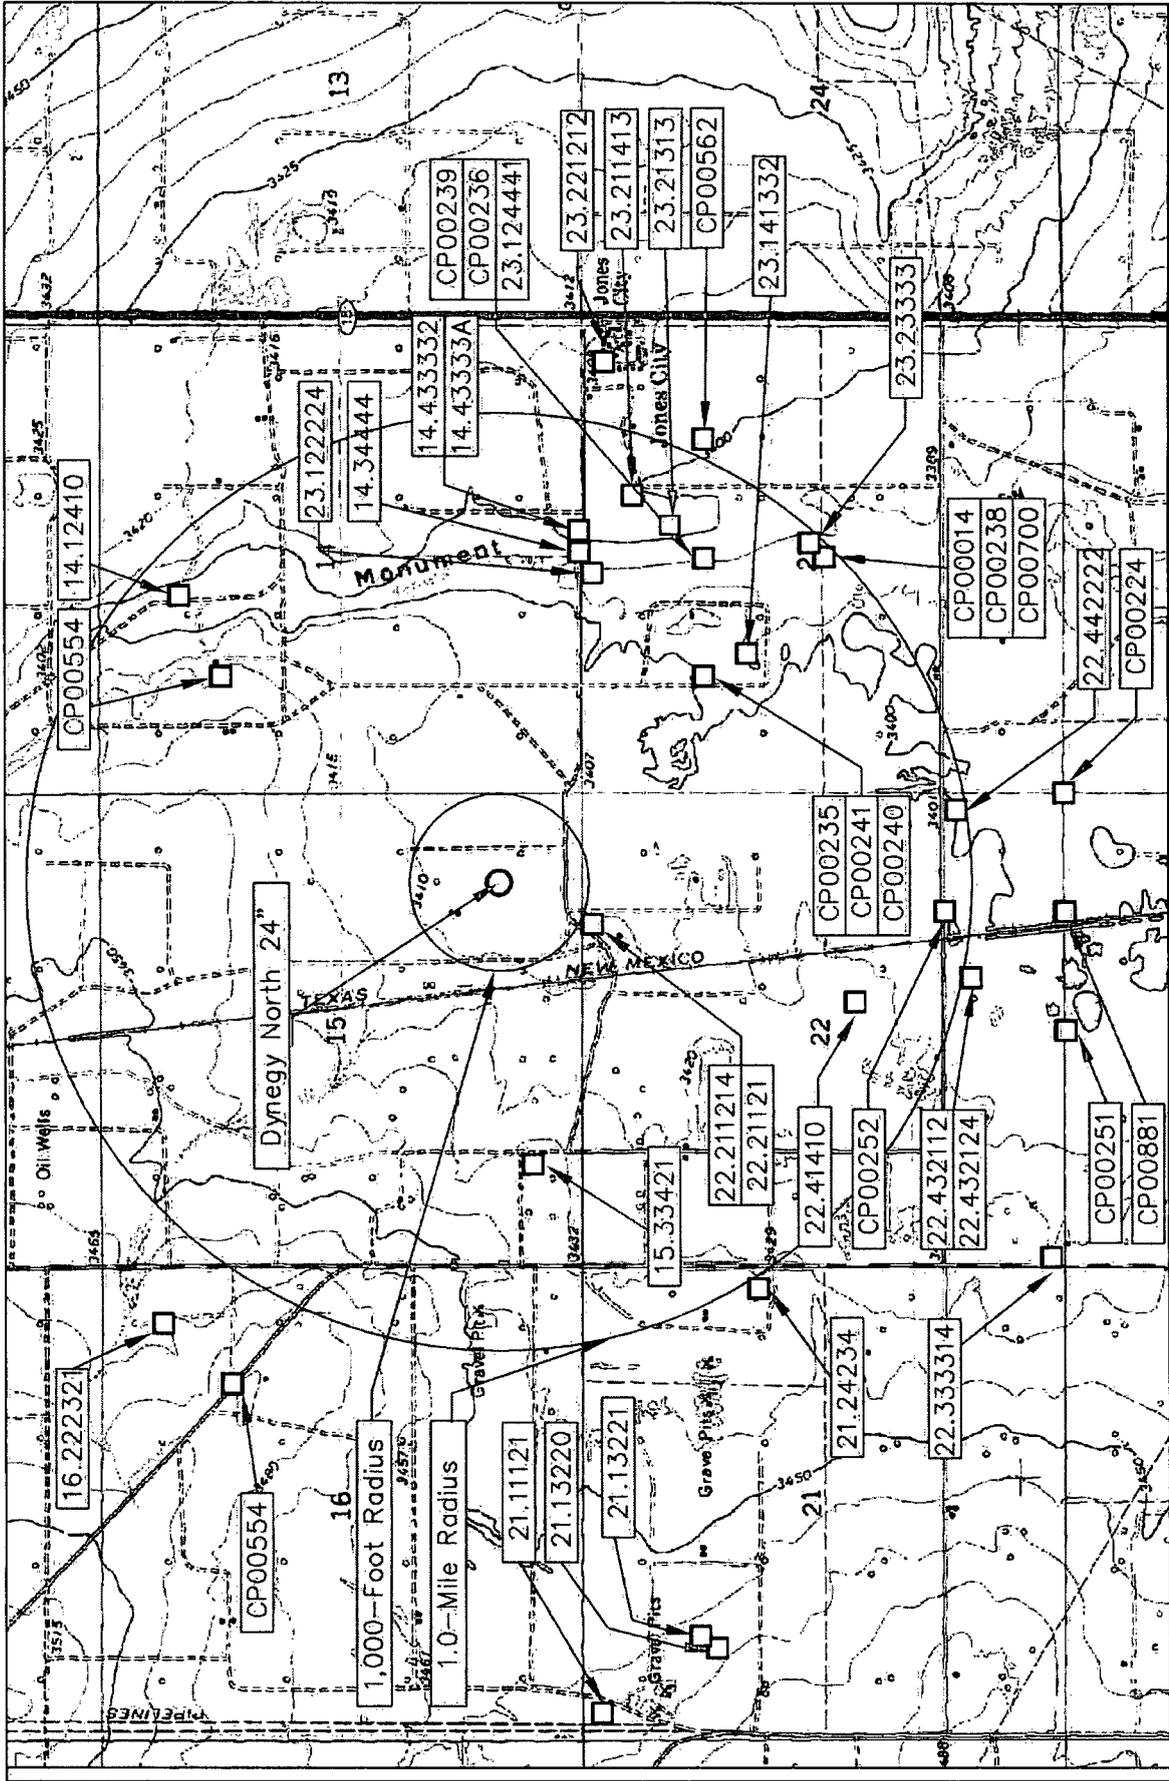
The site is located in the SE ¼ of the SE ¼ of Section 15, Township 21 South, Range 37 East, in Lea County, New Mexico on land owned by Mr. Charlie Bettis (reference *Figures 1* and *2*). A search for area water wells was completed utilizing the New Mexico Office of the State Engineer database, United States Geological Survey (USGS) database and USGS topographic maps of section 15, as well as adjacent sections. A total of fifty-three wells were found to be located in the area; however, only eighteen wells are located within a one-mile radius of the release site. There are no wells located within a 1,000-foot radius of the release site (reference *Figure 2*). The average reported depth to water in these wells is approximately 55 feet below ground surface (bgs) (reference *Table 3*). Based on available information, it was determined that the distance between the contamination and groundwater was <50 feet. Based on the distance from domestic water supply wells, depth to ground water and distance from bodies of surface water, NMOCD remedial goals are:

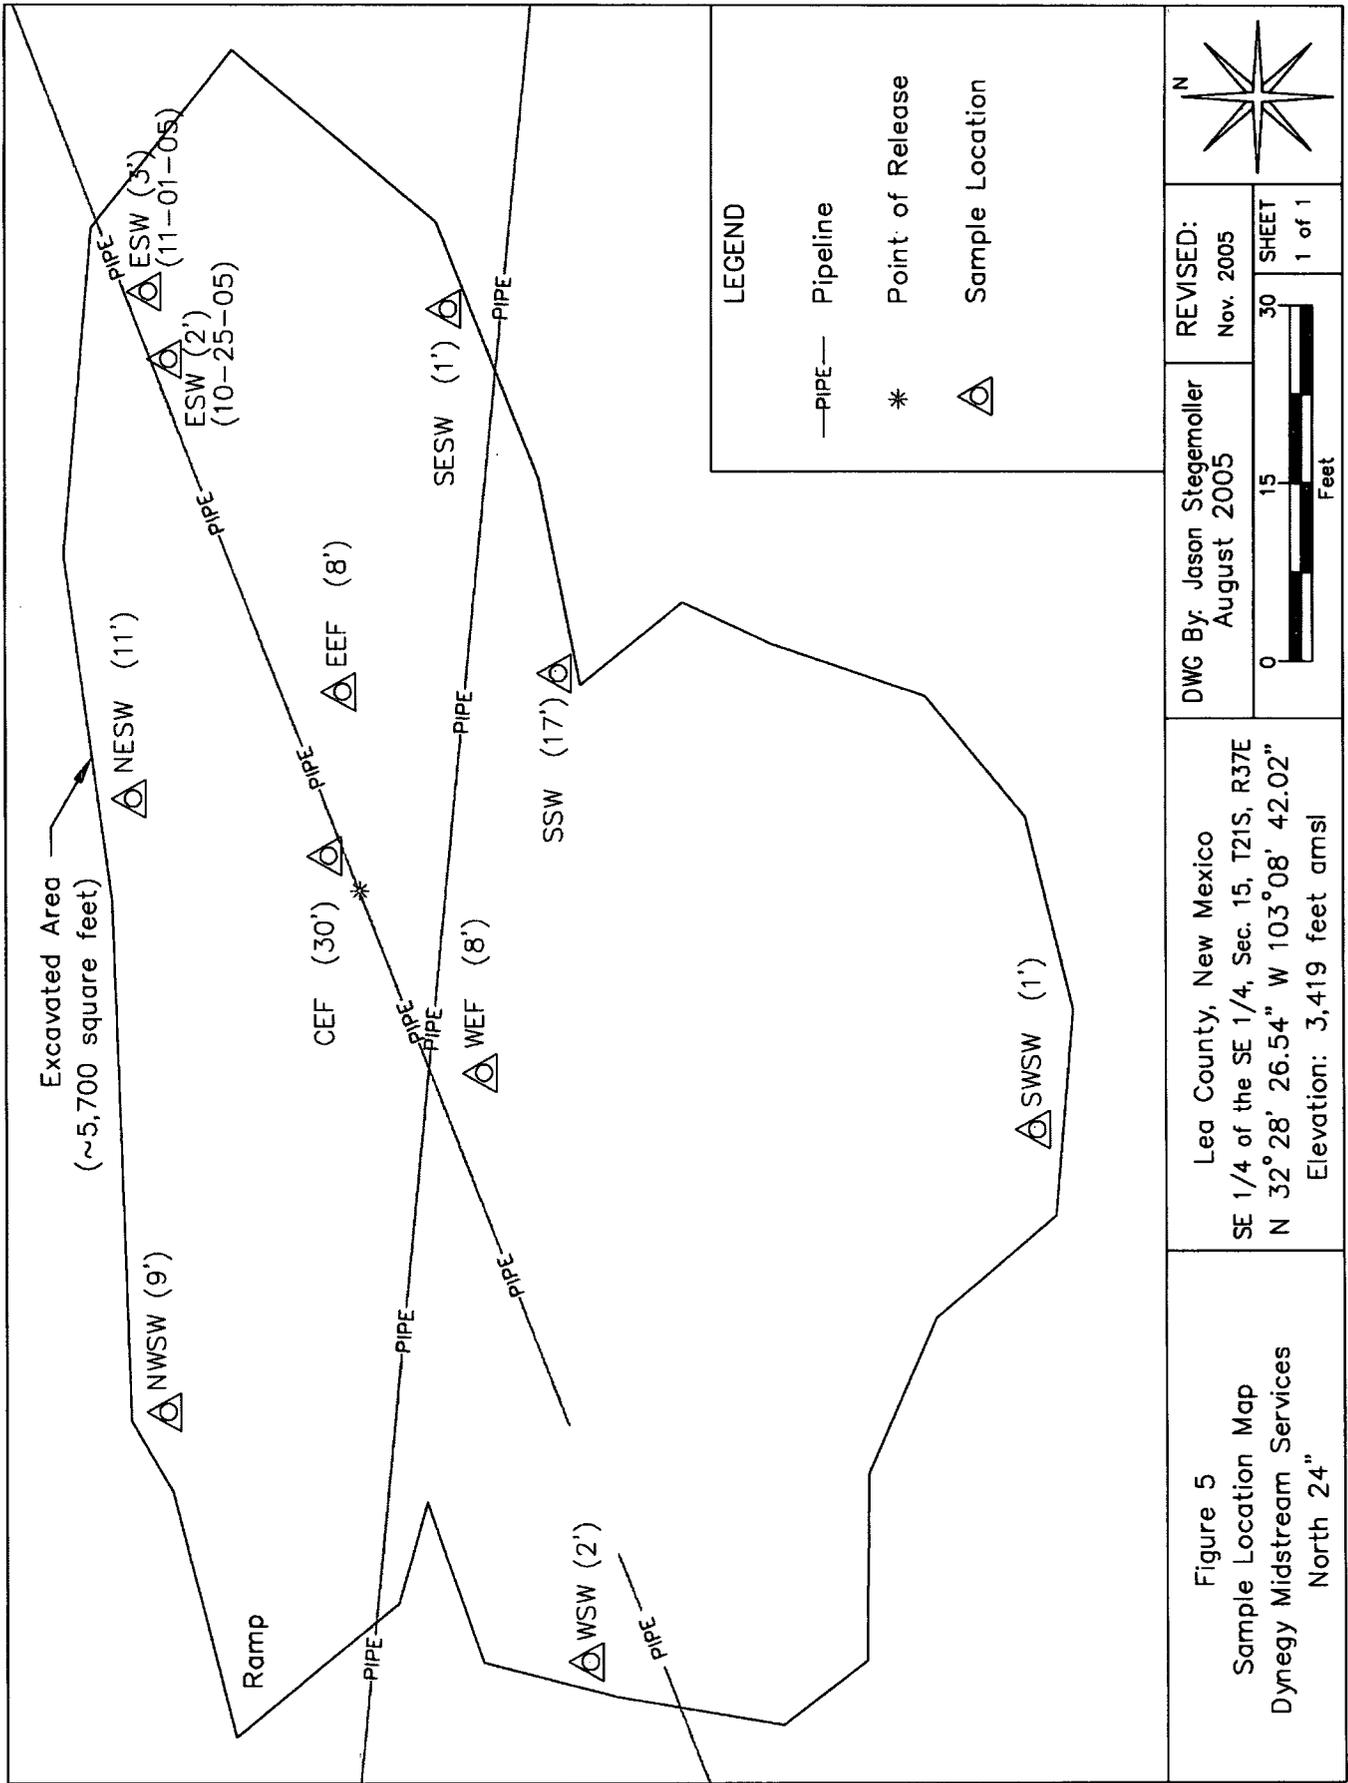
On October 25, 2005, EPI personnel collected 10 grab type soil samples from the excavation sidewalls and floor (reference *Figure 5*). A portion of each sample was placed in a laboratory provided container and set on ice for transport Cardinal Laboratories of Hobbs, New Mexico for quantification of benzene, toluene, ethylbenzene and total xylenes (BTEX) and total petroleum hydrocarbons (TPH). Analytical results for all sample locations indicate hydrocarbon concentrations were below NMOCD remedial thresholds for the site, with the exception of the sample collected from the east sidewall (ESW). Analytical results for sample ESW indicated TPH concentrations were 486 mg/Kg, in excess of the site NMOCD remedial thresholds of 100 mg/Kg (reference *Table 1*).

The excavation currently comprised an area of approximately 5,640 square feet to a maximum depth of 30 feet at the point of release (reference Figure 5). Approximately 2,150 cubic yards of soil impacted above the NMOCD remedial thresholds was excavated and transported to the State of New Mexico approved EPI Land Farm for treatment. Approximately 1,800 cubic yards of clean soil was purchased from the landowner, combined with the previously purchased soil to be utilized as backfill for the excavation.

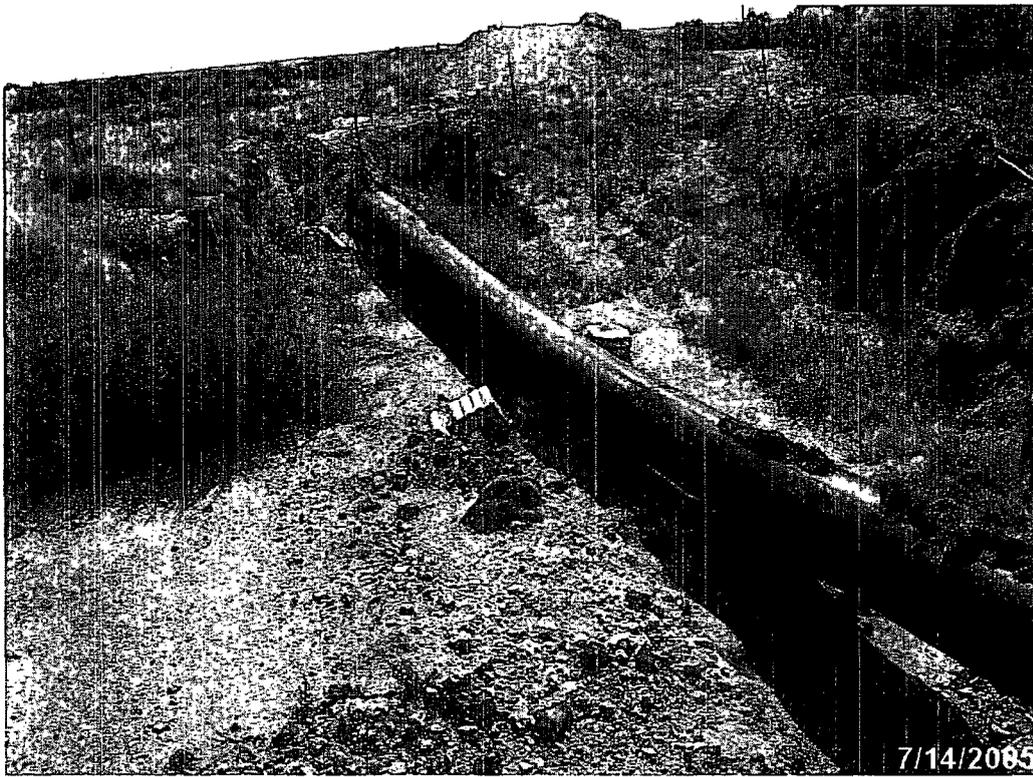
**Photograph #1- Excavation area as of 14 July 2005, looking easterly.**

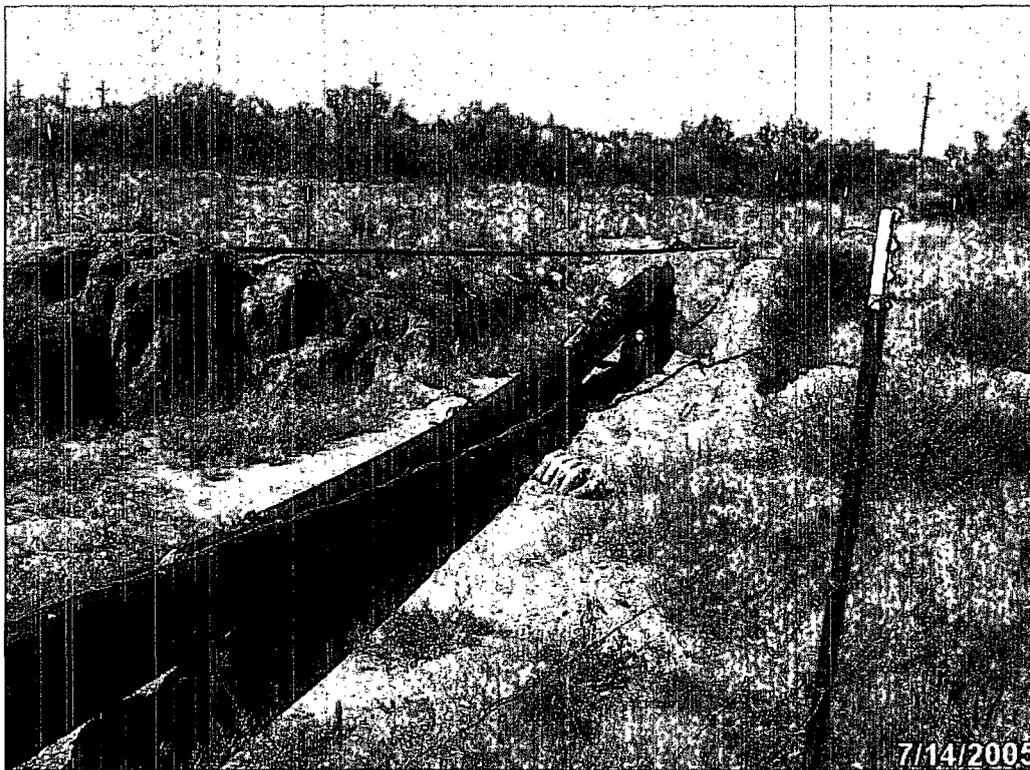
**Photograph #2- Excavation area as of 14 July 2005, looking westerly.**

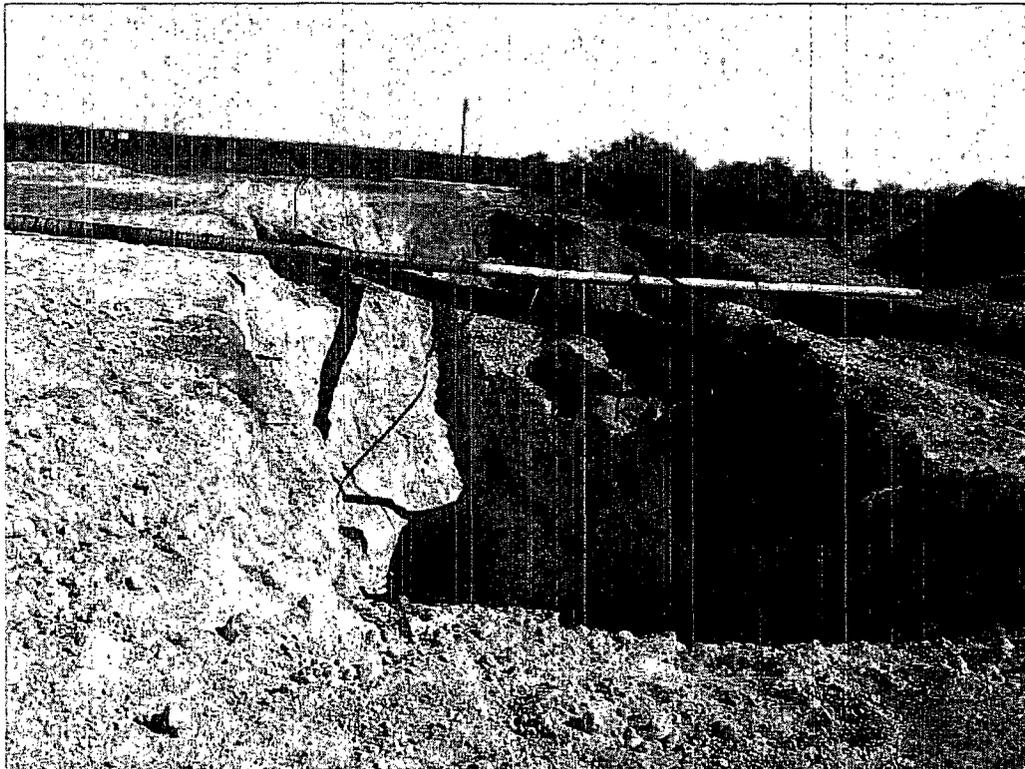
**Photograph #3- Excavation area as of 25 October 2005, looking easterly.**

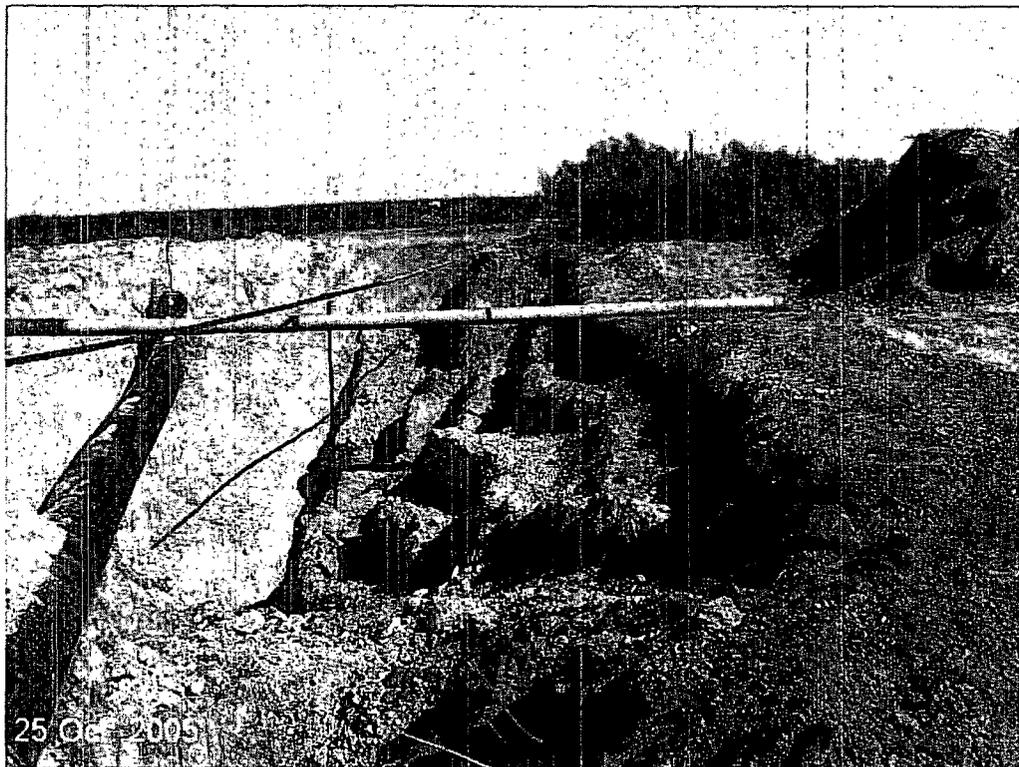
**Photograph #4- Excavation area as of 25 October 2005, looking easterly.**

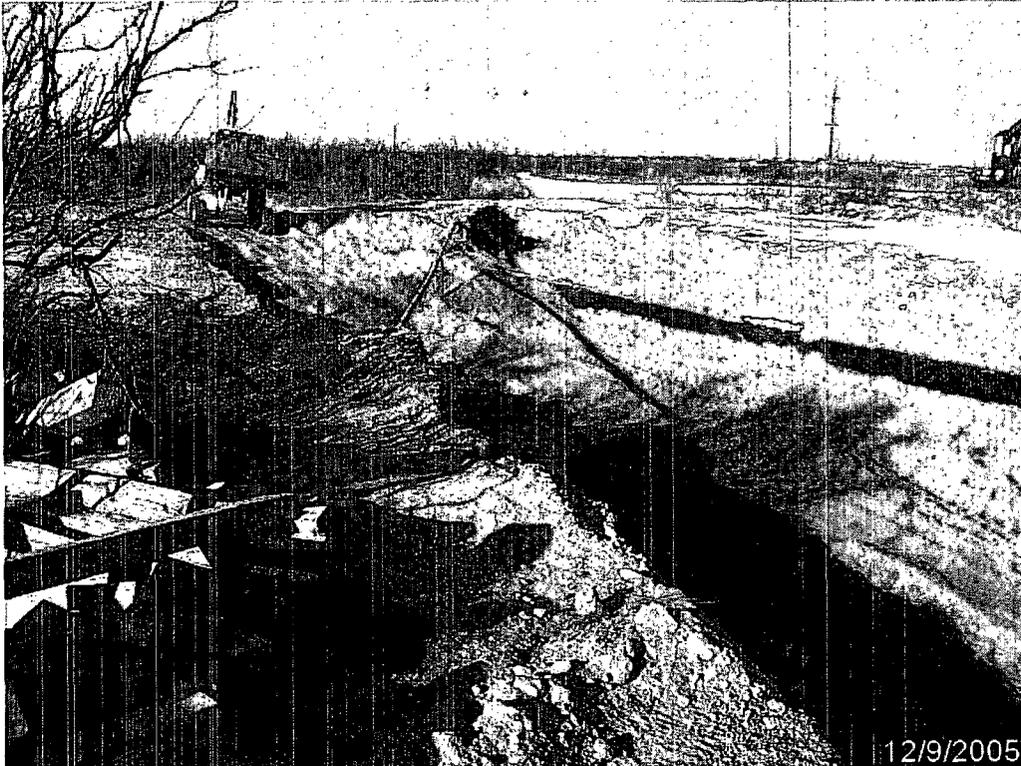
**Photograph #5- Backfilling excavation, looking westerly.**

From December 8 through 12, 2005, the excavation was backfilled with the clean soil and contoured/graded to allow natural drainage. Final remediation activities are limited to seeding the remediation site with a seed mixture preferred by the landowner.

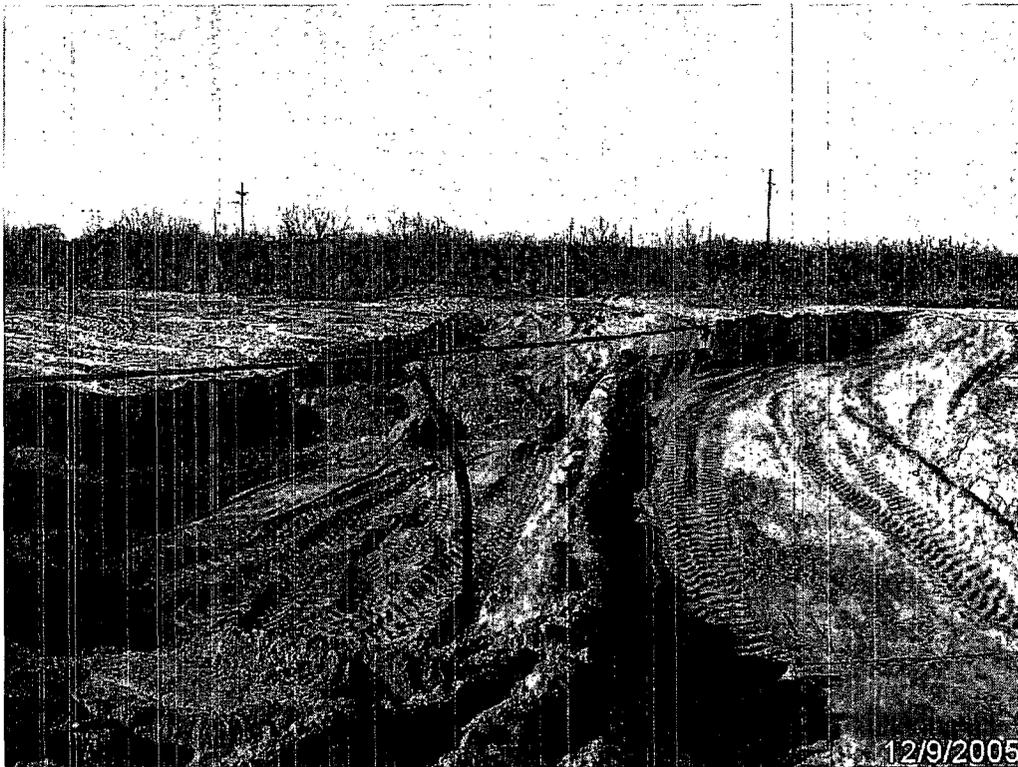
**Photograph #6- Backfilling excavation, looking westerly.**

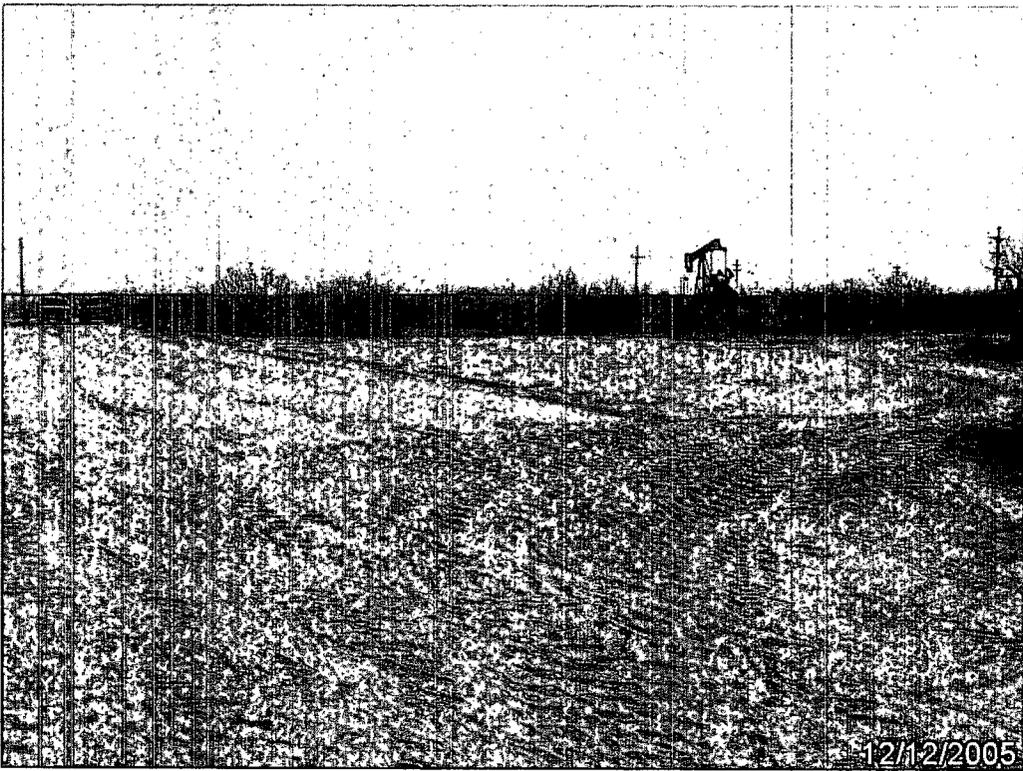
**Photograph #8- Site graded/contoured, looking easterly.**
