P & S BRINE SALES
Eunice, NM
Unit O, Sect. 34, Tws. 21 S., Rng. 37 E.
GPS 32 25' 47"N 103 08' 57"W

WORK PLAN
SAMPLING & SURFACE RESTORATION

Prepared By
Eddie Seay Consulting
June 2006

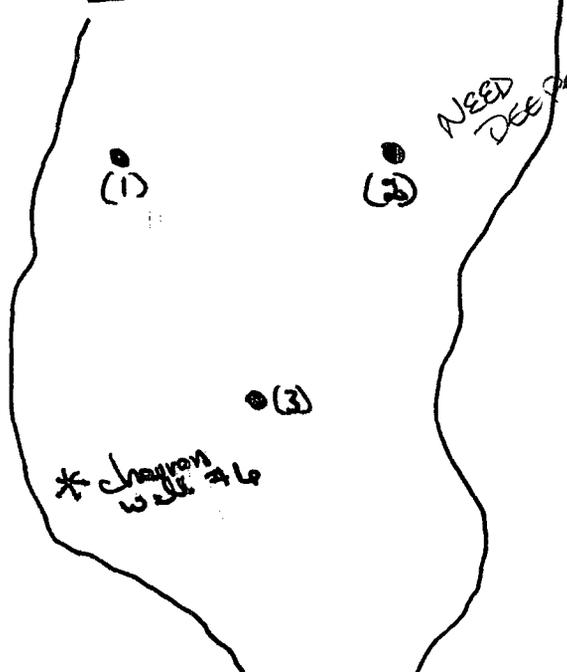
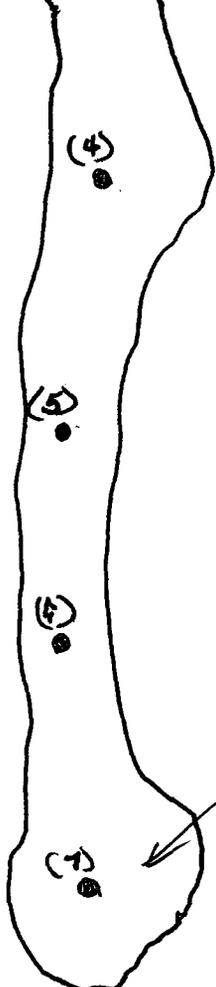
Sampling Points

6.6.06
NEED ADD'L SAMPLE
② DEEPER POINT ON
2 & # 7 TO BELOW 1000 FPM
JASON OK TO PROCEED - 6:30 PM
6.6.06

NEED DEEPER SAMPLE

2450 (NEED DEEPER SAMPLE)

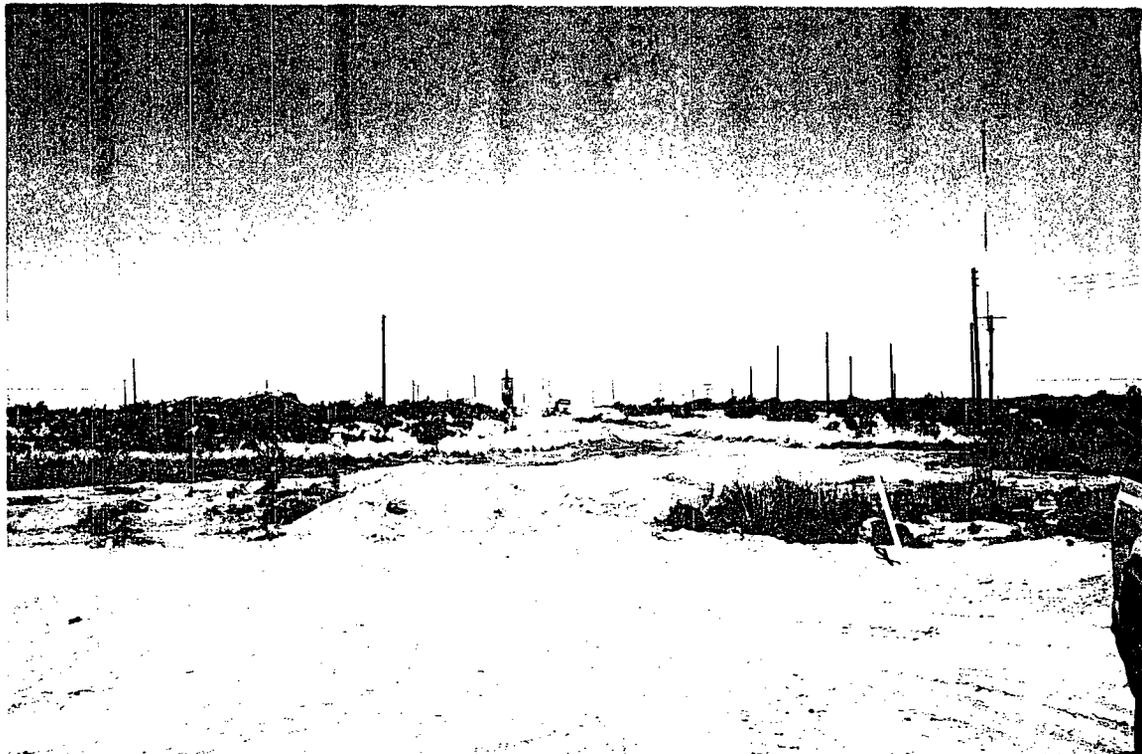
On May 24, we conducted sampling at the site to determine additional cleanup. Seven sites were selected to samples at various depths. (Attached is map and analytical.)

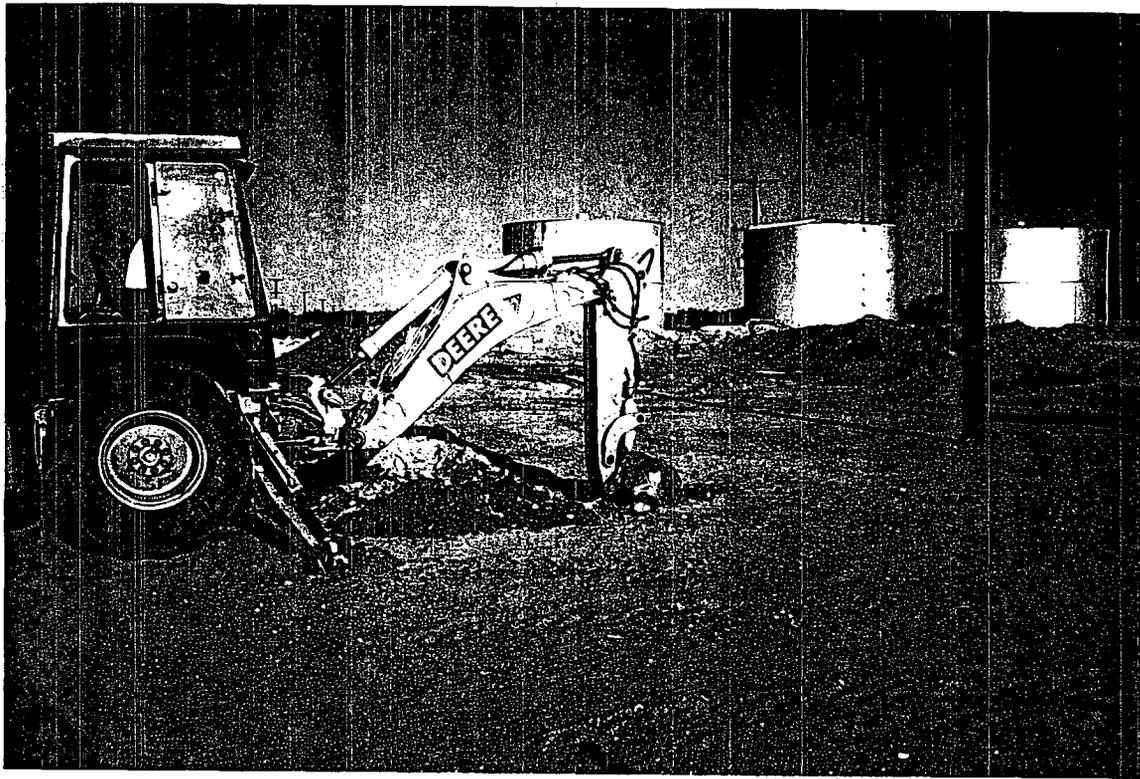
PS
1

PS 1-1	Surface	sand	6E
PS 1-2	2 ft.	sand & clay from 4" to 18"	6E
PS 1-3	5 ft.	caliche from 18" to 5'	
PS 2-1	surface	sand	
PS 2-2	2 ft.	sand & clay 4" to 3'	
PS 2-3	5 ft.	caliche 3' to 5' hard	
PS 3-1	surface	sand	
PS 3-2	2 ft.	sand & clay 4" to 2'	
PS 3-3	4 ft.	very hard caliche	
PS 4-1	surface	sand	
PS 4-2	2 ft.	sand & clay 4" to 2'	
PS 4-3	4 ft.	caliche & hard rock 2' to 4'	
PS 5-1	surface	sand & rock	
PS 5-2	2 ft.	very hard rock -backhoe could not dig	
PS 6-1	surface	sand & rock	
PS 6-2	2 ft.	caliche surface to 18"	
PS 6-3	3 ft.	hard rock - backhoe could not dig	
PS 7-1	surface	sand	
PS 7-2	2 ft.	sand & clay 4" to 4'	
PS 7-3	5 ft.	caliche 4' to 5'
