HESS CORPORATION

Graham Resources Laughlin Battery #82 LEA COUNTY, NEW MEXICO

SITE CLOSURE REPORT

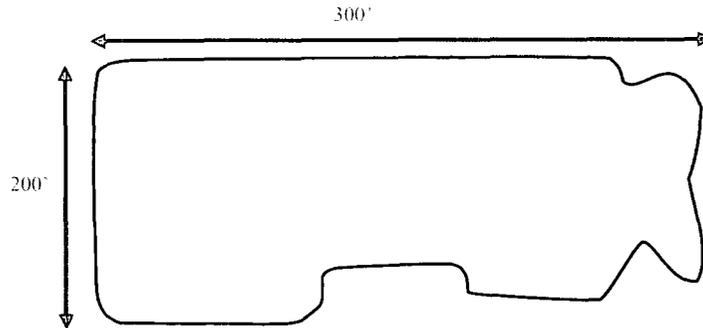
February 1, 2006

A burn pit was located at the southwest corner of the site. On February 1, 2006, a sample was taken at a depth of fifteen (15) feet below ground surface (bgs) at the center of the burn pit. Laboratory analyses on the sample included Chloride, Benzene-Toluene-Ethylbenzene-Xylene (BTEX), and Total Petroleum Hydrocarbons (TPH) – gasoline range organics (GRO)/diesel range organics (DRO). Chloride was 16 parts per million (ppm), GRO was 20.4 ppm, and DRO was 780 ppm. Benzene was 0.263 ppm, Toluene was 0.107 ppm, Ethylbenzene was 0.745 ppm, and Total Xylenes were 0.471 ppm. All site diagrams can be found in Appendix I, laboratory analyticals can be found in Appendix II, site photographs can be viewed in Appendix III, and email correspondences can be found in Appendix IV.

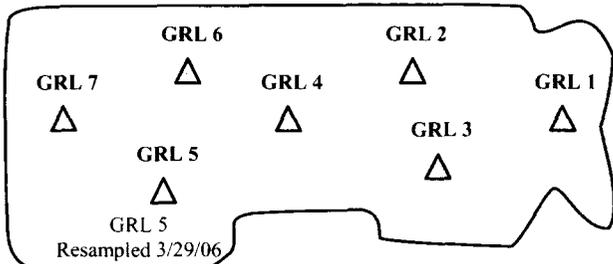
March 13, 2006

NMOCD was notified on March 9, 2006 of closing samples to be collected March 13, 2006. Seven (7) samples were collected from the excavation floor at three (3) feet bgs. GRO was non-detect in all of the samples, and DRO ranged from non-detect to 72 ppm in six (6) of the samples. Sample 5 contained 314 ppm DRO. Chlorides ranged from 16 ppm to 80 ppm, and BTEX was non-detect in every sample except for sample 6. In sample 6, Benzene was 0.003 ppm, Toluene was 0.006 ppm, Ethylbenzene was 0.002 ppm, and Total Xylenes were 0.010 ppm.

The area around sample 5 was excavated an additional foot. On March 24, 2006, NMOCD was informed of the sampling results and that sample 5 would be retaken on March 29, 2006. Sample 5 was collected at four (4) feet bgs. TPH and BTEX were non-detect, and chlorides were 16 ppm.

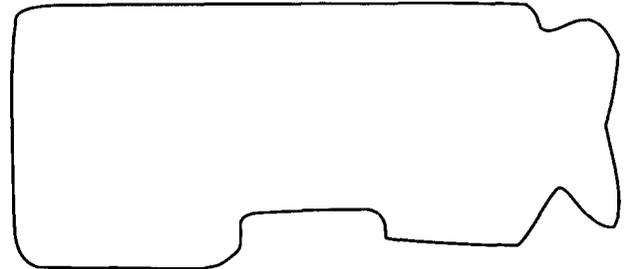
March 20, 2006

On March 17, 2006, BBC notified NMOCD of drilling and sampling to take place at the burn pit on March 20, 2006. One (1) soil boring, SB 1, was placed in the center of the pit, and four (4) soil borings (SB 2, SB 3, SB 4, SB 5) were placed around the perimeter of the pit. SB 1 was drilled to thirty (30) feet bgs with samples taken at three (3) feet, five (5) feet, and at every five foot interval thereafter. The perimeter soil borings were drilled to twenty (20) feet bgs, and were sampled in the same manner as SB 1.

Samples at SB 1 showed that TPH was non-detect at 3', however, there were 3,659 ppm at 5', 3,452 ppm at 10', and 2,137 ppm at 15'. The remaining samples for SB 1 were non-detect for TPH. The perimeter soil boring samples were non-detect for TPH except the 3' and 5' samples taken at SB 4, which were 1,100 ppm and 861 ppm respectively.

BTEX was detected at SB 1 to a depth of 15'. The 3' sample was non-detect for BTEX, however the 5' sample contained 0.238 ppm. The 10' sample contained 2.042 ppm, and the 15' sample had 0.865 ppm BTEX. BTEX was non-detect in all remaining SB 1 samples to 30' bgs. Samples in all other soil borings were also non-detect for BTEX.

At SB1, chlorides were less than 250 ppm in all samples except 15' to 25' bgs. The 15' sample was 496 ppm, the 20' sample was 704 ppm, and the 25' sample was 656 ppm. Chlorides were back to 176 ppm at 30' bgs. At SB 2, chlorides were below 250 ppm except the 20' sample which was 256 ppm. At SB 3, all samples above 20' were below 250 ppm. At 20' bgs, chlorides were 304 ppm. All samples collected from SB 4 and SB 5 showed chlorides to be under 250 ppm.

On March 31, 2006, BBC personnel spoke to NMOCD and proposed to excavate the burn pit to 10' bgs, install a clay liner, and backfill with clean soil. The proposal was approved. *(By whom?)*
