**SOILS CLOSURE REPORT
LIVINGSTON RIDGE STATION
LEA COUNTY, NEW MEXICO
SRS #2005-00204**

Soils Closure Report

**Plains Marketing, L.P.
Houston, Texas**

Talon/LPE PROJECT NO. PLAINS025SIT

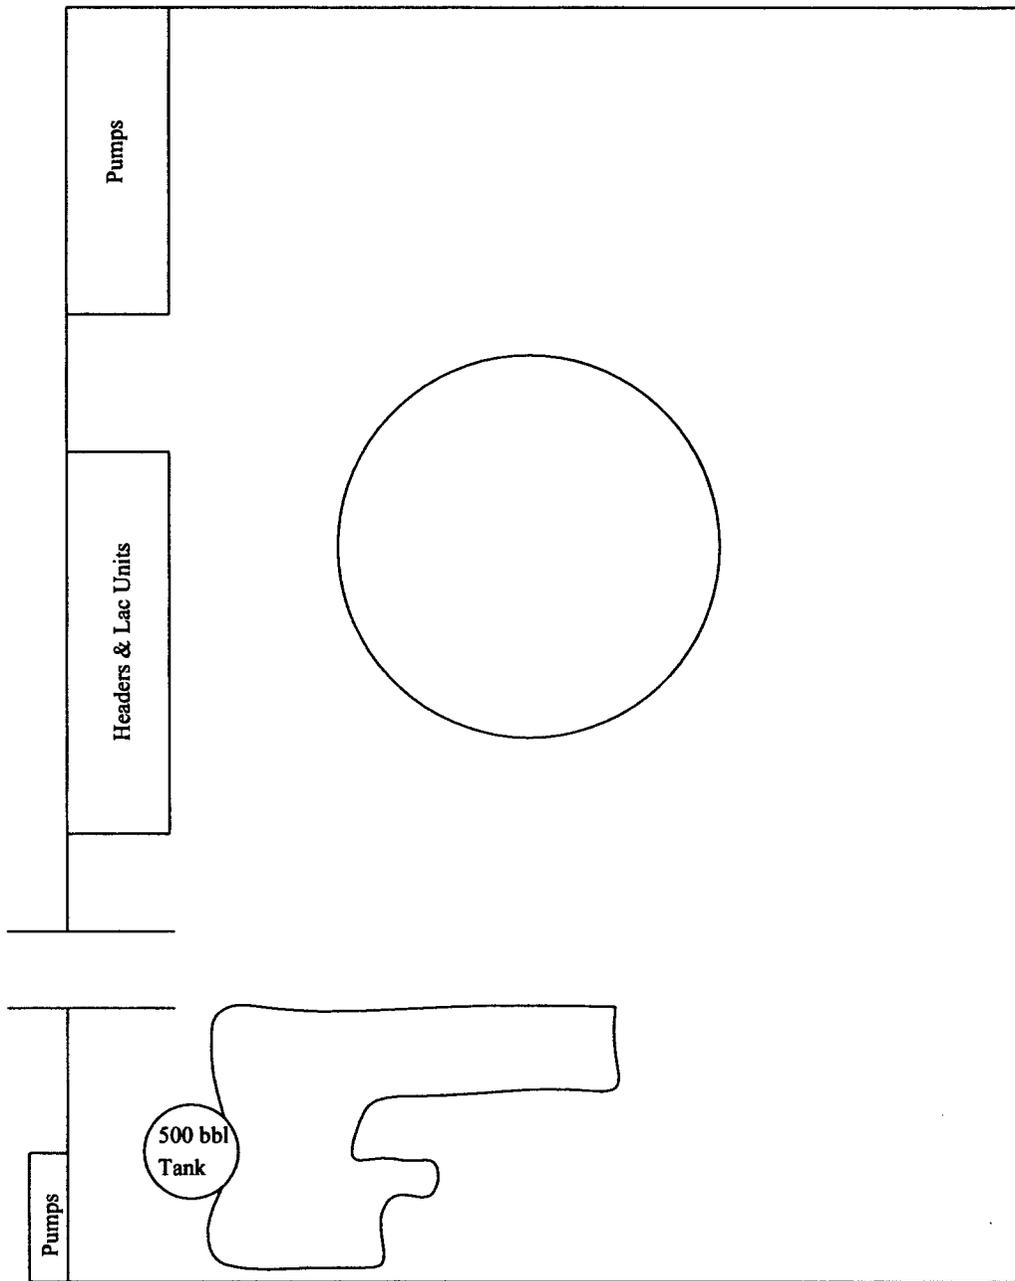
Figure 2
Site Layout Map

On March 2, 2006 HMR&V was contacted by Plains personnel and responded to contain a crude oil spill from a tank overflow. After containing the release, excavation of the release point and flow path was initiated with the excavated soil being placed on a 6-mil poly-liner to be hauled off at a future date. The excavated area is approximately 64 feet long by 41 feet wide by 2 to 3 feet (bgs) (see Figure 2, site map).

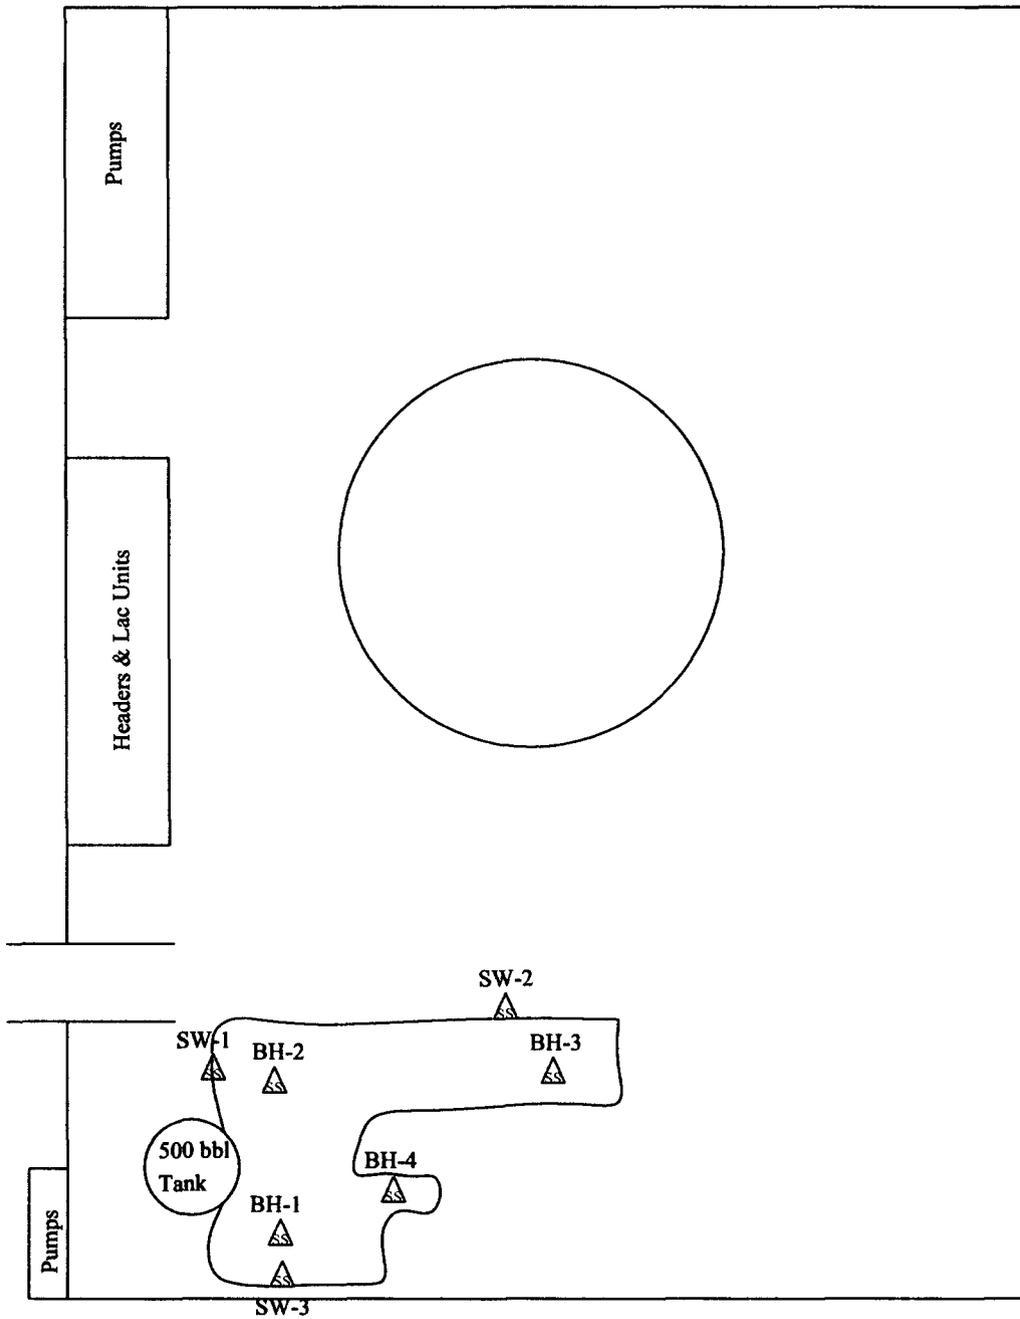
Figure 3
Soil Sampling

On March 10, 2006, confirmation samples were collected from the excavated area. The samples were field screened with a PID, (see Figure 3, soil sampling locations). All selected soil samples were analyzed for benzene, toluene, ethylbenzene, and xylenes (BTEX), and total petroleum hydrocarbons-gasoline range organics/diesel range organics (TPH-GRO/DRO). Laboratory results of the confirmation soil samples indicated that the walls and the floor of the excavated area were below NMOCD regulatory standards for BTEX and TPH concentrations (see Appendix B, Table 1, soil chemistry table).

Analytical results from the March 10, 2006 soil sampling event indicated that the concentrations of BTEX and TPH were below NMOCD regulatory limits for the bottom and the sidewalls of the excavation.

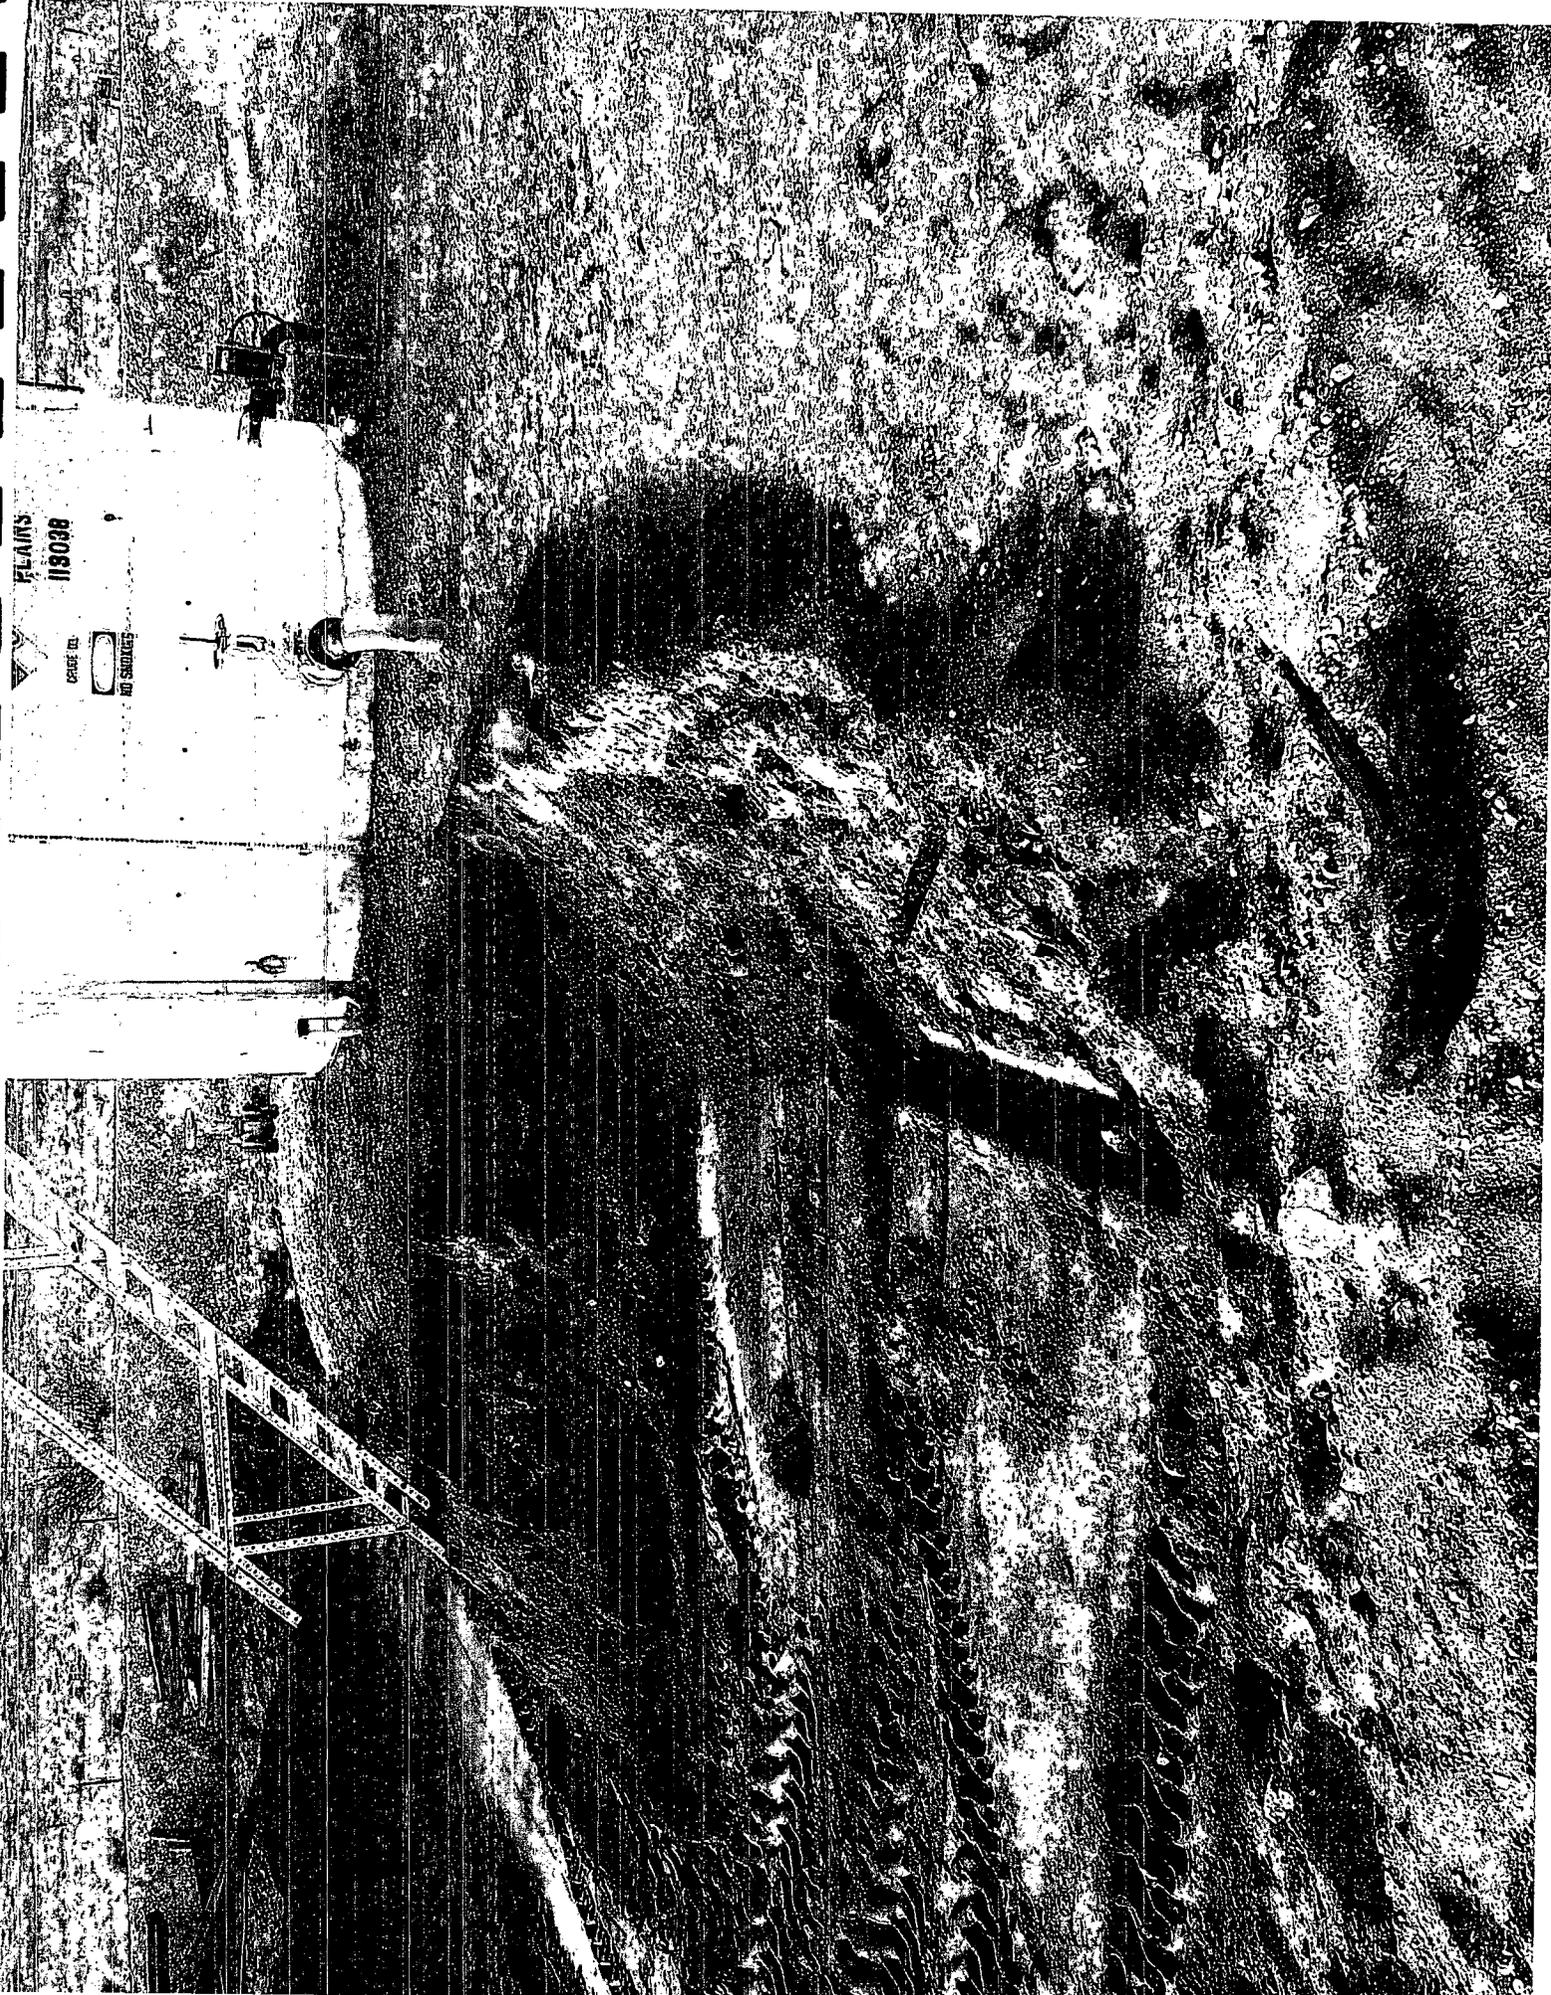
View looking south at excavated area.
