ENVIRONMENTAL PLUS, INC.
CONSULTING AND REMEDIAL CONSTRUCTION

RE: Closure Report
ExxonMobil Bridges State 120 (Ref. #190020)
UL-B (NW¼ of the NE ¼) of Section 14, T17S, R34E
Latitude N 32° 50' 20.4" and Longitude W 103° 31' 38.7"

ExxonMobil retained Environmental Plus, Inc. (EPI) to delineate the extents of contamination at the above-referenced site. This letter report documents the delineation and remediation activities performed.

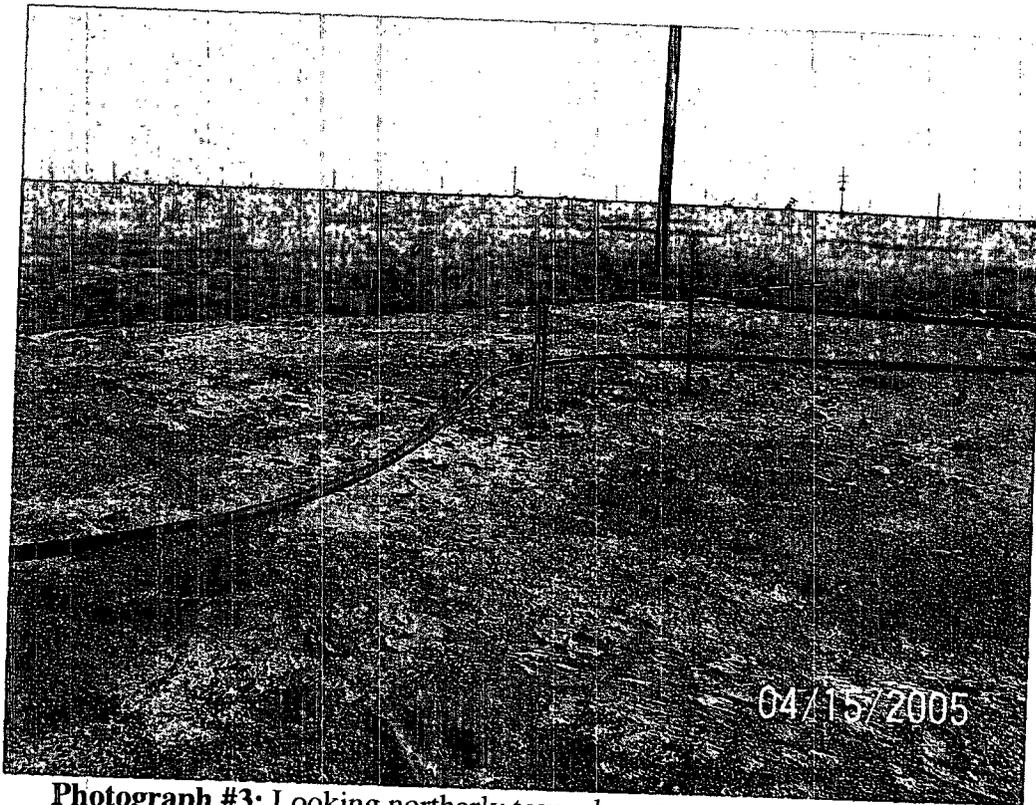
Photograph #3: Looking northerly toward pasture area. Stained caliche indicates contamination.

Based on information obtained during delineation activities, excavation of impacted soil in the pasture area commenced on May 9, 2006. The excavation area totaled approximately 7,000-square feet excavated to a maximum depth of 5-feet bgs. The excavation area was comprised of a northern and southern excavation of 2,900 and 4,100-square feet, respectively. Approximately 2,651-cubic yards of soil were excavated and separated. Approximately 1,635-cubic yards of rock were obtained after separation and stockpiled on site for use as backfill material. The remaining portion of soil, approximately 1,016-cubic yards, was transported to Sundance Services, Inc. for disposal.
