HESS CORPORATION

TEXACO "J" STATE BATTERY #15 LEA COUNTY, NEW MEXICO

SITE CLOSURE REPORT

October 12, 2006

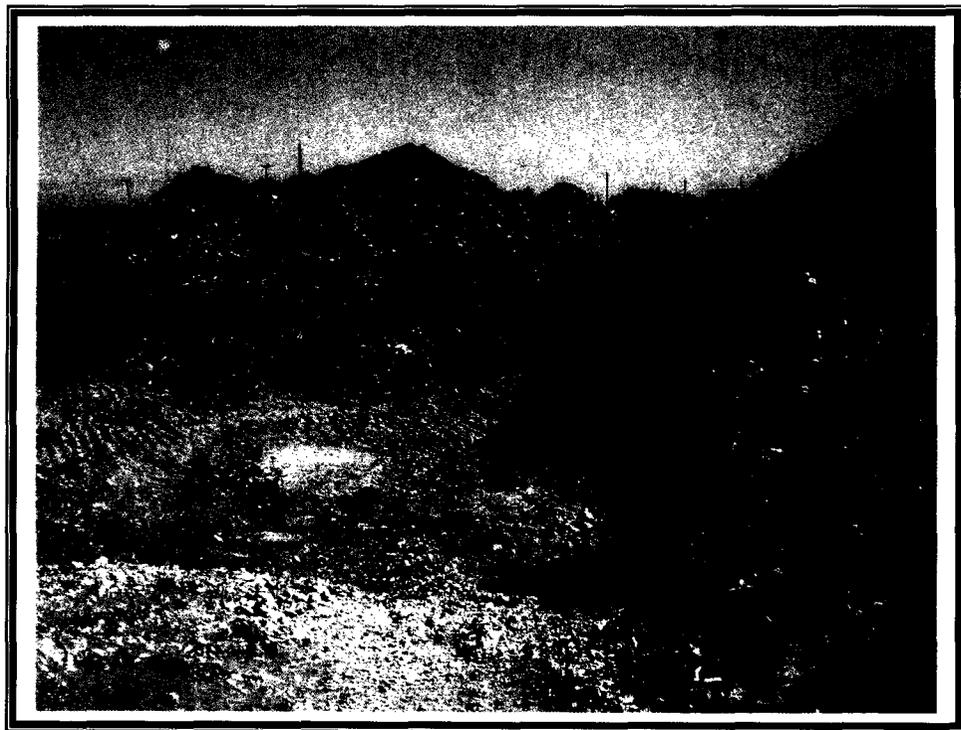
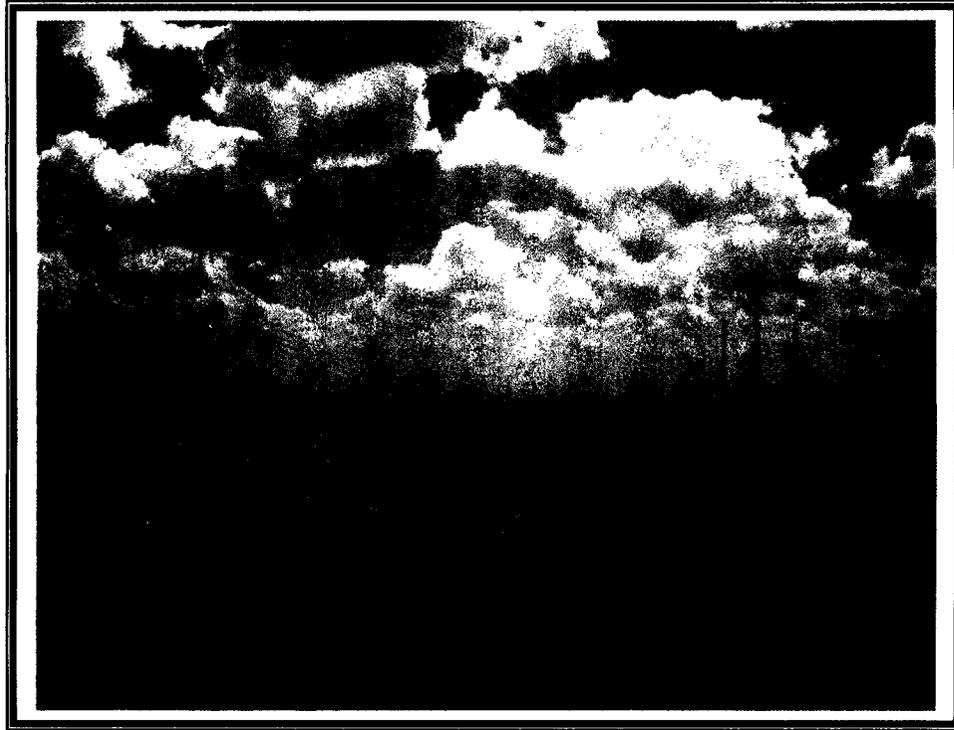
Texaco "J" State Battery #15 burn pit excavation

On June 9, 2006, BBC personnel drilled five (5) soil borings at the burn pit which was excavated to 10 feet below ground surface (bgs). A borehole was placed in the center floor of the pit and four (4) boreholes were placed in the area immediately surrounding the pit. Soil samples were collected from each borehole at 3 bgs, 5 feet bgs, and at every five foot interval thereafter. BBC screened all samples with a photoionization detector (PID) and field chloride tests. Samples were submitted to a laboratory for analyses depending on screen results, as were all samples from the 20 foot bgs range. A total of 16 samples from the burn pit were analyzed for total petroleum hydrocarbons (TPH) – gasoline range organics (GRO)/diesel range organics (DRO), chloride, and benzene-toluene-

On July 5, 2006 BBC sent an email to NMOCD confirming an agreement to backfill the burn pit. NMOCD approved the backfill the same day. Hess was not required to excavate further. The excavation was backfilled with clean caliche up to four (4) feet bgs. A compacted clay layer of one (1) foot thickness was installed. The remaining three (3) feet of the excavation was backfilled with clean topsoil.

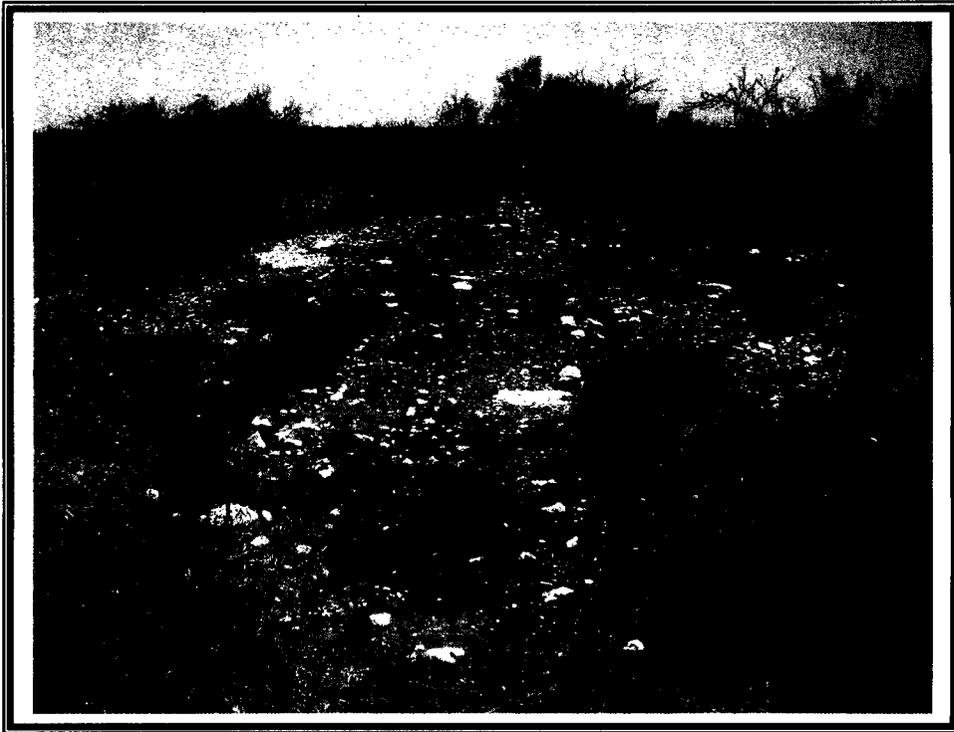
Texaco "J" State Battery #15 flare line area before excavation

On June 26, 2006, a flare line area was excavated to about 1 foot bgs, and BBC collected 3 samples from the floor of the excavation. GRO was non-detect in all samples, DRO ranged from non-detect to 45.3 ppm, chlorides ranged from 16 ppm to 48 ppm, and BTEX was non-detect in all samples.

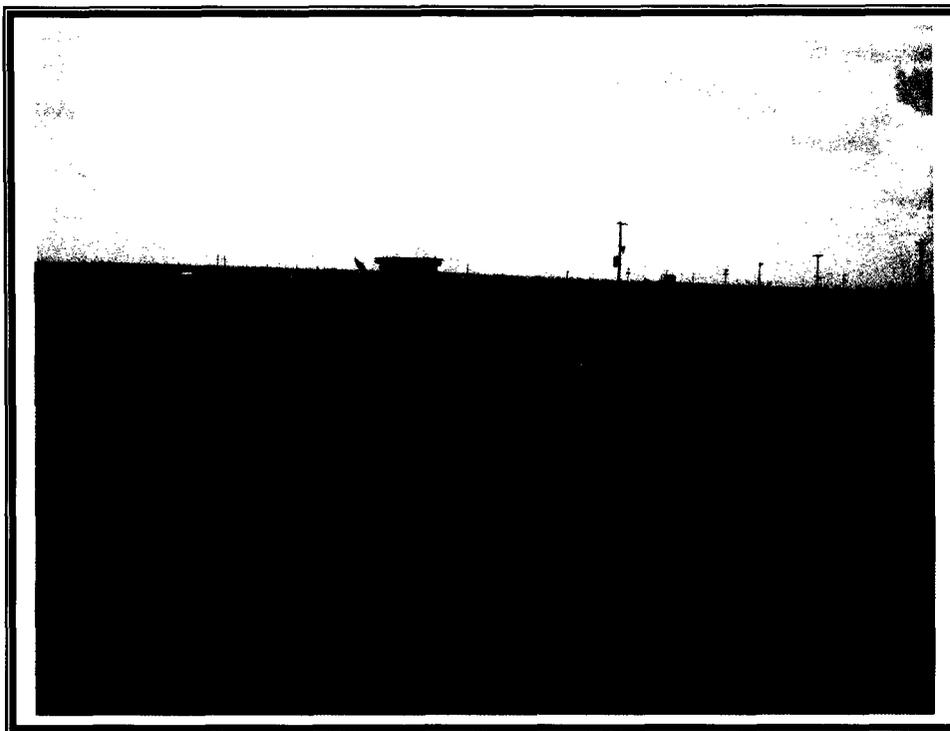
Texaco "J" State Battery #15 burn pit clay liner

Texaco "J" State Battery #15 burn pit clay liner—addition of water for compaction

Texaco "J" State Battery #15 clay liner compaction

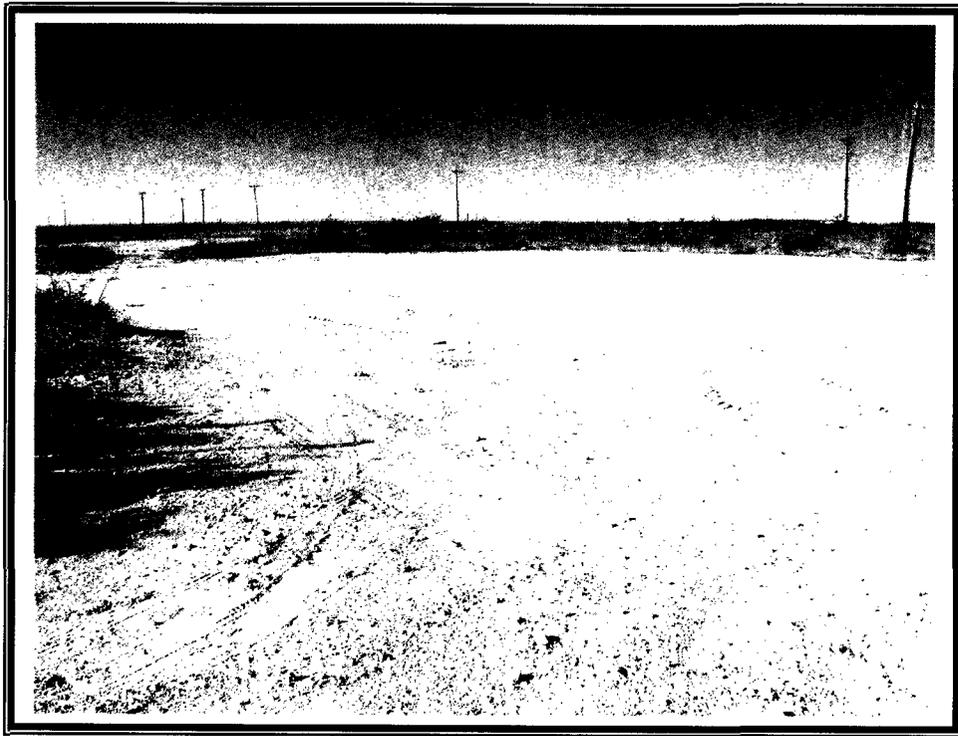
Texaco "J" State Battery #15 flare line area after reseeding

Texaco "J" State Battery #15 tank battery area after reseeding

Texaco "J" State Battery #15 burn pit area after reseeding

Site excavation was completed on June 16, 2006, and 6,656 yards of contaminated soil was hauled to a landfarm. Backfilling and contouring was completed with a total of 4,636 yards of clean soil on August 2, 2006. The site was seeded on September 25, 2006.
